STATE OF WASHINGTON
DEPARTMENT OF ECOLOGY

February 27, 2013

Re: Further Action at the following Site:

- **Site Name:** Clarion Hotel
- **Site Address:** 900 Capitol Way South, Olympia
- **Facility/Site No.:** 9488181
- **Cleanup Site ID No.:** 348
- **VCP Project No.:** SW1266

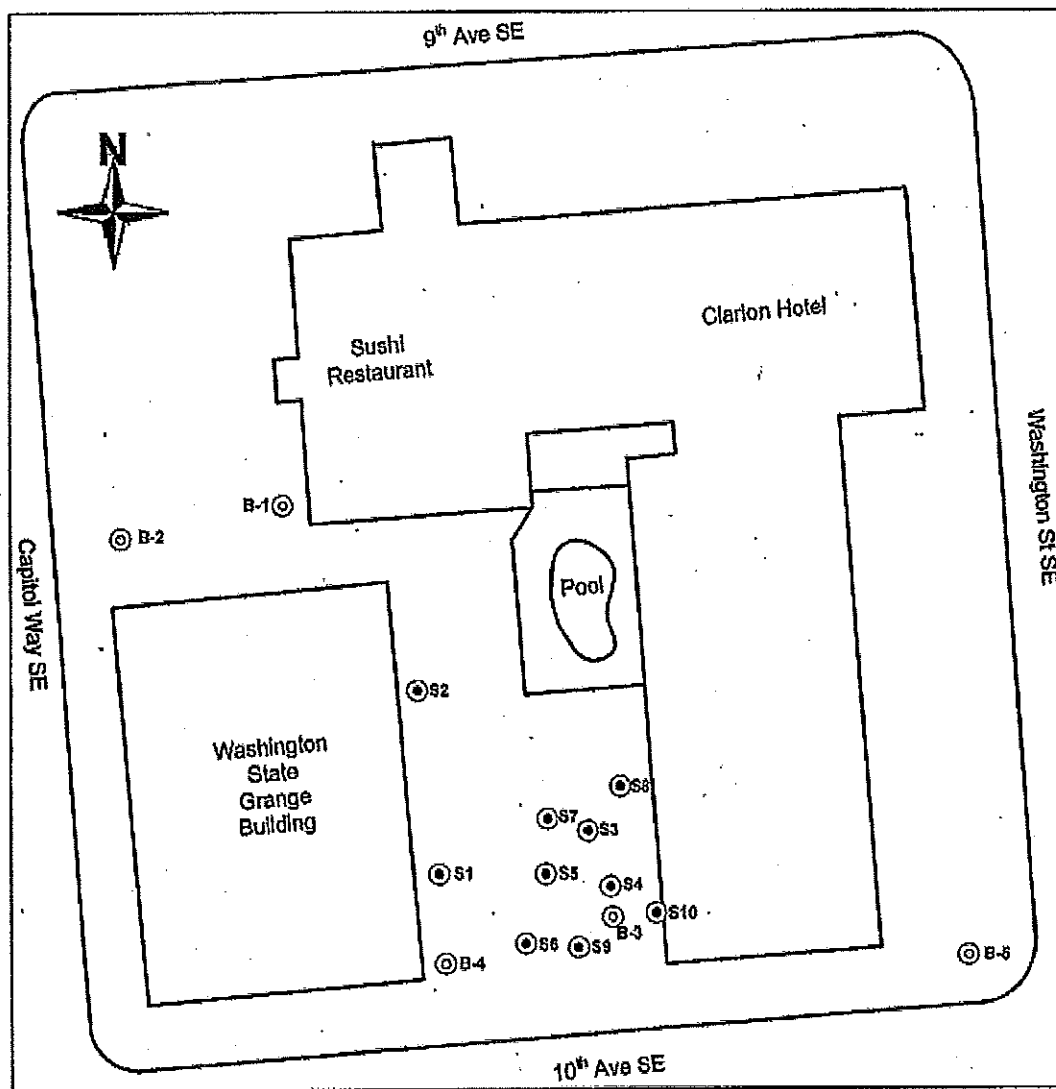
Fig. 2 Soil (and groundwater) sampling locations at Clarion Hotel Site (Courtesy of Envitech, LLC)

2. For the March 14, 2008 sampling event, it appears that one groundwater sample was collected from Boring S5 at the Site during this sampling event according to Figure 5 of the report. This sample was identified as "W", and TPH-Dx was detected at a concentration of 4,900, but no unit was specified. However, according to the legend of the figure, soil and groundwater standards were provided and the values matched the MTCA Method A cleanup levels in their respective units of mg/kg and ug/L, in which

case, the TPH-Dx in groundwater exceeded the MTCA Method A cleanup level of 500 ug/L. Boring S5 is located at the south central part of the Site, close to where the UST was removed. Additional groundwater sampling is warranted to characterize the groundwater plume at this area.

- The adjacent Washington State Grange Building is also a confirmed petroleum contaminated site, which has not been cleaned up, its facility number is 1439).
- B1 through B5 were advanced by Associated Environmental Group (AEG) on Feb. 12, 2008.
- S1 through S10 were advanced by Envitech, LLC on March 14, 2008 before soil excavation.

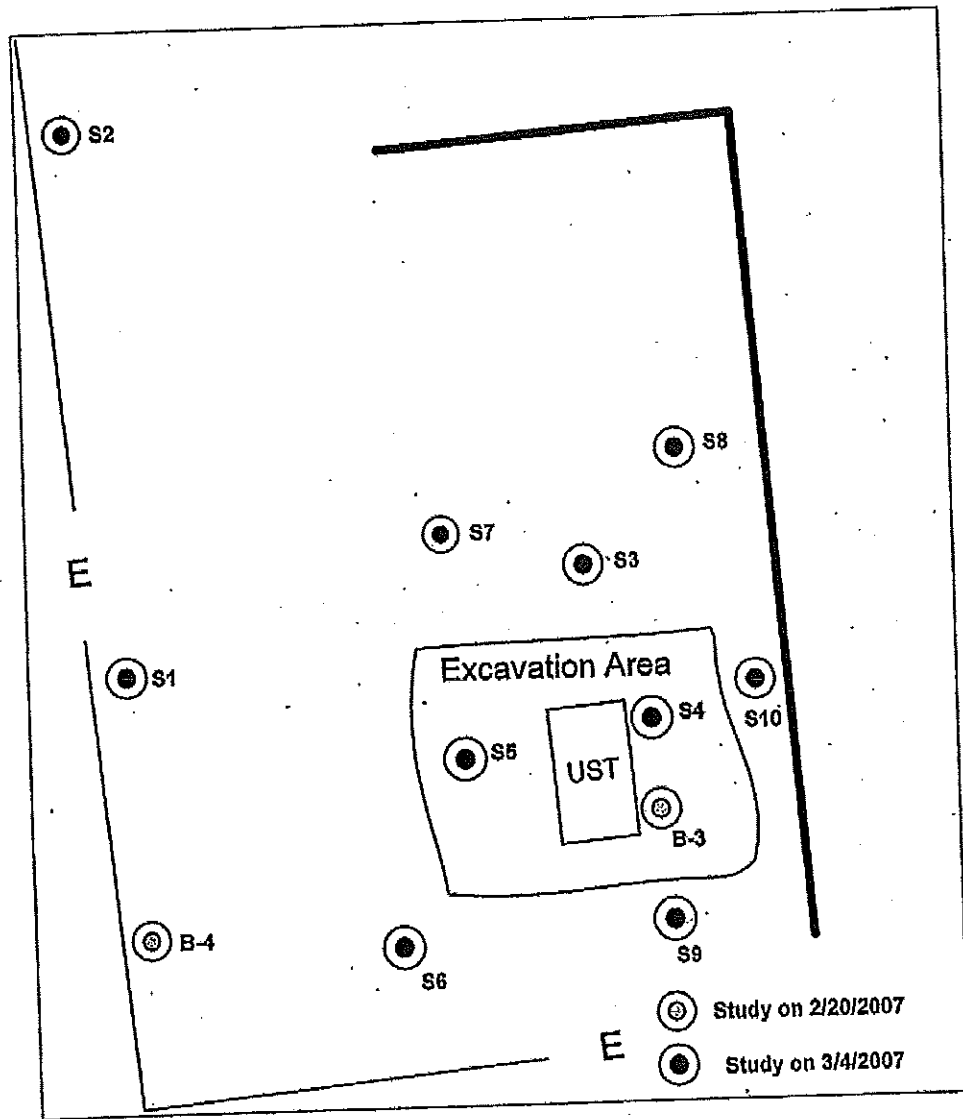
Fig 3. Location map of the heating oil underground storage tank (UST) and the extent of soil excavation. The Excavation started on October 16, 2008, and completed on October 21, 2008

- Without previous information, a heating oil UST was discovered during the soil excavation. The single-walled steel UST was at a depth of approximately 4 feet bgs and was approximately 46 inches in diameter and 8 feet long. The UST was removed by Birk Enterprises, Inc. on October 18, 2008. The slurry and heating oil remaining in the UST was removed with vacuum truck by Marine Vacuum Service, Inc. and the UST was disposed of after triple rinses.

Additional inconsistency exists with regard to extent of contamination and the volume of contaminated soil disposed of. The Remedial Action Report (Envitech, LLC., Nov. 4, 2008) stated that the excavation pit was 16 feet by 16 feet, and 16 feet deep, which should have yielded a total of 151 cubic yards of removed soil. On page 3, under Section 1.4 of this report, however, it stated that "contamination area was estimated with dimensions of an approximately 40 feet by 15 feet, and a thickness of an approximately 13 – 15 feet. A total of approximately 280 – 330 cubic yards of soil appear to be contaminated with petroleum contaminants." On the other hand, the final amount of soil disposed of was only 70 tons, if assume the bulk density of the soil as 1.65 gram per cubic centimeter, the volume of the 70 tons of soil is only 55 cubic yards, which was significantly less than the estimated volume of 280 – 330 cubic yards, and also significantly less than the volume of the excavated soil (151 cubic yards). Clarification of the amount of soil excavated and disposed of, and the extent of contamination (also see Section 1 of this letter), is warranted.
