Re: 20 Day Release Report
De Vere & Sons Dist., Inc.
Cle Elum, Washington

Pacific Northern Environmental Corp. ("PNE") has prepared this letter to summarize the activities performed to date in response to the diesel fuel release that occurred at the De Vere & Sons Distributing, Inc., Cle Elum, Washington Mini Mart Service Station / Bulk Facility ("the Site"). This report is prepared in conformance with the WDOE publication "Guidance for Remediation of Releases from UST's".

Re: Supplement to 20 Day Release Report
Suspected Diesel Fuel Release
De Vere & Sons Dist. Inc.
Cle Elum, WA.

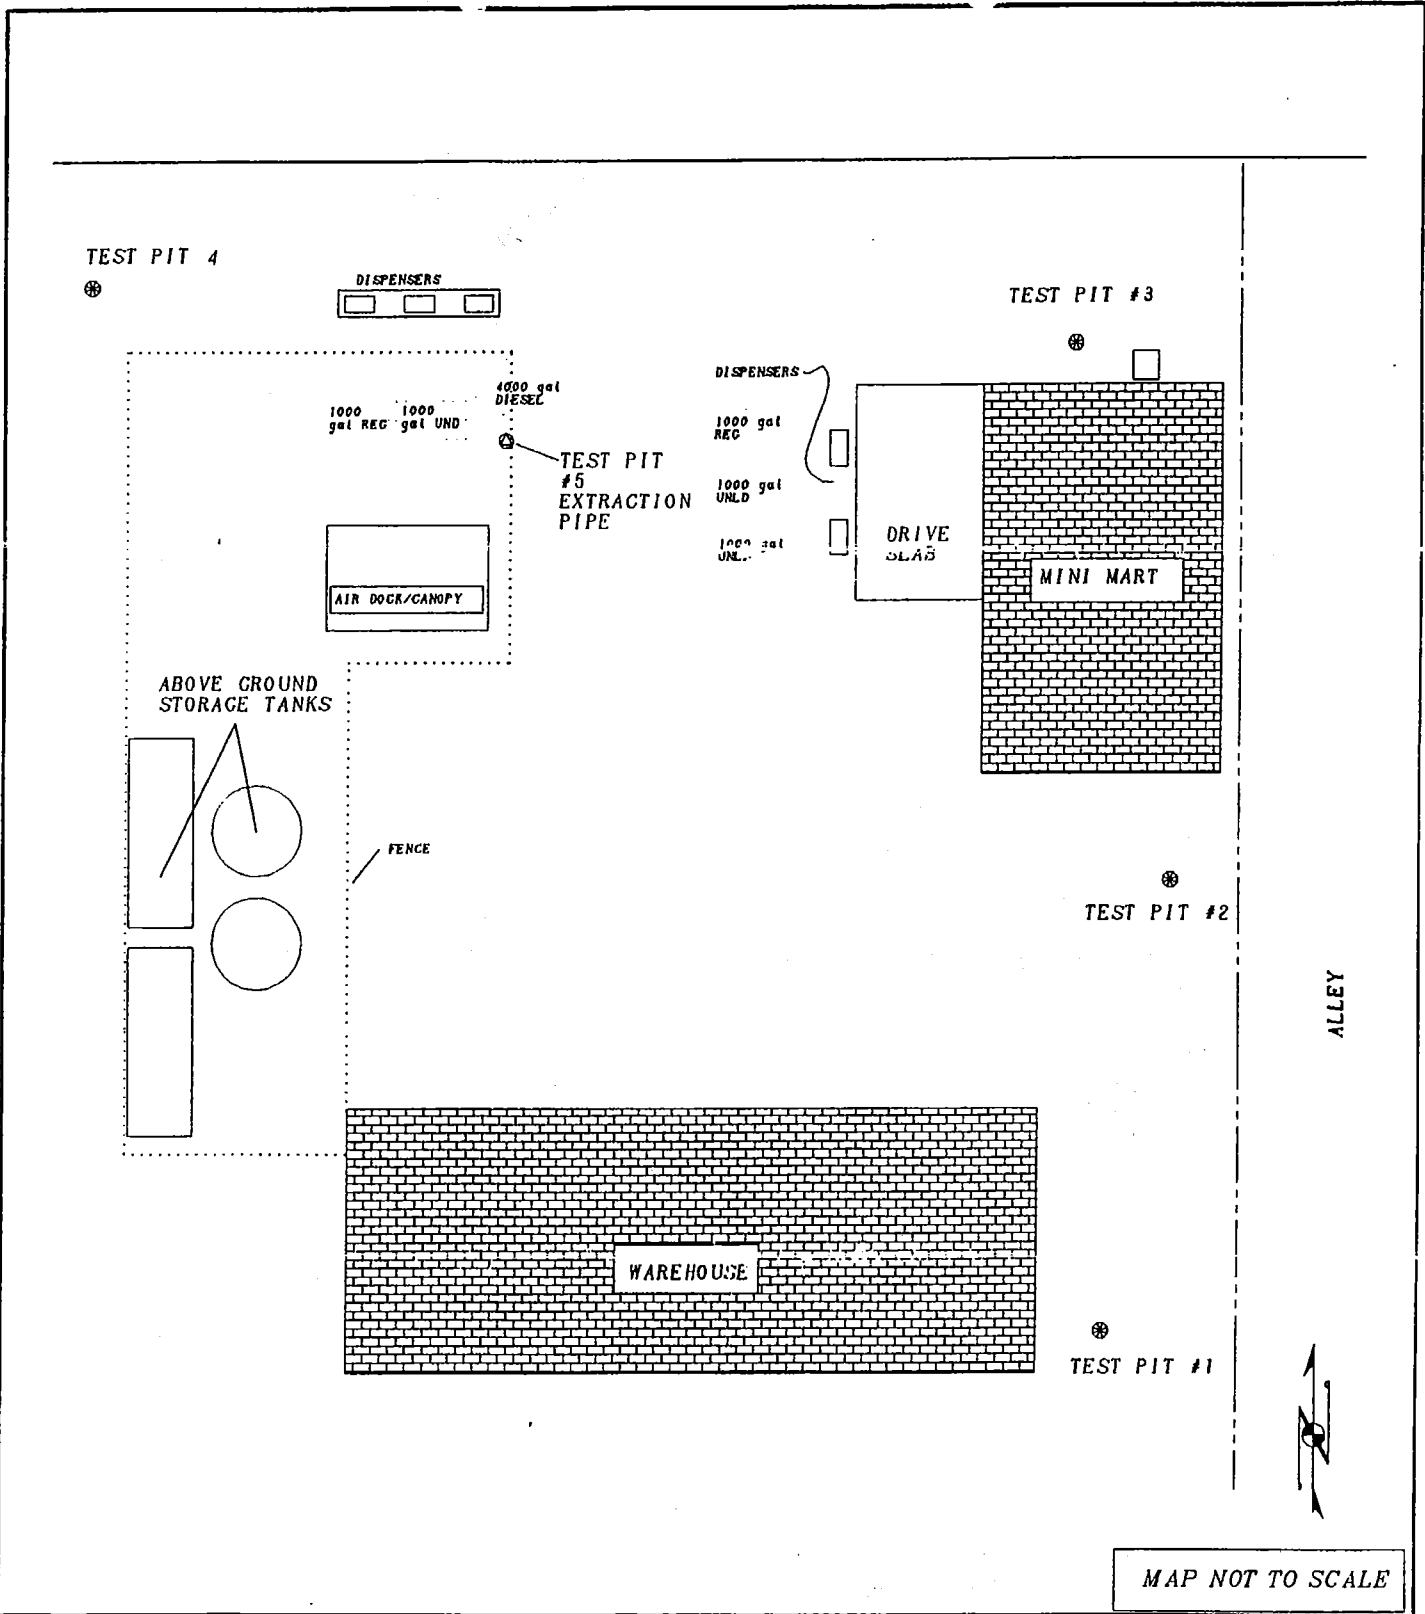
FIGURE 1

SITE MAP

On March 12, 1994 PNE began excavating the test pits with a backhoe. Please refer to the attached Site Vicinity Map for test pit locations. Test pits 1,2,3 and 4 were excavated to a depth of 8 feet below ground surface; groundwater was encountered at approximately 7 feet 5 inches below ground surface. Field screening was performed on soil as it was excavated from the test pits. Field screening consisted of photoionization detector readings, visual observations and odors. Petroleum hydrocarbon compounds were not identified (via field screening) in soil. Groundwater was encountered in test pits 1,2,3 and 4, however no petroleum sheens or field screening detectable observations of petroleum hydrocarbon compounds were noted. Soil samples from the soil water interphase and groundwater samples were collected from the four test pits. The samples were delivered to a laboratory for chemical analyses to determine the presence of petroleum hydrocarbon compounds.

Test pit 5 was then excavated. Test pit 5 was located as close to the leak location as possible, approximately 15 feet away from the leak location to the east. At a depth of approximately 6 feet below ground surface, field screening of detectable petroleum hydrocarbon compounds was observed in soil. At a depth of 7 feet 5 inches below ground surface, groundwater was encountered. Liquid phase hydrocarbons was measured on the groundwater surface at approximately 1/2 of an inch in thickness. The test pit was further excavated to a depth of 9 feet below ground surface and a 12' diameter perforated PVC extraction pipe was installed into the test pit. The test pit was then backfilled with clean 7/8 inch minus gravel. The associated soil generated while excavating test pit 5 was placed on and covered with visqueen.
