STATE OF WASHINGTON
DEPARTMENT OF ECOLOGY

Re: No Further Action at the following Site:

- Name: Webb Property Auto Dismantlers
- Address: 2402 Gibson Rd., Everett, WA
- Facility/Site No.: 7444412
- CS ID: 2722
- VCP No.: NW2700

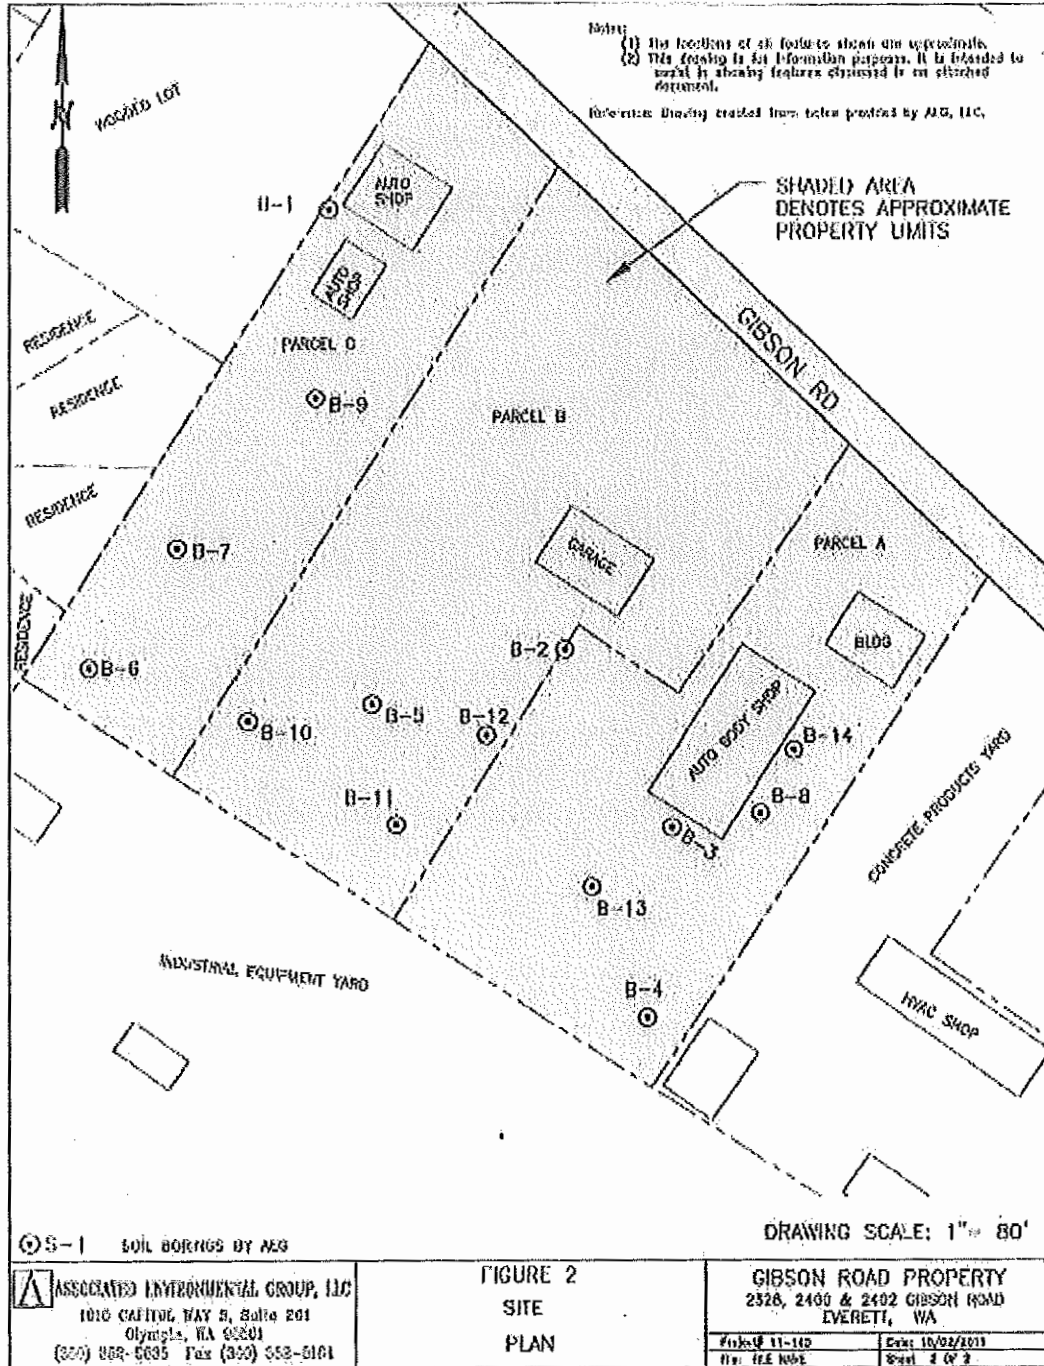
Figure 2 Locations of the Soil Borings

The Phase II investigation included 14 soil borings advanced from 3 to 18 feet below ground surface (bgs). The soil sample analytical results obtained from the borings (Figure 2) revealed that all of the analytes except chromium were at non-detectable levels. Chromium was exhibited with concentrations ranging from 9 to 17 mg/kg, which is below the MTCA Method A cleanup level.

Groundwater: The compact, dense nature of glacial till and the associated soil characteristics existing at the Site limits the presence and movement of groundwater. Perched water was encountered in a thin, isolated sand lens within the till in soil boring B-14 at approximately 16 feet bgs, but it was present in less than sufficient quantity for collection of a groundwater sample.

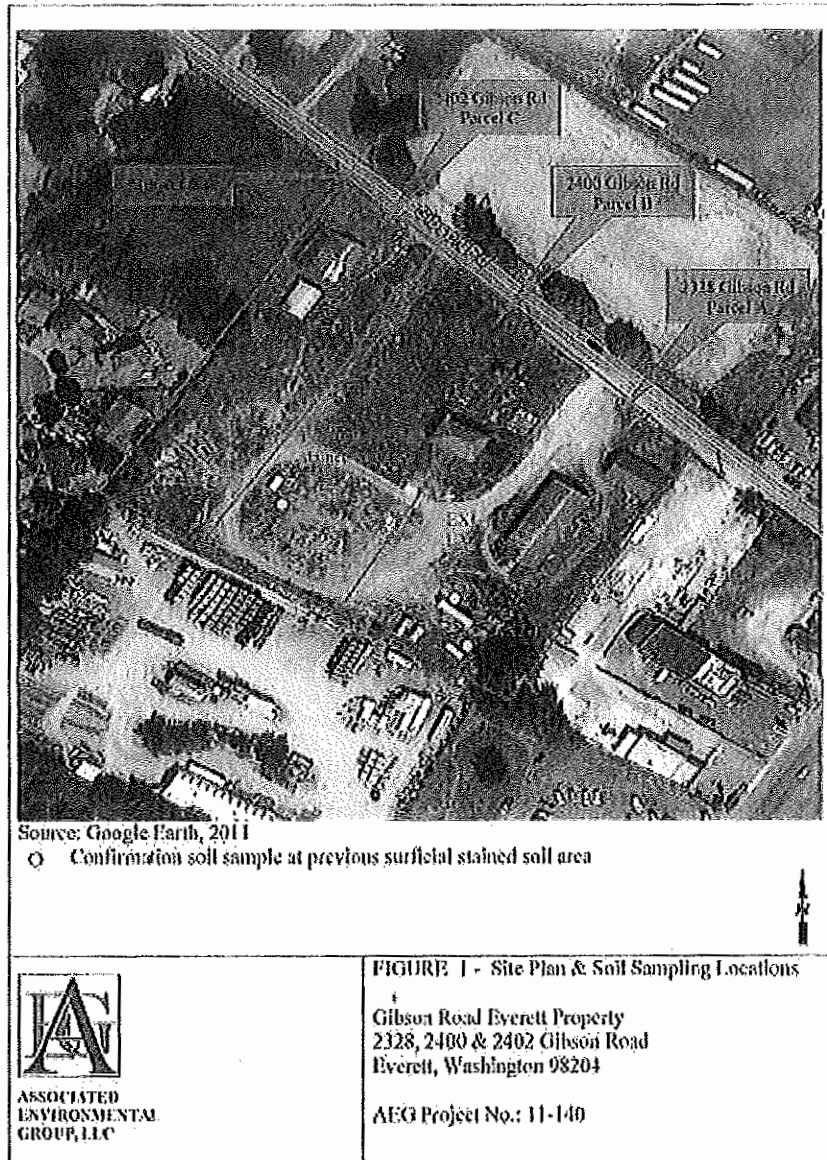
Figure 3 Locations of the Soil Excavations and Confirmation Sampling

Following soil excavation of approximately 10 tons, confirmation samples were collected at the three excavations. The results indicated TPH-HRO and other TPH products in soil at concentrations below MTCA Method A soil cleanup levels.

b. Soil samples for laboratory analysis were collected at the three excavations to confirm success of the soil cleanup that met the MTCA Method A cleanup levels for unrestricted land use. The soil sampling results also indicated the contamination was limited within 2 feet from the surface.
