***Emergency Remedial Action  
Construction Completion Report  
Upper Tailings Pile  
Van Stone Mine***

***Prepared for  
Washington State  
Department of Ecology***

***December 26, 2012  
17800-34***

Prepared by  
**Hart Crowser, Inc.**

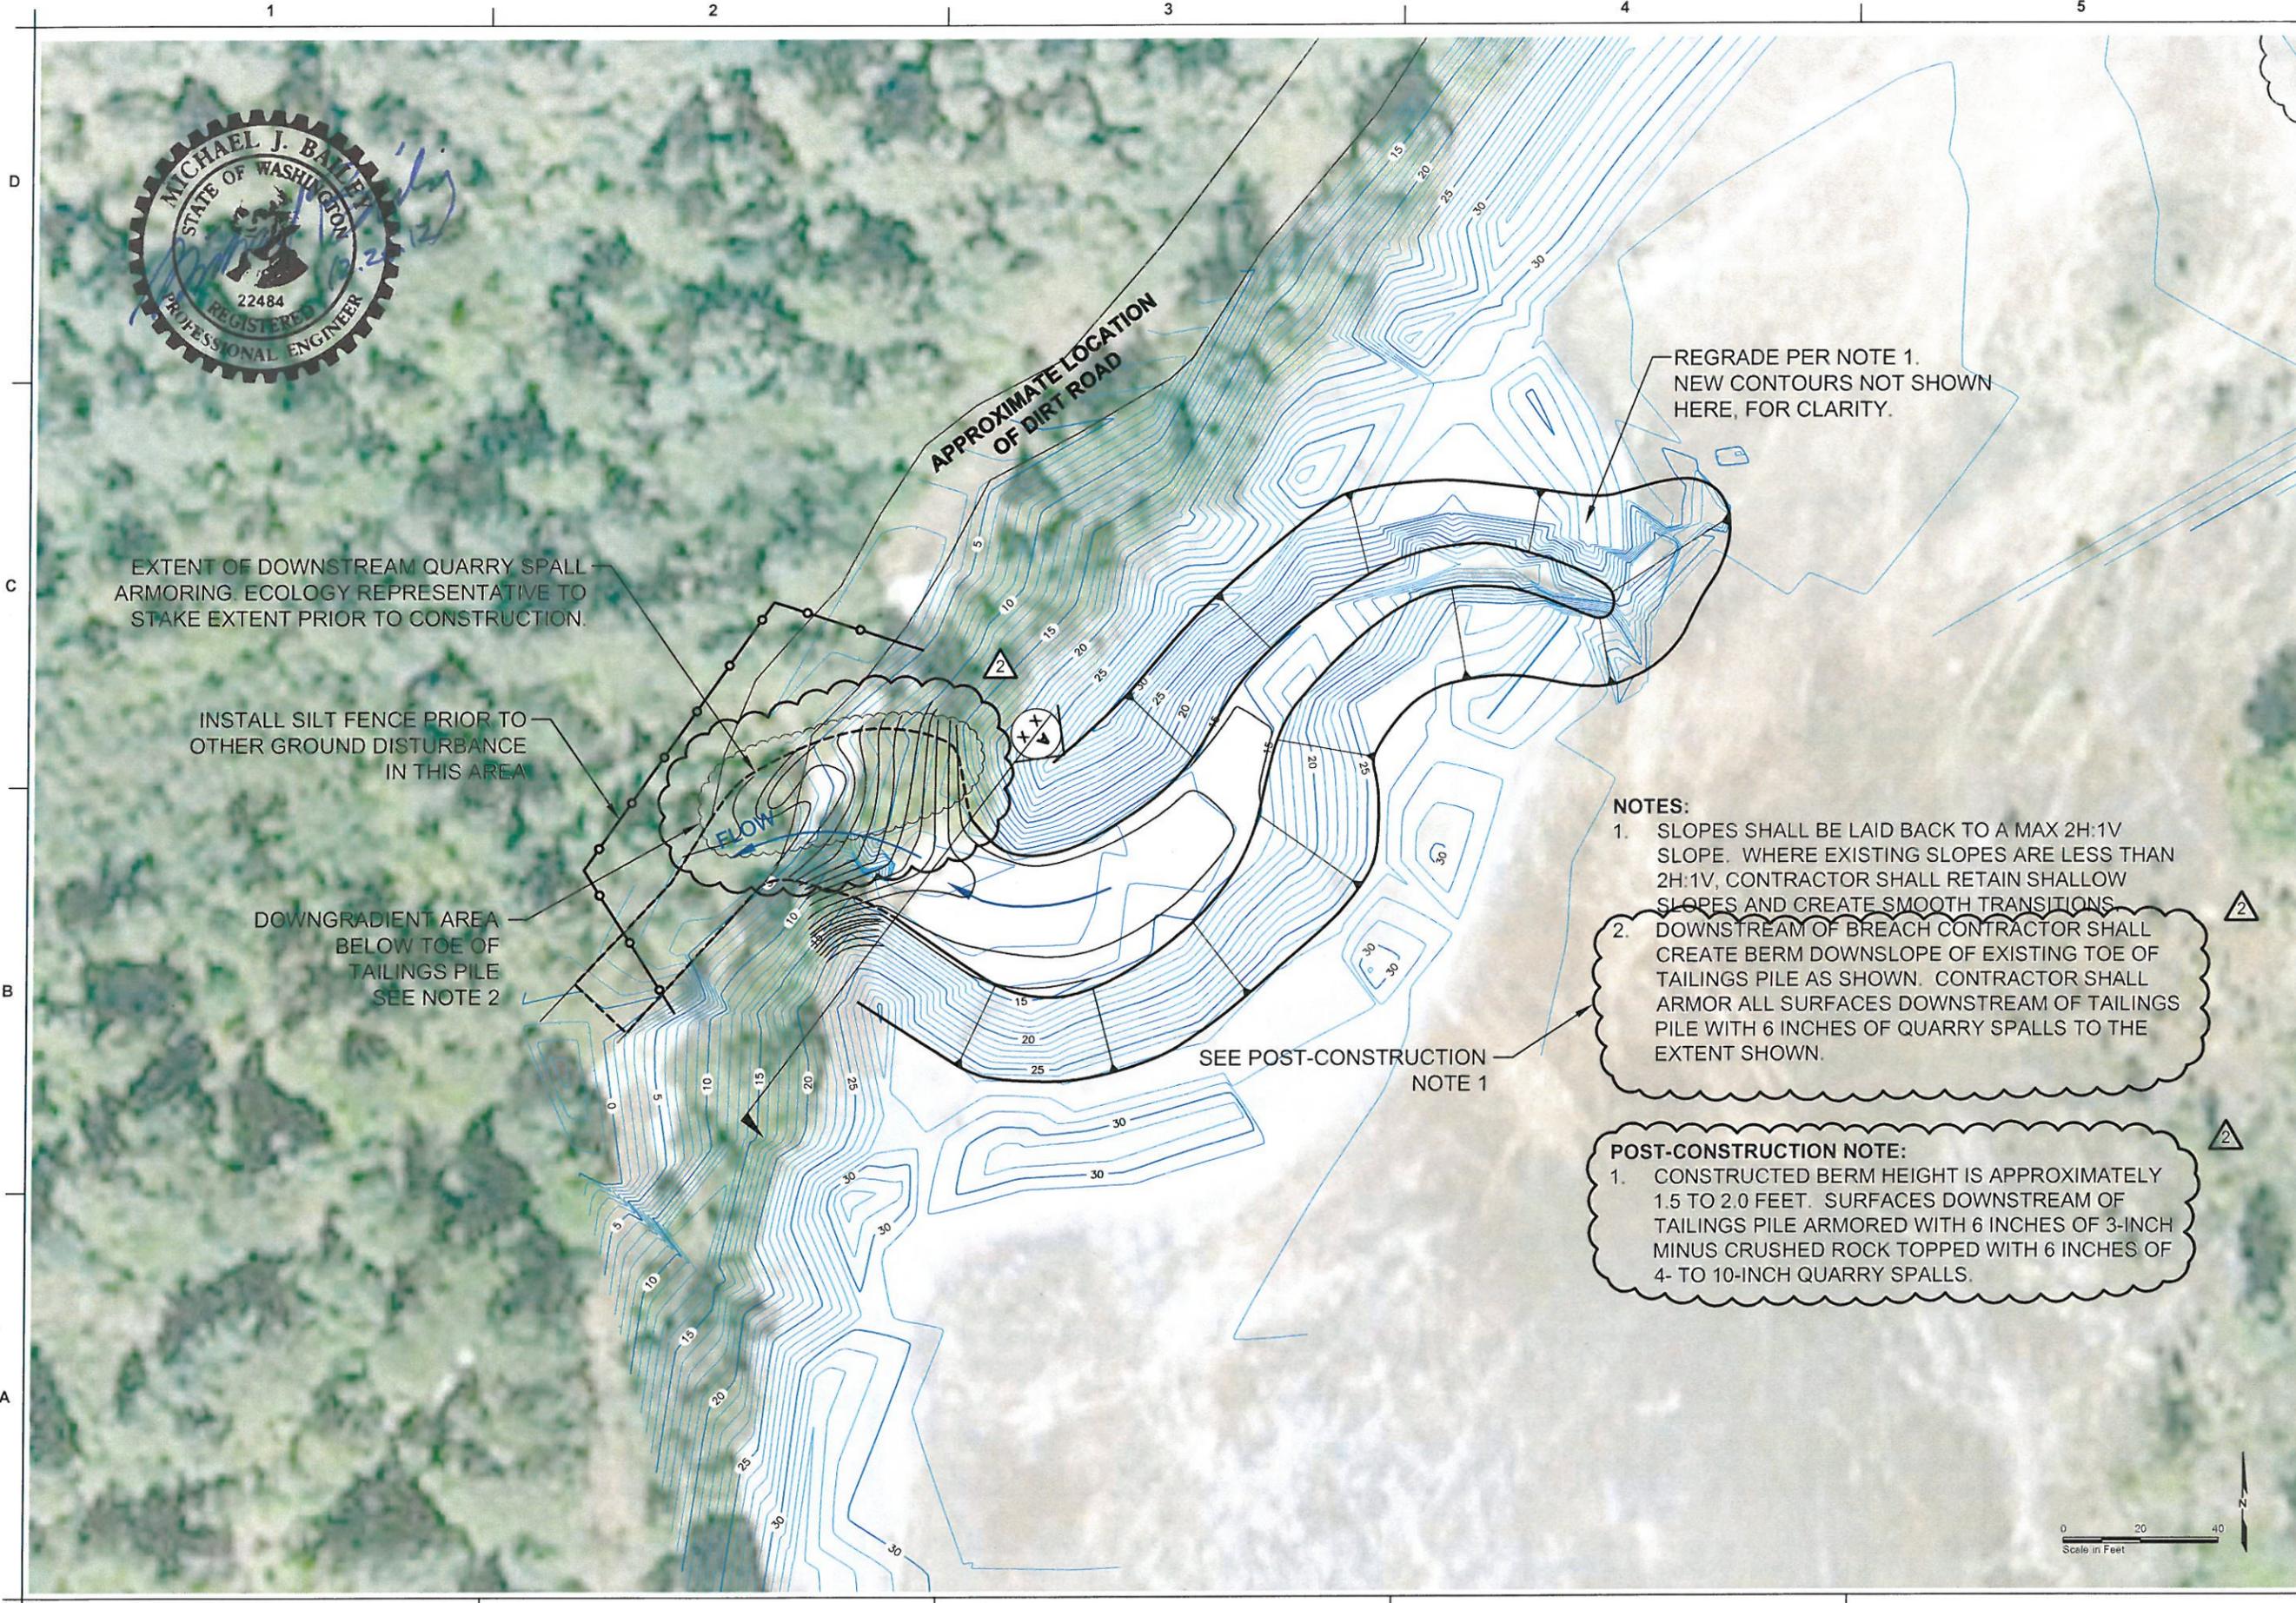
Drawing Reference Number:  
**C-2**  
 Sheet 4 of 6

1. CONSTRUCTED BERM HEIGHT IS APPROXIMATELY 1.5 TO 2.0 FEET. SURFACES DOWNSTREAM OF TAILINGS PILE ARMORED WITH 6 INCHES OF 3-INCH MINUS CRUSHED ROCK TOPPED WITH 6 INCHES OF 4- TO 10-INCH QUARRY SPALLS.

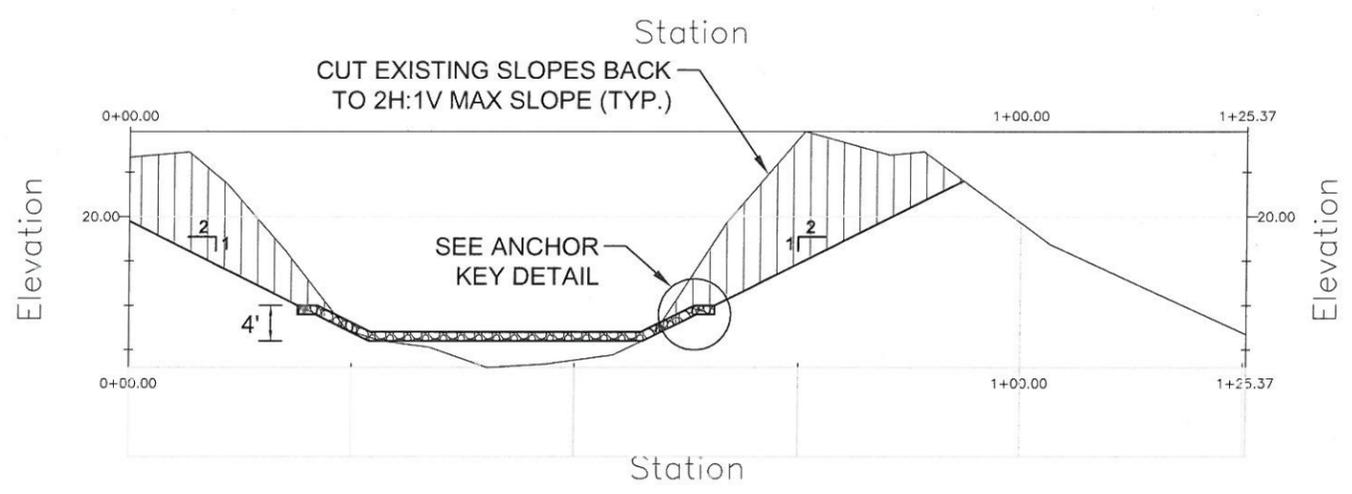
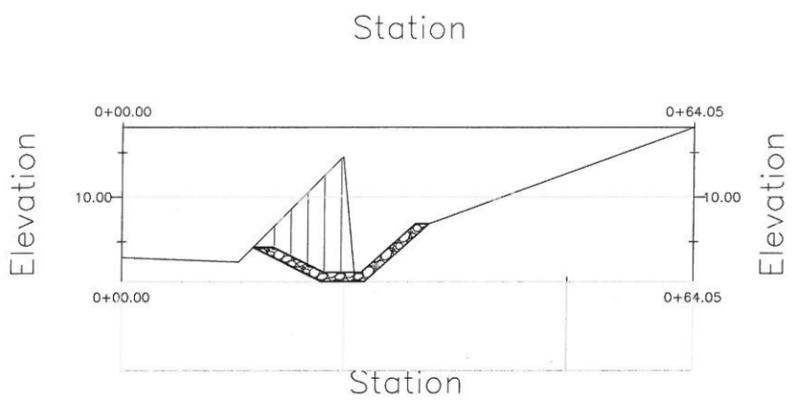
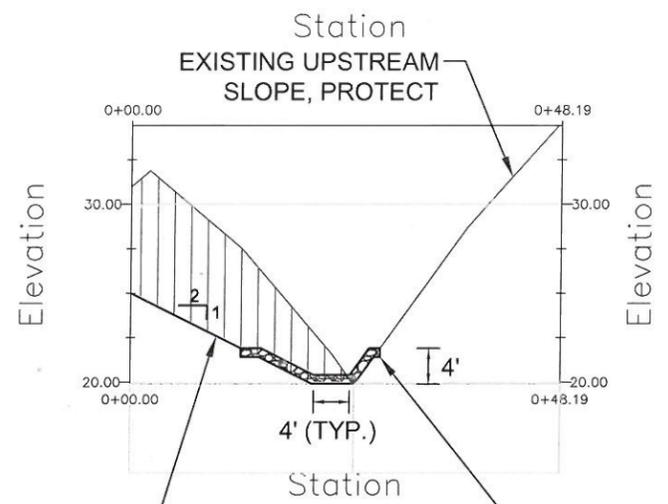
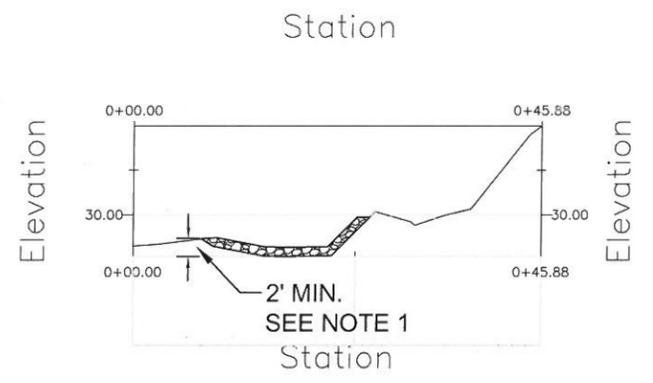
**POST-CONSTRUCTION NOTE:**  
1. DUE TO UNAVAILABILITY OF SPECIFIED ROCK MATERIAL AT THE TIME OF CONSTRUCTION, THE CHANNEL WAS LINED WITH A 12-INCH LAYER OF 3-INCH MINUS CRUSHED ROCK TOPPED WITH A 6-INCH LAYER OF 4- TO 10-INCH QUARRY SPALLS.

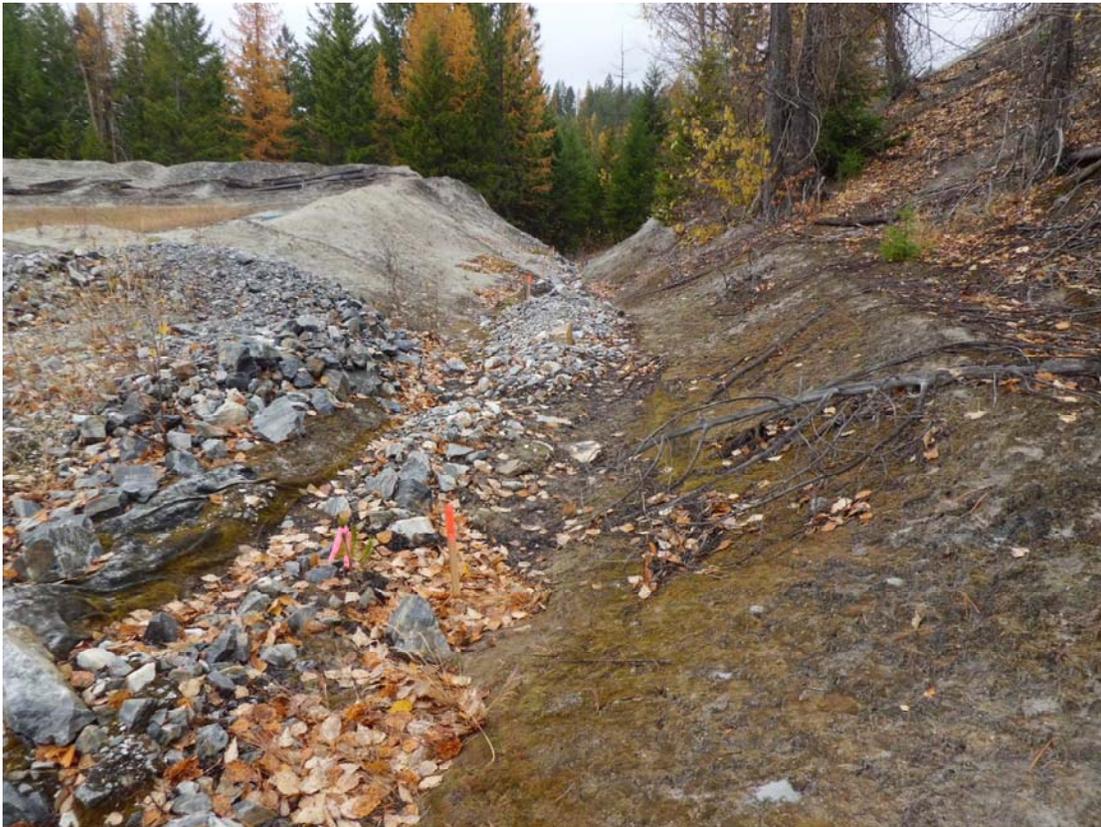
Photograph 1 – Initial condition of intermediate channel, Area 2, 10/30/12.

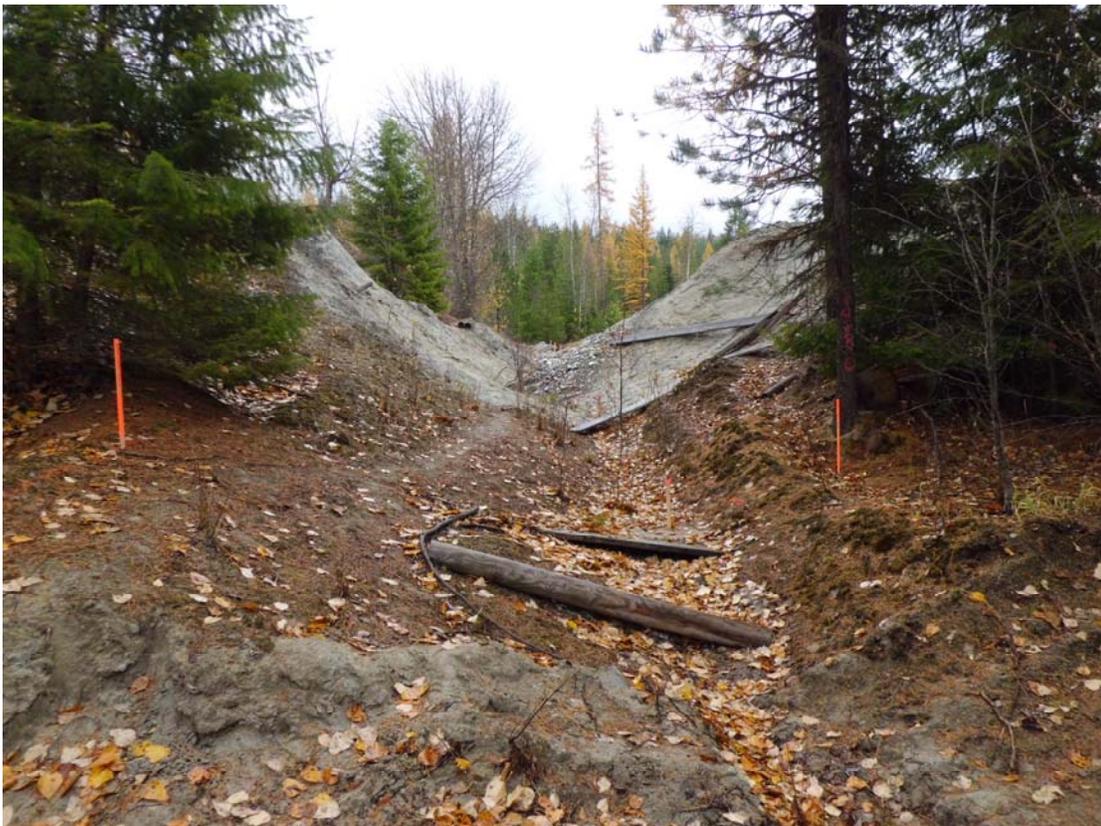
Photograph 2 – Initial condition of intermediate channel, Area 2, 10/30/12.

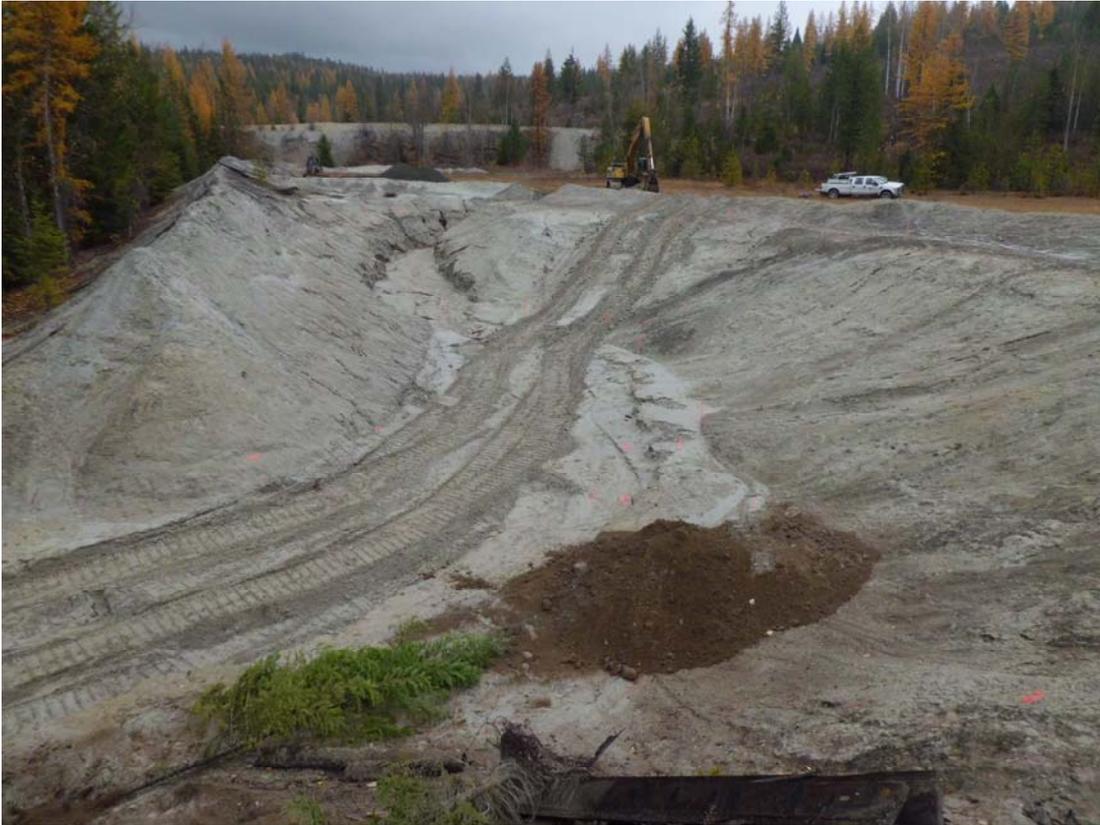
Photograph 3 – Initial condition of Area 1 from south side of breach, 10/30/12.

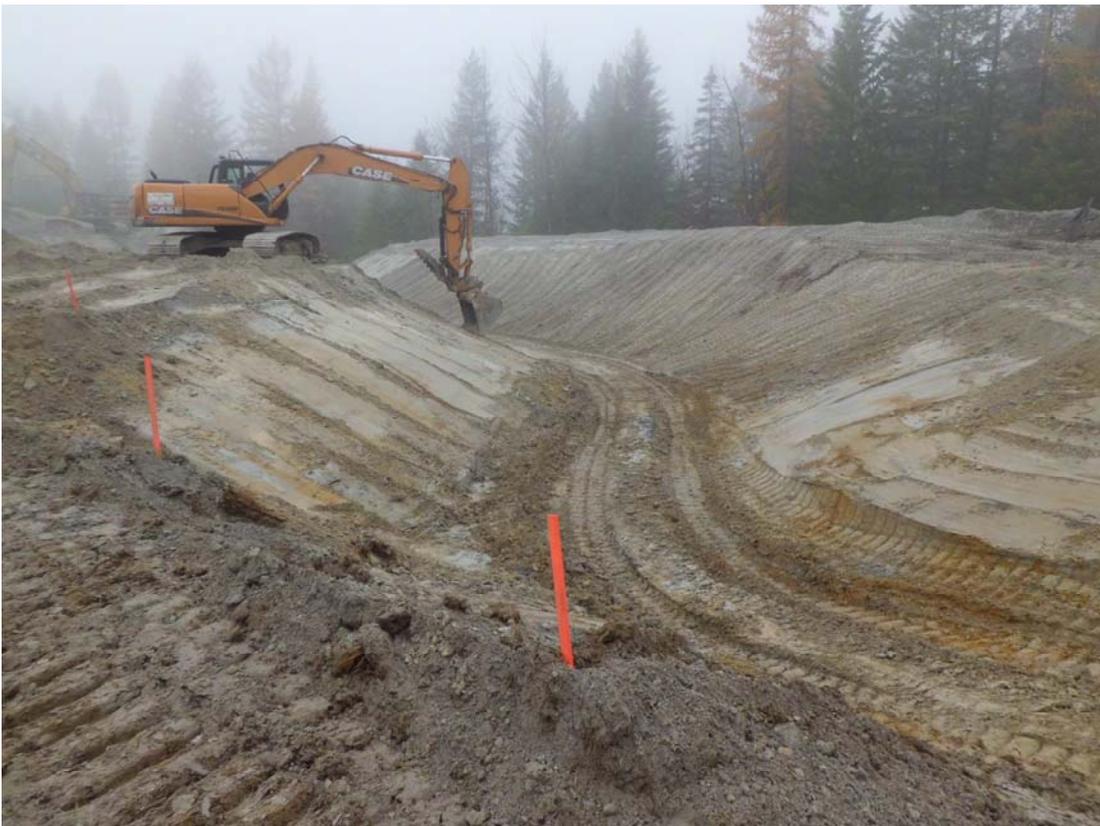
Photograph 4 – Pulling back Area 1 slopes, 10/31/12.

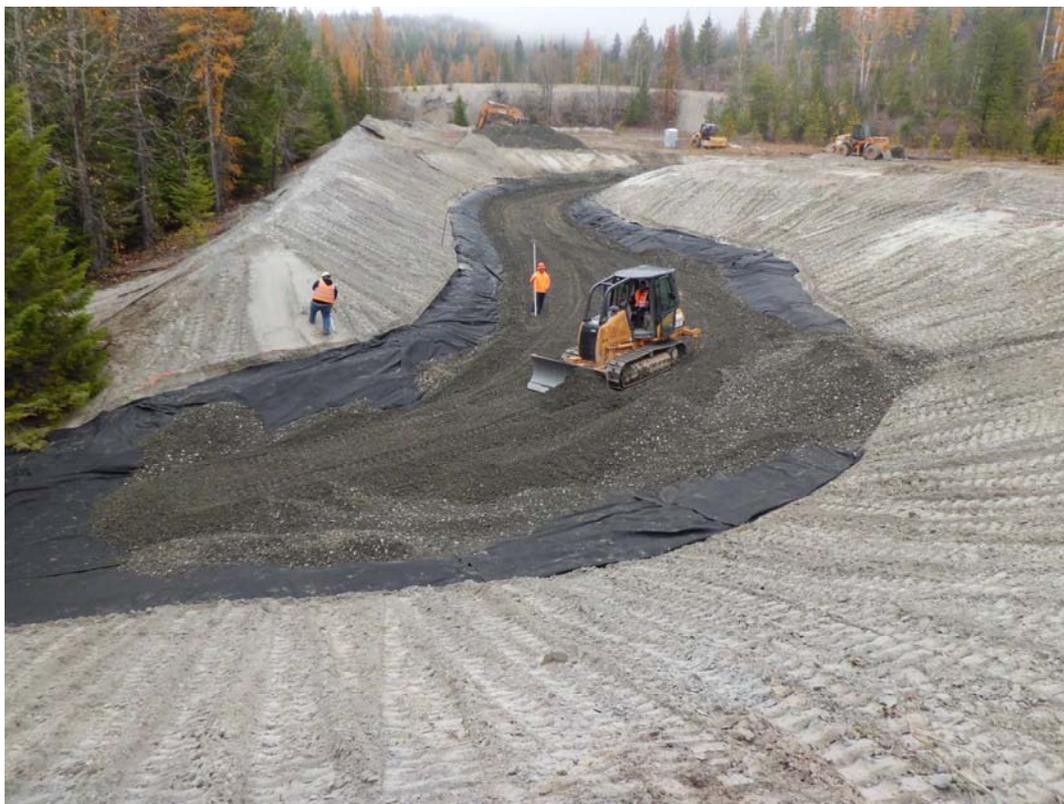
Photograph 5 – Grading the channel in Area 1, with extent of geotextile visible, 11/02/12.

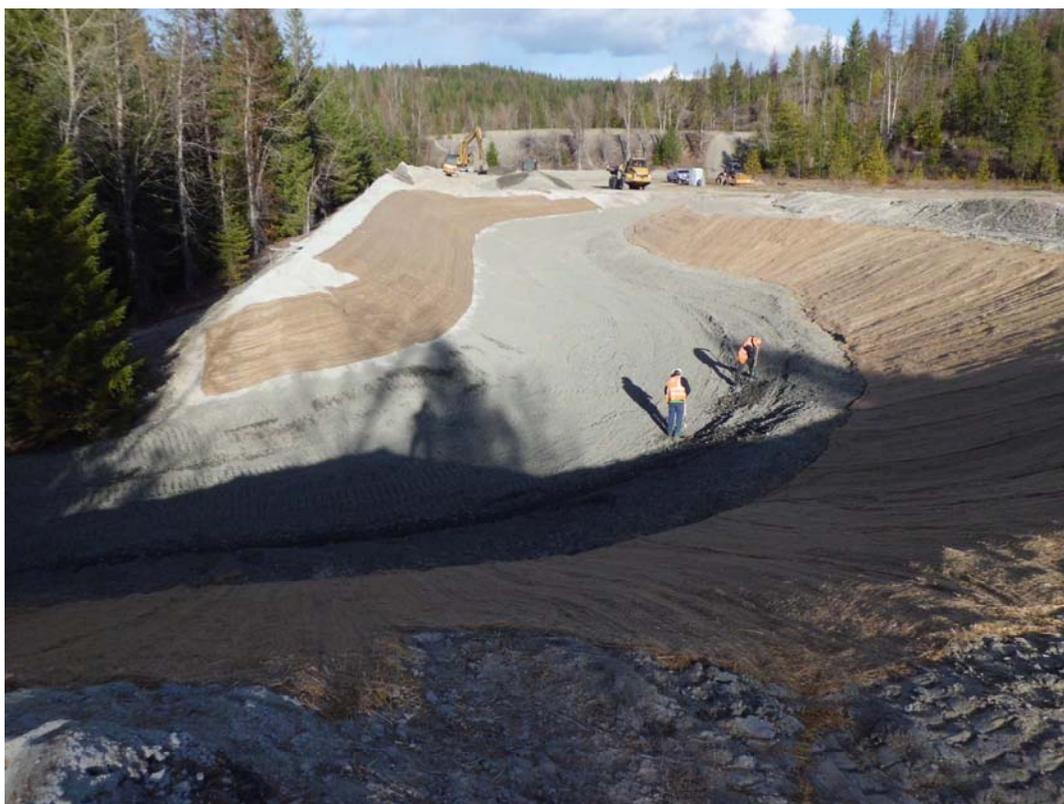
Photograph 6 – Erosion control matting placed above channel lining in Area 1, 11/07/12.

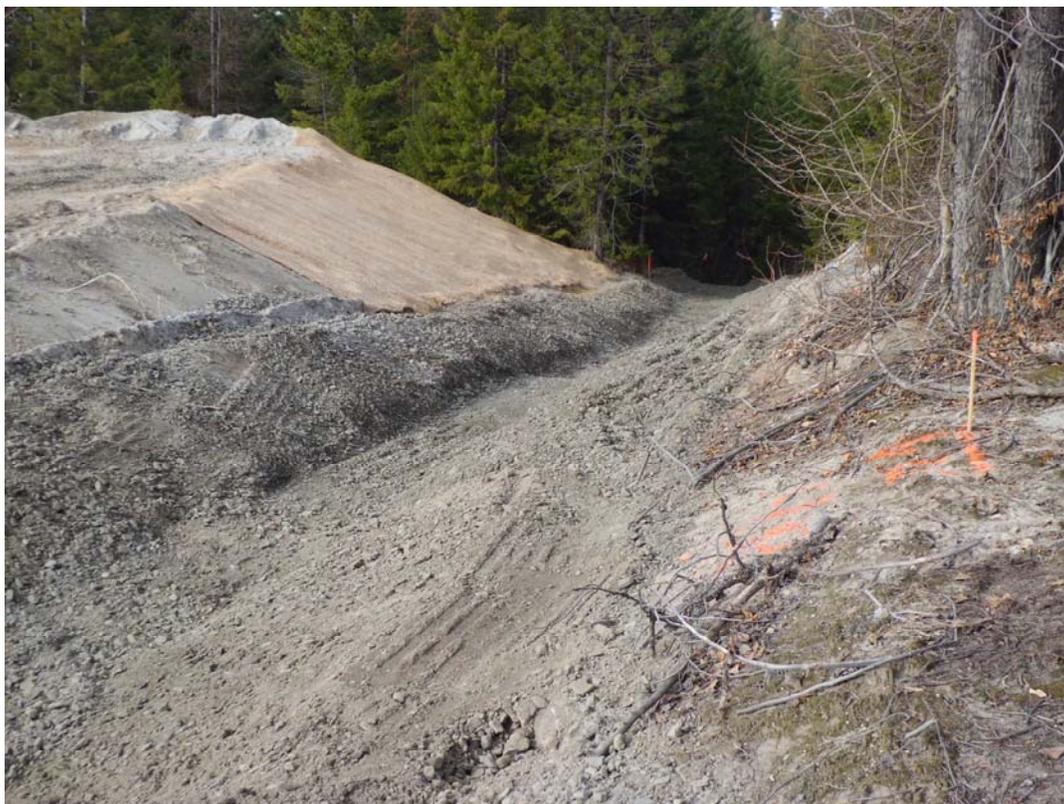
Photograph 7 – Erosion control matting placed above channel lining in Area 2, 11/08/12.

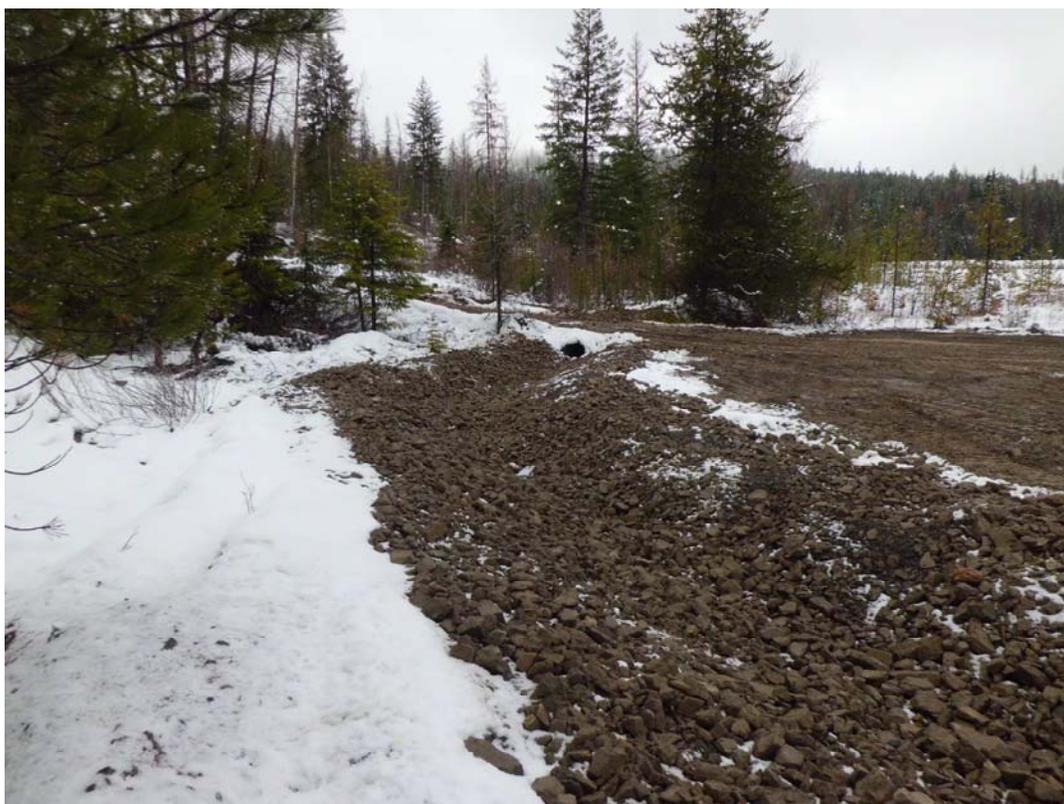
Photograph 8 – Area 2 channel condition downgradient of culvert at end of construction, 11/14/12.

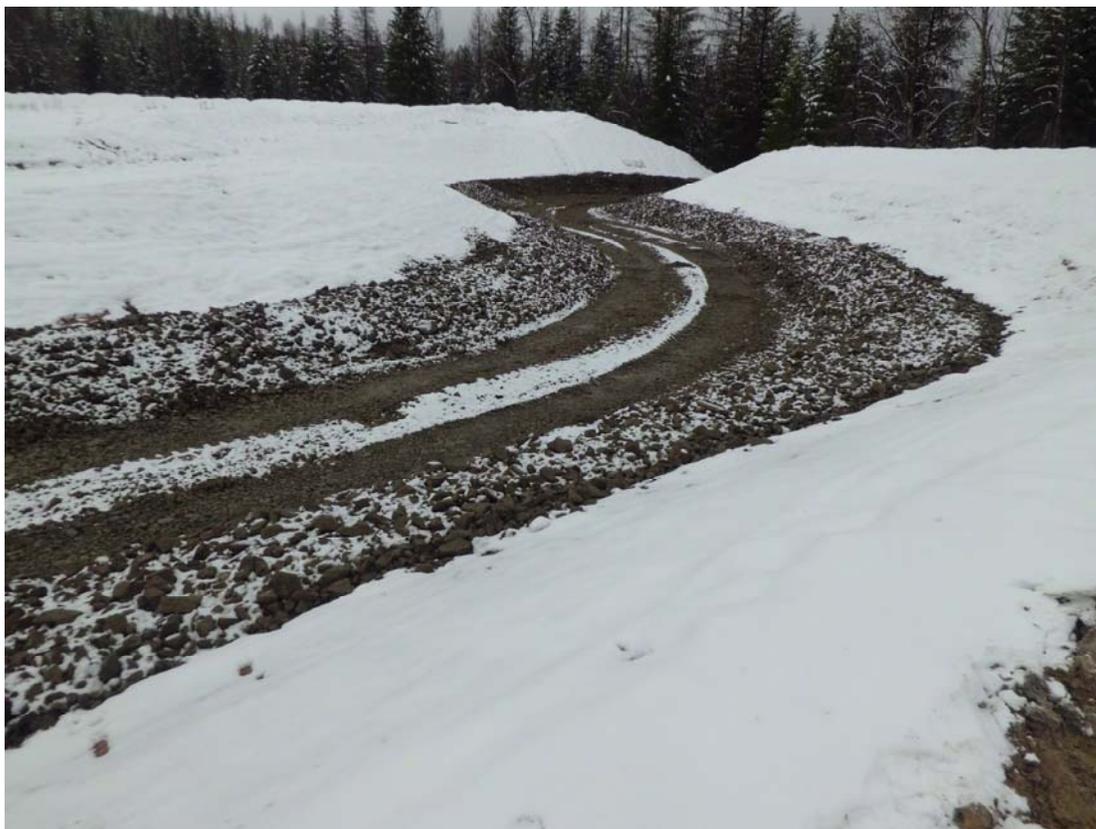
Photograph 9 – Area 1 channel condition at end of construction, 11/14/12.

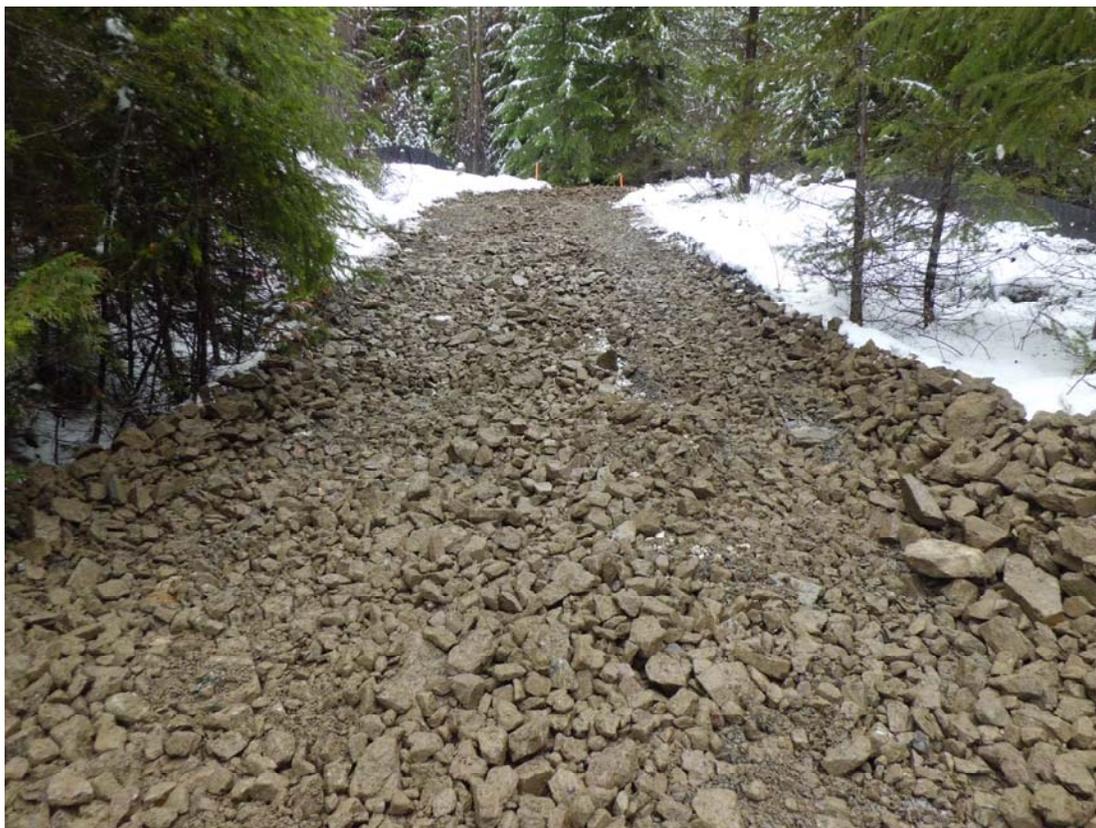
Photograph 10 – Area 1 channel condition downgradient of tailings pile toe at end of construction, 11/14/12.

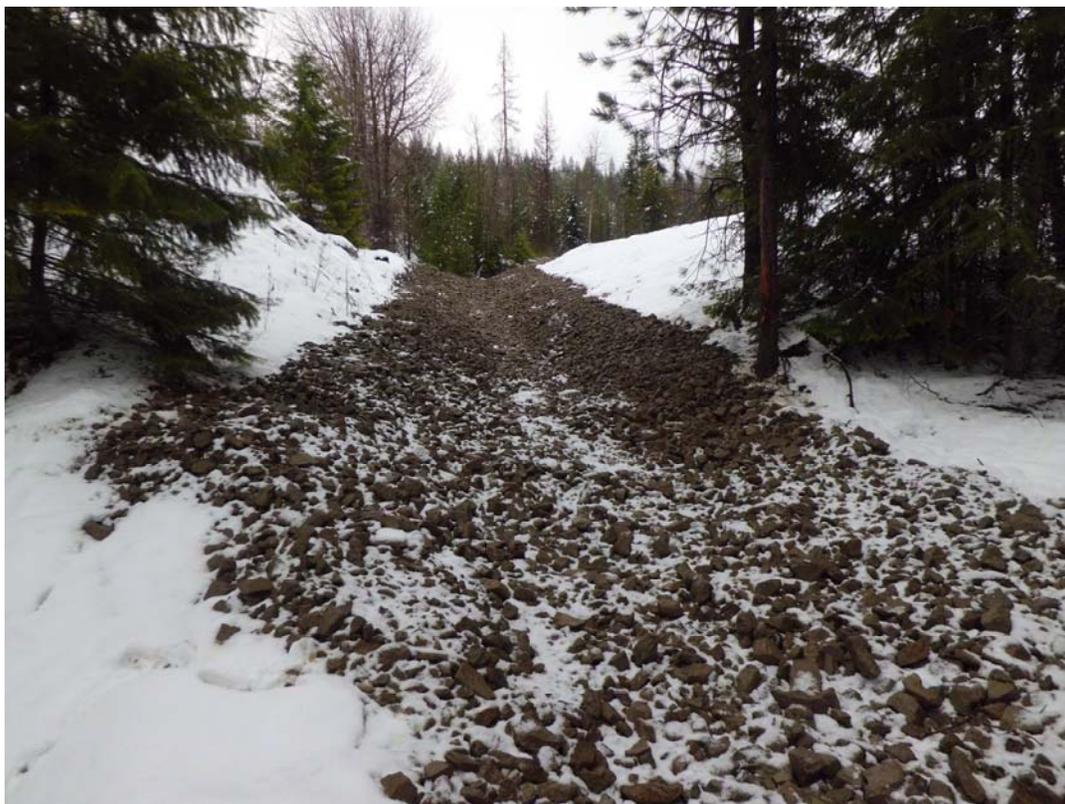
Photograph 11 – Condition of Area 2 intermediate channel at end of construction, 11/14/12.

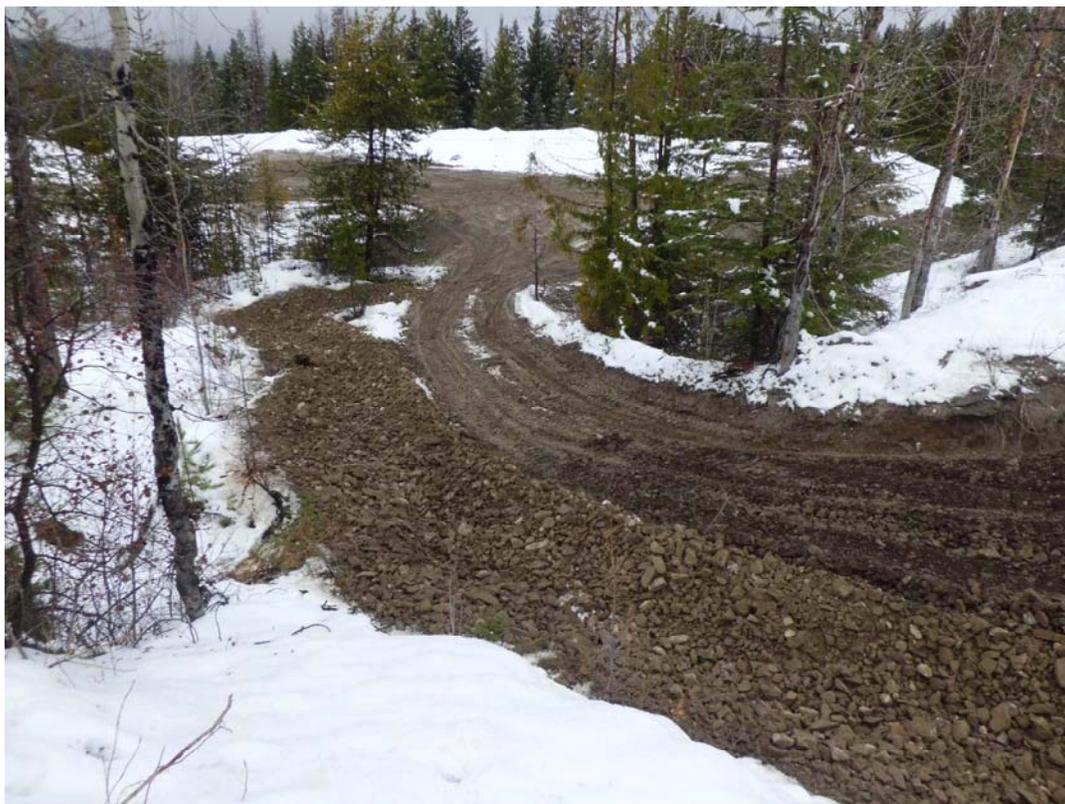
Photograph 12 – Area 2 channel condition upgradient of culvert and adjacent to access road, 11/14/12.
