November 9, 2010

Project No. 094-10023

Reference: Union Bank Log No. 10-1137  
Phase I Environmental Site Assessment  
Riverbend Site  
4304 State Route 530  
Arlington, Washington 98223  
APNs: 01052900000100 (Lot 1) - 01052900000300 (Lot 3)  
and 01052900000500 (Lot 5) - 01052900001500 (Lot 15)

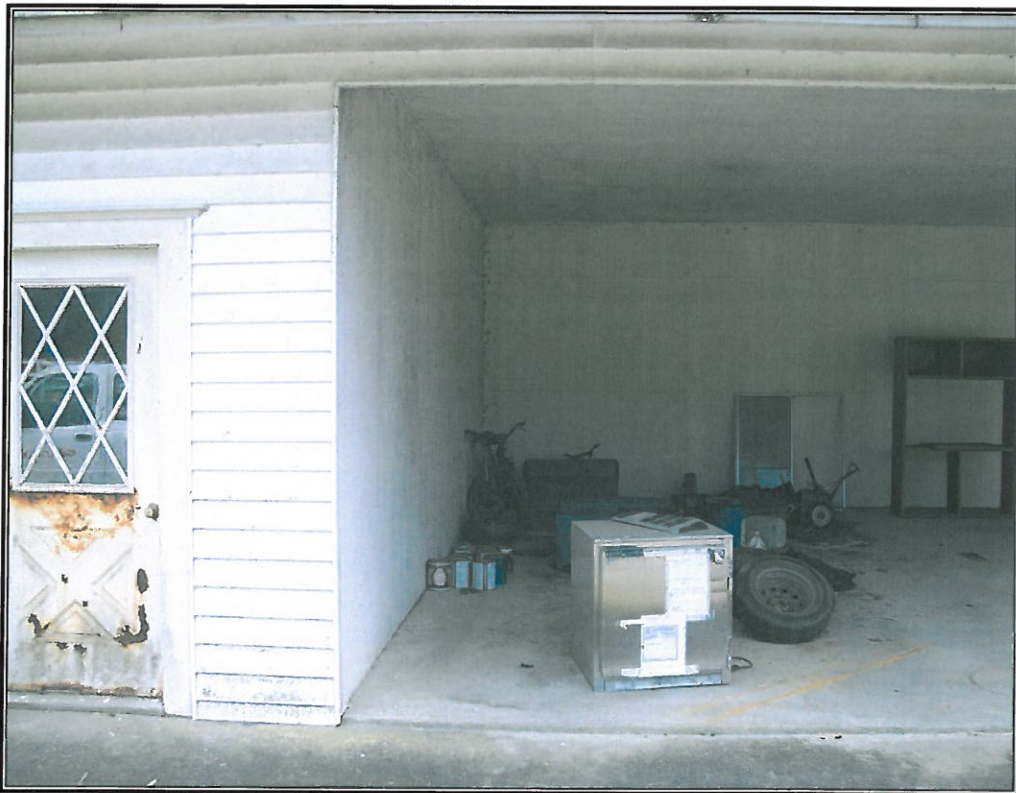
During the visual observations of the subject site, indications of hazardous materials were observed. *De minimis* quantities of paint (approximately nine 1-gallon cans) and other discarded items (such as old

**Photo 6:** Looking at east end of car port out building and miscellaneous discarded items.

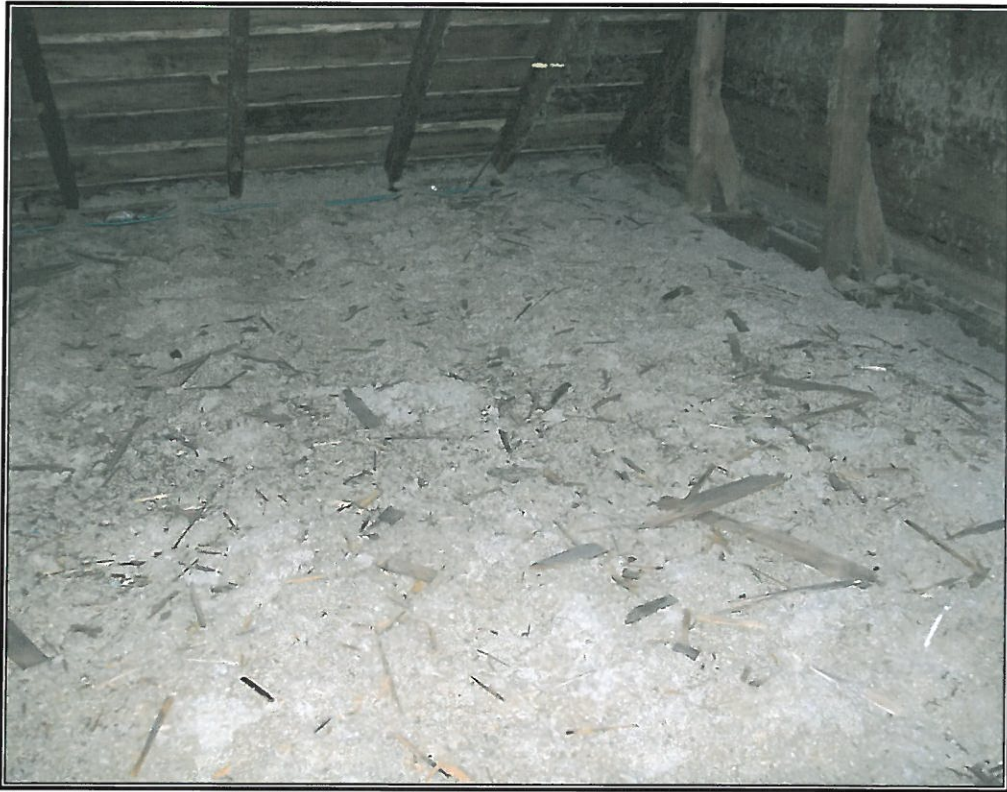
**Photo 15:** Current attic with blown-in insulation and shingle pieces from previous roof.

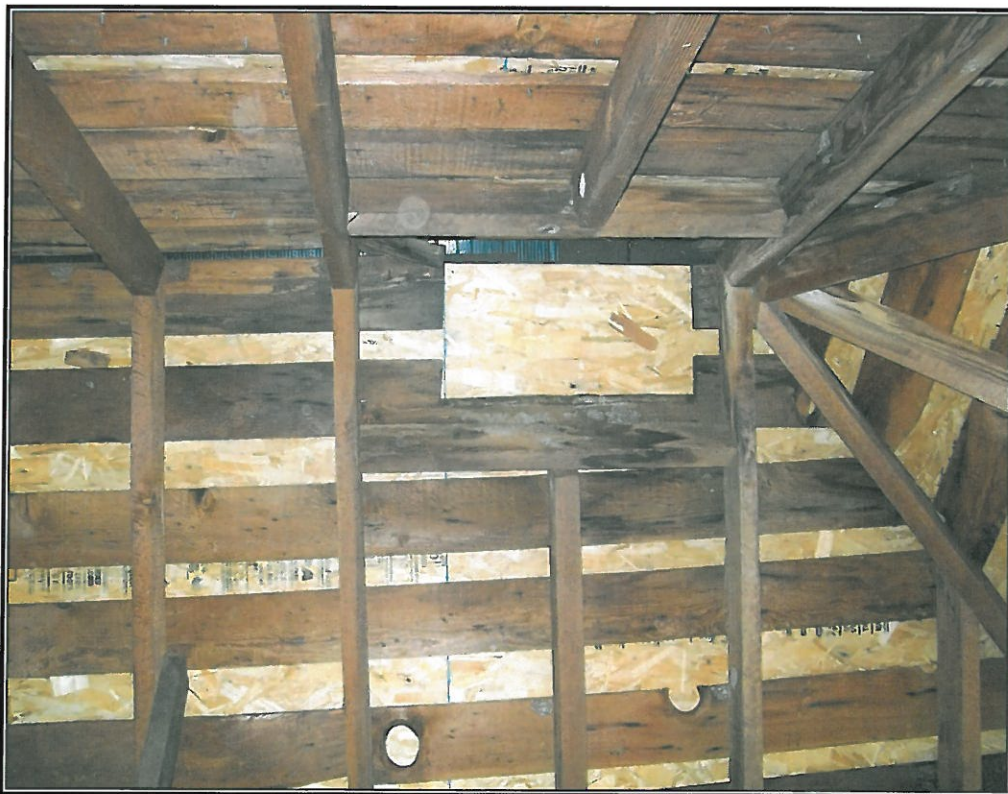
**Photo 16:** Underside of roof showing skip sheeting, OSB underlayment and hole patch of former chimney.

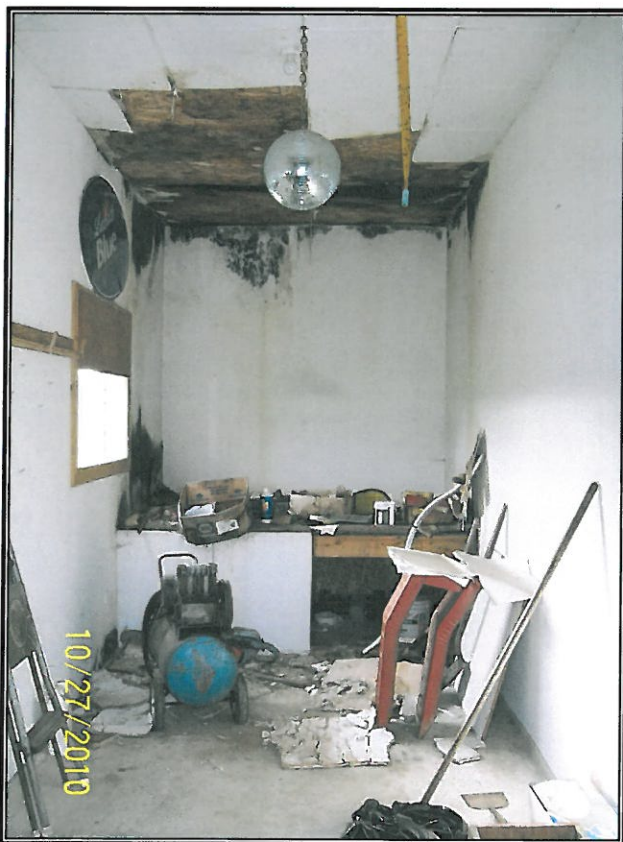
- An isolated mold issue is present in the east end storage room of the car port. We observed approximately 60 sq. ft. area of mold growth localized in the southern half of the east storage room. Black colored mold is concentrated at the ceiling/wall corners, on the walls and around the work bench.

Krazan's site reconnaissance included notations of visual conditions suggestive of mold issues. Approximately 60 sq. ft. of mold was observed in the small storage room at the east end of the car port. The area of mold growth is localized in the southern half of the east storage room. Black colored mold is concentrated at the ceiling/wall corners, on the walls and around the work bench. A strong mold-like odor is persistent inside of the storage room. A roof leak appears to be the source of water infiltration into this area. Photograph #18 documents this condition.

**Photo 18:** Interior of east end carport storage room. Mold issues. Discarded items.

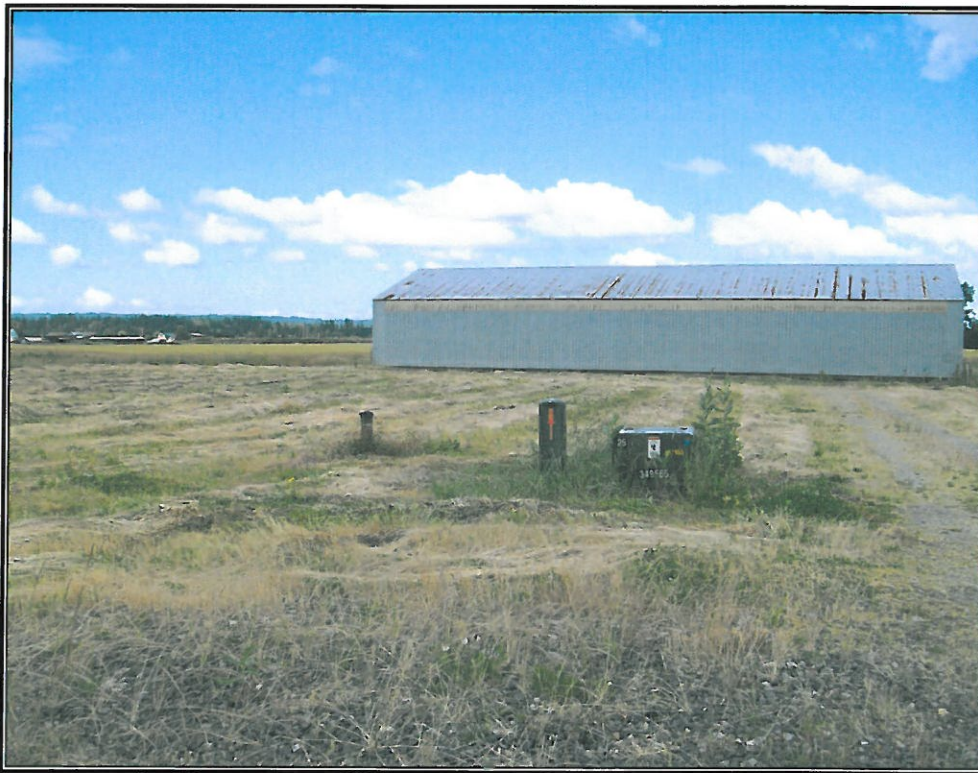
We observed pad-mounted electrical transformers at several locations across the site (please see photographs following text). The transformer casings displayed no visual evidence of leakage and the ground surface below the transformers displayed no evidence of discoloration. The transformers are labeled as containing NON-PCB mineral oil. Based on the recent development date of the subject site and the visual absence of apparent unauthorized releases of insulating fluids from the transformers at the time of Krazan's site reconnaissance, there is no evidence to suggest that the transformers currently represent an environmental concern.

**Photo 20:** Looking west from access road at transformer and well on Lot #3. Metal out building is remnant from former dairy farm.

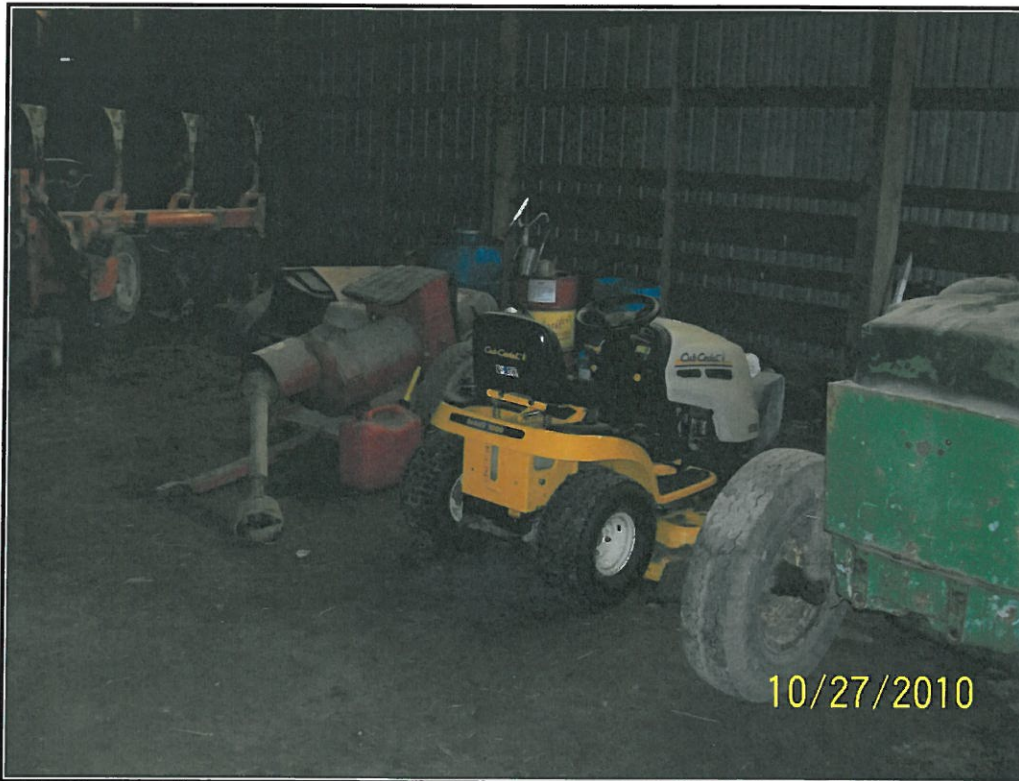
- Petroleum surface soil staining in areas surrounding farm machinery in the metal storage building (on Lot #3) was noted. It is believed that surface soil staining is the result of farm machinery maintenance and storage in this building since its construction in the early 1980s. The lateral and vertical extent of the petroleum staining has not been evaluated.

Photo 21: Interior of outbuilding on Lot #3.

*Krazan recommends soil testing in the location of the staining to assess the extent and volume of petroleum surface staining.*

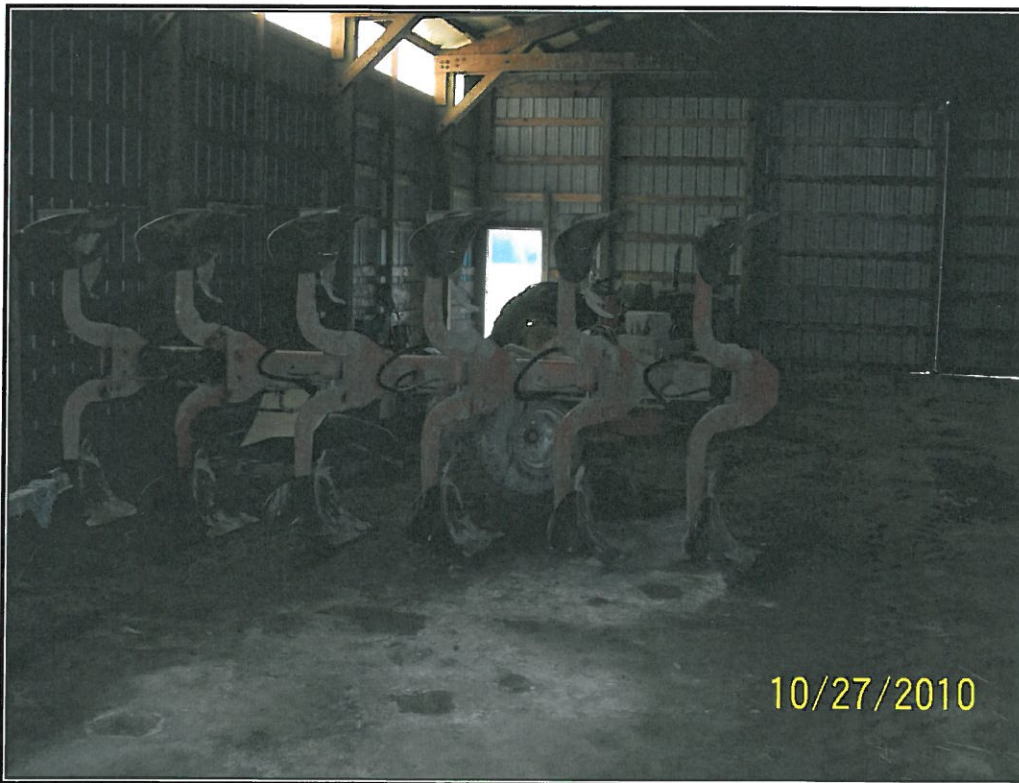
Photo 22: Interior of outbuilding on Lot #3.

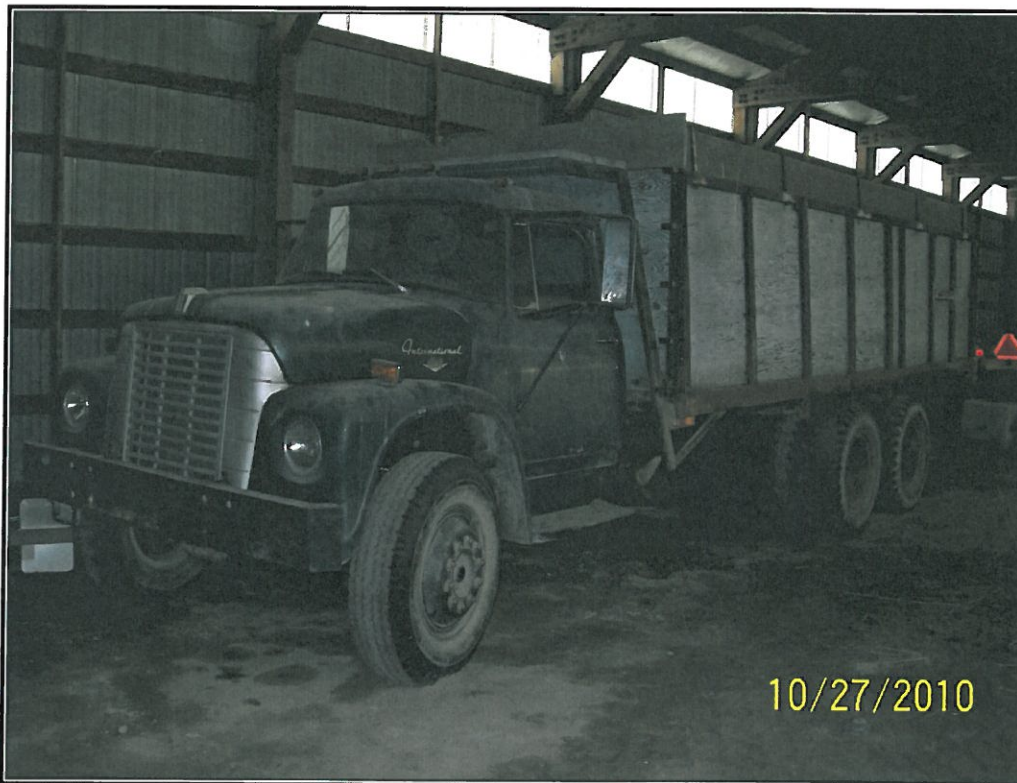
Photo 23: Interior of outbuilding on Lot #3.

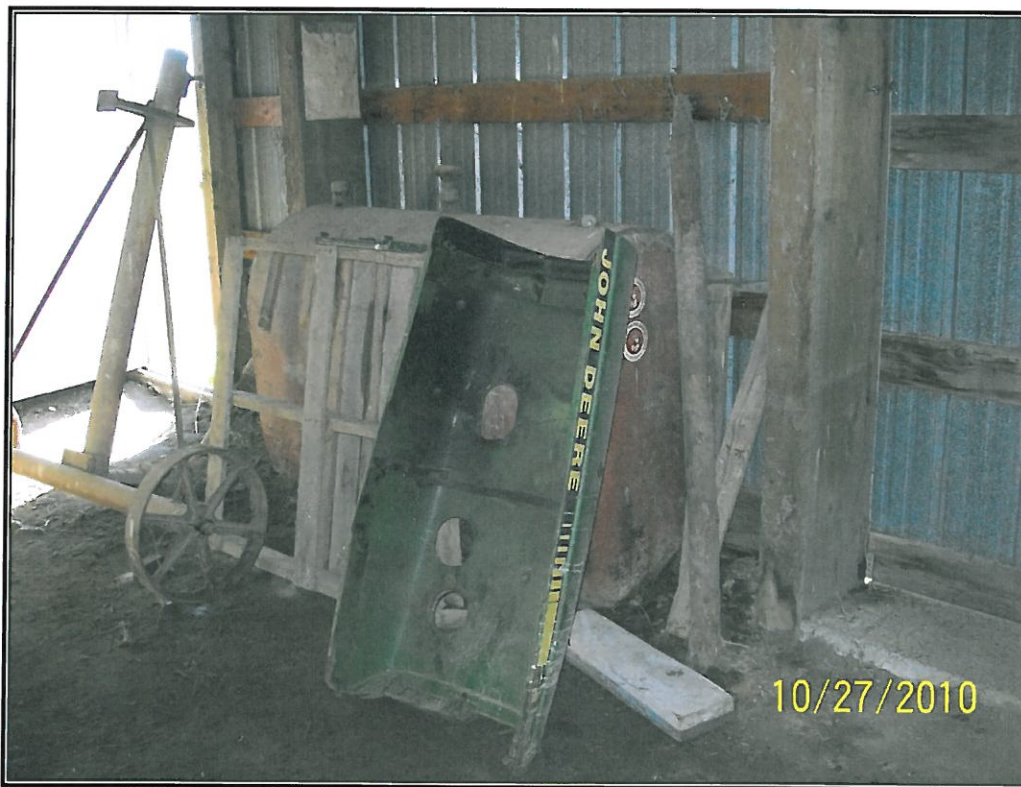
Photo 24: Interior of outbuilding on Lot #3.
