# SITE HAZARD ASSESSMENT

### Summary Score Sheet

**Site Name: US West Communications**

Address: 102 E Alder Street, Walla Walla, WA

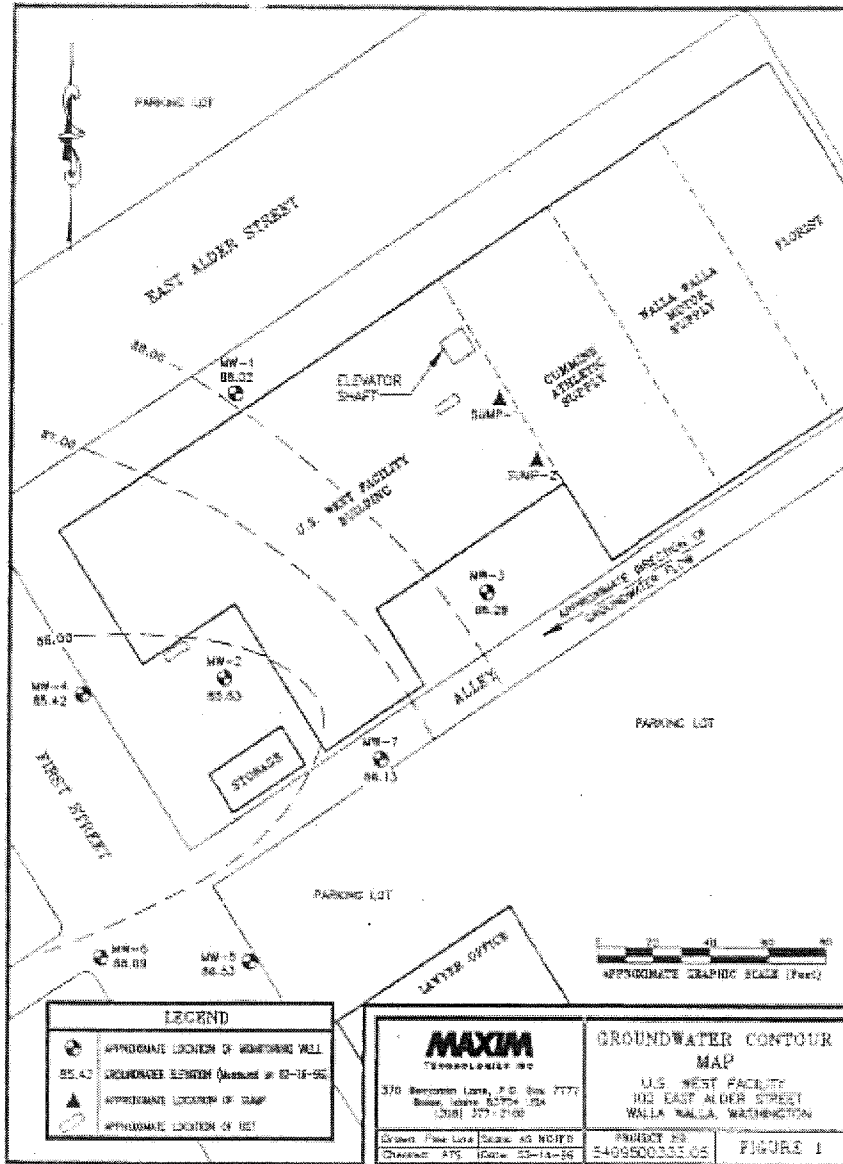
6.2 Site Plan

In November of 1994 the last operational underground storage tank was decommissioned. The tank was 1000-gallon diesel tank used to power the onsite emergency power generator. The tank was located in the parking area adjacent to South 1<sup>st</sup> Avenue (Figure 3). The tank was in good condition with minor staining near the fill pipe. A total of 15 cubic yards of petroleum contaminated soils (PCS) were removed from the excavation and disposed off-site. All samples collected from the excavation after the 15 yards of PCS was removed, were below the laboratory method detection levels.

Residual soil contamination remains beneath the building and in the area of MW-2 and beneath the basement near the closed in-place underground storage tank. No other areas of the Site have documented the presence of TPH levels in soils above the Method A cleanup action levels. Ground water contamination is confined to the boundary of the Site. The site is covered by the building foot print and pavement reducing the risk of direct contact of contaminated soils. There are no natural areas on the site that would allow plants or fauna to come in contact with the contamination. The surface water route is not applicable for WARM ranking this site.
