Re: SITE HAZARD ASSESSMENT: Facility Site ID # 90796658  
Sears Automotive Center  
2701 Utah Avenue South  
Seattle, WA 98134  
Property Tax # 7666207295  
Cleanup Site ID 6839

# SITE HAZARD ASSESSMENT

### Summary Score Sheet

Sears Automotive Center  
2701 Utah Avenue South  
Seattle, King County, WA 98134

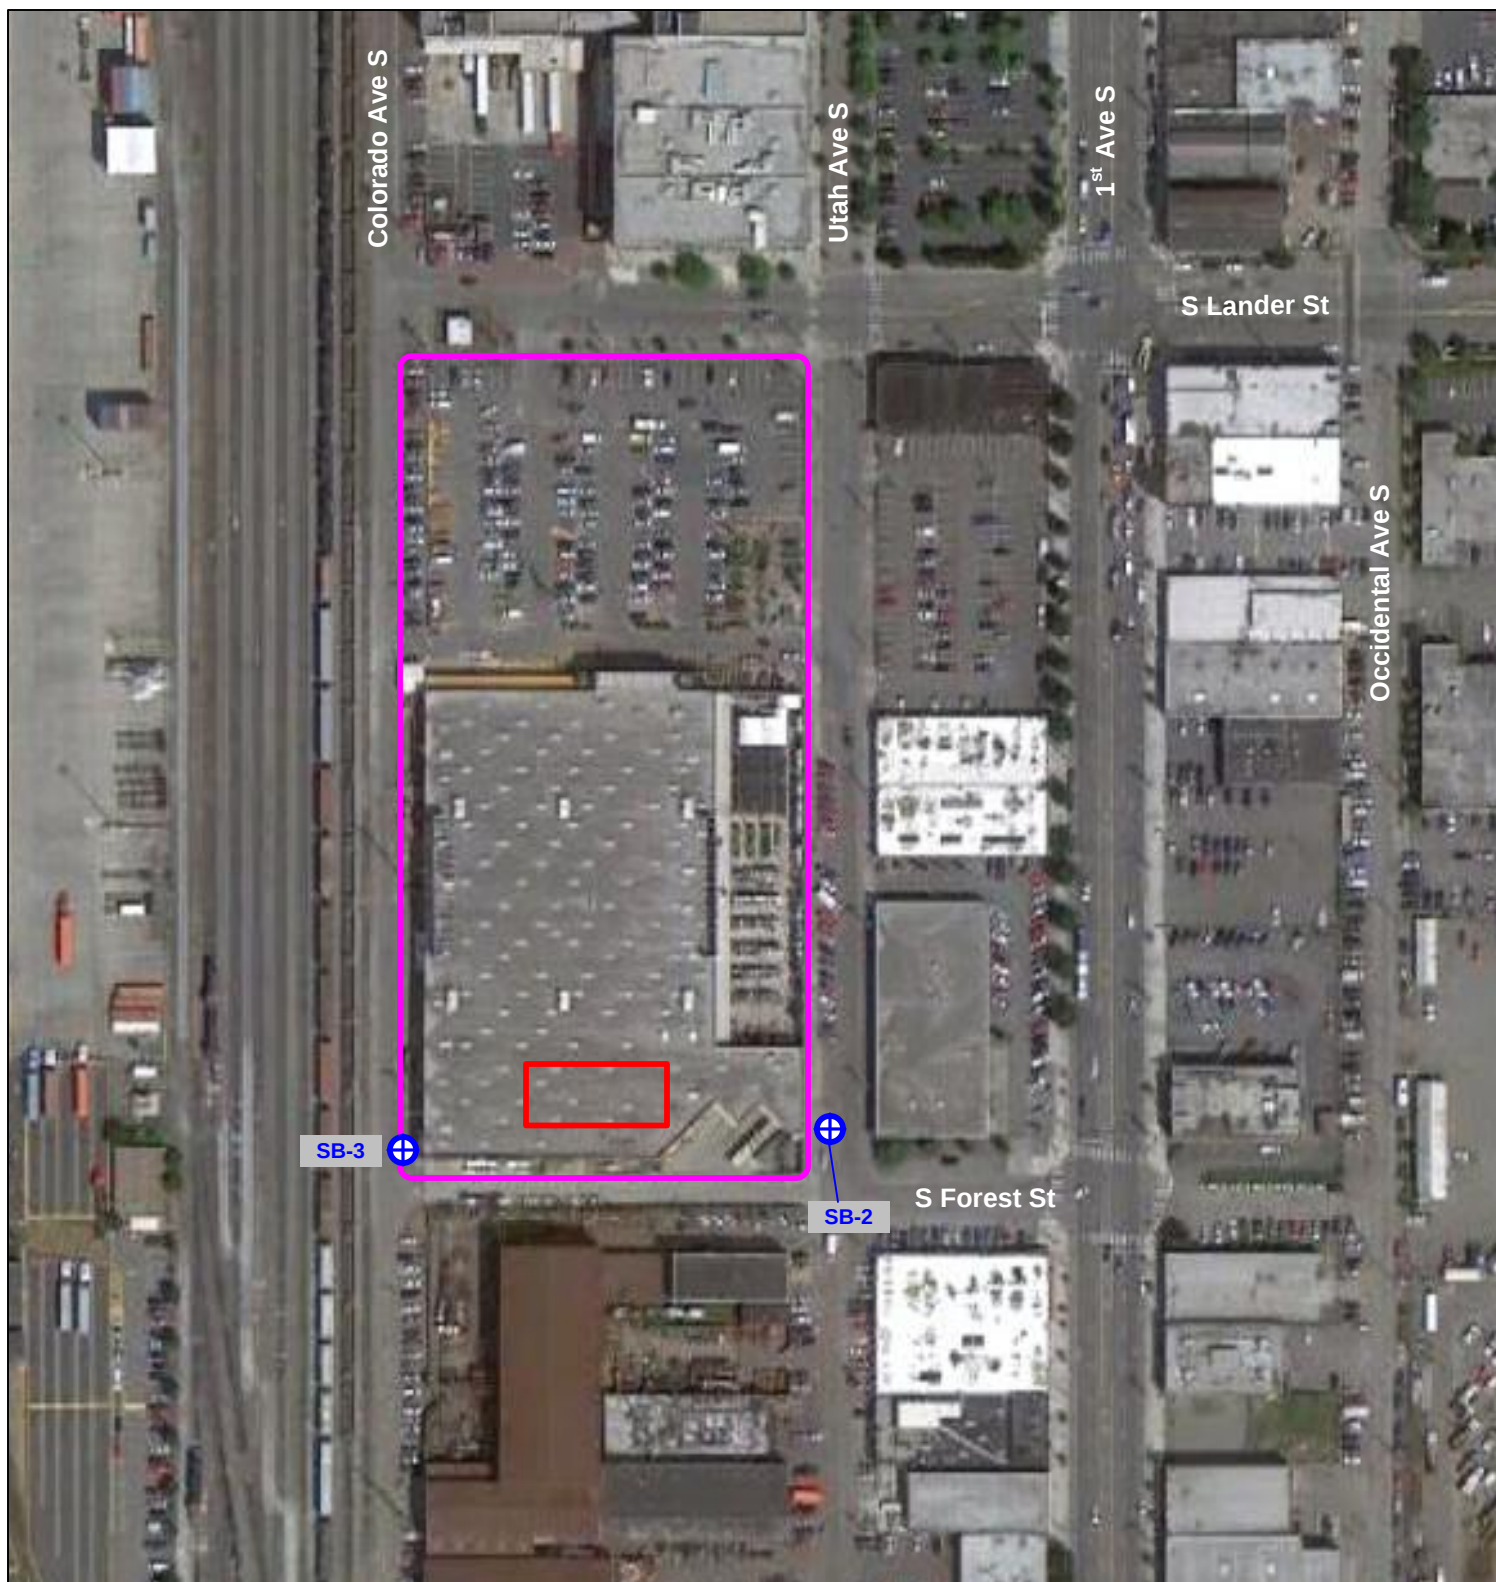
**Site Overview Map**

Ten USTs were removed in 1992 from one area located on the southern portion of the property. The USTs contained new oil and waste oil and ranged from 500- to 3,000-gallons in capacity. Soil excavation was performed following UST removal to the depth of groundwater, approximately 8 feet below grade. Approximately 80 cubic yards of contaminated soil was removed and disposed offsite. Soil sampling was performed following completion of excavation activities, but no groundwater samples were collected. Total TPH (analyzed by EPA 418.1) remained on the excavation floor at a concentration of up to 37,300 mg/kg. A release was reported to Ecology in October 1992.

Additional investigation activities were performed in 1994 with soil and groundwater samples collected from soil borings located to the east (SB-2) and west (SB-3) of the UST area. (Note: SB-1 was located over 500 feet north of the former UST area and was not considered for scoring purposes)
