Cornet Bay Marina
Oak Harbor
LUST# 2389

Cornet Bay Marina Bulkhead Assessment

November 8, 2006

Subject: Cornet Bay Marina Bulkhead Assessment

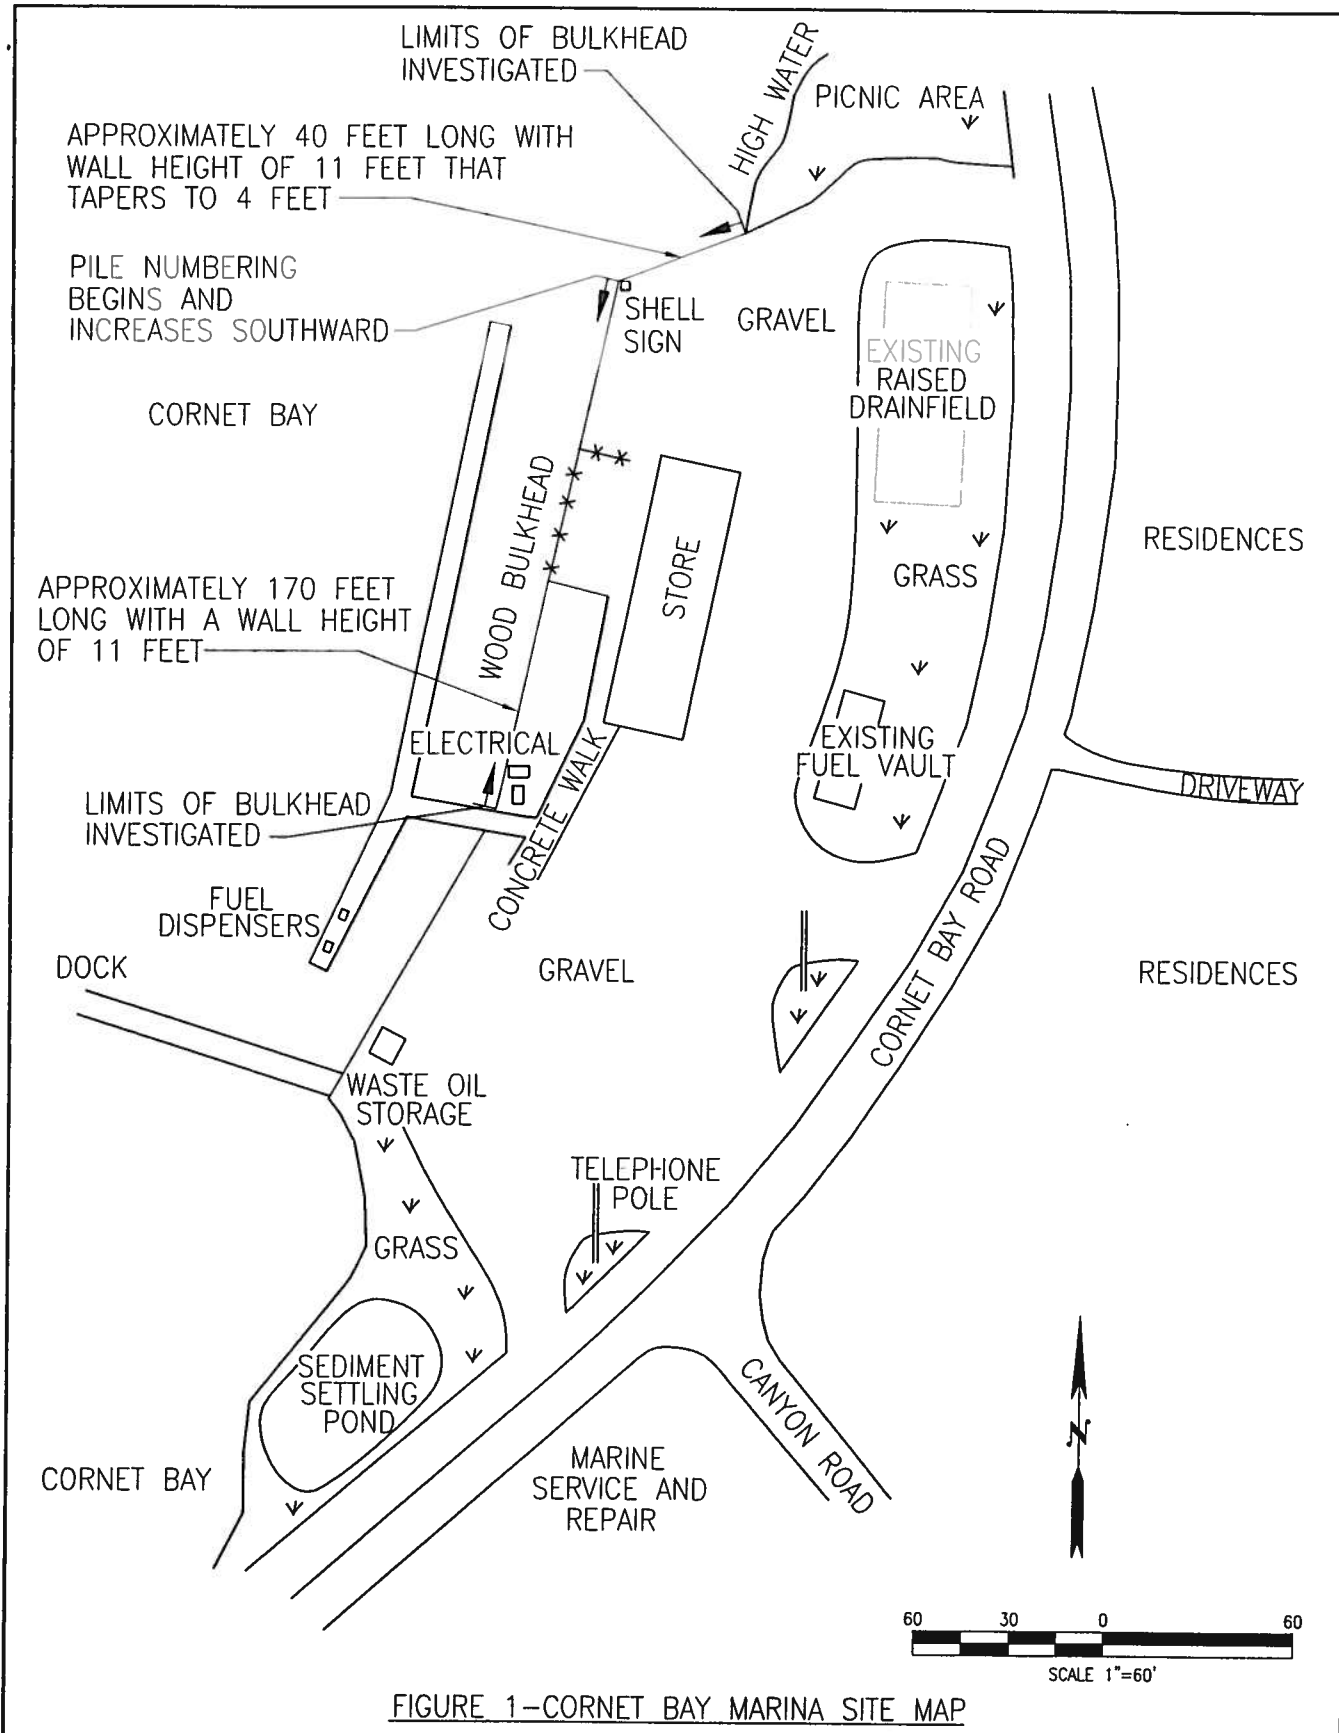
FIGURE 1-CORNET BAY MARINA SITE MAP

The investigation began at the north junction of the bulkhead at the “Shell” sign and proceeded south to the walkway to the marina. Subsequent numbering of elements is from north to south, see Figure 1. The main focus of the investigation is a section of bulkhead approximately 170 feet long. The 40-foot long section of bulkhead north of the “Shell” sign was also investigated.

There are three areas of notable deterioration of piling. The following groups of piling are rotten: Piling 4, 5, 13, 14, 15, 45, and 46. Cable tie-backs have some minor surface rust.

There are several locations where the lowest level walers are rotten. The most notable location is the rotten waler that spans from Pile 28 to Pile 33.
