**HILLTOP APARTMENTS SITE
REMEDIAL ACTIONS SUMMARY**

**1509 South Mission Street
Wenatchee, Washington**

Project Number 06-111

September 17, 2007

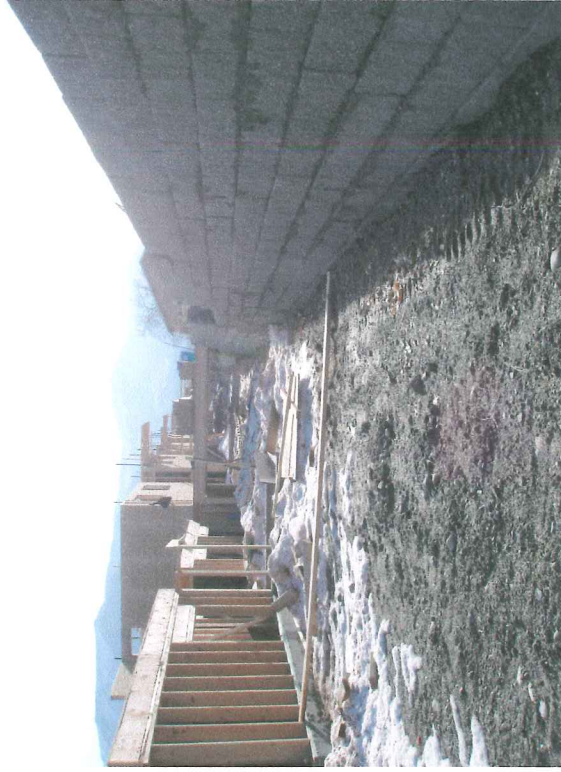
Construction of Retaining Wall West of the East Units

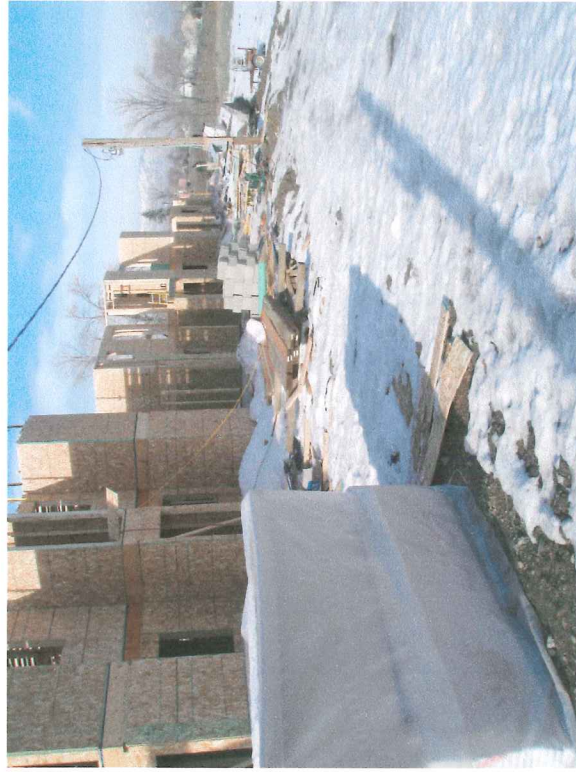
Construction of East Units (South View)

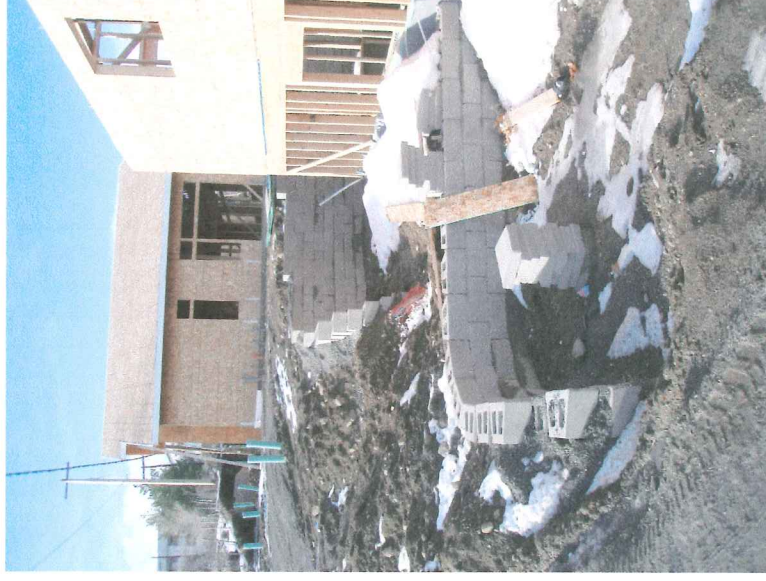
Retaining Wall Construction Between Units

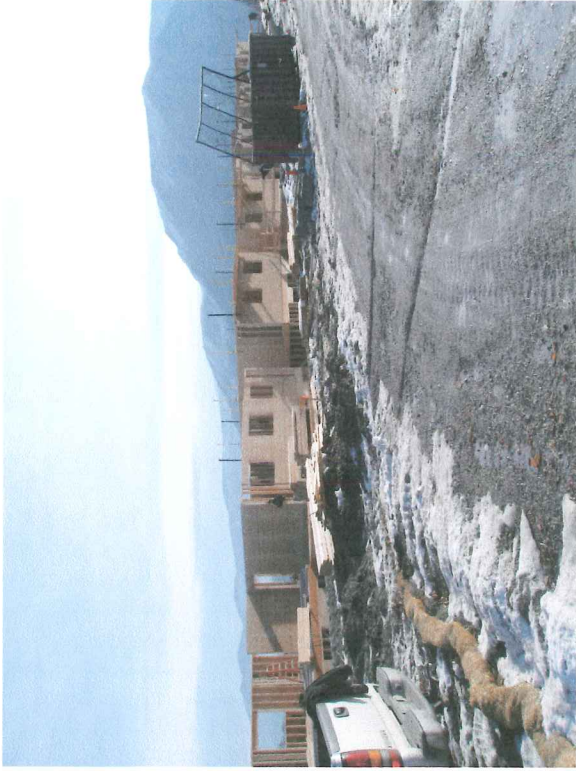
Application of Waddles as a Portion of Stormwater Management during Construction

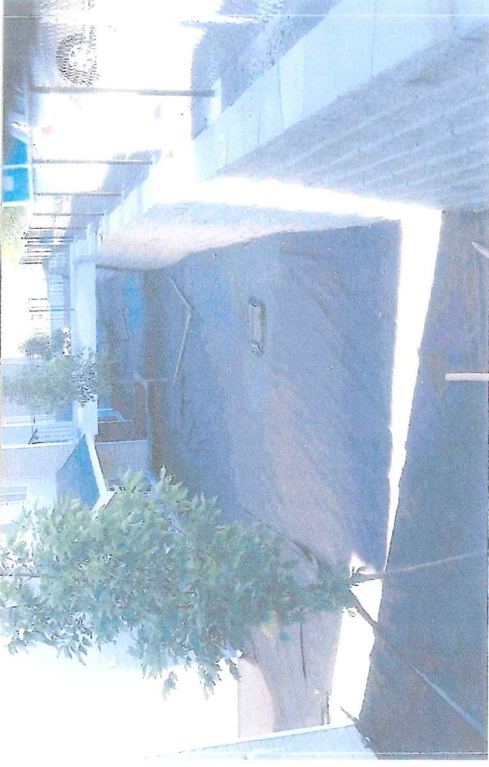
Fabric Application Between Parking and Units

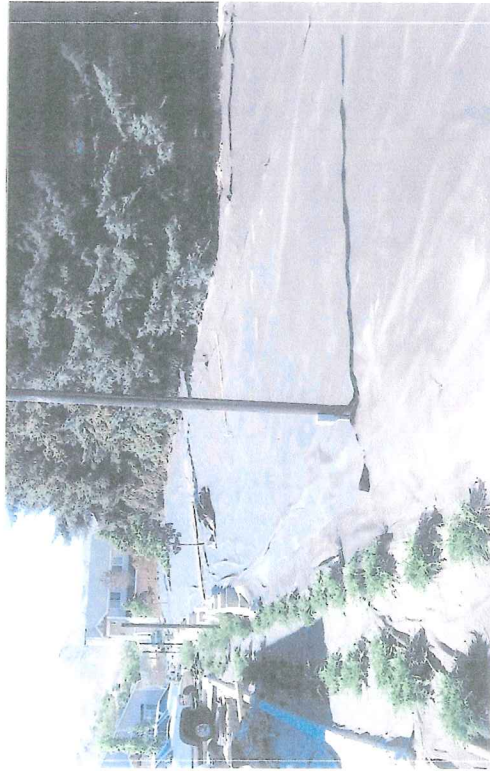
Fabric Application Around Retaining Wall

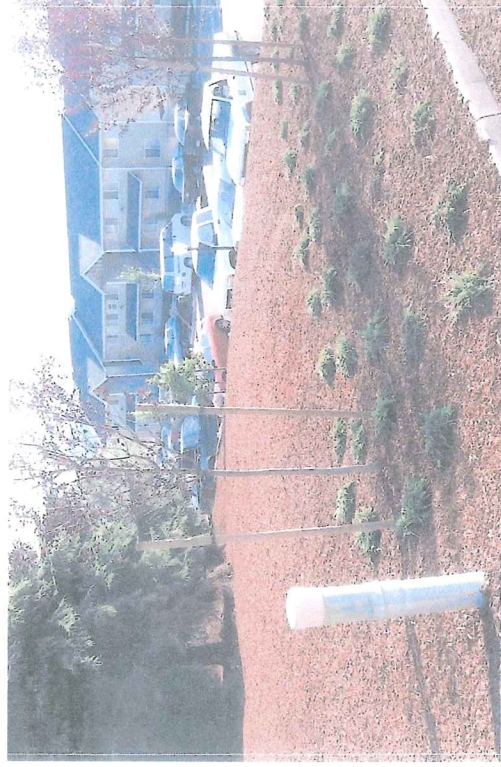
Landscaping Bark Over Fabric on West Side of Parcel
