***Abandoned Mine Lands  
Initial Investigation Report  
Copper Queen Mine  
Hurlbert, Washington***

***Prepared for  
Washington State  
Department of Ecology***

***December 28, 2006  
17274-00(CQ)***

***Abandoned Mine Lands Initial Investigation Report  
Copper Queen Fraction Mine  
Hurlbert, Washington***

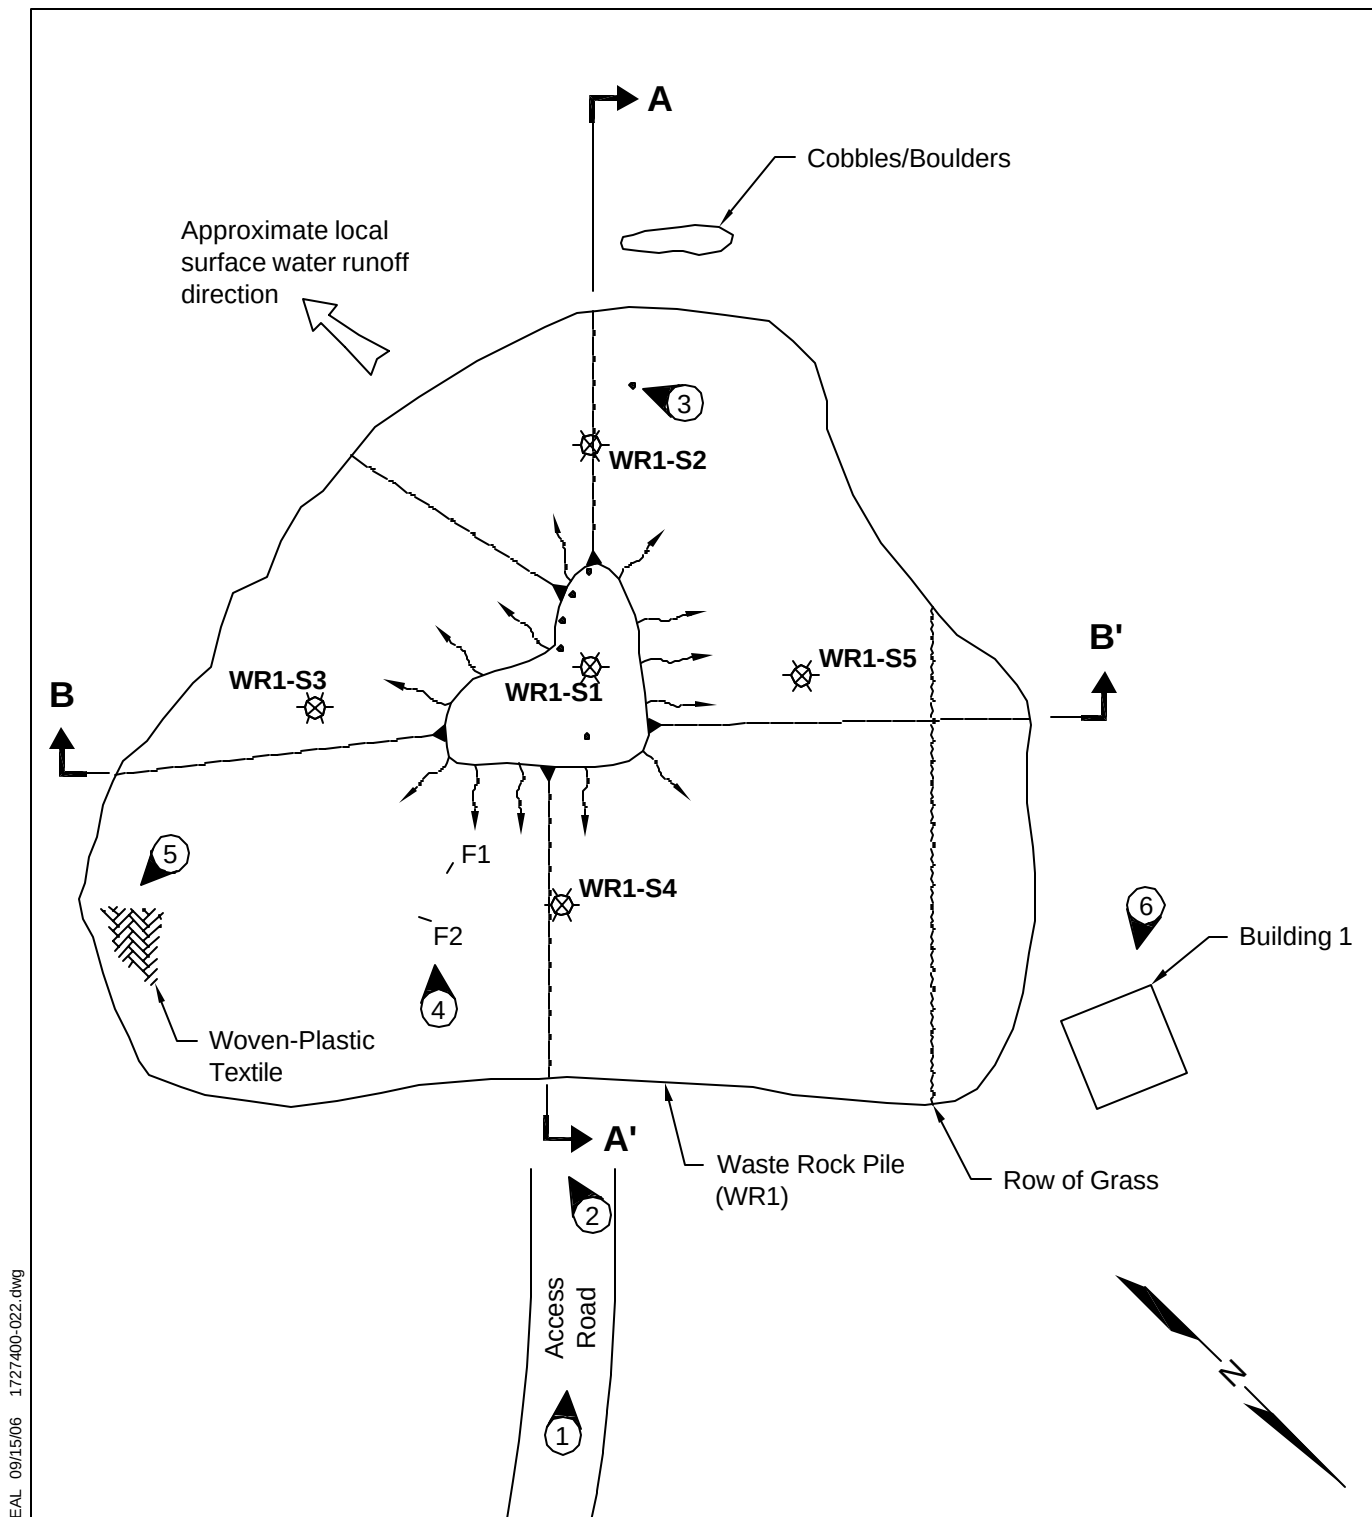
# Site Plan Copper Queen Mine

- 1-inch diameter black plastic hose protruding from pile (vent?)
- / F1 2-inch diameter white plastic pipe buried
- F2 2-inch diameter white plastic pipe broken

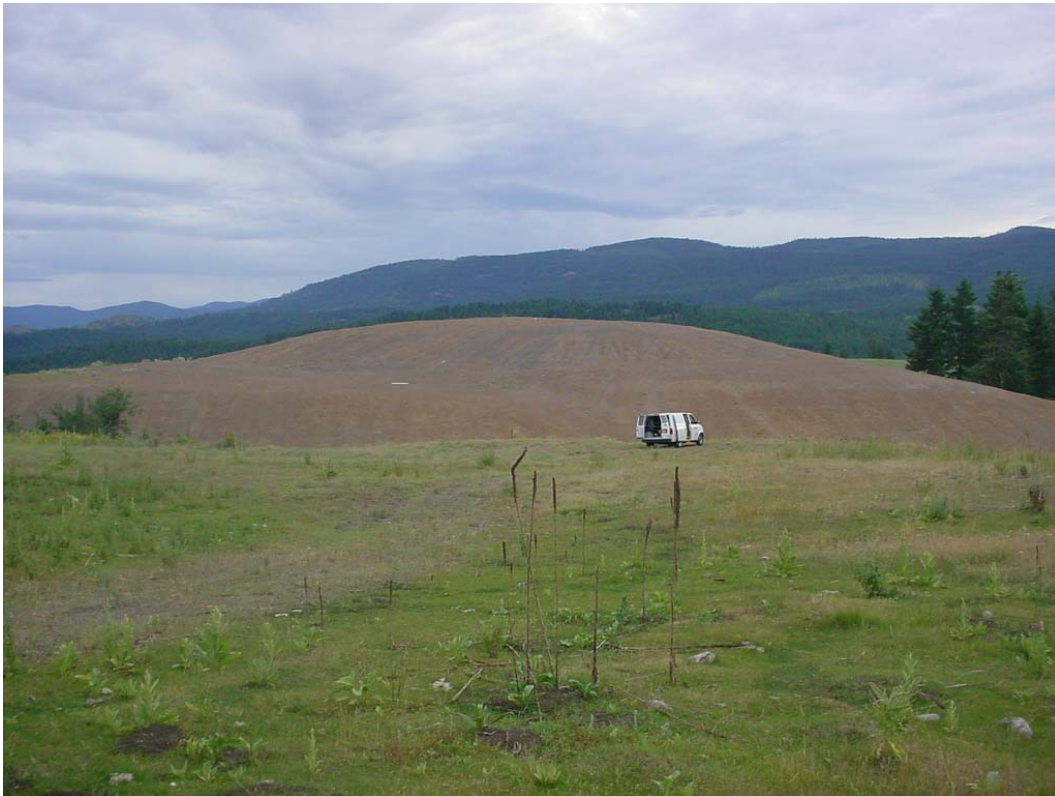
Photograph 1 - View of Waste Rock Pile 1 (WR-1).

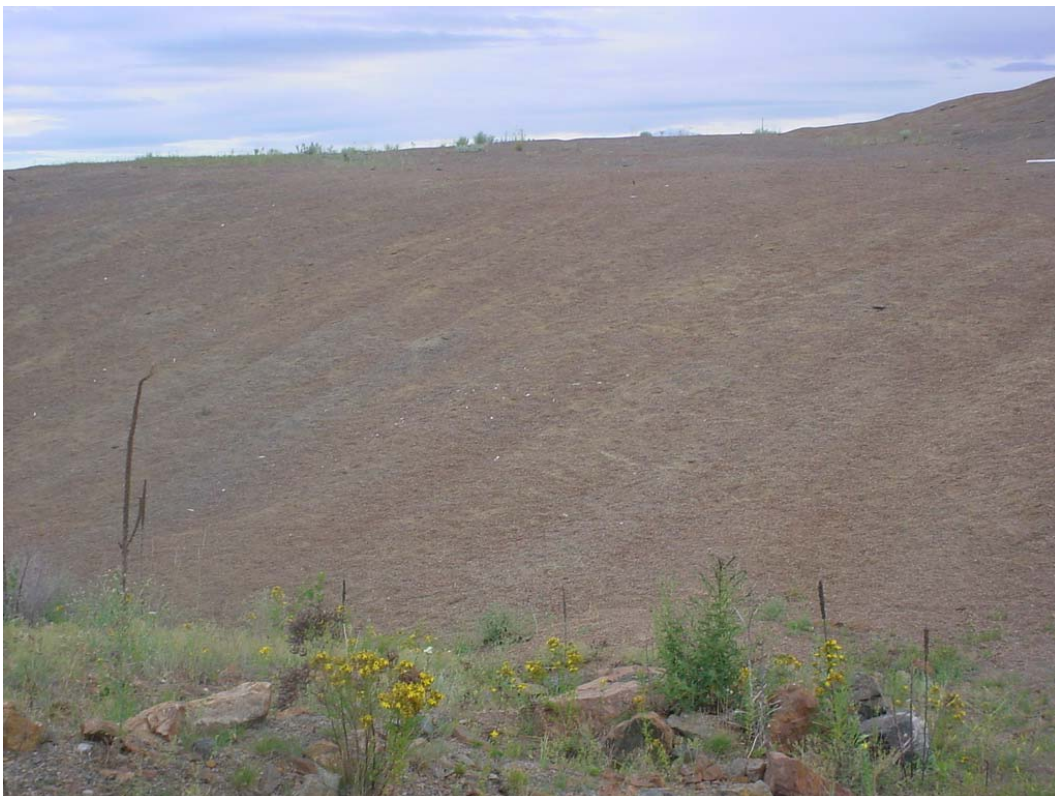
The Copper Queen Fraction Mine site is located just west of the Allis/Allis Fraction Mine site. The main feature of this site is a large crushed rock pile (Figure 3), WR-1, which is composed of a dry to moist, light brown, sandy Gravel and covers approximately 4.5 acres (Photograph 1). Cross sectional views of the crushed rock pile are shown on Figures 4 and 5. WR-1 is approximately 210,000 cubic yards in volume and has a thin row of grass near the western boundary. No other vegetation exists on the waste rock pile. Cattle were seen walking on the waste rock pile and grazing on the grass around it. Channels formed by erosion, either wind or water, were noted throughout the pile (Photograph 2).

Ephemeral drainage channels were observed throughout WR-1, but are probably due to erosion from heavy rain events. The channels did not extend beyond the crushed rock pile and, therefore, no samples were collected.

Photograph 2 - Example of drainage channels on WR-1.

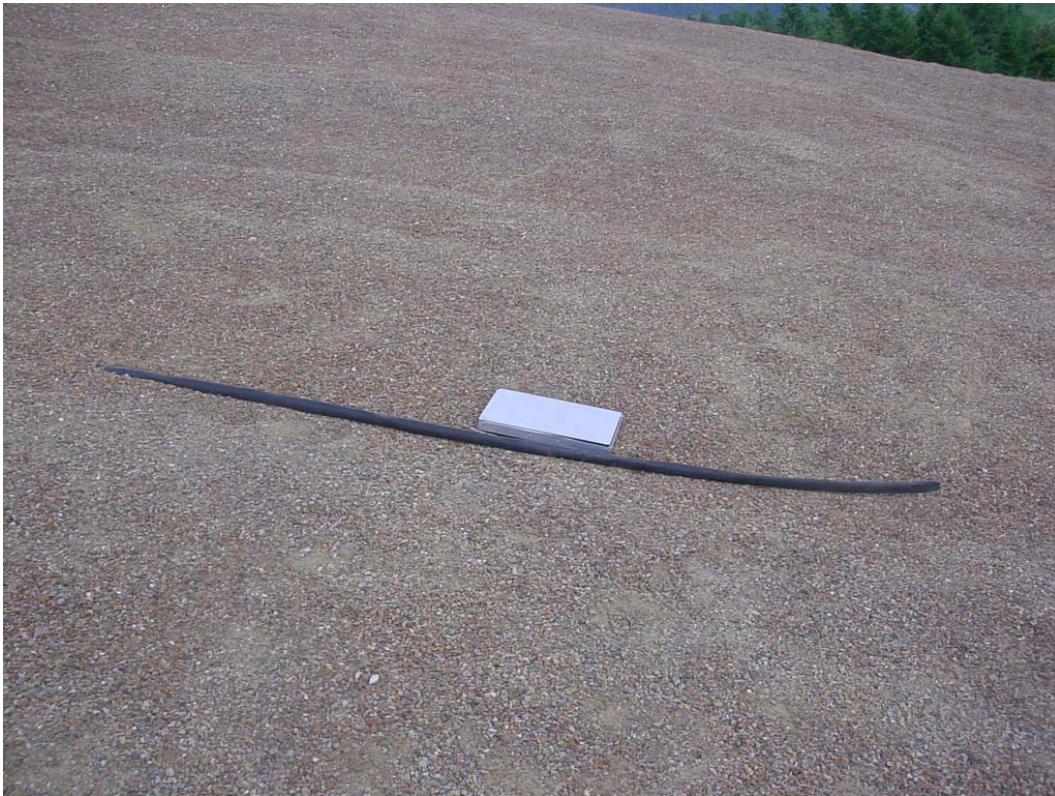
Pieces of small black plastic hose were observed protruding from the platform of the waste rock pile at regularly spaced intervals approximately 15 feet apart, and in scattered locations throughout the pile (Photograph 3). The hose may have been used for dust control or served as part of a type of leaching system. A white plastic pipe was partially uncovered near the center of the northeastern face of the waste rock pile. This pipe appears to be installed in a northeast-southwest orientation, running from the top of WR-1 to the bottom. A broken piece of white plastic pipe was also observed lying on the northern face of the site (Photograph 4). Pieces of a torn woven plastic textile, white on one side and yellow on the other, was scattered around the base of the eastern side of the pile (Photograph 5). However, no sumps, ponds, or leach collection systems were present. No seeps or ponds were observed on the site.

Photograph 3 - 1-inch-diameter, black plastic pipe scattered throughout WR-1.

Since it is possible that a leaching process may have been used at the site, additional sampling with analysis for cyanide may be appropriate.

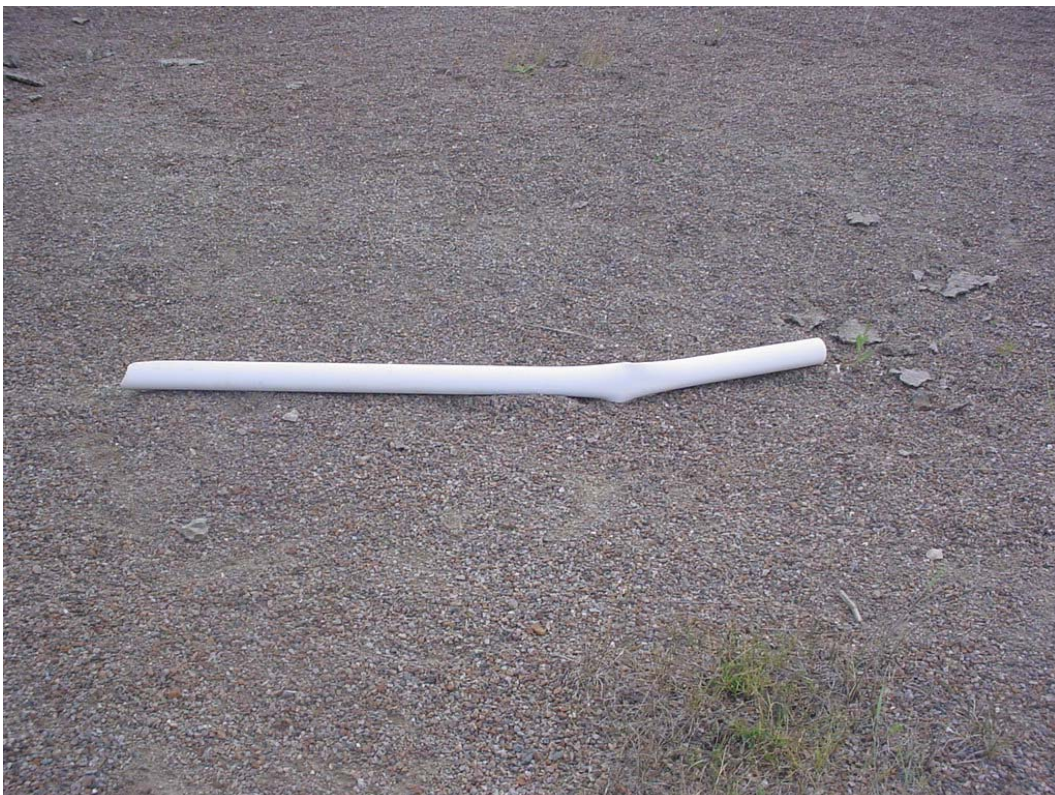
Photograph 4 - 2-inch-diameter, broken, white plastic pipe.

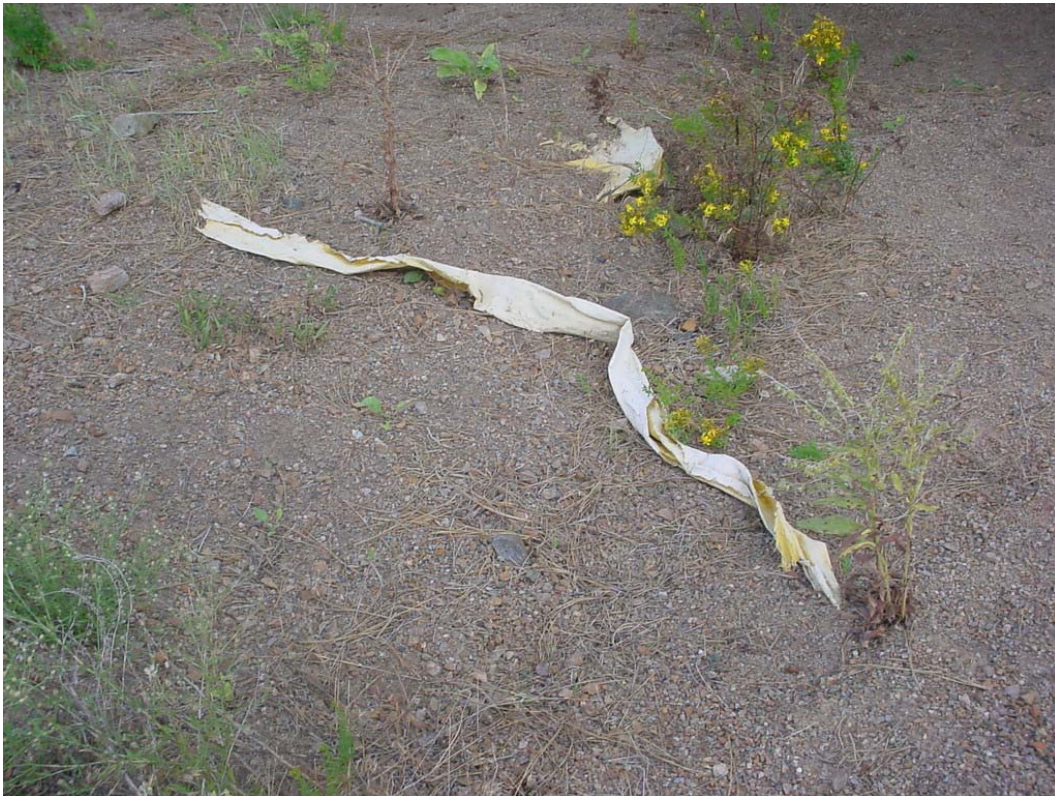
Photograph 5 - Woven-plastic textile on WR-1.

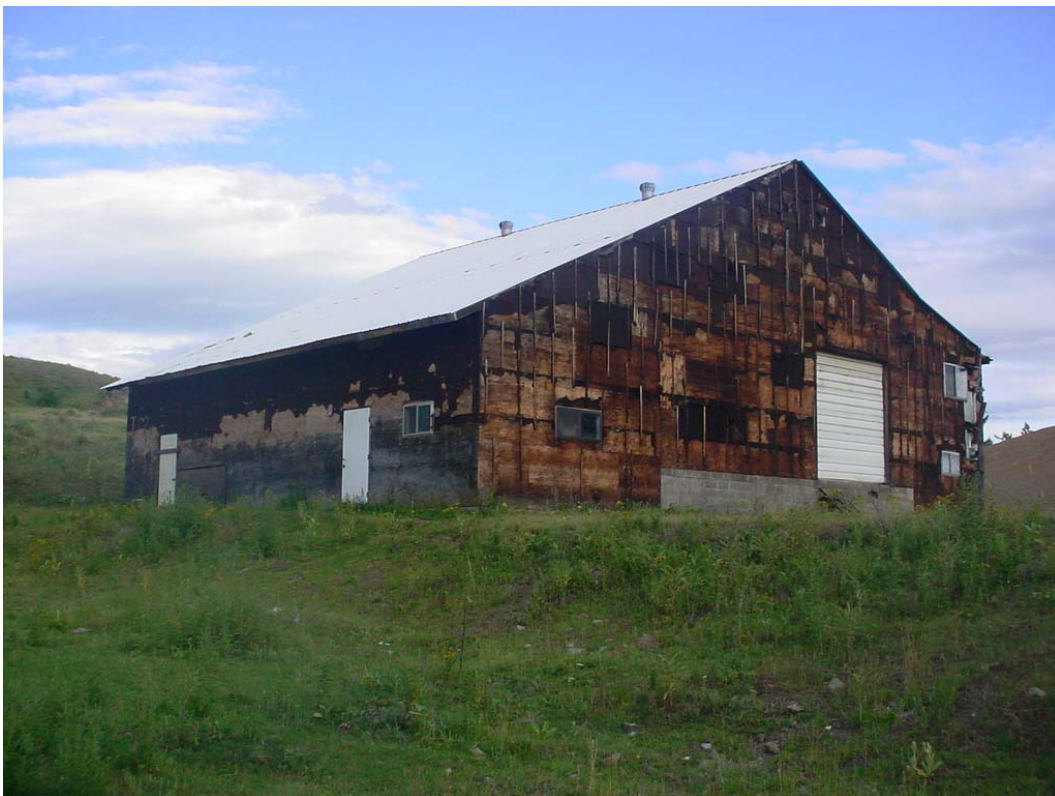
A building lies just off the northwest corner of WR-1 (Photograph 6). Although the siding has been stripped, the building is either relatively new or newly remodeled. The metal roof is in good condition and the building has plastic drainpipes and metal garage doors. The interior of the building could not be observed and its use is unknown.

Photograph 6 - View of Building 1.
