STATE OF WASHINGTON  
DEPARTMENT OF ECOLOGY

**Re: No Further Action at a Property associated with a Site:**

- **Site Name:** Aurora Rents, Inc.
- **Property Address:** 17230 Aurora Avenue N, Shoreline, WA
- **Facility/Site No.:** 1948477
- **VCP Project No.:** NW2619
- **Cleanup Site ID No.:** 11938

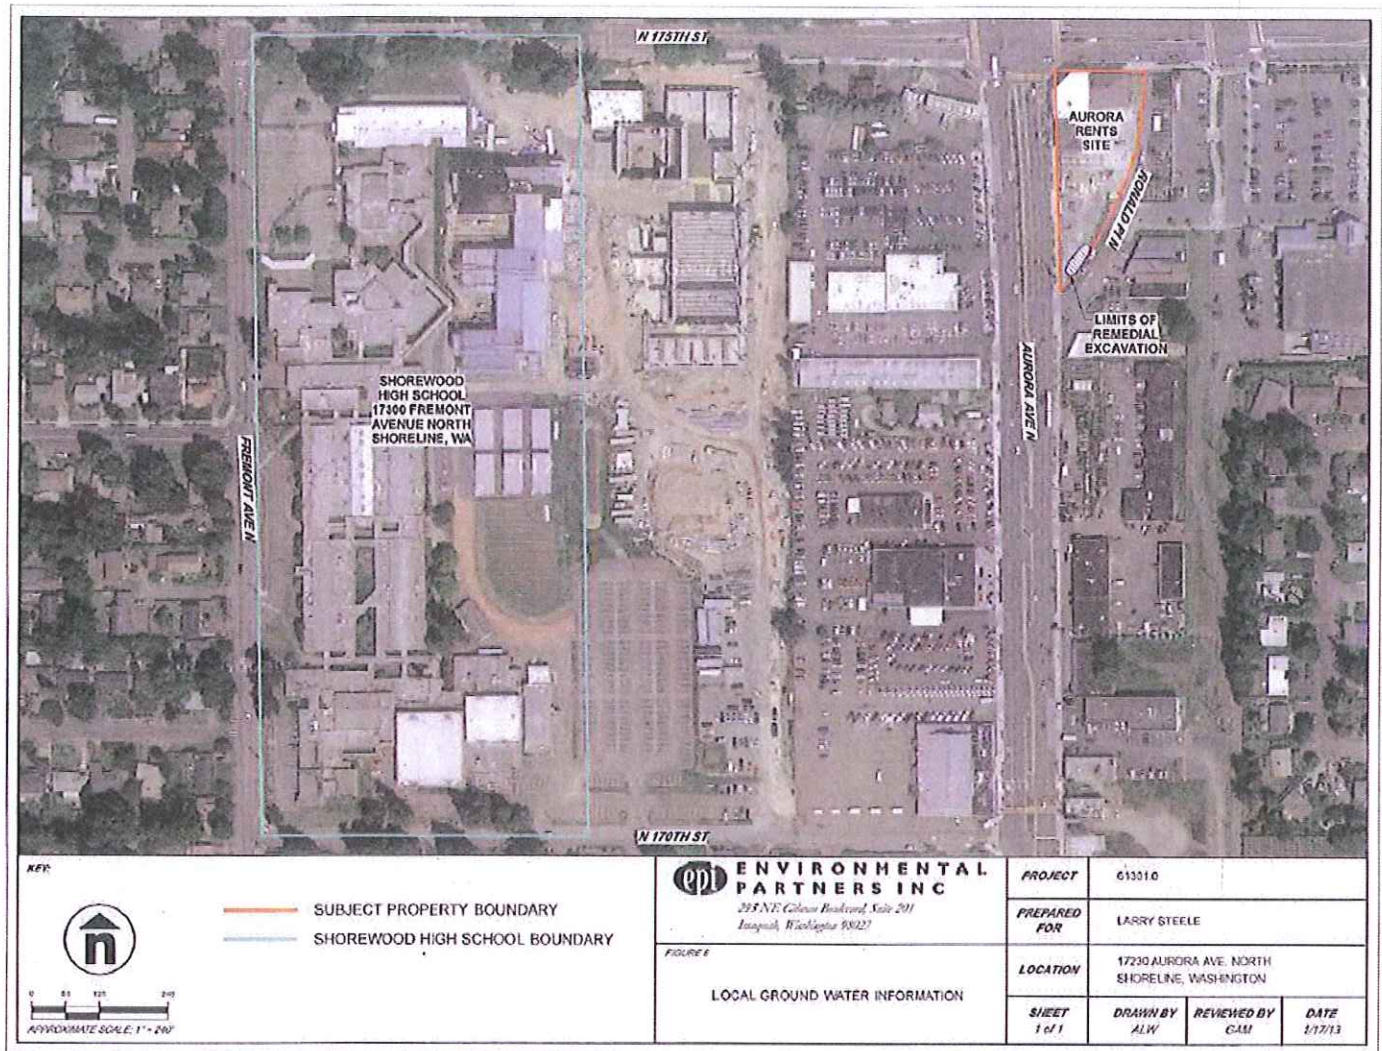
**Figure 2 General Vicinity Map Showing  
 Boundary of the Site**

While the soil contamination was adequately characterized in most areas within the Property, the status of the soil contamination was uncharacterized beyond the eastern boundary due to lack of accessibility (Figure 2 and Figure 3).

**Ecological Setting:** There is no terrestrial habitat within 500 feet from the contaminated portions of the Site (Figure 2), which is surrounded by commercial areas. Most land surfaces in the Site vicinity are covered by commercial properties.

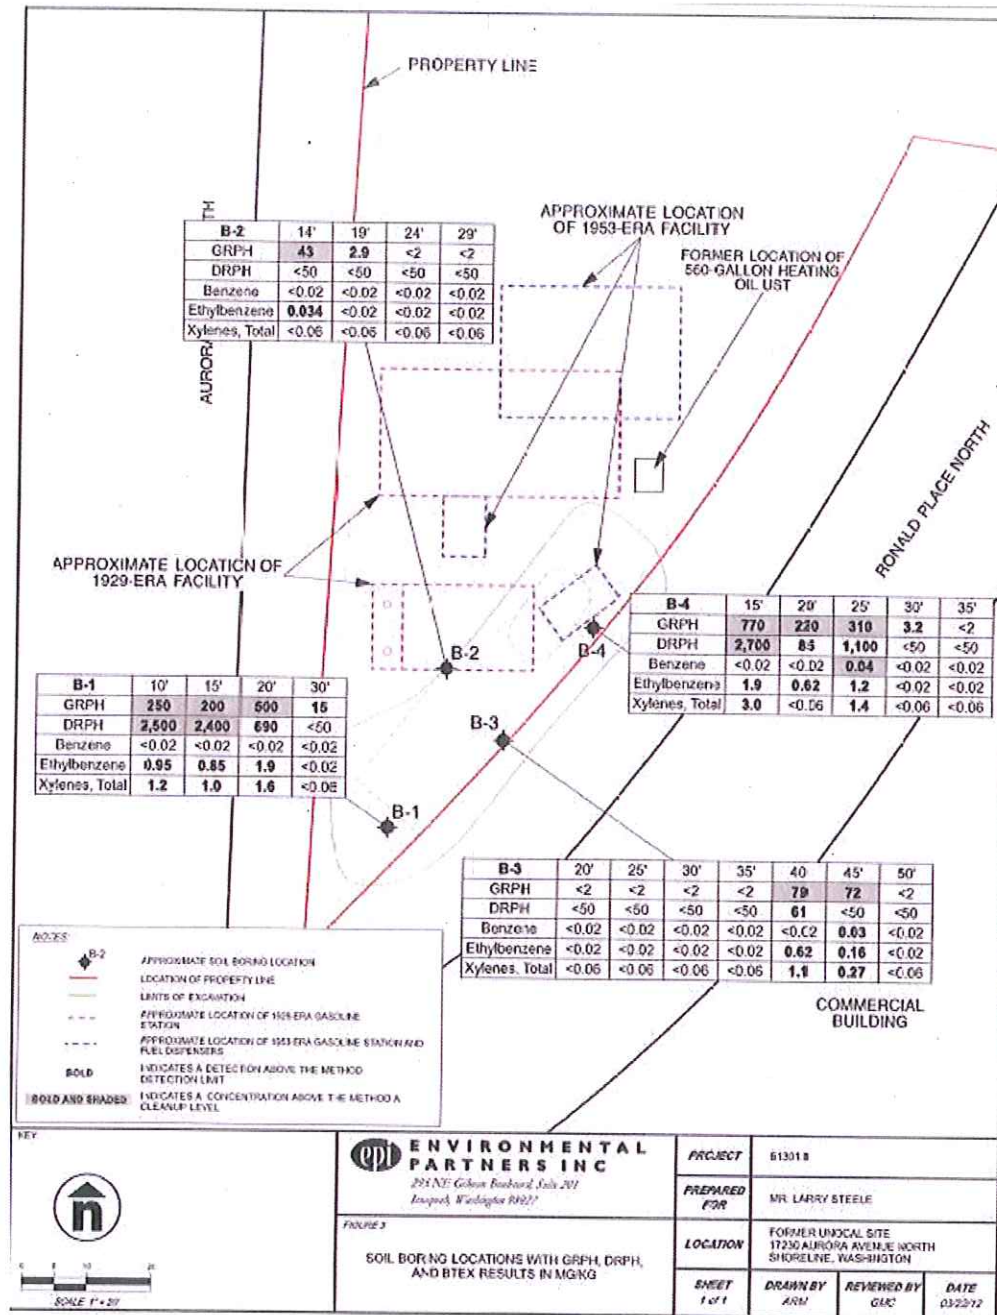
**Figure 3 Soil Sampling Locations with Analytical Results (mg/kg)**

On February 15 and 16, 2011, 4 soil borings were advanced at the locations near and along the eastern boundary of the Property, where the soil contamination previously demonstrated elevated concentration levels. The primary objective of this further assessment was to characterize the vertical extent of the soil contamination and, if encountered, to collect groundwater samples. Depth of the borings extended from 30 to 50 feet bgs. Twenty soil samples were obtained for laboratory analysis at 5-foot intervals in the borings. Exceedances of TPH-GRO, -DRO and BEX were discovered from various intervals at the soil borings (detailed in Figure 3)

1) Site characterization has identified the nature and extent of soil contamination at the Property within the Property boundary (Figure 3 and Figure 4).

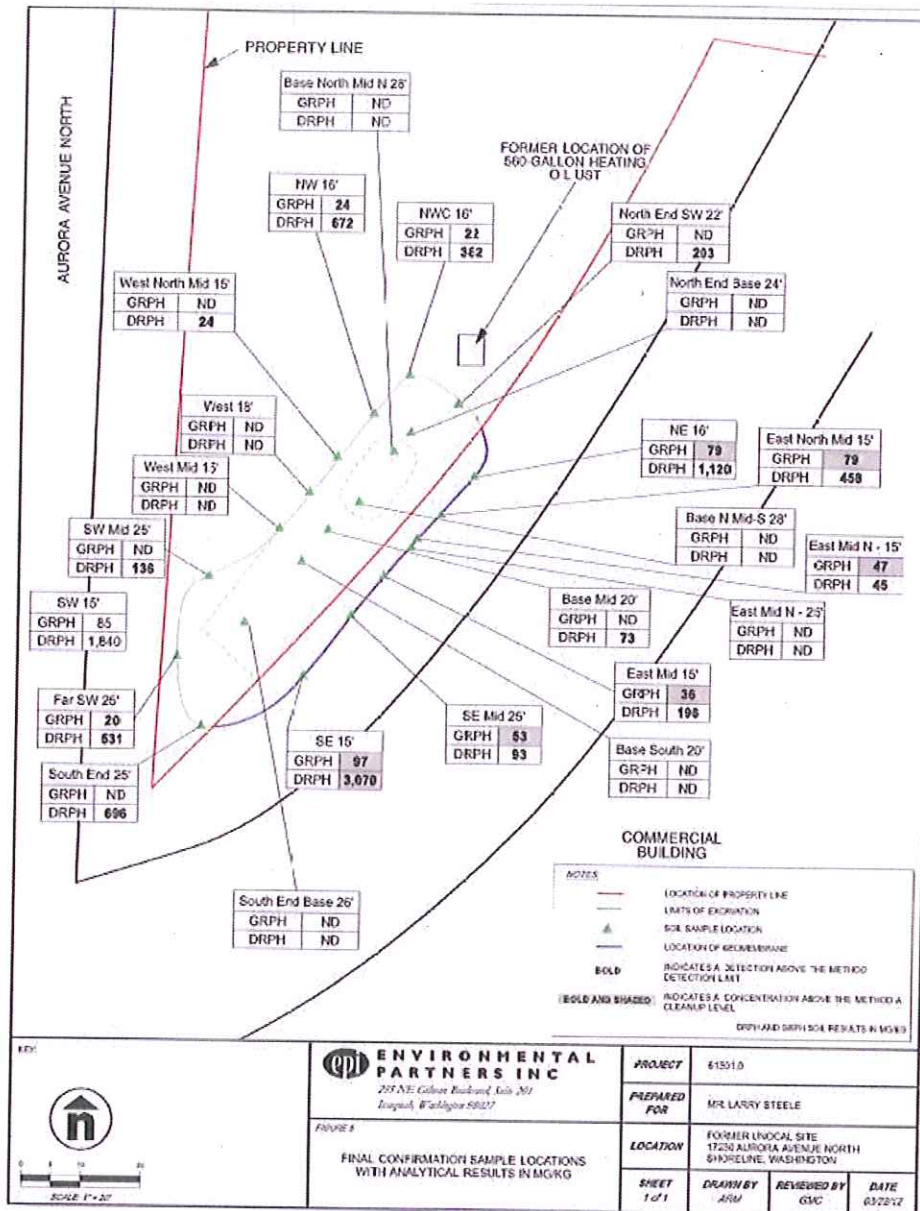
**Figure 4 Confirmation Sampling Locations with Analytical Results (mg/kg) at the Excavation**

**Releases and Extent of Soil Contamination:** Soil contamination was confirmed by a Site assessment. Following the Site assessment, the soils exceeding Method A cleanup levels were removed from within the Property and appropriately disposed off-site. However, remediation of the contaminated soil exceeding Method A cleanup levels remaining beyond the eastern Property boundary (Figure 4) is required to characterize and cleanup the Site.

2) A total of 605 tons of soil containing TPH-GRO, -DRO and BEX exceeding the MTCA Method A cleanup level was excavated (Figure 4) and disposed at a regulated landfill facility for unrestricted land use. Soil samples collected in the excavation confirmed the success of the soil remediation to meet the cleanup levels.
