MEMORANDUM

To: Joyce Mercuri, Washington State Department of Ecology
Date: July 1, 2013

From: Joy Dunay and David Templeton, Anchor QEA
Project: 040289-02.07

Re: Eddon Boat Park Long-Term Monitoring Plan Year 5 Memorandum

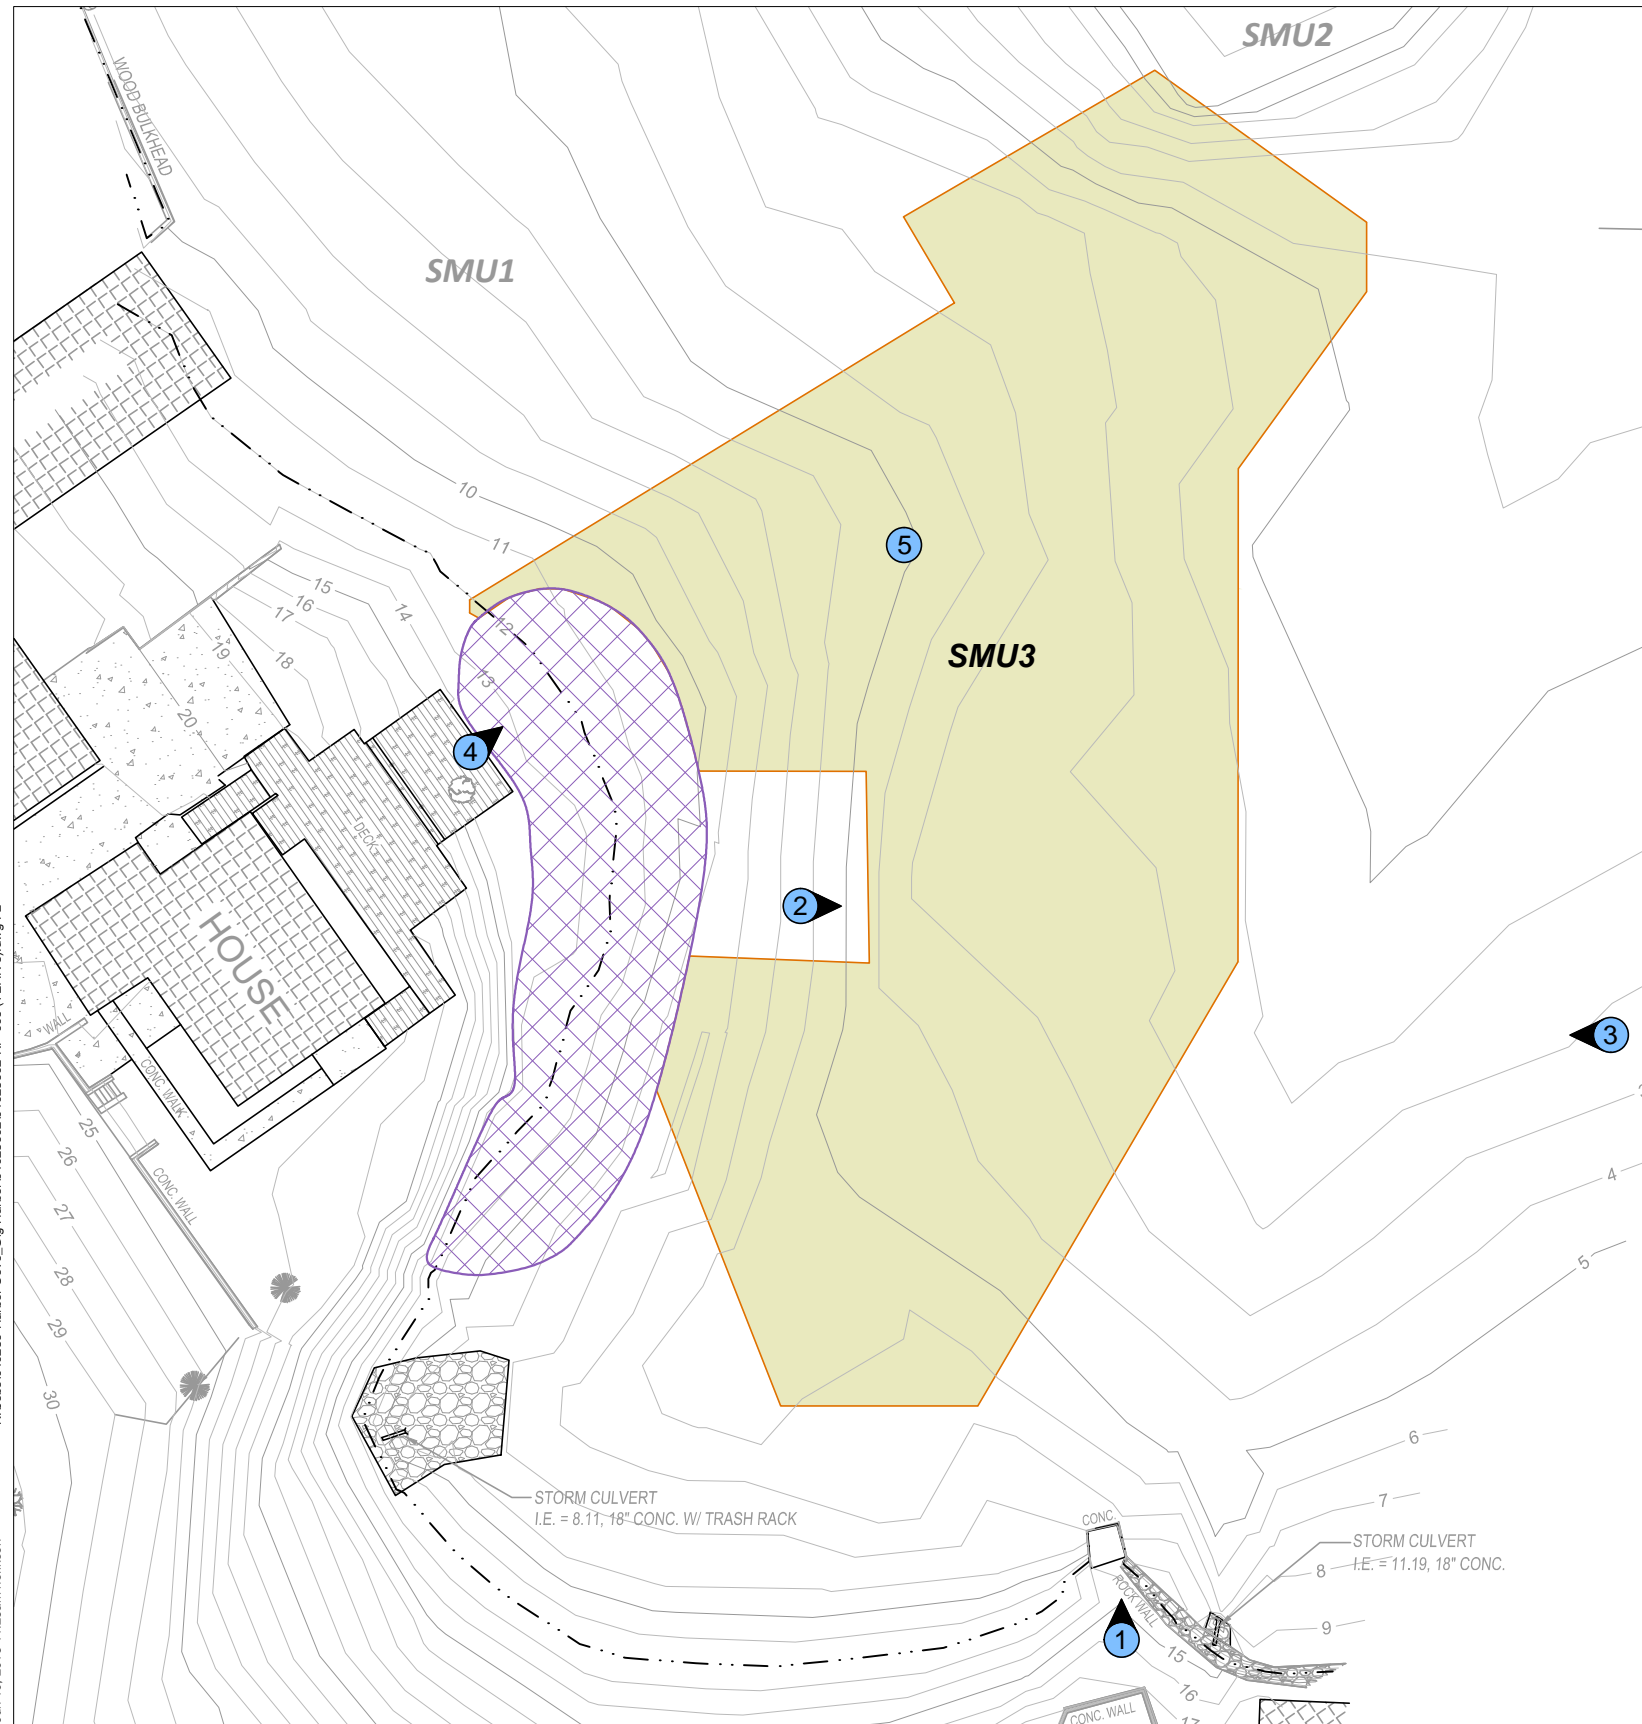
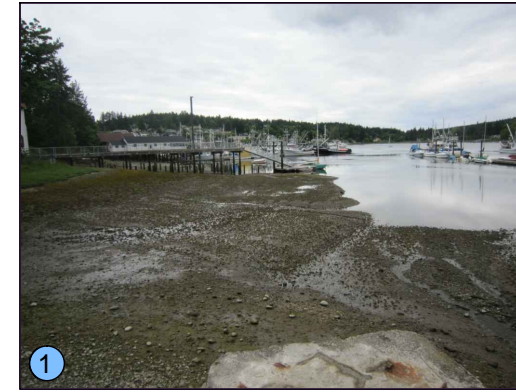
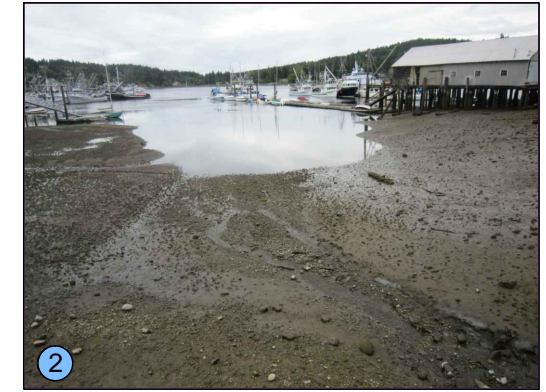
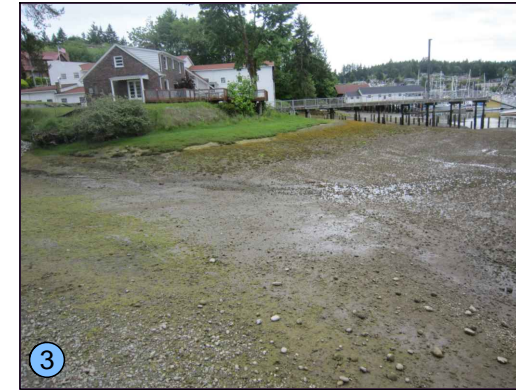
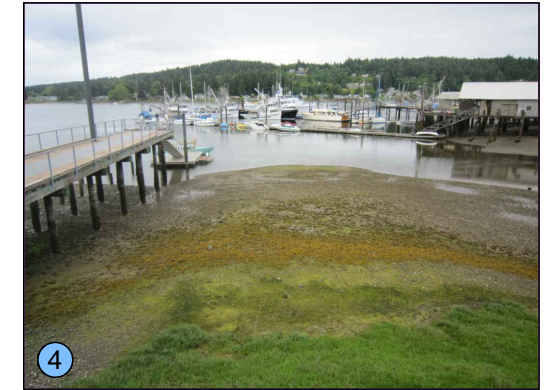
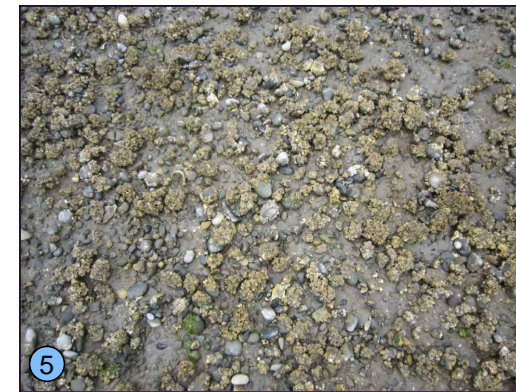
In conclusion, Year 5 monitoring was performed in accordance with the Ecology-approved LTMP. Visual inspection confirmed that the cap material is present in SMU-3 and shows no sign of erosion. As expected, some fine-grained material has accumulated, and recolonization of native plant species such as rockweed (*Fucus gardneri*) and pickleweed (*Salicornia virginica*) is evident. Similarly, the material placed in SMU-2 is present, has not eroded, and is showing signs of deposition. This is consistent with the yearly visual inspections conducted since 2009 and confirms that the cleanup action has functioned as desired and in accordance with the CAP.
