**SITE HAZARD ASSESSMENT
KENMORE INDUSTRIAL PARK/KENMORE LANDFILL
6400 BLOCK OF NORTHEAST 175TH STREET
KENMORE, WASHINGTON**

Figure 1
 Kenmore Industrial Park
 Kenmore, WA

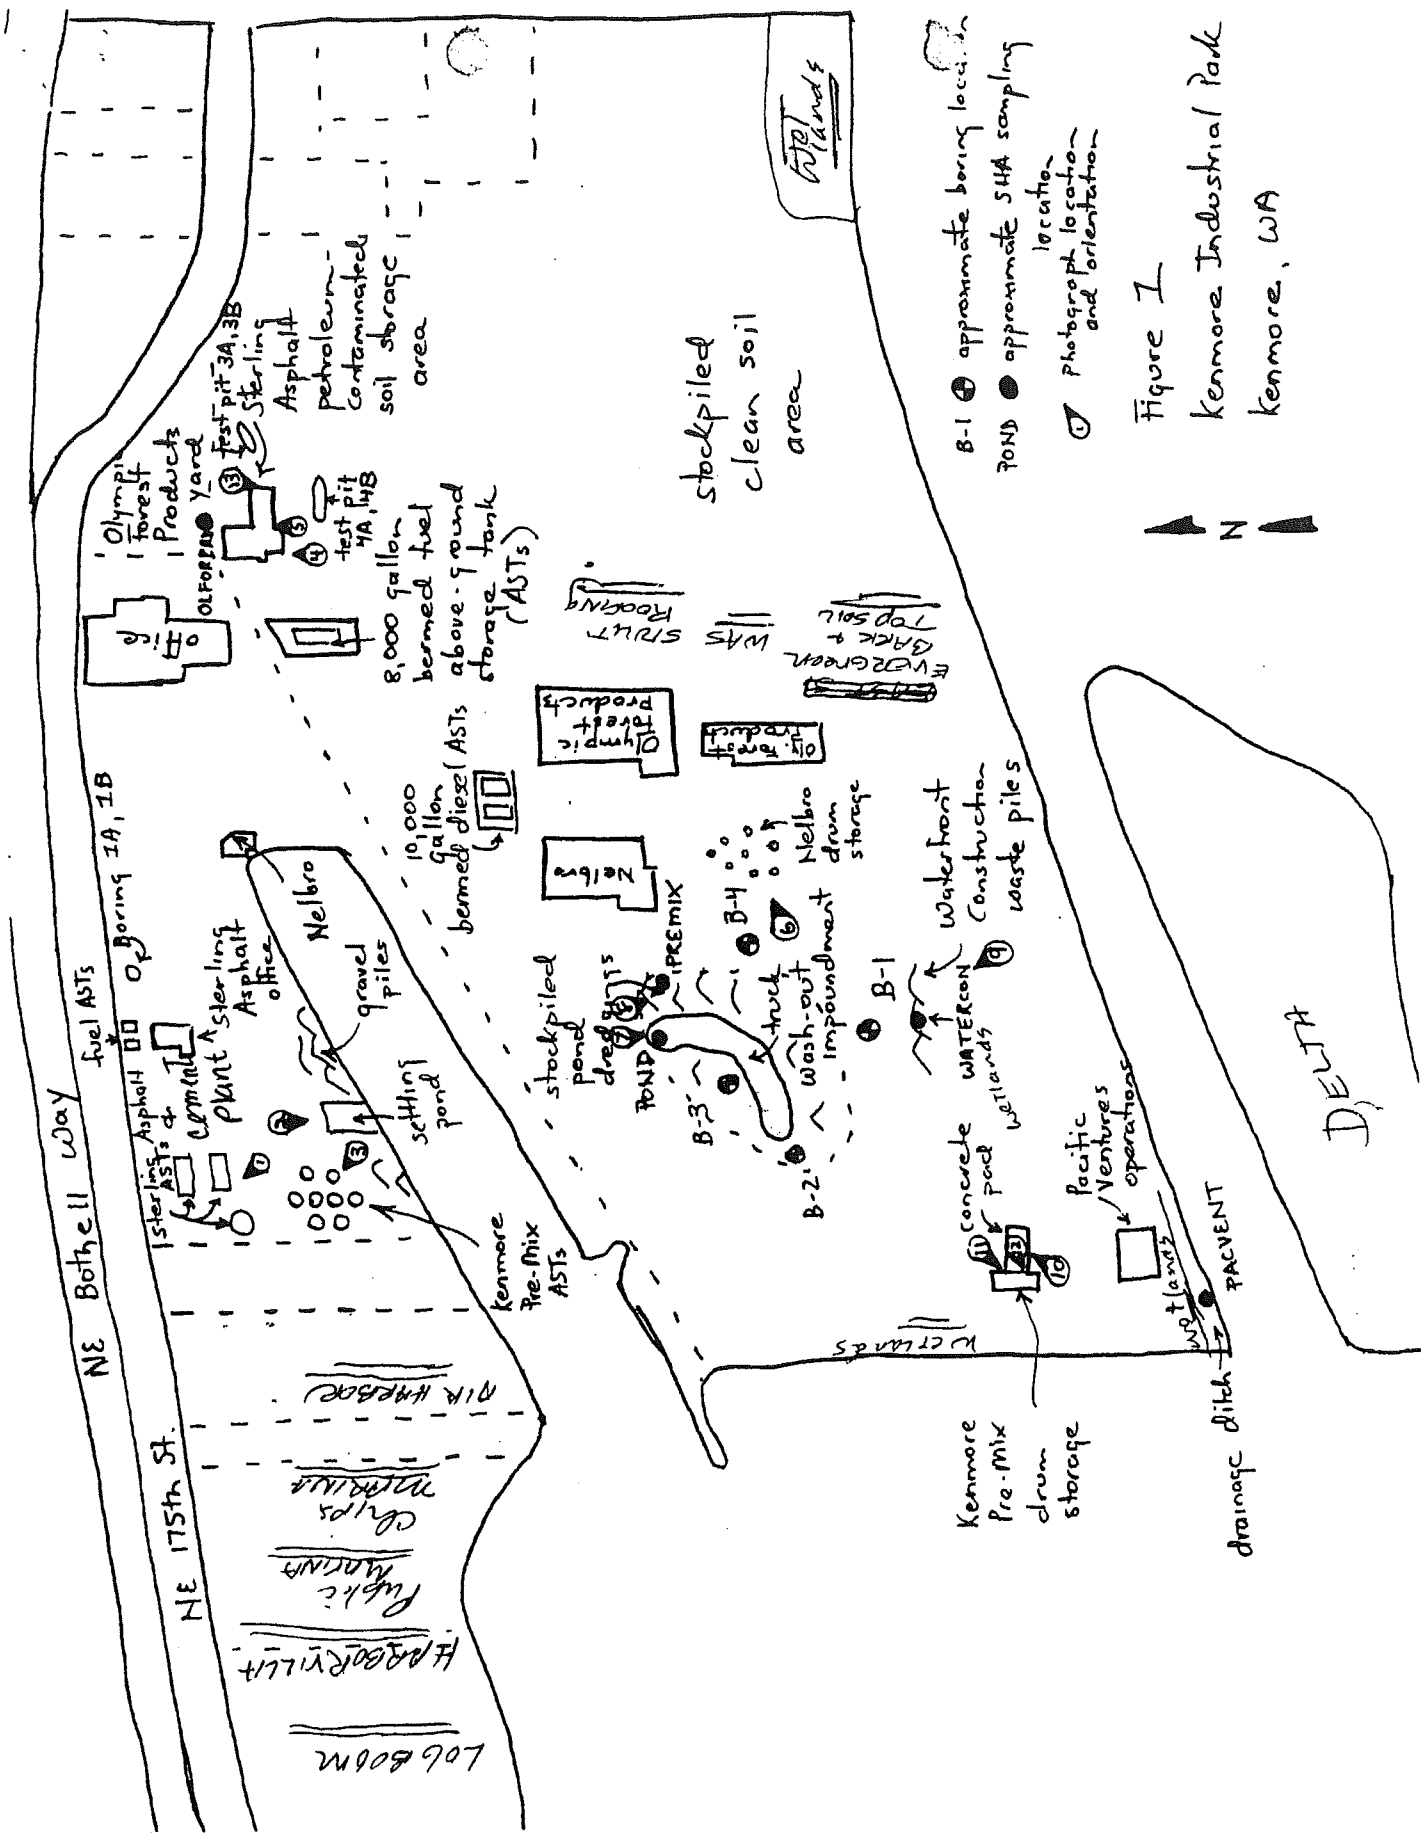
Sterling Asphalt. The Sterling Asphalt facility was first investigated during the field inspection (Figure 1). The asphalt plant was noted to be very clean and well-maintained. No above-ground pipeline leakages or other spillages were noted at the plant.

A waste pile is maintained by Sterling Asphalt on another section of the site leased from Pioneer Towing (Figure 1). The waste pile consists of TPH-contaminated soils brought onto the site from various off-site leaking underground storage tank (LUST) removals and related cleanup operations. These TPH-contaminated soils are processed through the asphalt plant within 8 weeks after receipt at the site. Sterling Asphalt supplied analytical results for a number of the TPH-contaminated soils it had accepted for batching. All of the analytical results indicated that the soils were free of solvents, PCBs, and elevated heavy metal concentrations.

The waste pile was maintained in an open structure with a roof, or under tarps (photograph 4). It is stored on an asphalt-lined area. The storage area is partially bermed; however, there appears to be no run-on/runoff control (photograph 5). During a heavy rain, runoff from the waste pile would flow to the adjacent Olympic Forest Products lumber storage yard. Also, there is no leachate

Nelbro Packing, Inc.. Nelbro Packing, Inc. maintains a boat dock at the eastern end of the dredged channel on Pioneer Towing property (Figure 1). Fishing boats from Alaska and other locations are loaded and unloaded at this location. A number of 55-gallon drums were noted stored near the loading dock.

Kenmore Pre-Mix. Kenmore Pre-Mix maintains 10 ASTs at the Kenmore Industrial Park. Seven of these are in one location adjacent to Sterling Asphalt operations (Figure 1, photograph 3). They range in size from 1,500 to 8,000 gallons. These tanks are not bermed; however, they also drain to the nearby lined, bermed impoundment area.

Numerous 55-gallon drums are stored by Kenmore Pre-Mix in an open, covered storage area adjacent to Lake Washington (Figure 1, photographs 11 and 12). A bermed area located between the drums and the lake functions as secondary containment for the storage area. The drums are also stored on a concrete pad, although the pad itself is not bermed. Although many of these drums are empty, several were noted to contain petroleum products and related materials. Some oil-stained soil was noted surrounding the drum storage area.

The Kenmore Pre-Mix truck wash-out pond is used to wash out trucks (Figure 1, photograph 7). It also collects water from truck exterior washing operations using muriatic acid. In addition, storm water collected from the lined impoundment situated near Sterling Asphalt is also emptied into the pond. The wash-out pond is situated over the approximate location of the former Kenmore Landfill. The pond covers an estimated 1,700 square foot area and contains an estimated 40,000 gallons of liquid. The landfill area is thought to contain at least 15,000 cubic yards of waste.

It was also noted during the site inspection that the petroleum-contaminated soil waste piles maintained by Sterling Asphalt were only partially covered with tarps (Figure 1, photograph 13). No run-on/runoff control was observed for the area.
