PERIODIC REVIEW

**Pacific Recycling
Facility/Site ID #: 326**

**1615 Chemical Drive
Kennewick, Washington 99336**

August 2009

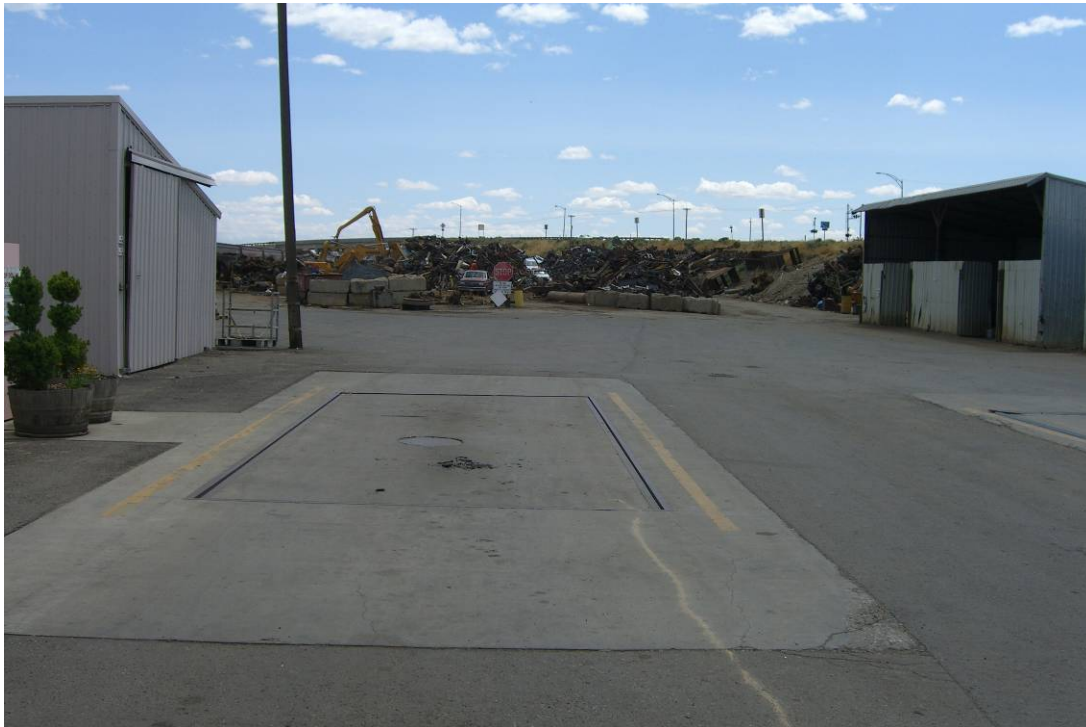
Photo 1: Scale Near Main Office - from the northwest

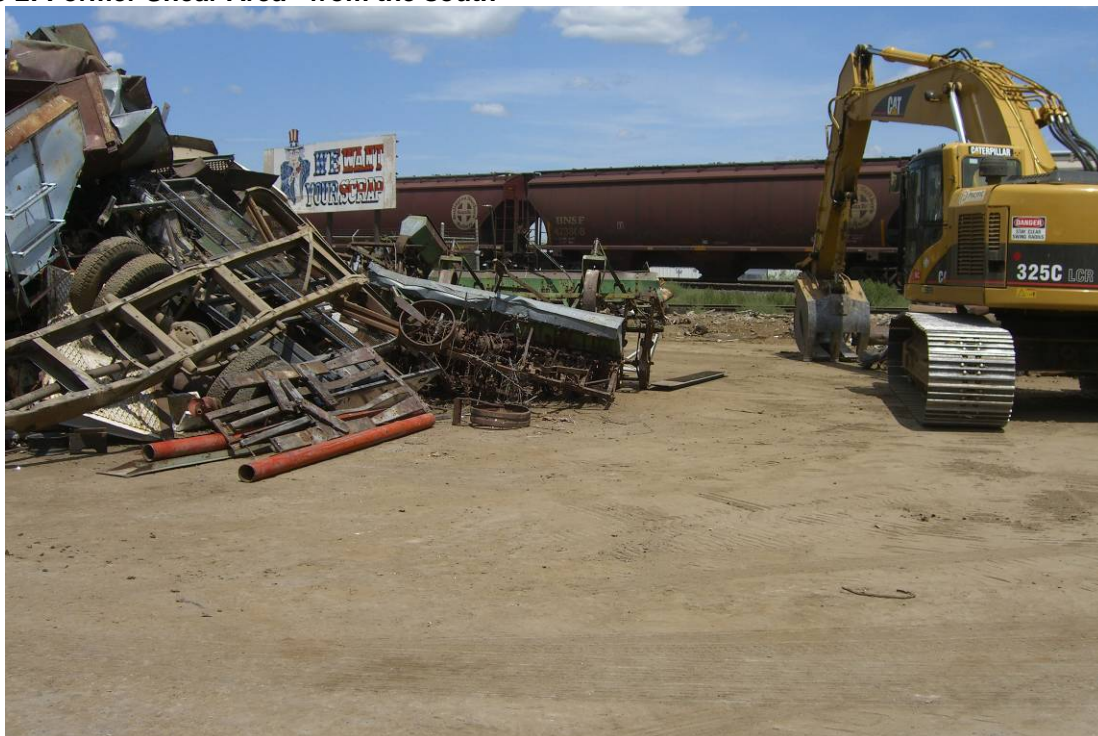
Approximately 150 tons of impacted soils were excavated from the southwestern side of the shear immediately adjacent to its concrete foundation. The excavation included an area approximately 70 feet by 10 feet and a maximum of 12 feet below ground surface (bgs) at its deepest location. Deeper excavation in this location would have undermined the shear's foundation.

backhoe, the narrowness of the excavation, and sidewall instability. The soil sample collected at 9 feet bgs was thought to be representative of soils in the deepest portion of the excavation based on field screening and field observations. No other detections of TPH at or above the MRLs were made in any of the samples collected from the shear remedial excavation. The excavation was backfilled with clean soil. The area has since been covered with an on-grade concrete slab.

Photo 2: Former Shear Area - from the south

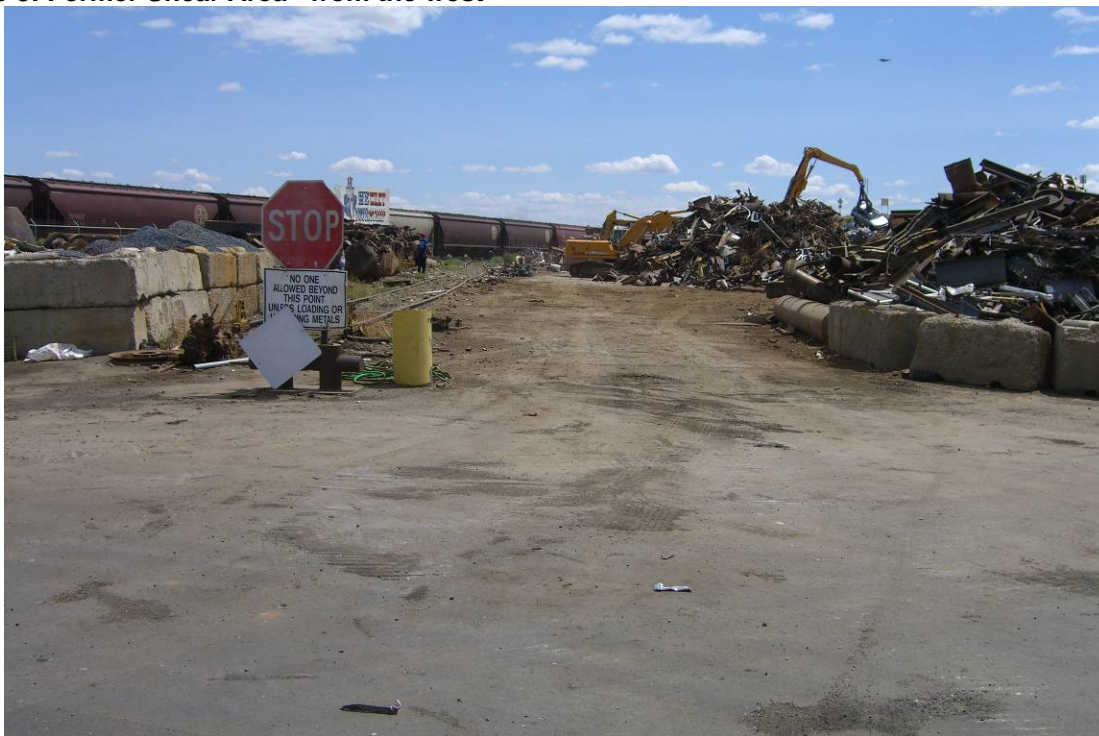
Photo 3: Former Shear Area - from the west

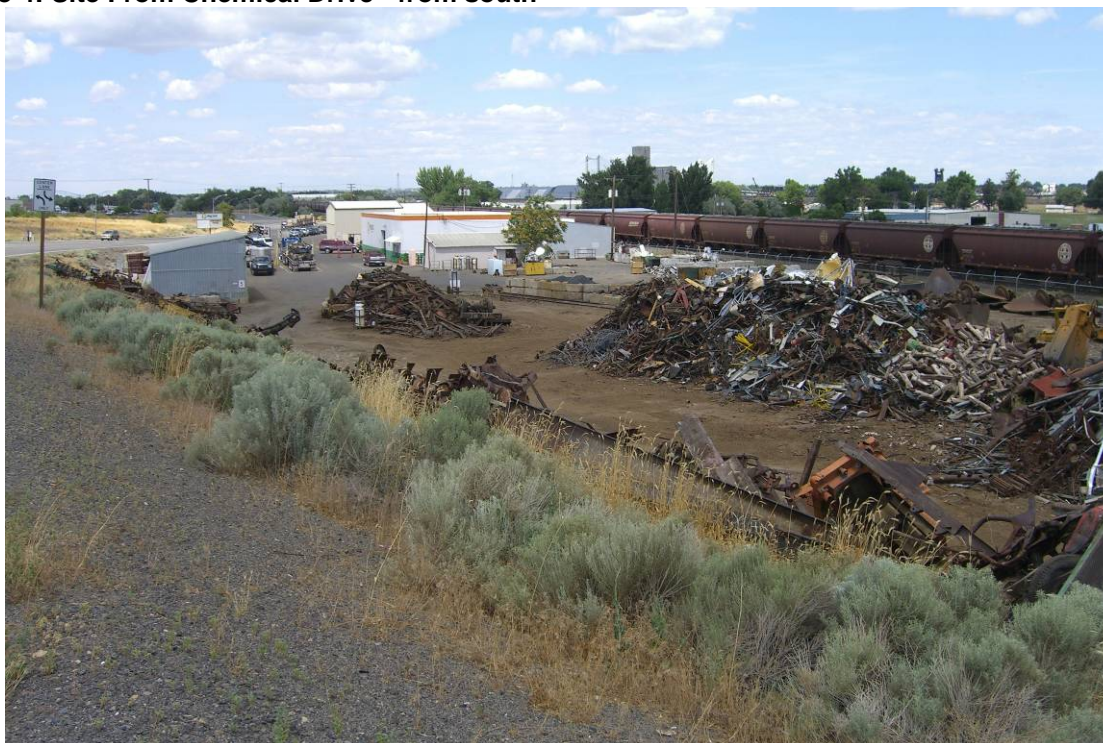
Photo 4: Site From Chemical Drive - from south
