RE: Final Report 2013 Annual Performance Monitoring Black Sand Beach Project Stevens County, Washington URS Job No. 36310197

Presented in this letter report is a summary of the third annual performance monitoring event conducted at Black Sand Beach in Stevens County, Washington on October 9, 2013. The purpose of this report is to document changes in the Black Sand Beach, including sediment erosion and/or re-deposition, since completion of the Black Sand Beach project in October 2010. The 2013 annual performance monitoring event was performed in accordance with a Washington Department of Ecology (Ecology) – approved Performance Monitoring Plan dated March 2010.

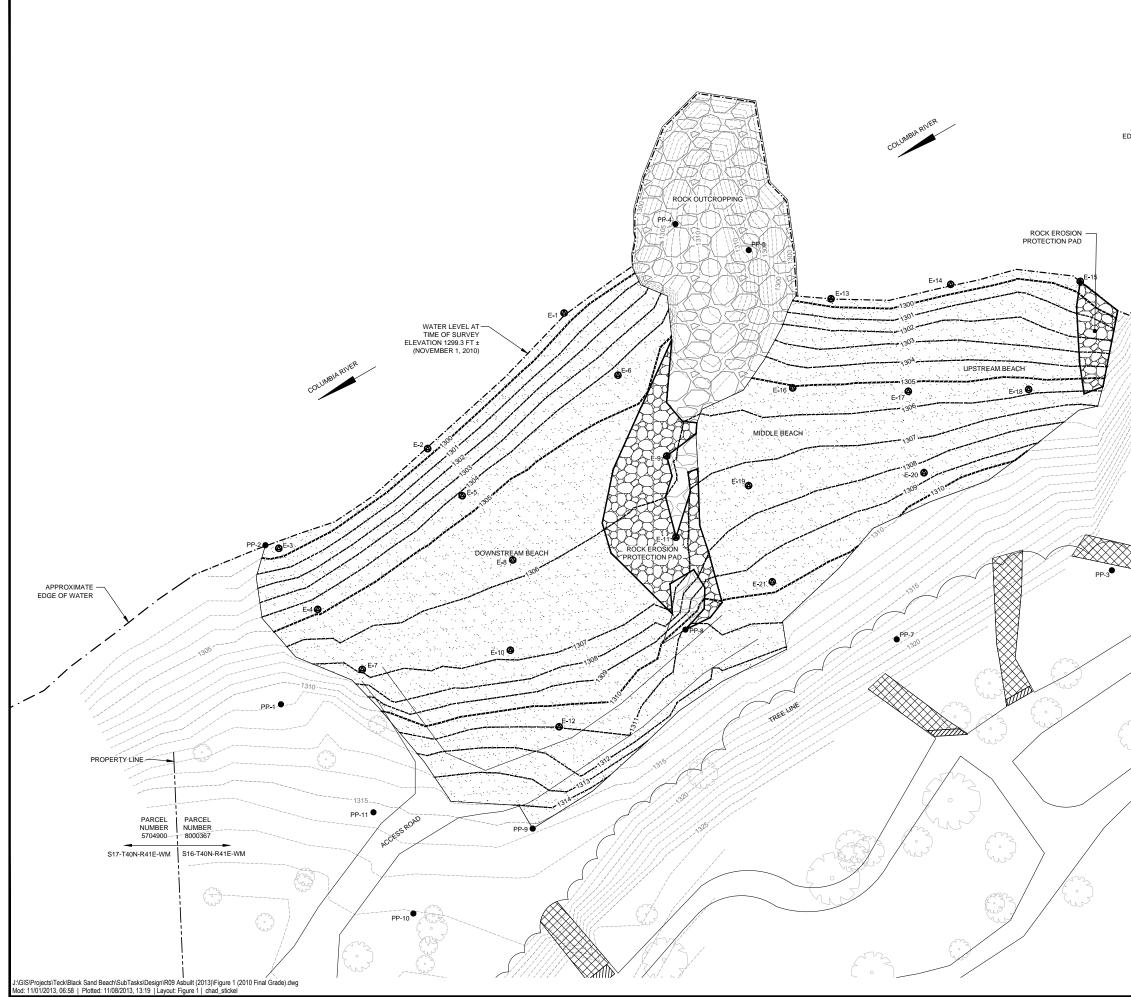
- **Figure 1 2010 Topographic Survey Map**: Figure 1 illustrates 1-foot (ft) topographic elevation contours at time of the As-Built Survey following completion of the Black Sand Beach project. The topographic survey was performed by a licensed land surveyor (Survey Solutions) on November 1, 2010.

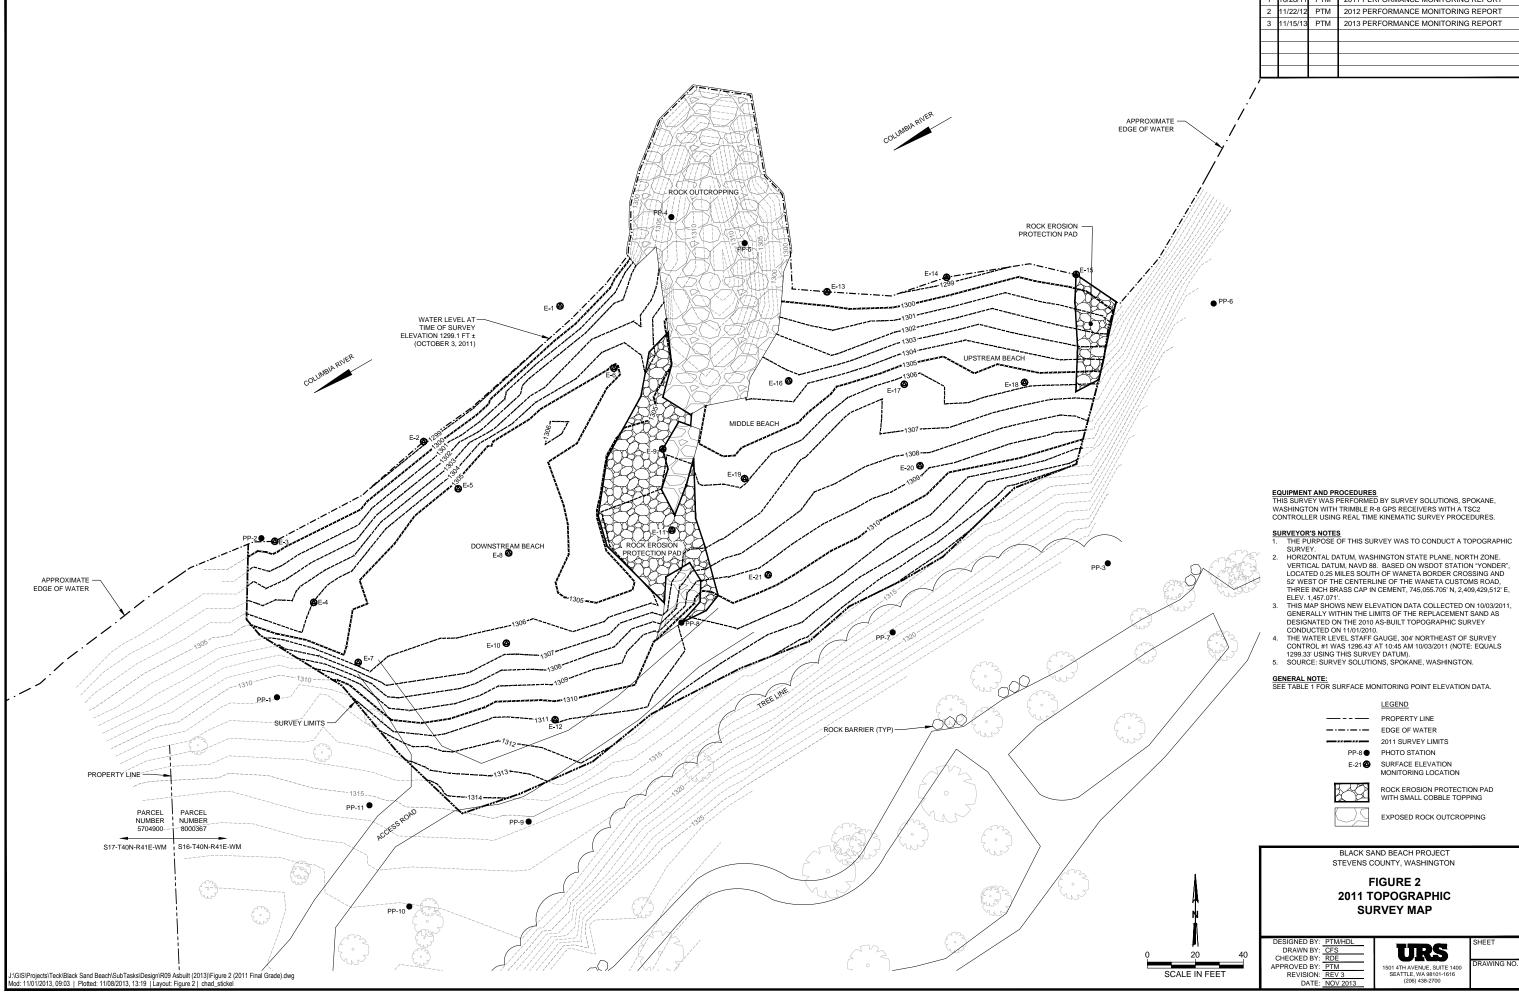
- **Figure 2 2011 Topographic Survey Map**: Figure 2 illustrates 1-ft topographic elevation contours at the time of the 2011 Annual Performance Monitoring (October 3, 2011). This topographic survey was performed by Survey Solutions.

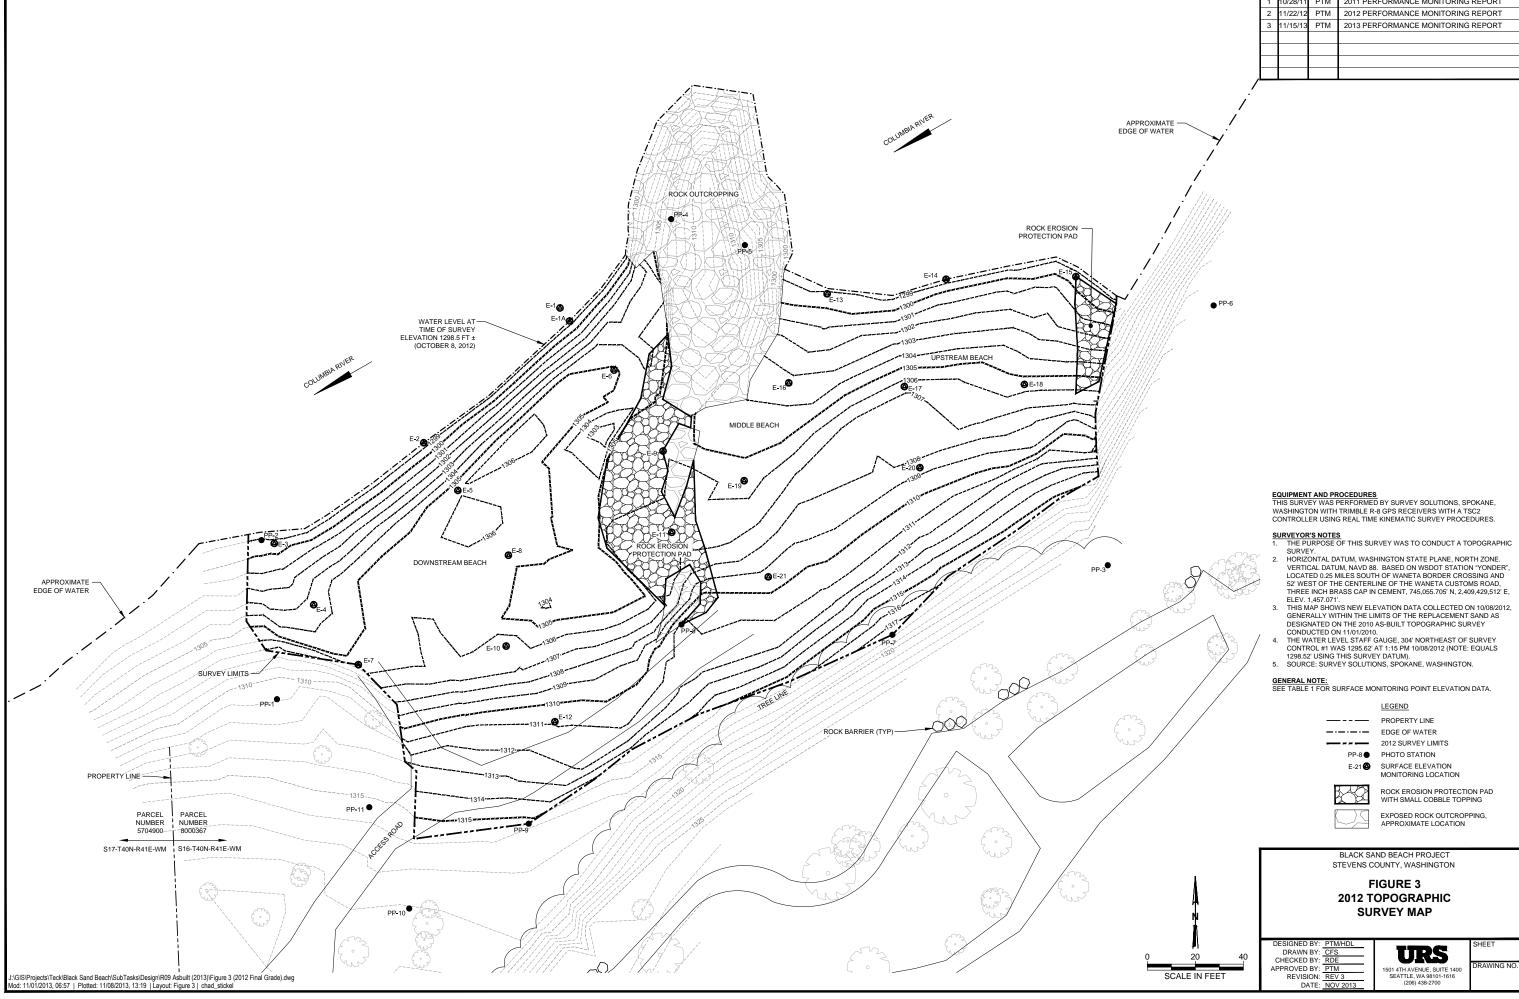
- **Figure 3 2012 Topographic Survey Map**: Figure 3 illustrates 1-ft topographic elevation contours at the time of the 2012 Annual Performance Monitoring (October 8, 2012). This topographic survey was performed by Survey Solutions.

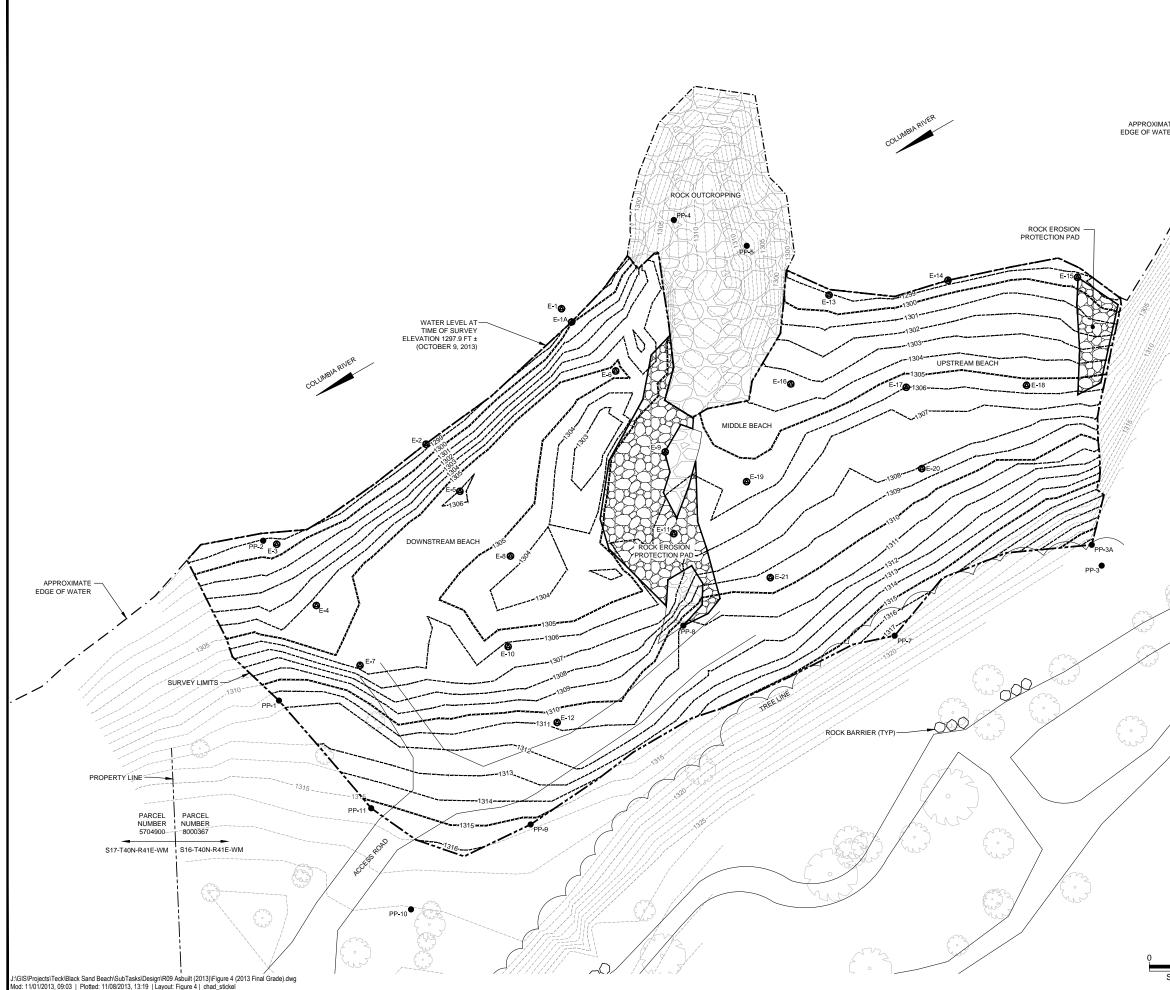
- Figure 4 2013 Topographic Survey Map: Figure 4 illustrates 1-ft topographic elevation contours at the time of the 2013 Annual Performance Monitoring (October 9, 2013). This topographic survey was performed by Survey Solutions.

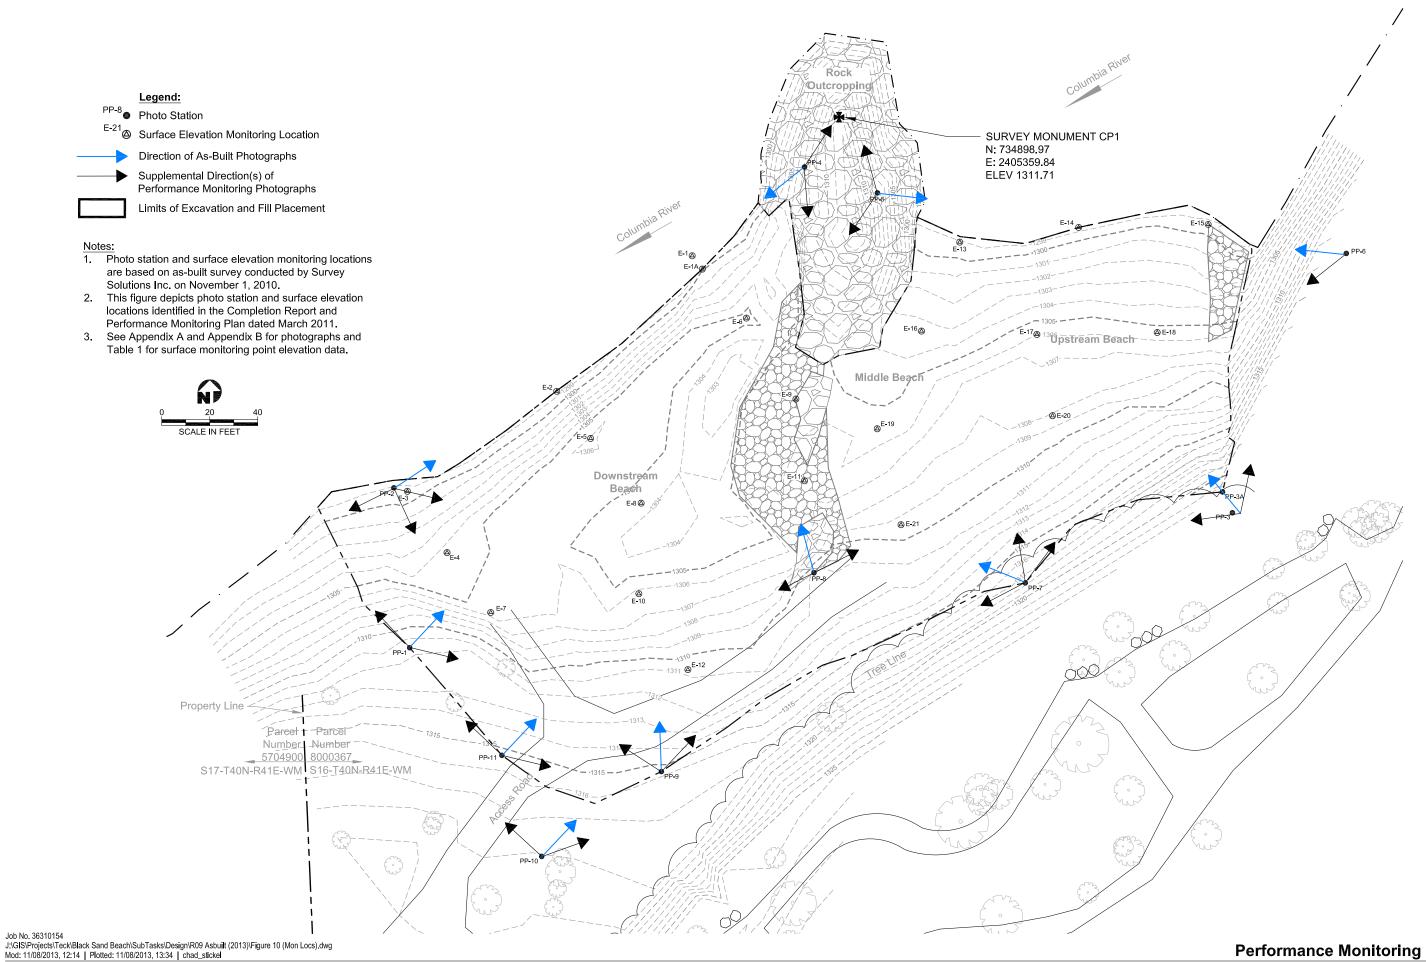
Figure 10 Performance Monitoring Locations

- **Figure 10 Performance Monitoring Locations**: Figure 10 depicts locations of pre-selected photographic stations and surface elevation monitoring point stations. These stations were identified in the Completion Report for subsequent monitoring and are intended to provide a consistent set of locations to document changes in beach conditions over time.

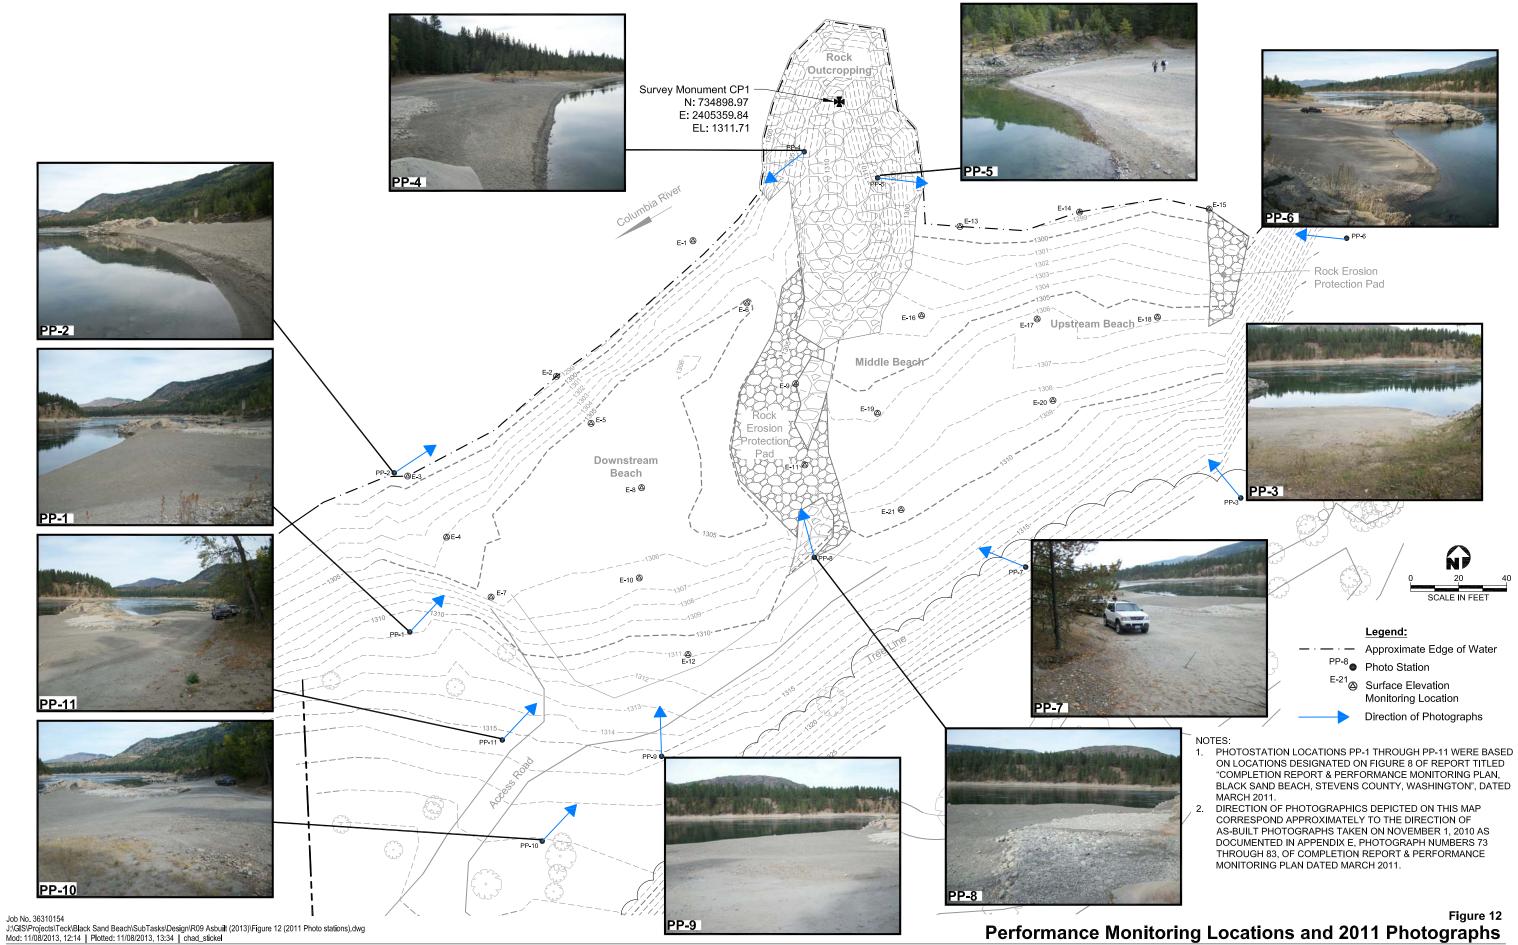
Performance Monitoring Locations and 2011 Photographs

- **Figure 12 Performance Monitoring Locations and 2011 Photographs**: Figure 12 provides photographs taken during the October 3, 2011 Annual Performance Monitoring event. Surface elevations shown on this figure are based on the October 3, 2011 topographic survey.

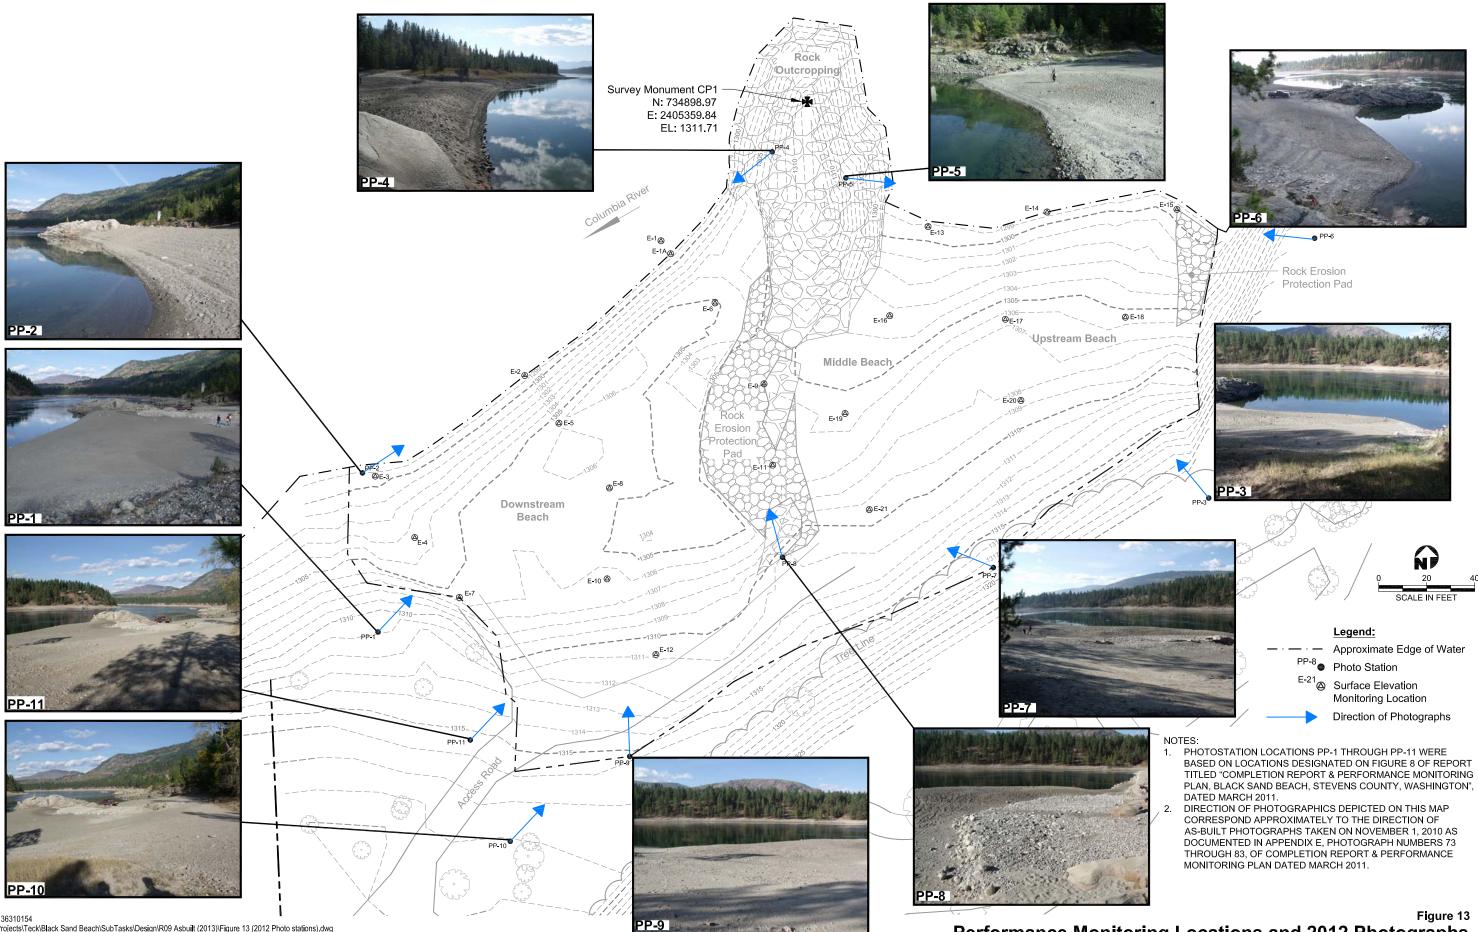
Performance Monitoring Locations and 2012 Photographs

- **Figure 13 Performance Monitoring Locations and 2012 Photographs**: Figure 13 provides photographs taken during the October 8, 2012 Annual Performance Monitoring event. Surface elevations shown on this figure are based on the October 8, 2012 topographic survey.

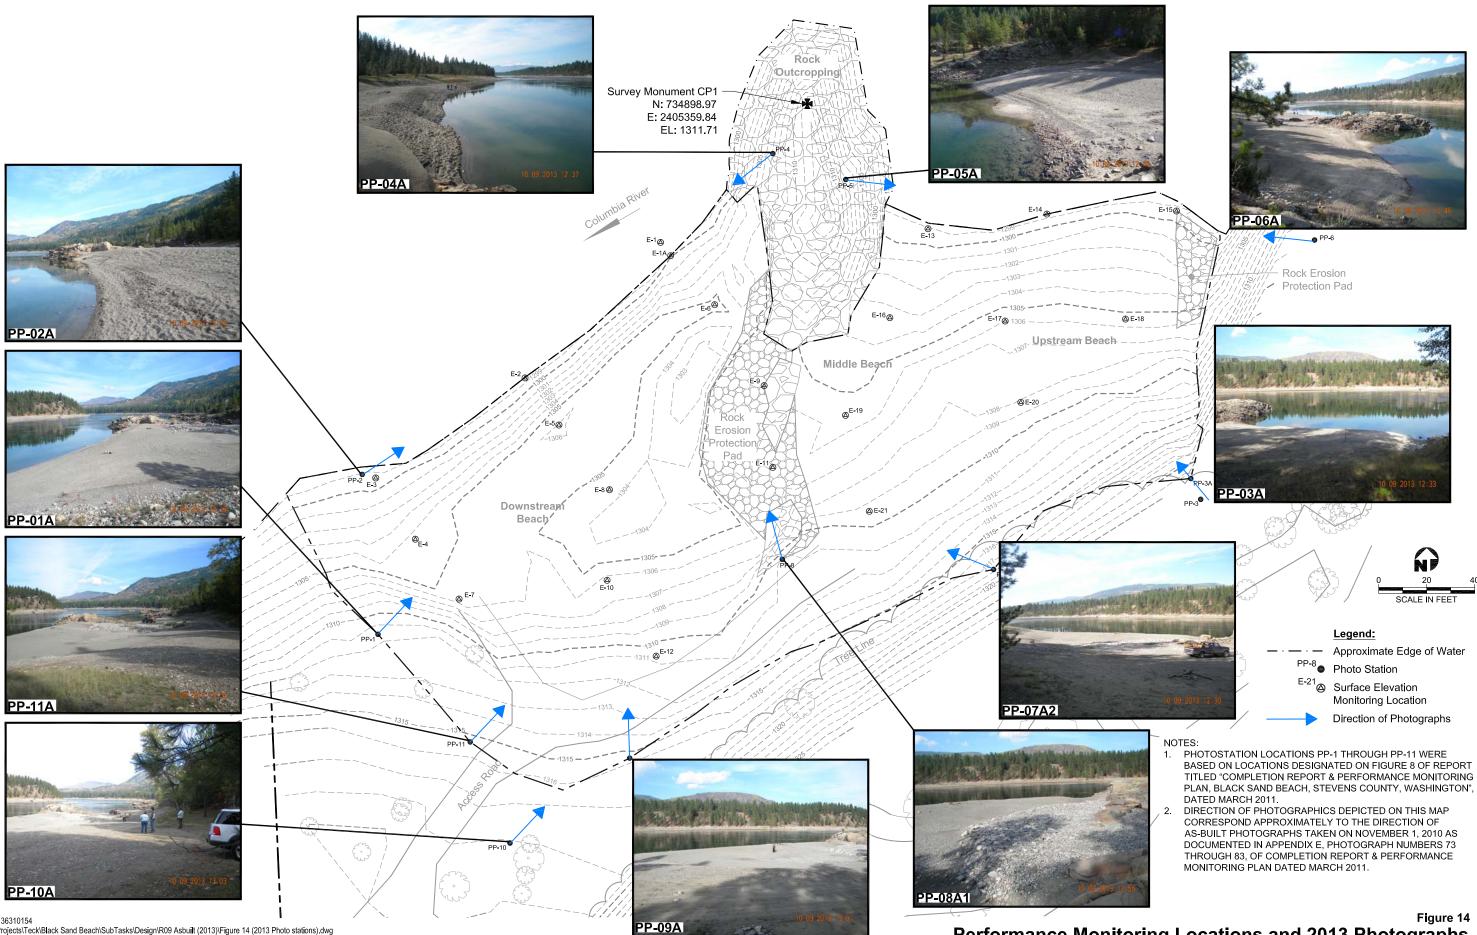
Performance Monitoring Locations and 2013 Photographs

- **Figure 14 Performance Monitoring Locations and 2013 Photographs**: Figure 14 provides photographs taken during the October 9, 2013 Annual Performance Monitoring event. Surface elevations shown on this figure are based on the October 9, 2013 topographic survey.

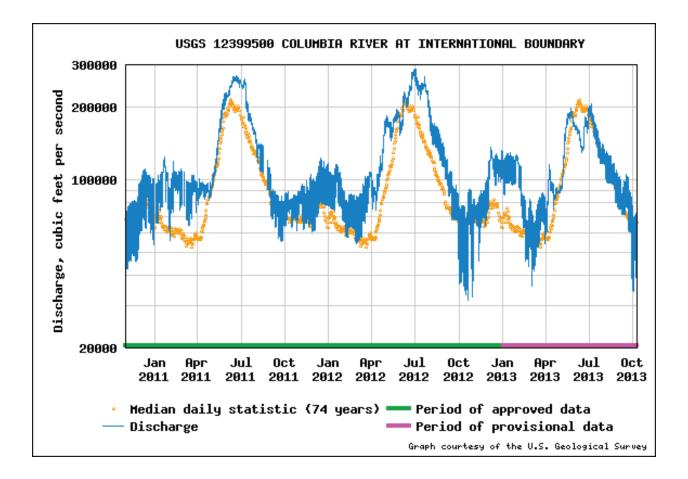
Figure 15 Discharge at USGS Columbia River Station 12399500 at International Boundary

- Figure 15 Discharge at USGS 12399500 Columbia River at International Boundary. Figure 15 depicts a time-series graph of the Columbia River discharge in cubic feet per second (cfs) measured at USGS station 12399500, Columbia River at International Boundary during the period November 1, 2010 through October 9, 2013. This graph is courtesy of the USGS and was downloaded from the USGS website at the following address: http://waterdata.usgs.gov/usa/nwis/uv?site_no=12399500. Measured river discharges are compared to median daily statistics of river discharge over a 74 year period to allow comparison of measured discharges since completion of the As-Built survey to historic average values. As illustrated on Figure 15, river flows since completion of the Black Sand Beach project to present have generally been at or above historic values over the last 74 years.

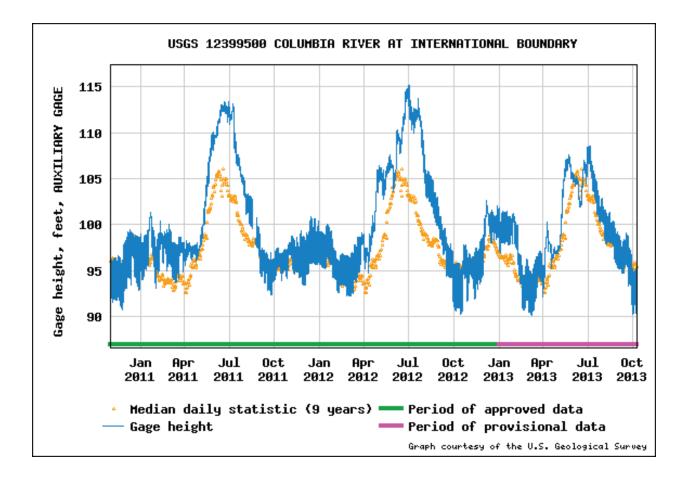
Figure 16 Gage Height at USGS Columbia River Auxiliary Station 12399500 at International Boundary

- Figure 16 Gage Height at USGS 12399500 Columbia River at International Boundary Auxiliary Station. Figure 16 illustrates river elevations at USGS Auxiliary Gage Station No. 12399500 during the period November 1, 2010 through October 9, 2013. This graph is courtesy of the USGS and was downloaded from the USGS website address identified above. This graph compares the measured gage heights at this gauging station to median daily statics over a 9 year period. As illustrated on this figure, river elevations since completion of the As-built survey have generally been at or above historic trends.
