# SITE HAZARD ASSESSMENT

### Summary Score Sheet

Kimberly-Clark Worldwide, Inc.  
2600 Federal Ave  
Everett 98201

*Site scored/ranked by Mike Young, Snohomish Health District for the February 2014 update of the Hazardous Sites List.*

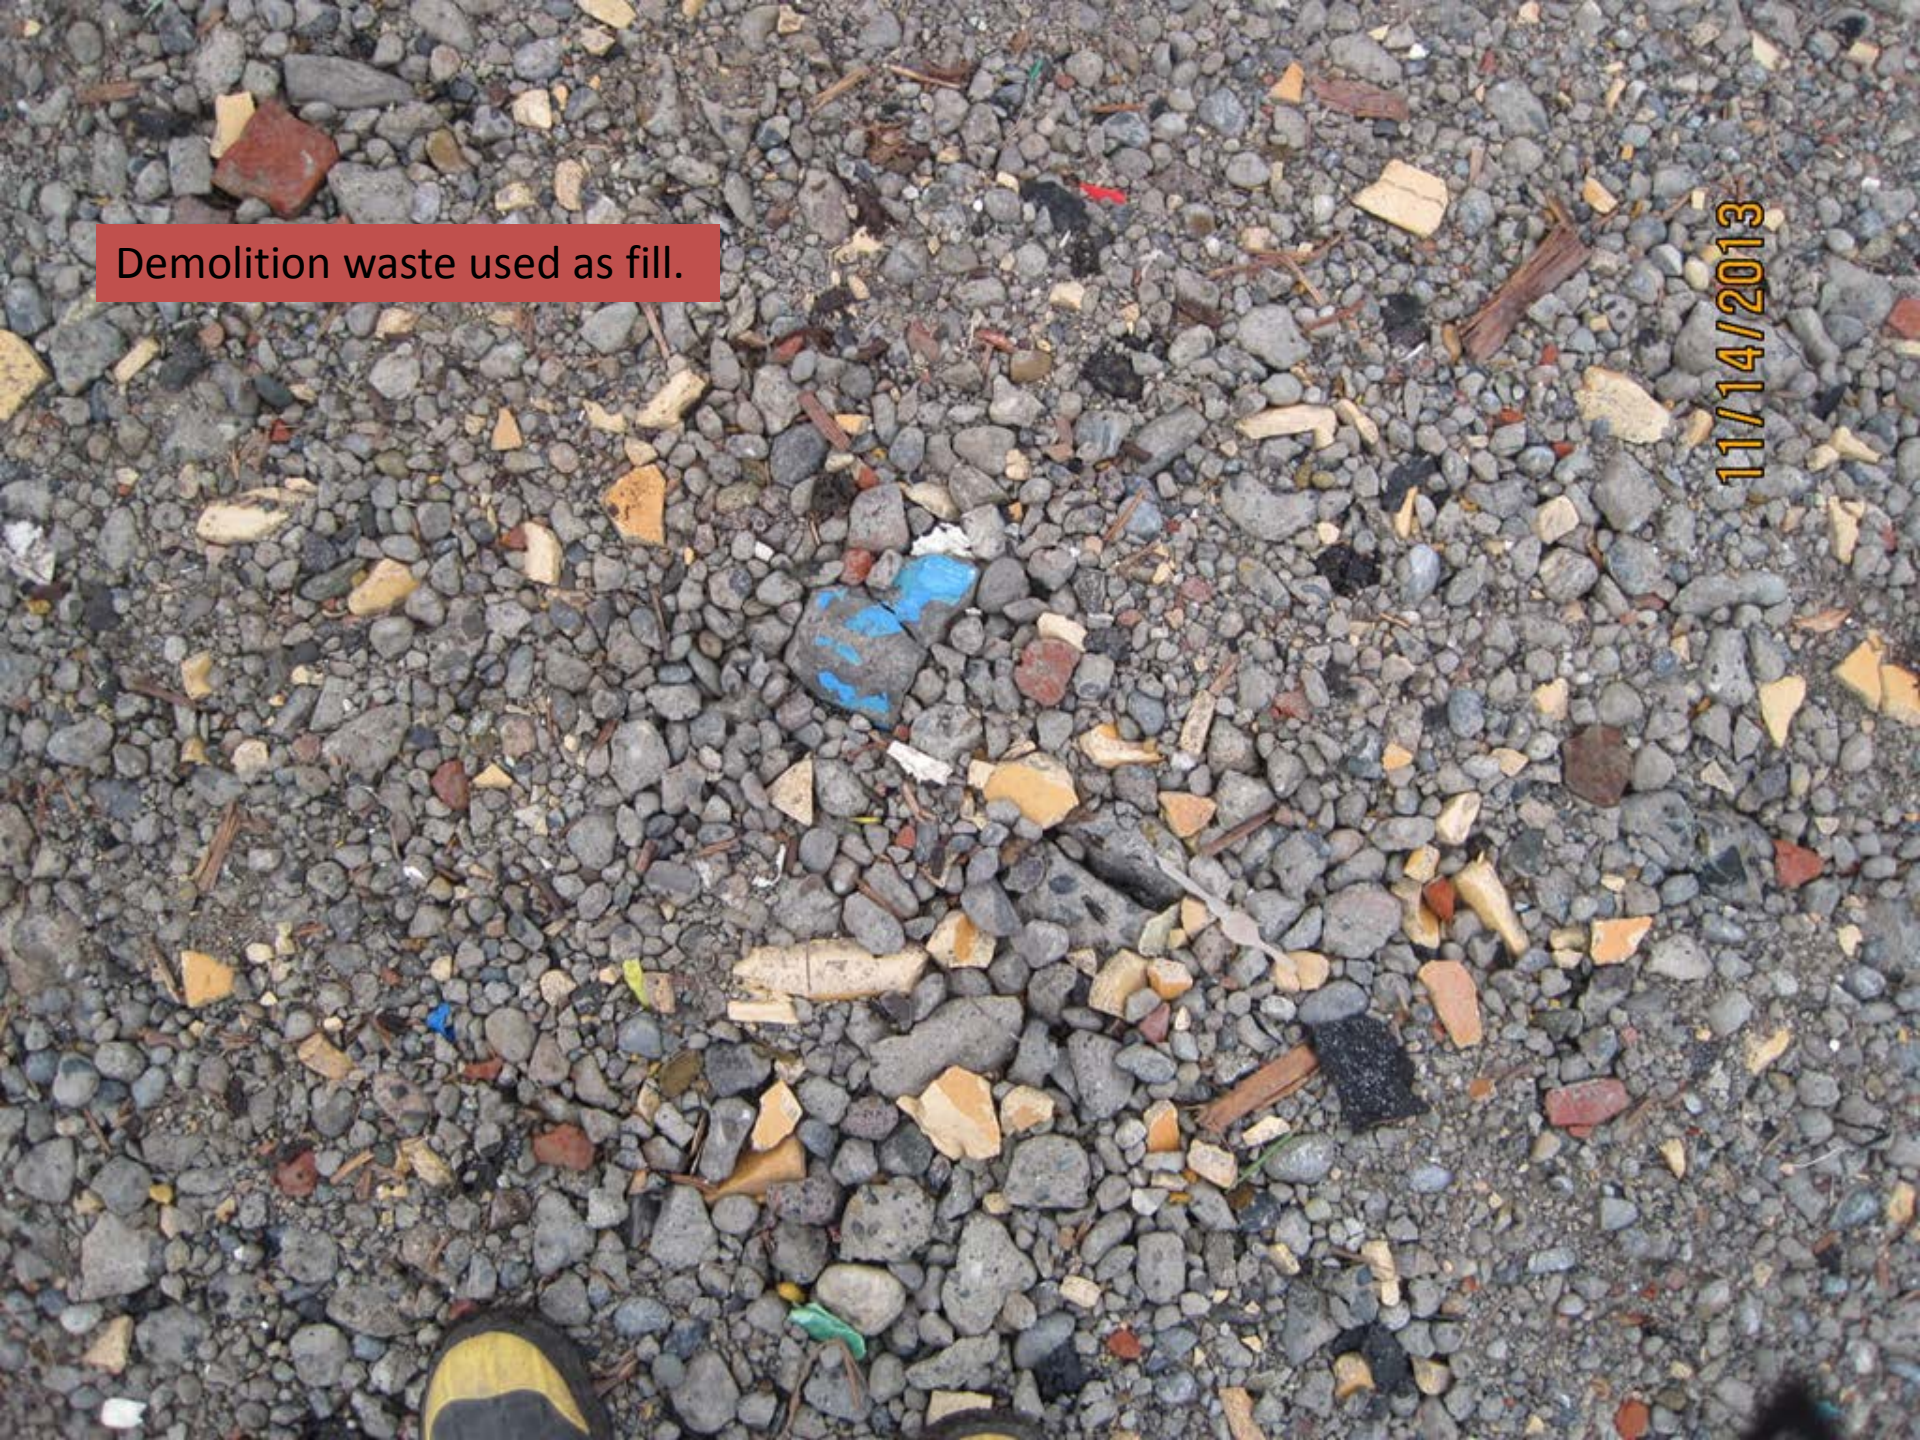
View south west, Easter Waterway in background.

Pavement surface before demolition

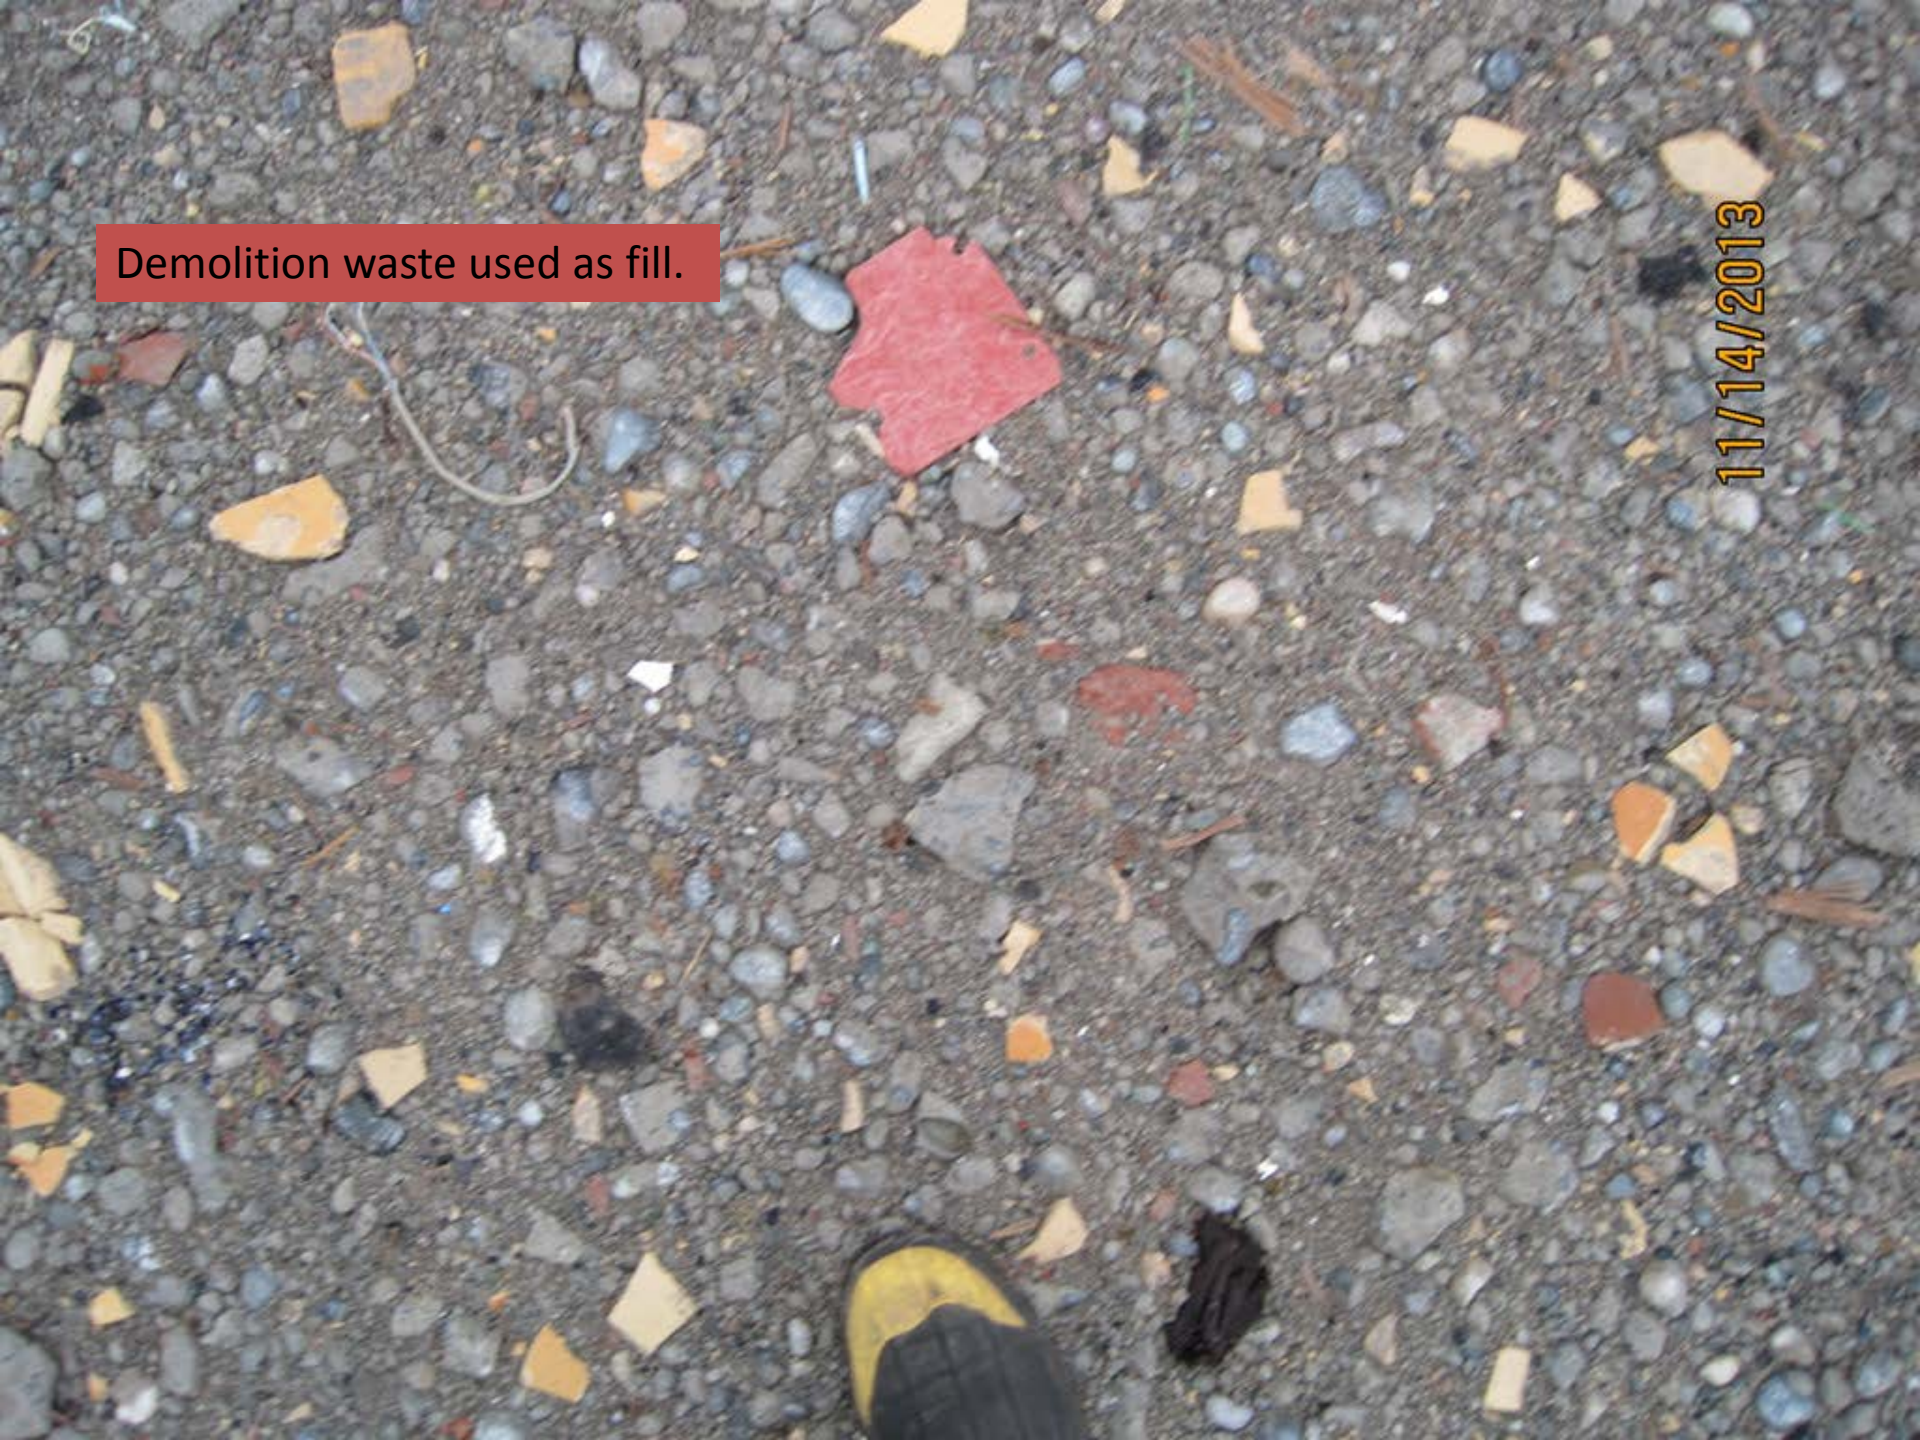
Demolition waste used as fill.

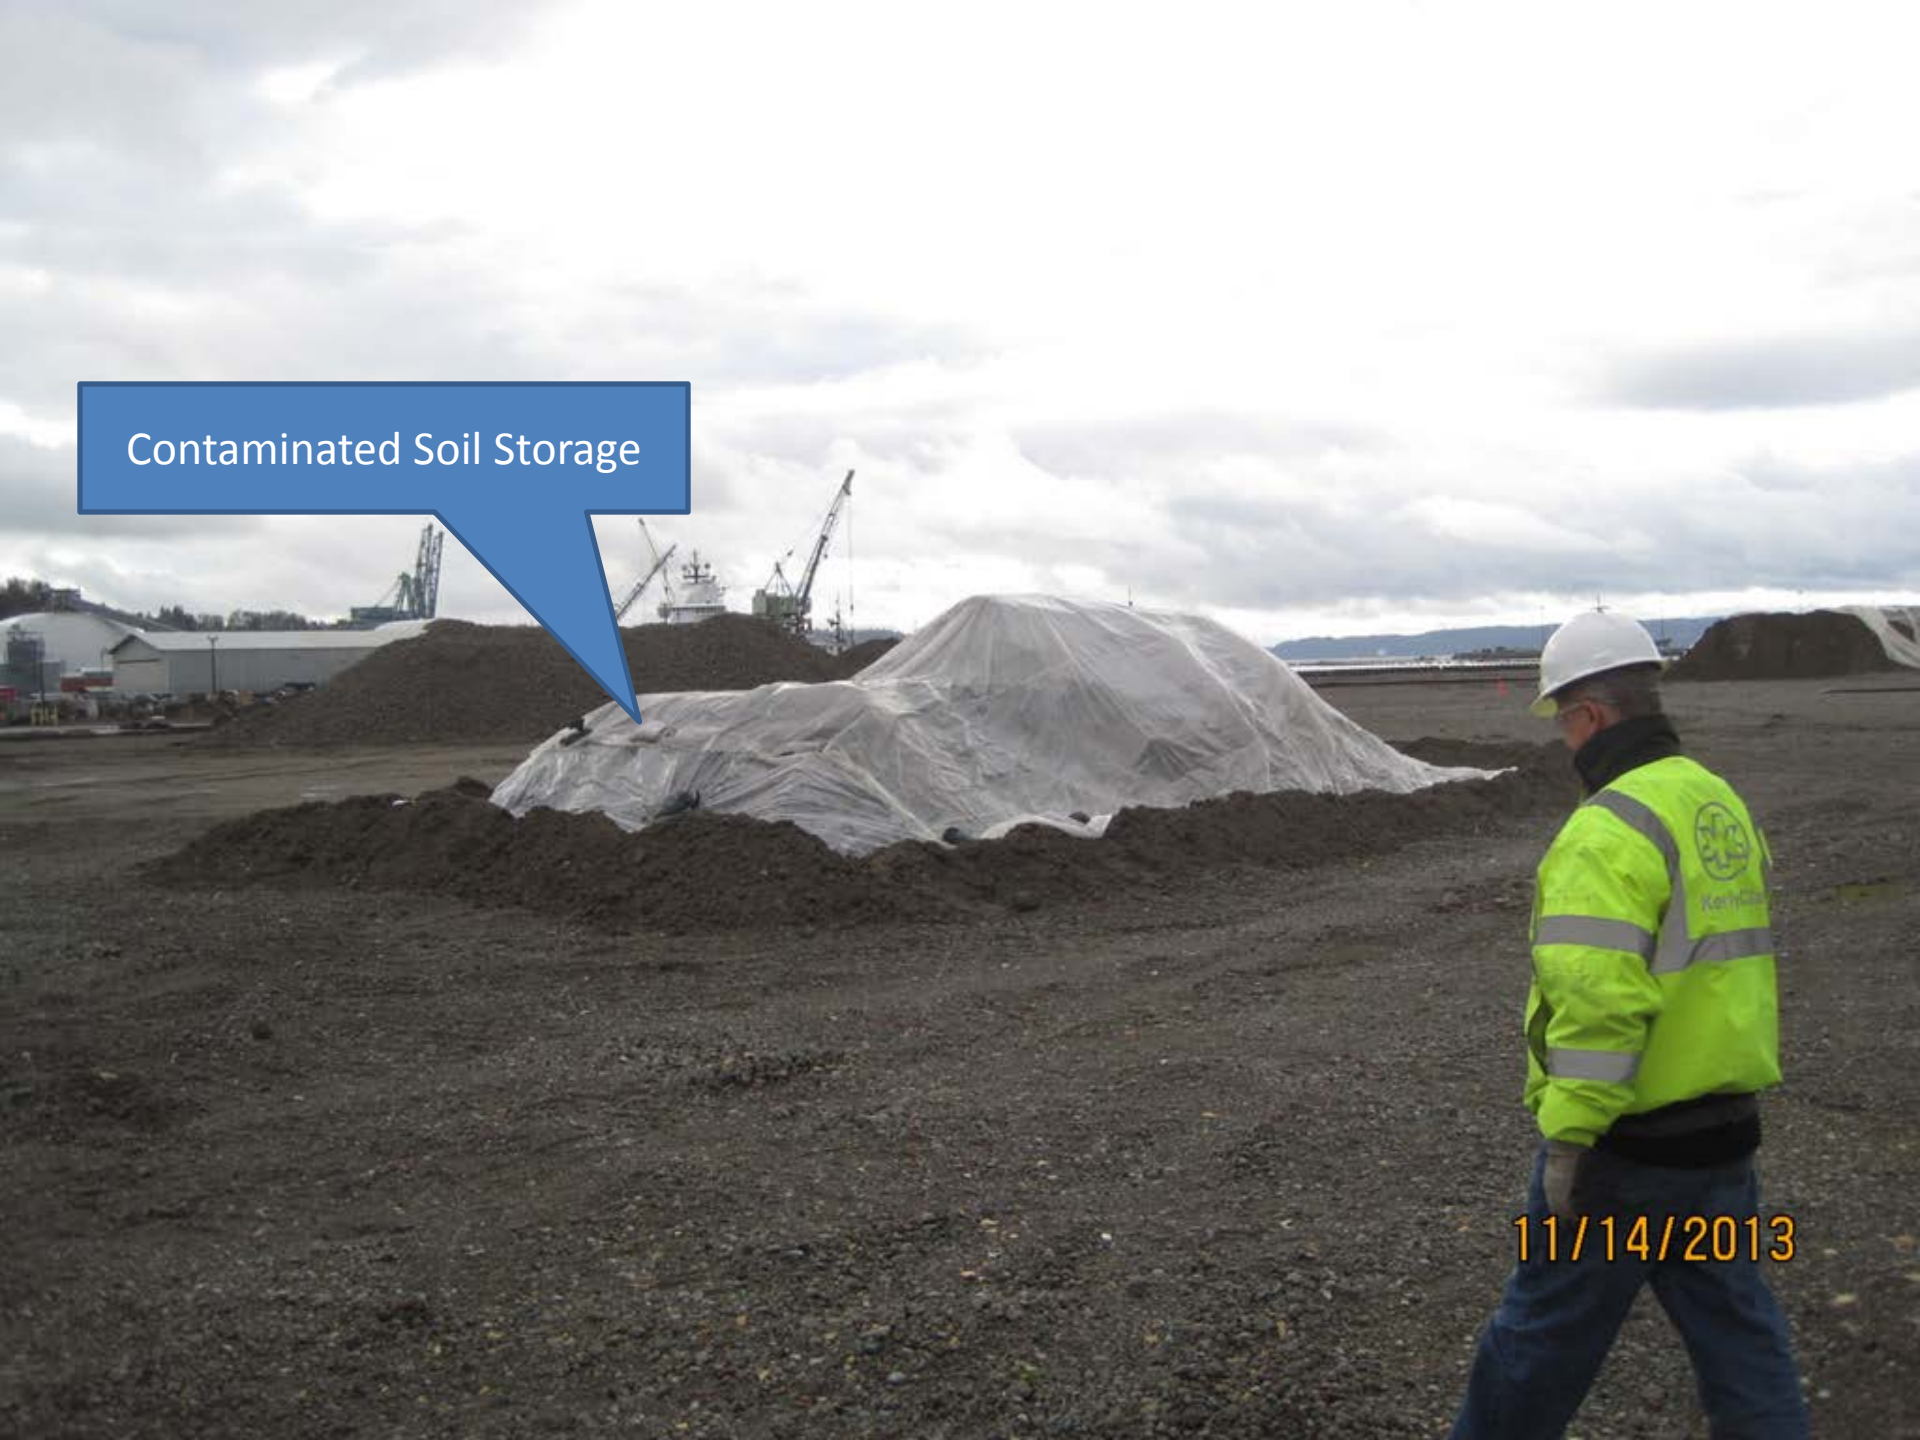
View south, excavation of contaminated soil.

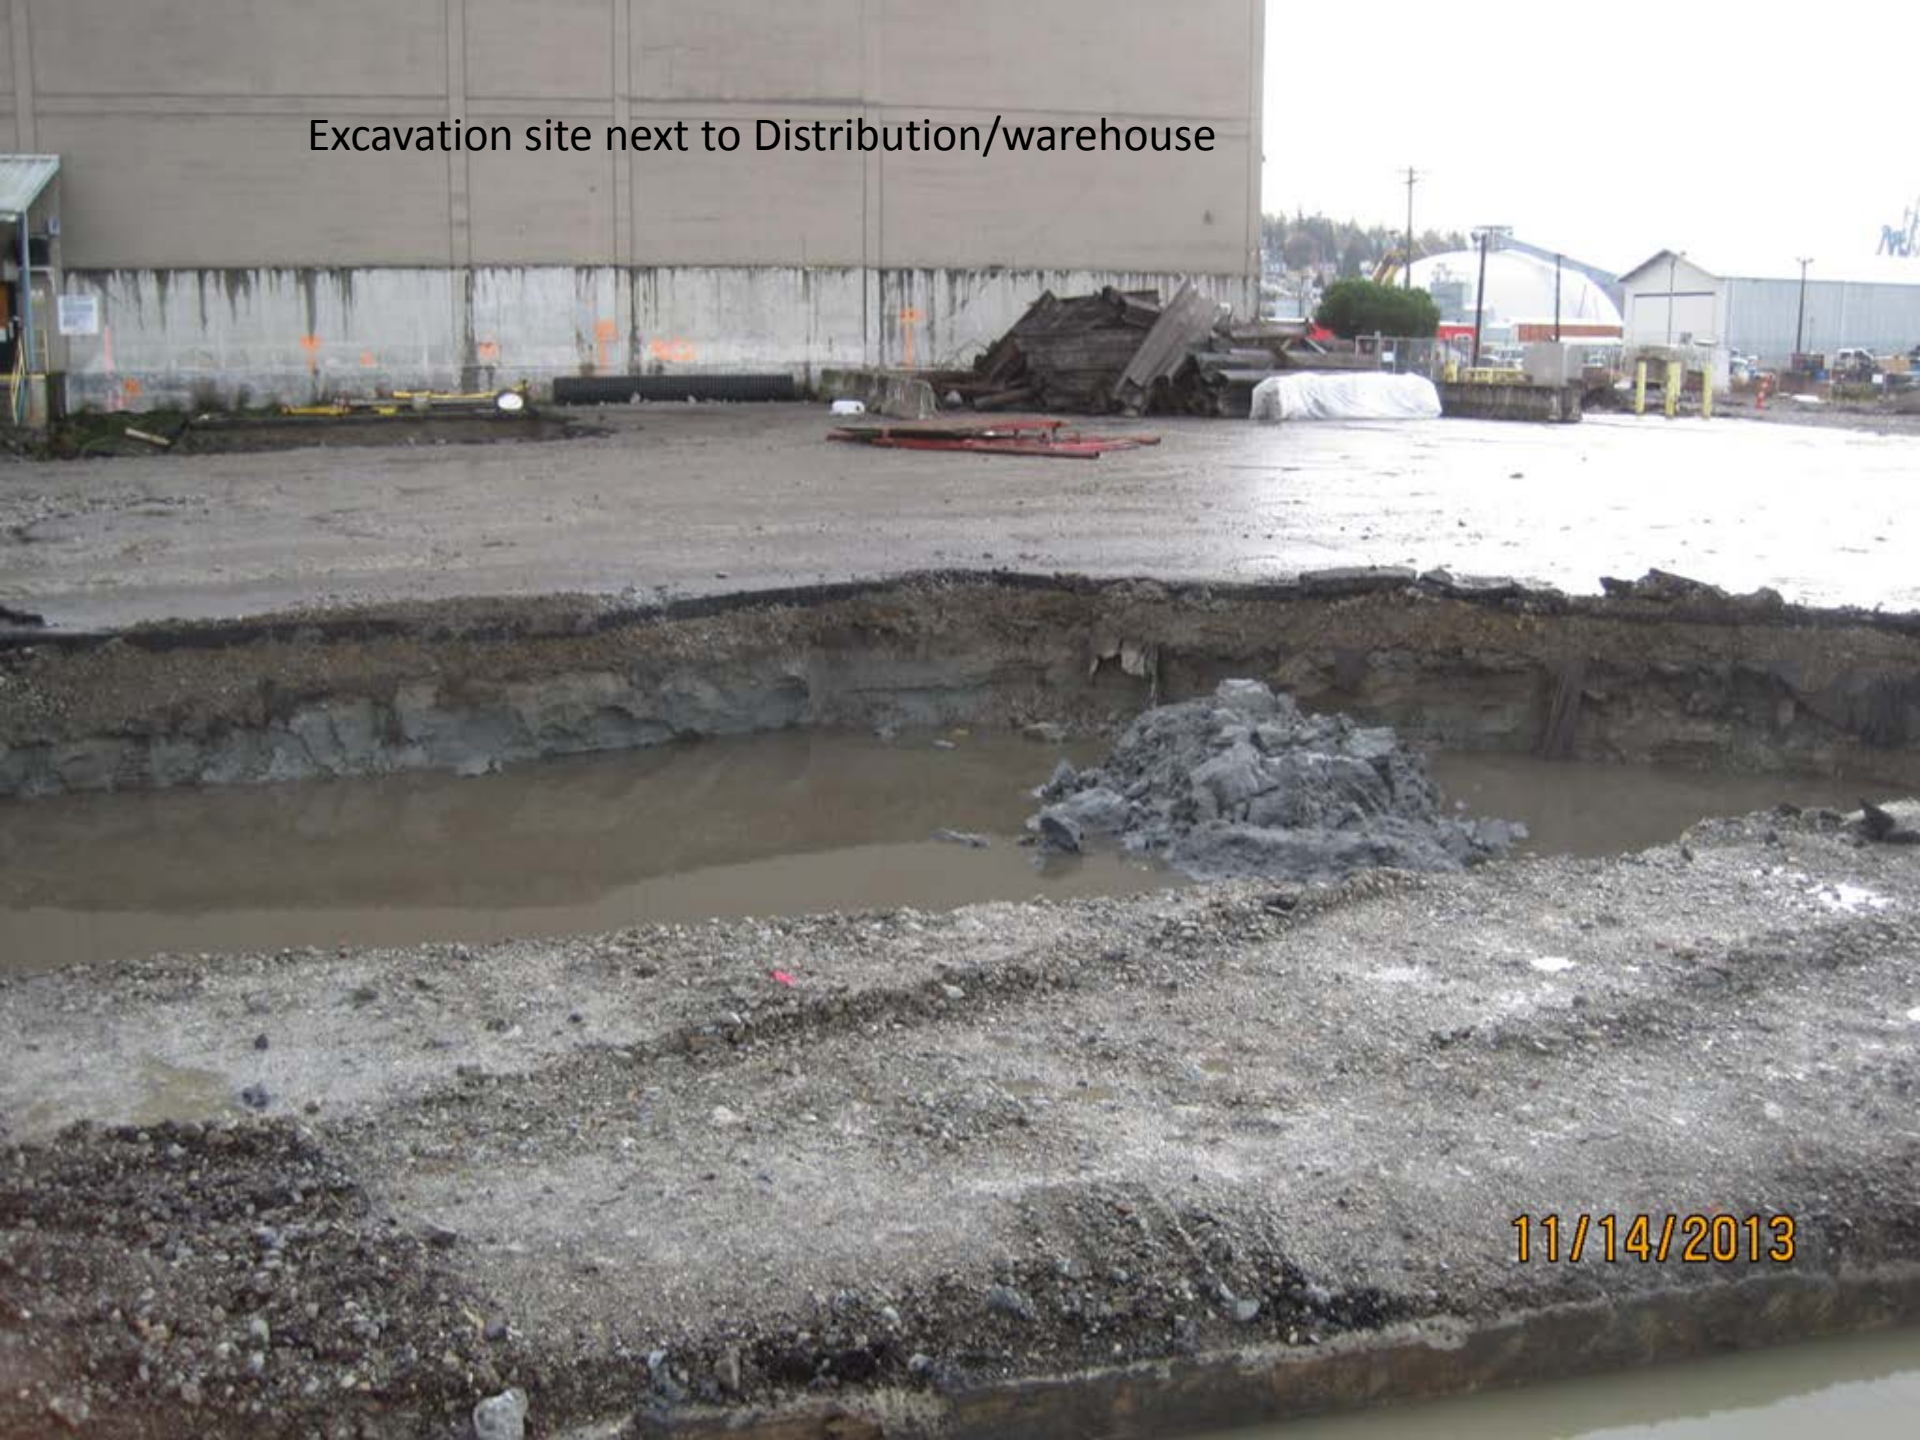
Excavation site next to Distribution/warehouse

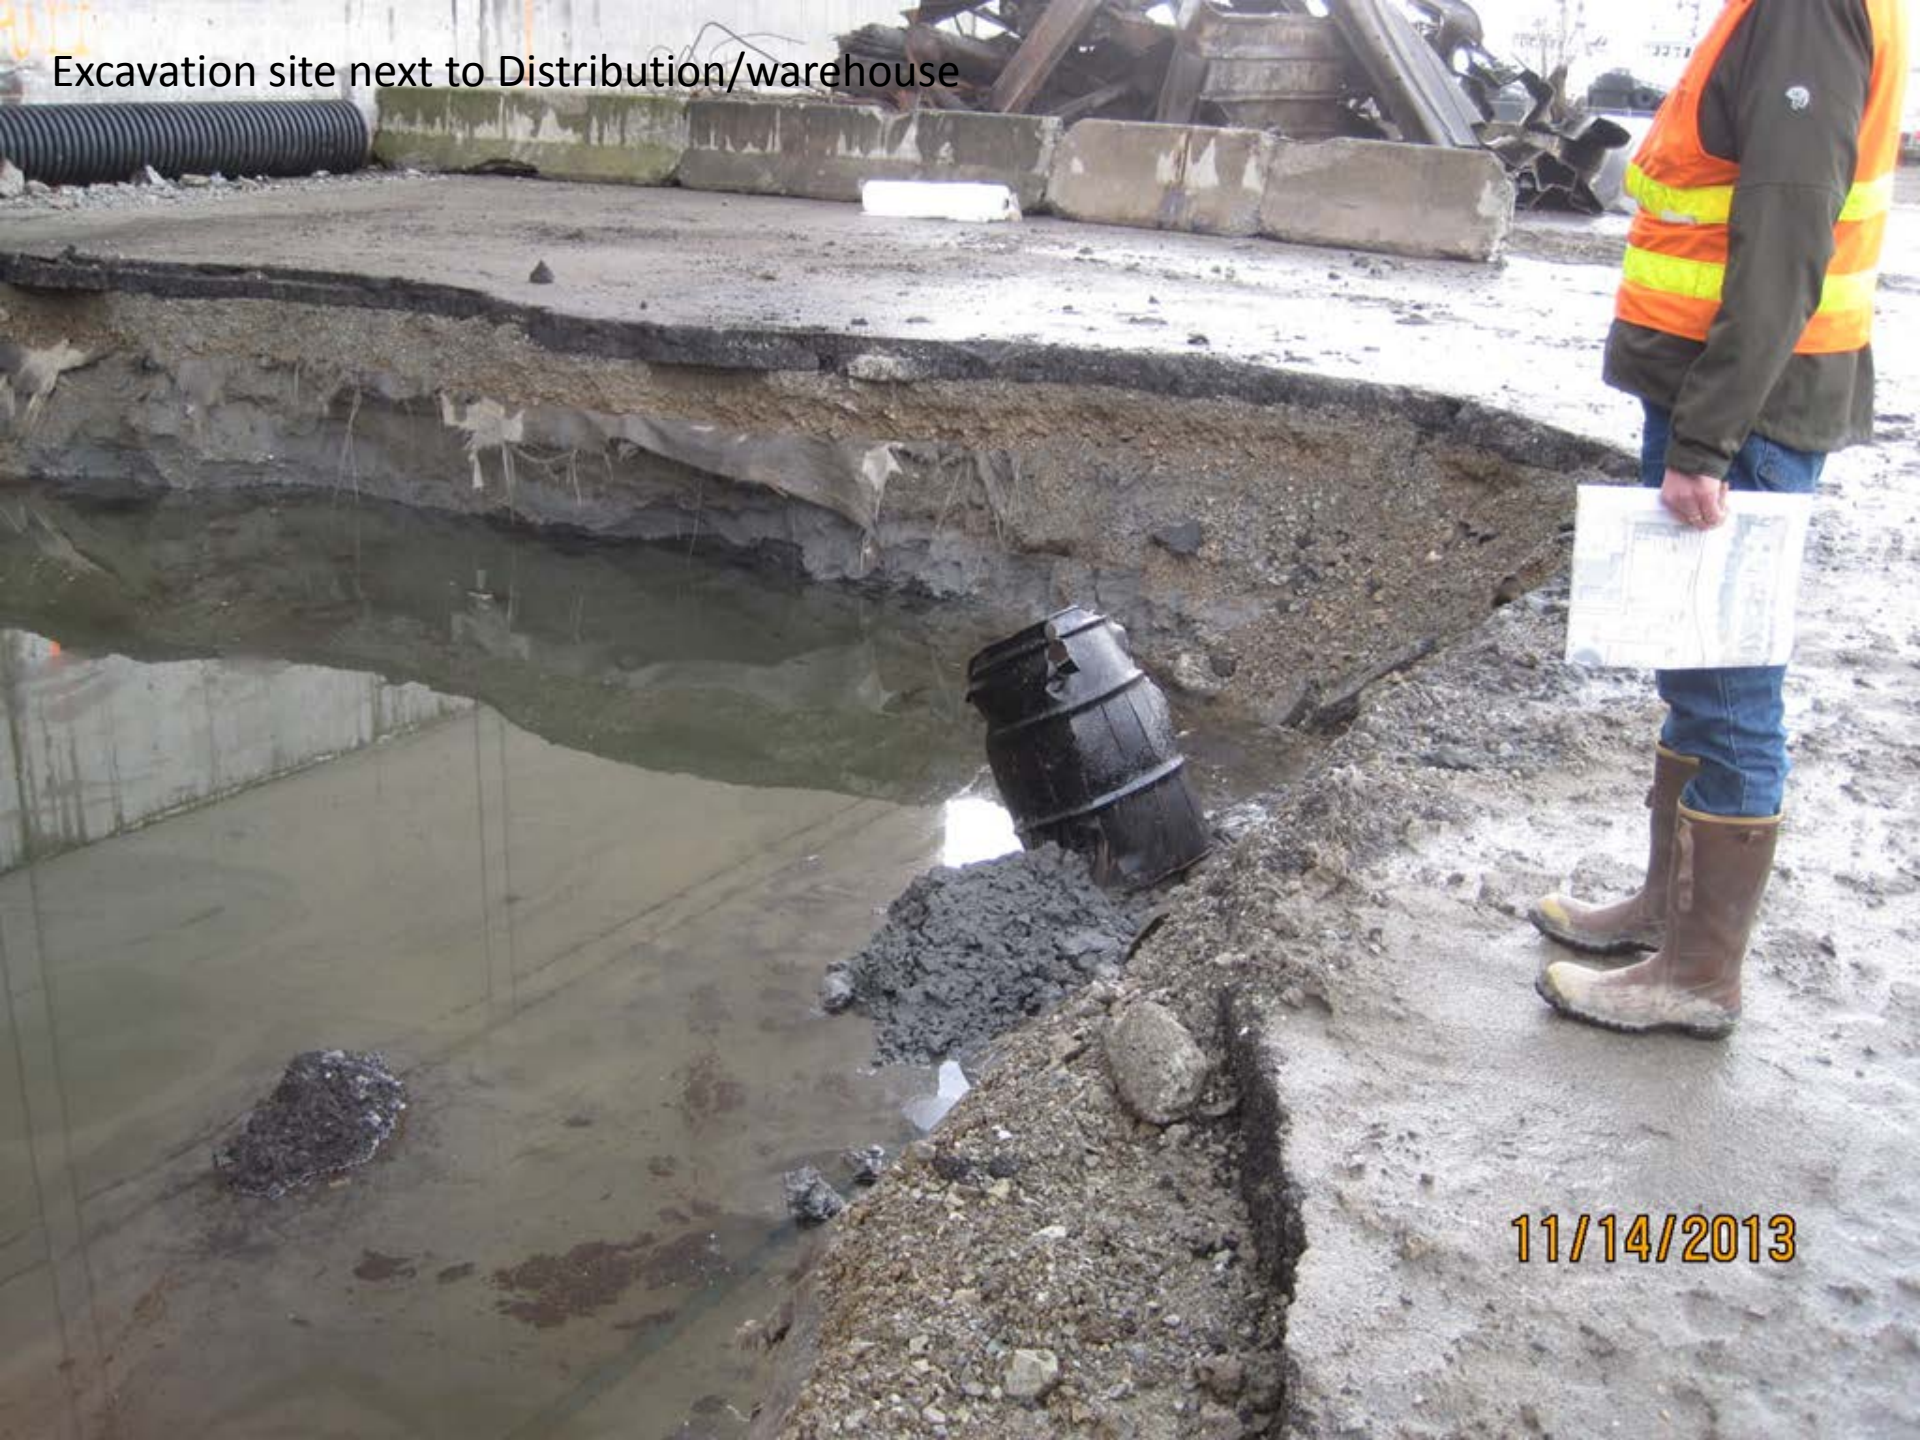
Excavation site north west of Distribution/warehouse, showing old fill under pavement.

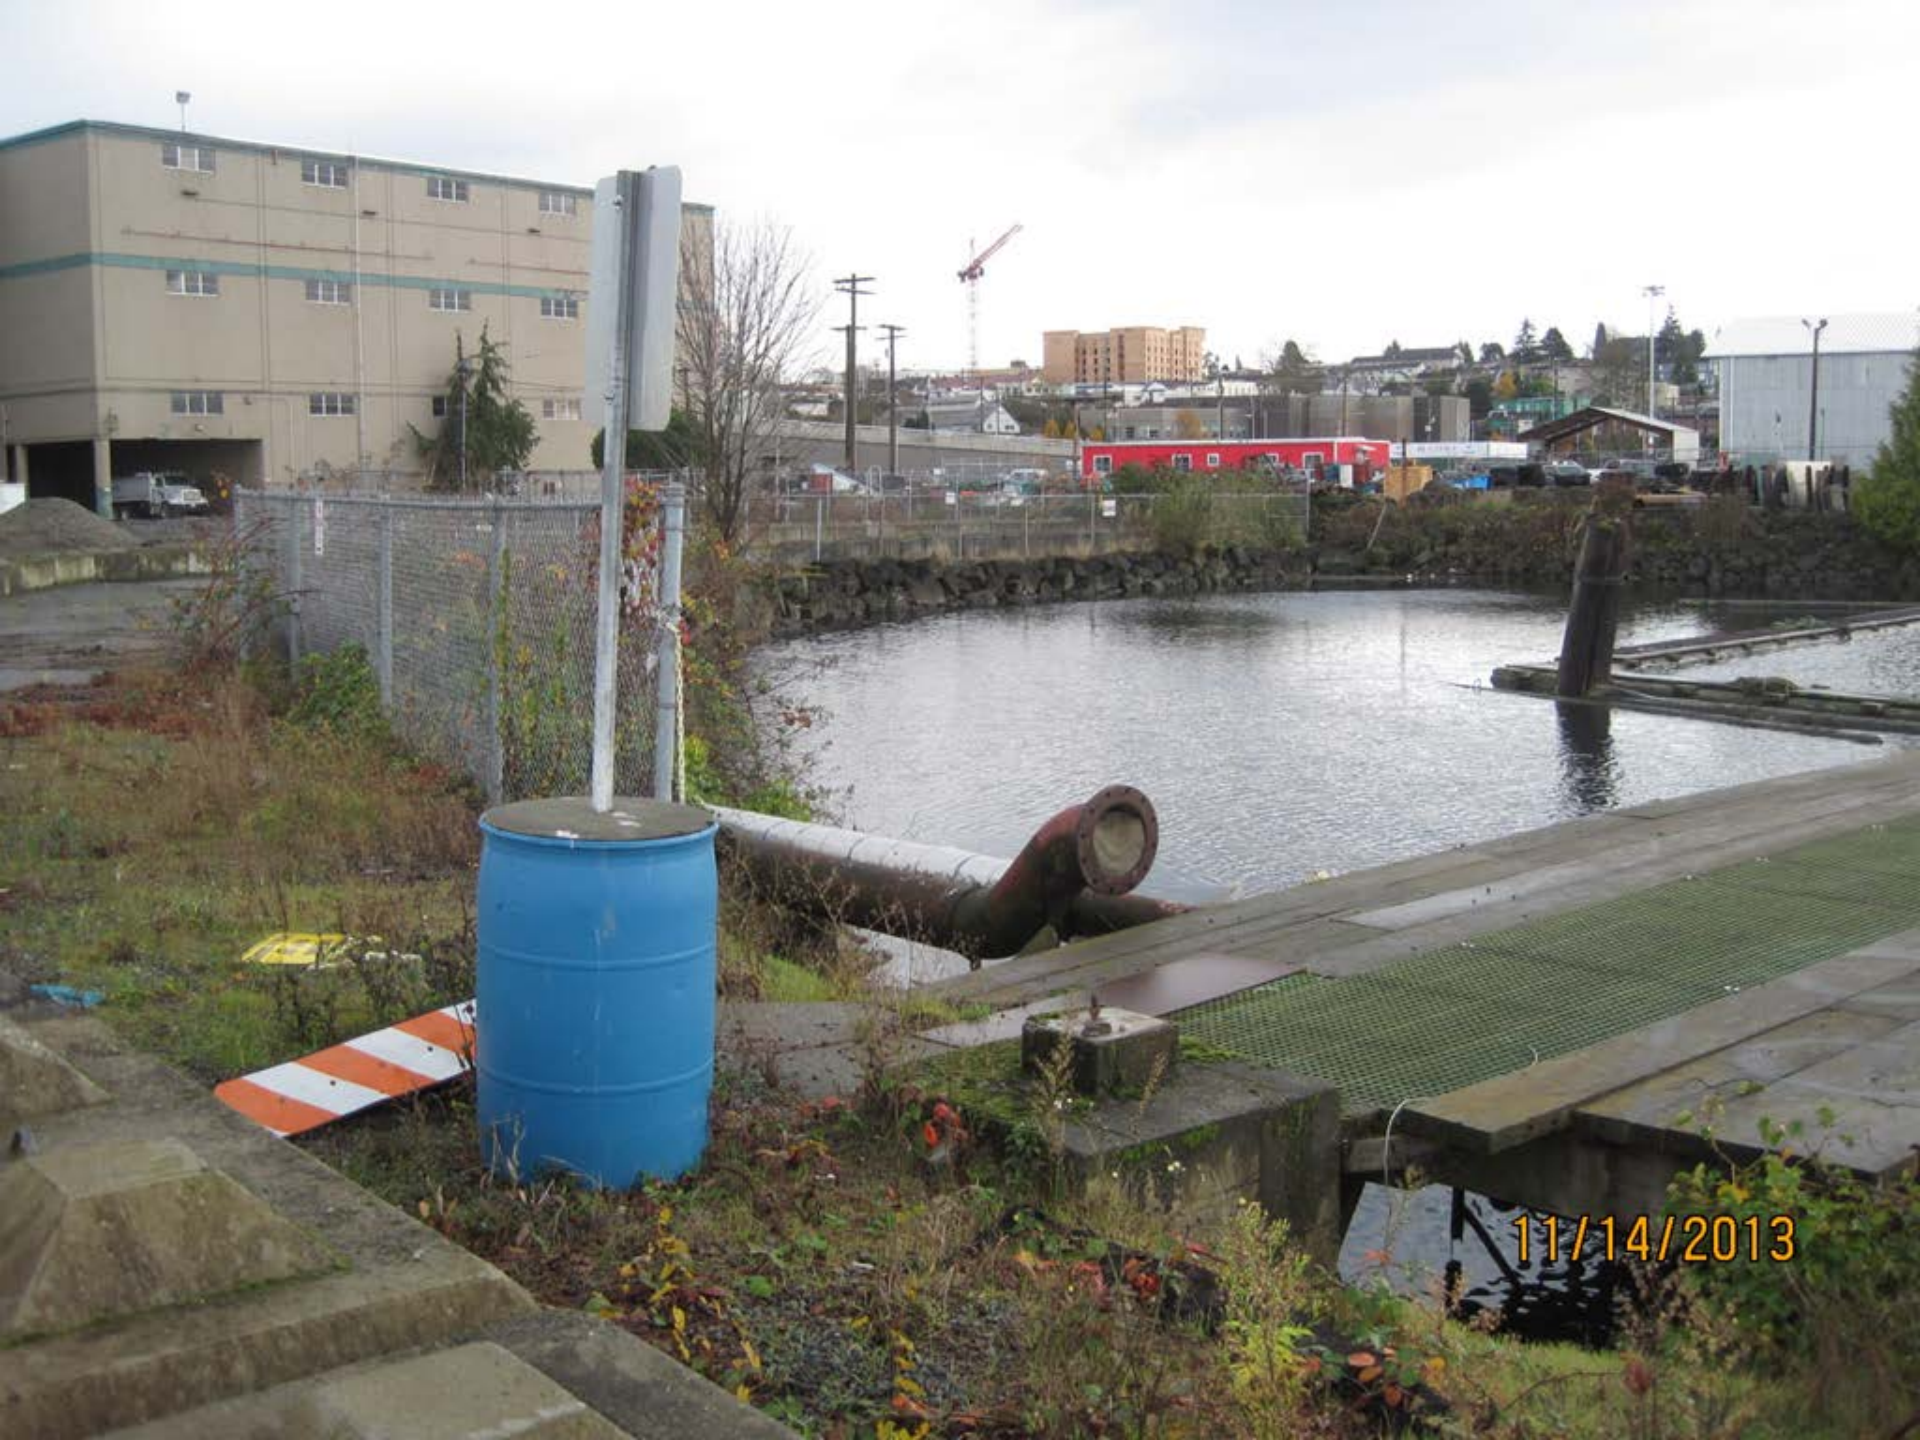
Surface water is collected on site and drained to the wastewater treatment lagoons on the north end of the site. Ecology blocks and soil protect run-off, to Port Gardner.

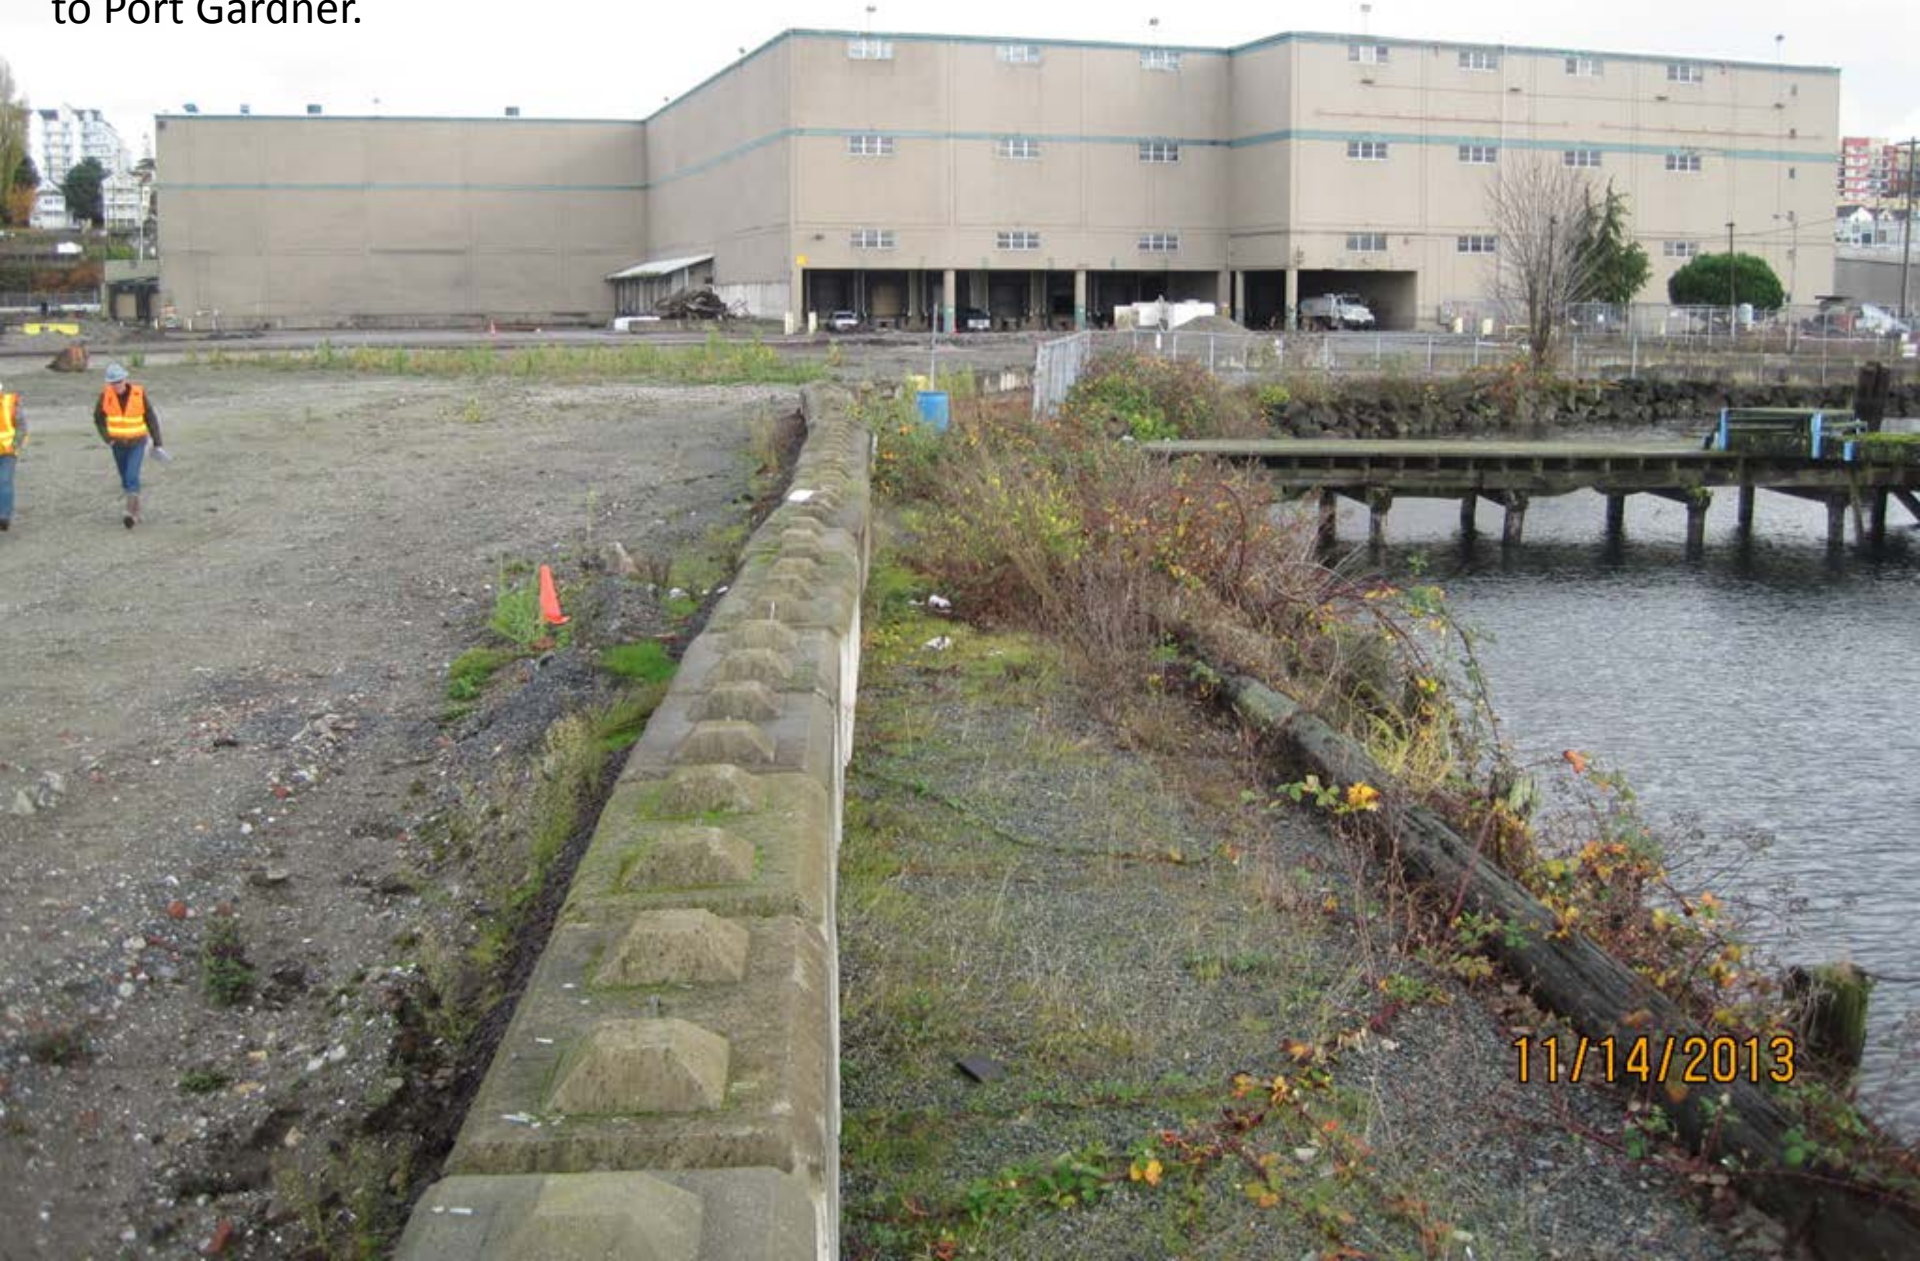
View west, ecology blocks and soil protect run-off, to Port Gardner.

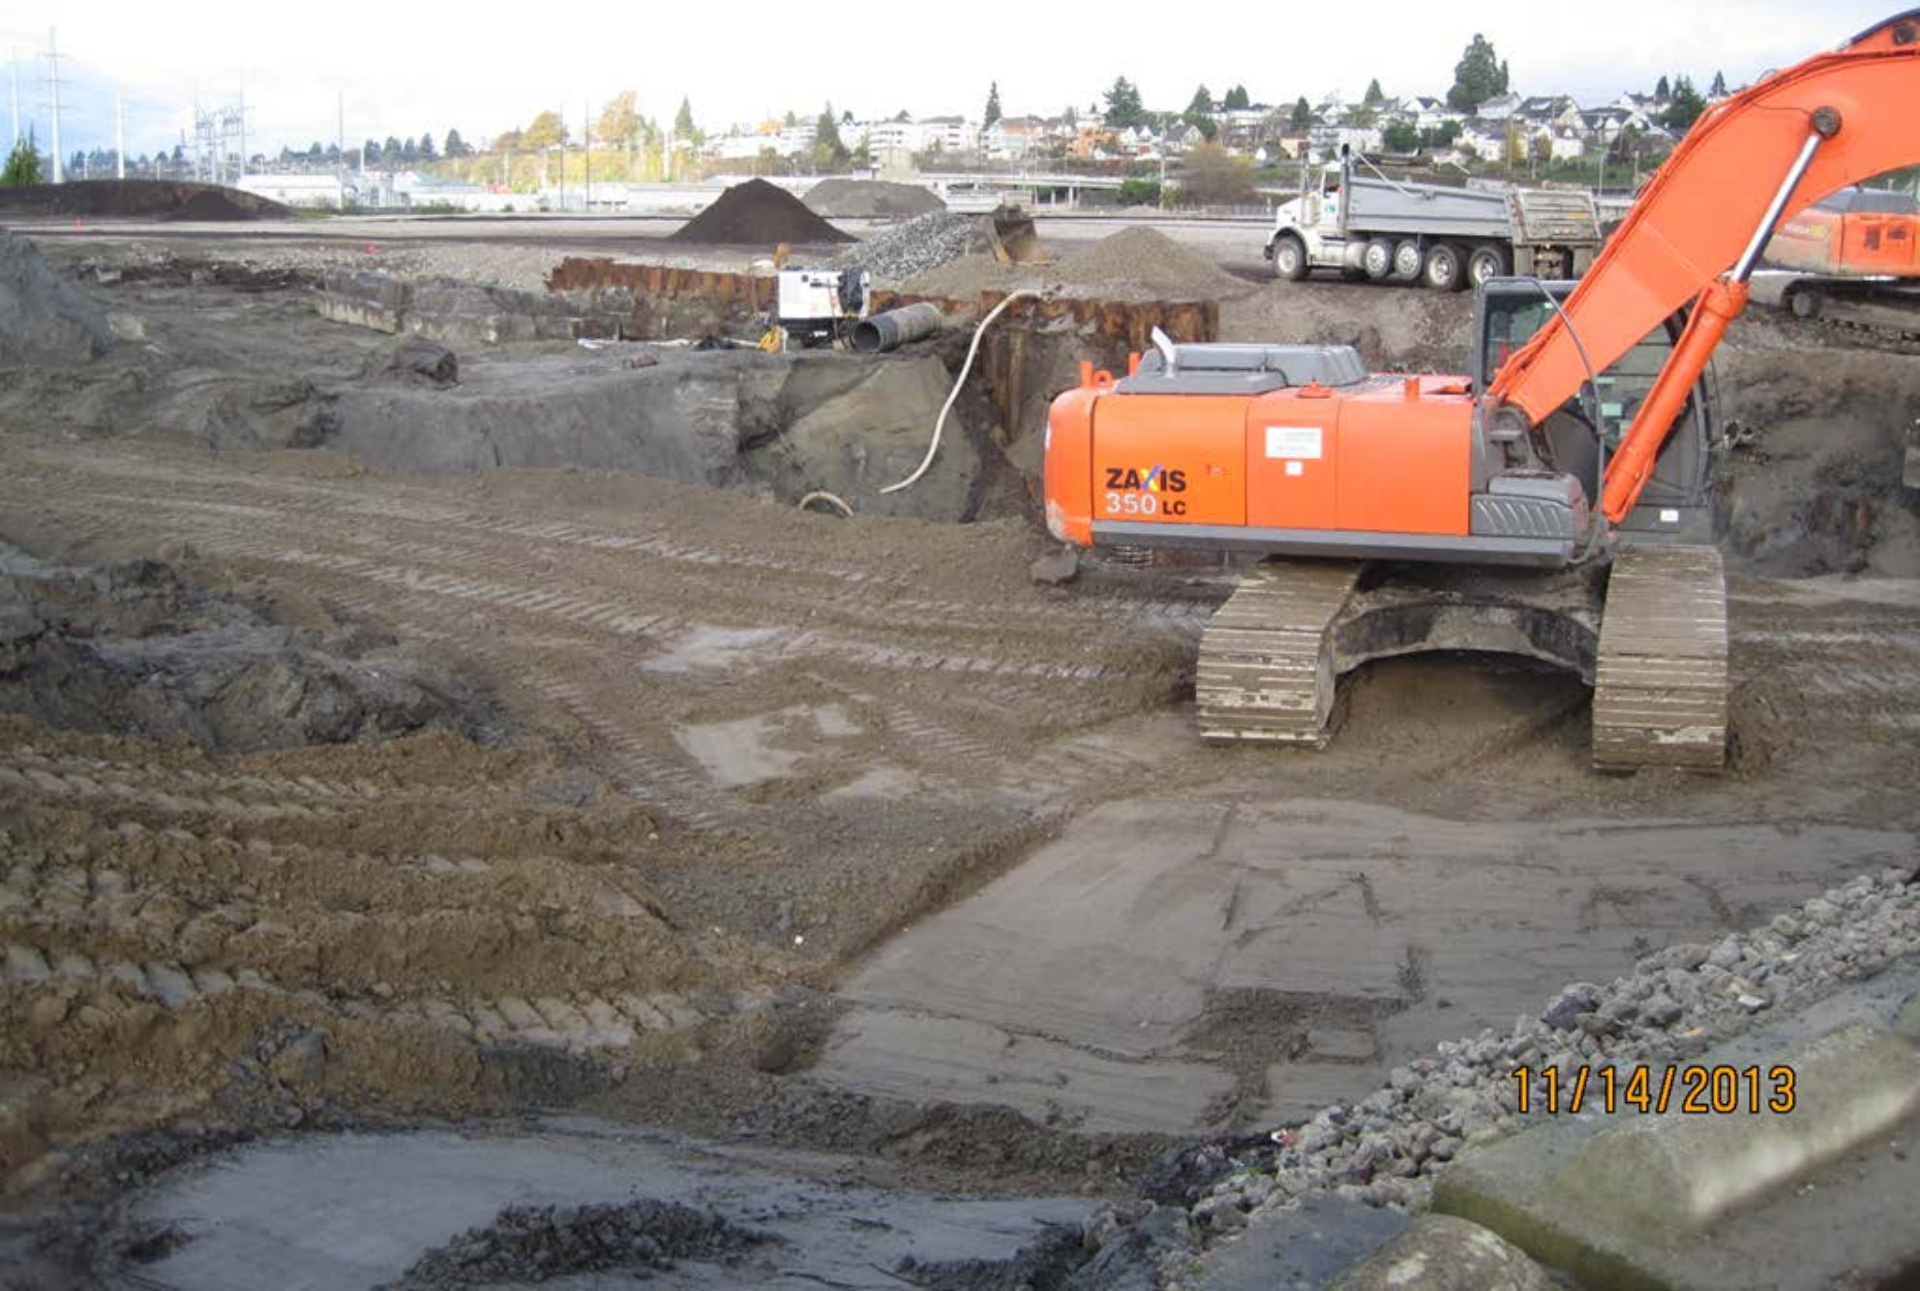
Excavation site at UST 70, view north
