WASHINGTON STATE
DEPARTMENT OF
ECOLOGY

RE: Cummins Northwest Inc. Longview
SW1309

Re: No Further Action at the following Site:

- **Site Name:** Cummins Northwest Inc. Longview
- **Site Address:** 1153 3rd Avenue, Longview, WA 98632-3204
- **Facility/Site No.:** 98511436
- **Cleanup Site ID No.:** 11312
- **VCP Project No.:** SW1309

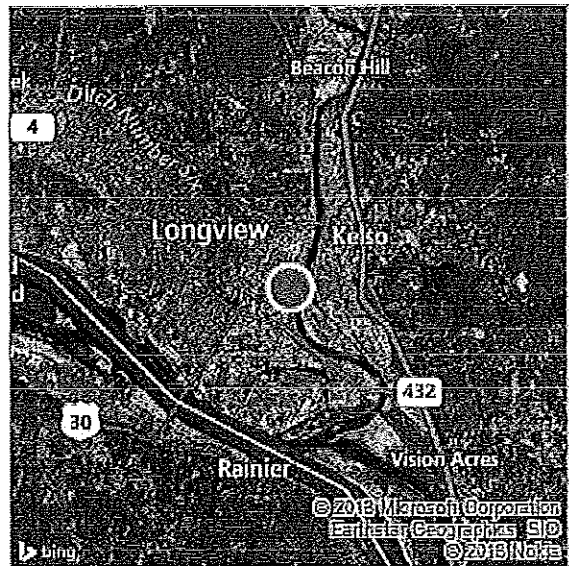
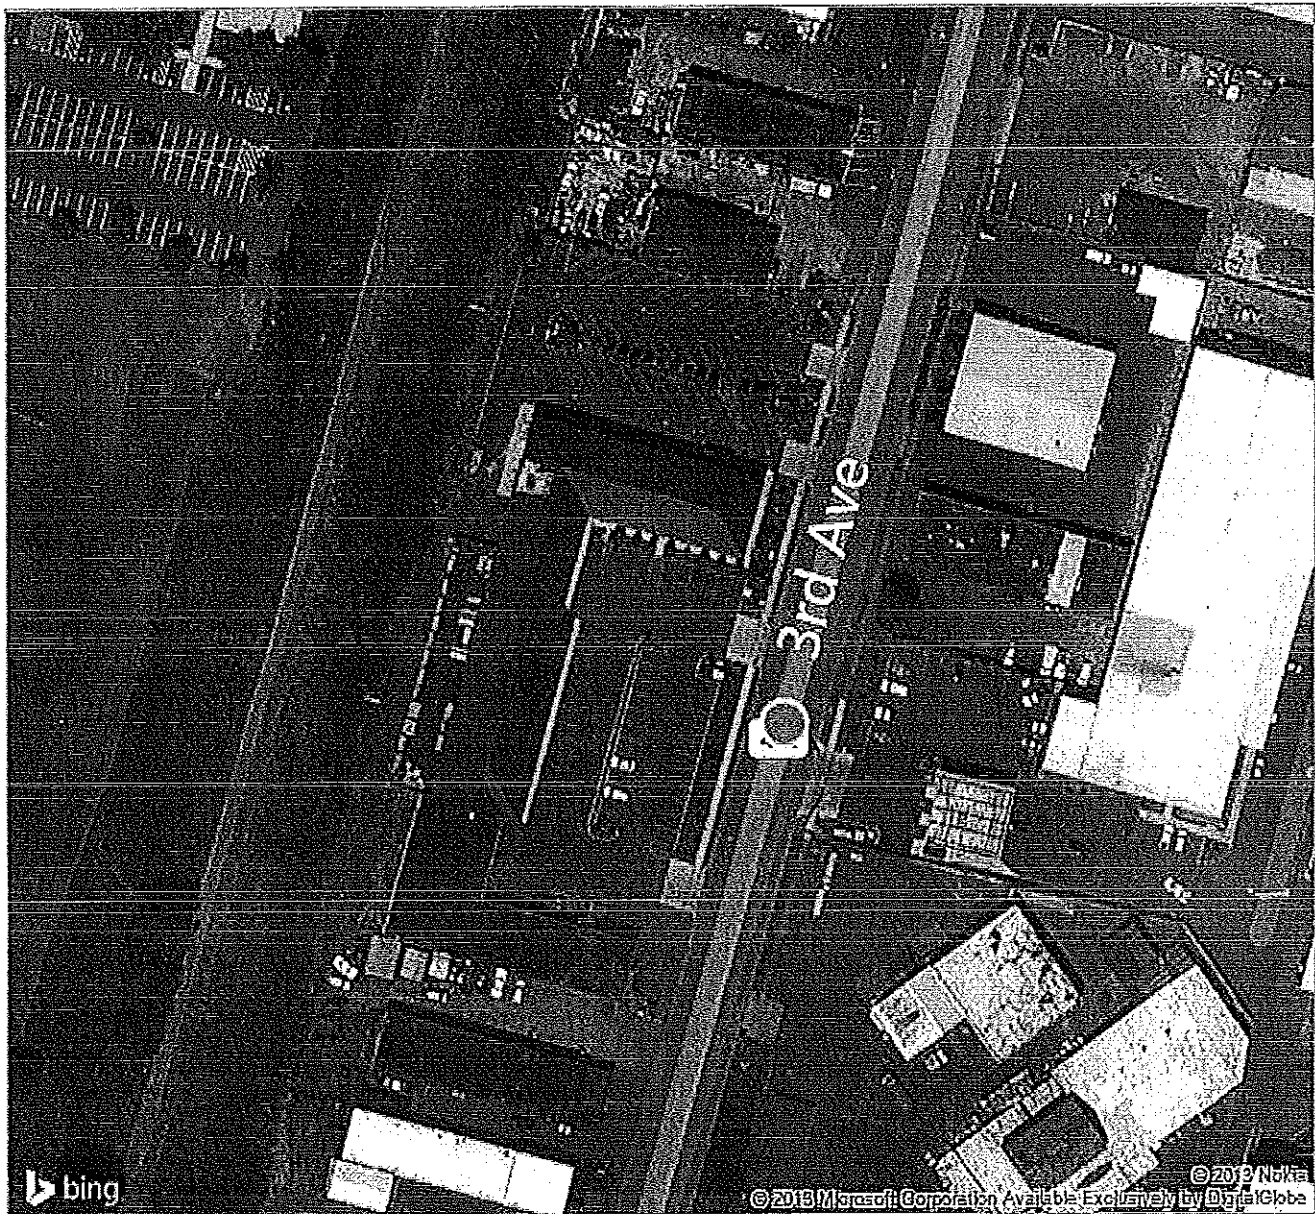
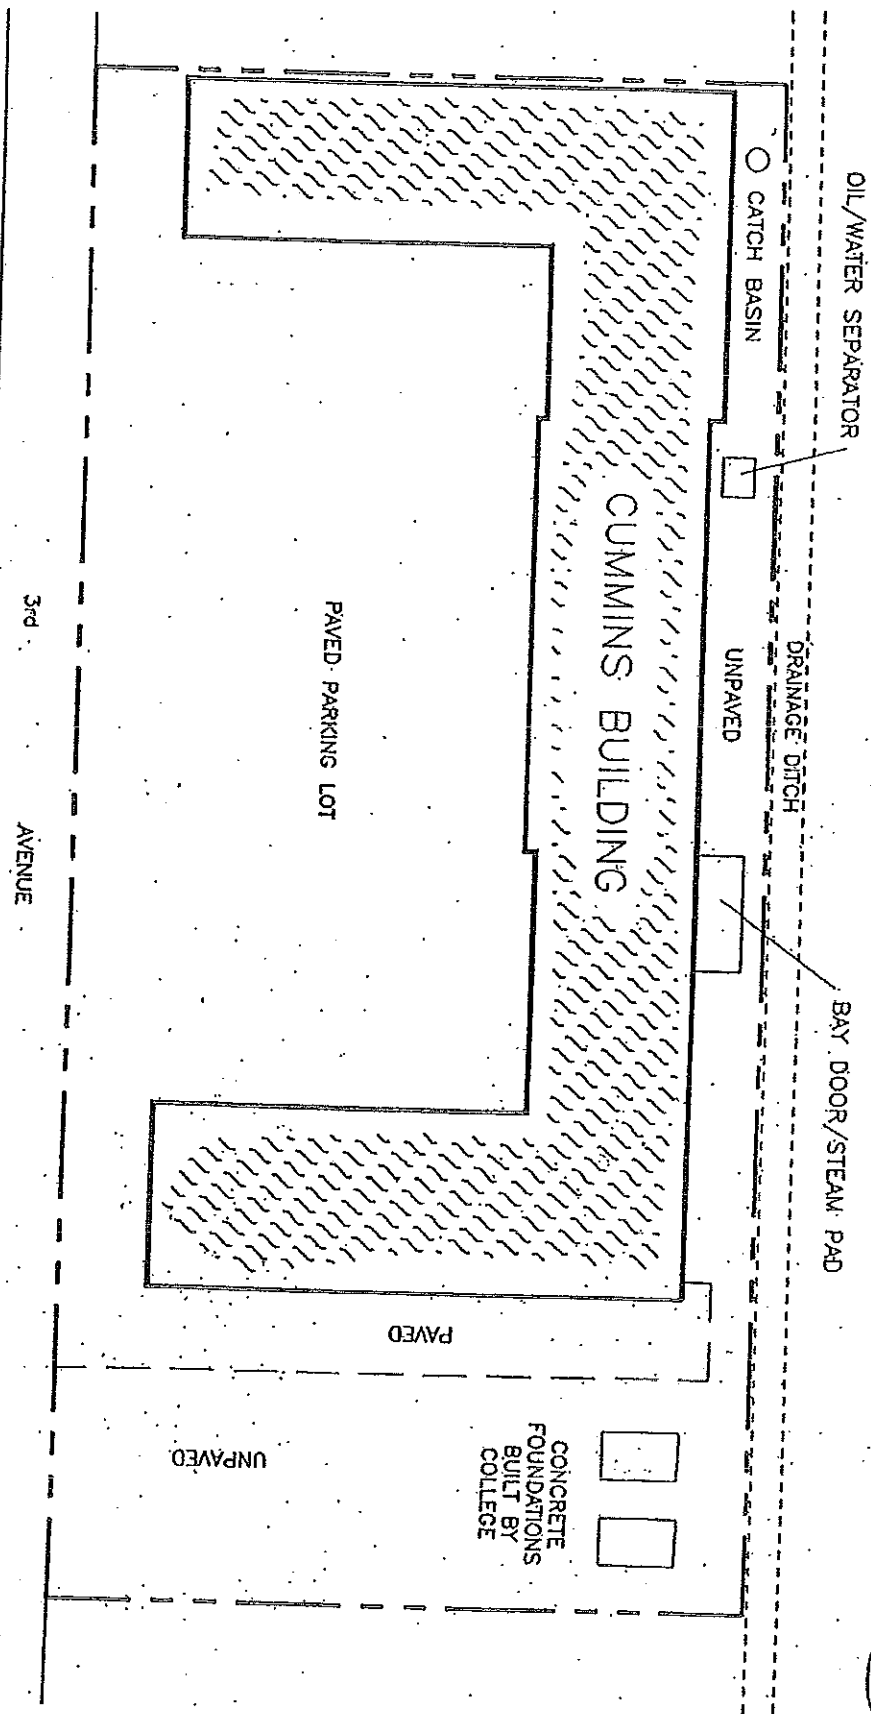
Figure 1

There were three areas of concern at the Site as shown on Figure 1. The floor drains in the south section of the building originally discharged to an outside catch basin (Concern 1) at the southwest corner of the building. Overflow from the catch basin reportedly discharged to the county ditch on the west side of the property. The floor drains were rerouted to the city's storm sewer system in the late 1970s. The catch basin was described as being round, constructed of steel, measuring 4 feet in diameter and 5 feet deep. Based on the description, size, and content, the catch basin is most likely the UST listed on Ecology's database. Two backhoe trenches (Fig.1) were excavated in the southeast corner of the property in an attempt to locate the catch basin and examine the soil in the area around the basin. Once the catch basin was located, Spencer Environmental Services of Oregon City, Oregon pumped the sludge from the tank. Two soil samples (Tank-1-soil and Tank-2-soil) were collected for analysis using EPA Method 418.1 giving results as Total Petroleum Hydrocarbons (TPH). The Tank-1-soil sample showed TPH at 5,500 milligrams per kilogram (mg/kg) just outside the catch basin. The Tank-2-soil sample, collected approximately 10 feet from the catch basin showed TPH at 240 mg/kg. Payne Reimer estimated that approximately 200 to 400 cubic yards was in place that would exceed the current (1990) cleanup standard of 200 mg/kg for motor oils.

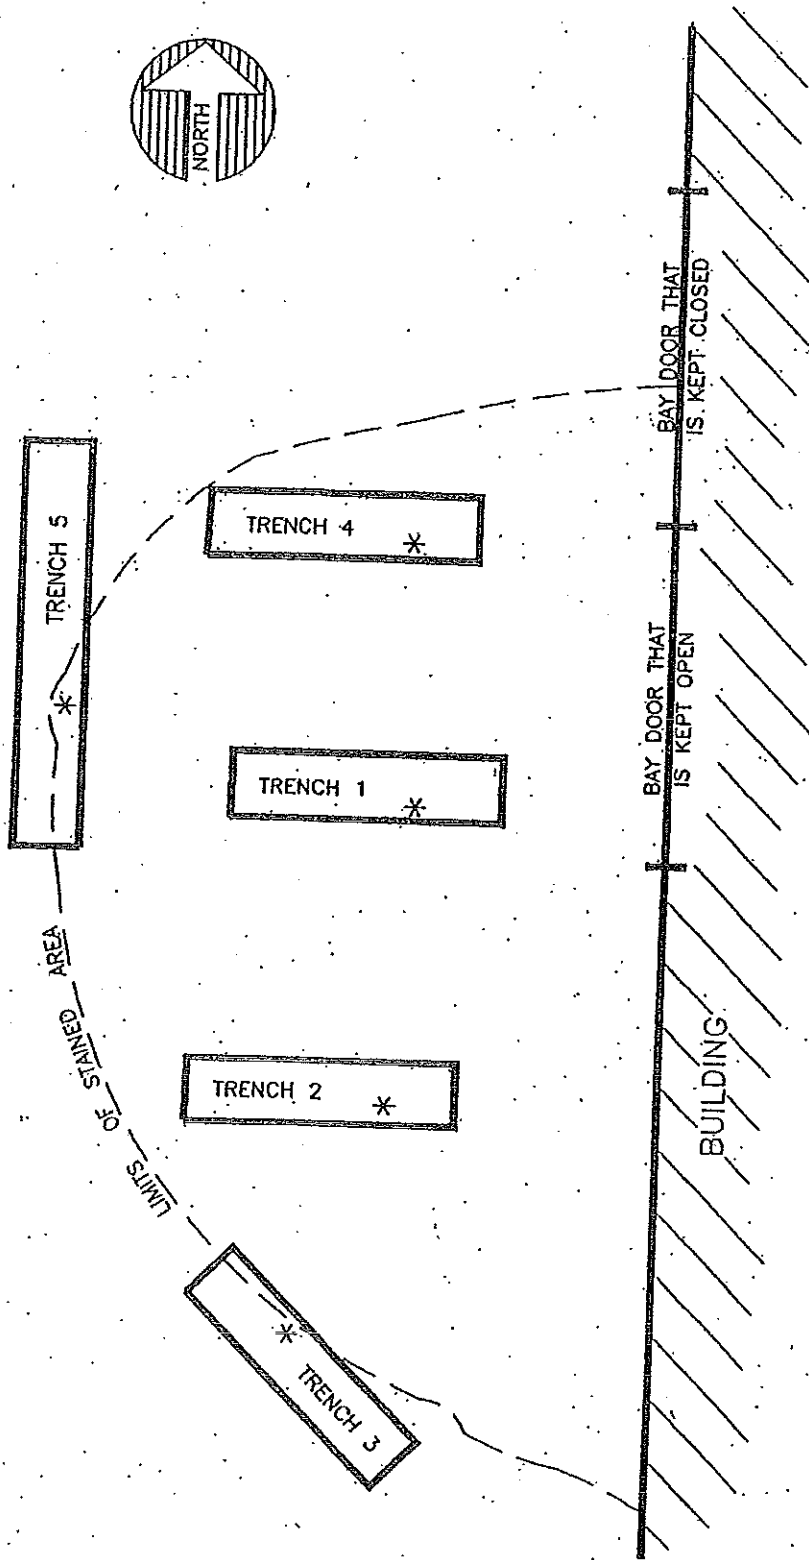
DESCRIPTION LOCATION OF BACKHOE TRENCHES
NEAR THE BAY DOOR

The second area of concern is referred to as the "Bay Door Area". This was an area outside of a large bay door on the west side of the building where Cummins steam-cleaned engines and other truck parts prior to the 1970s. The steam cleaning operation was moved indoors in the mid-1970s. Five backhoe trenches were excavated in the area around the bay door where surface staining was observed (Fig.1). None of the samples exhibited results above the MTCA Method A cleanup levels for soil.

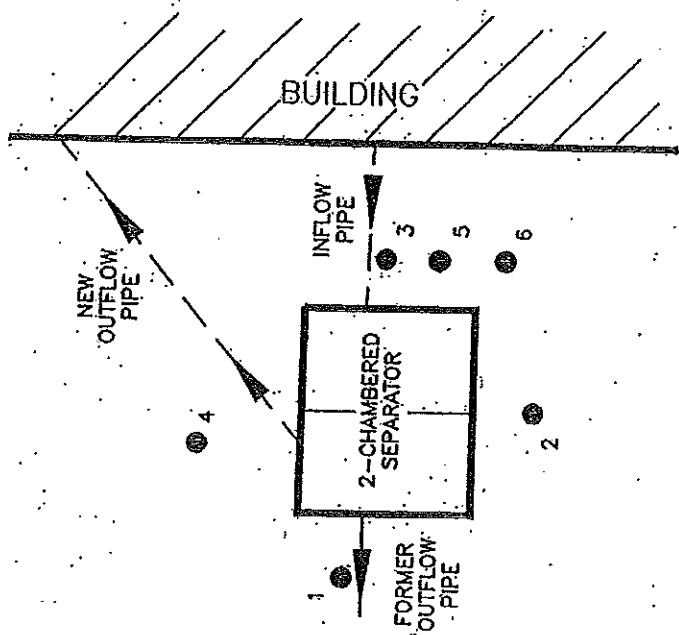
CLIENT	CUMMINS ENGINE CO.	FIGURE	5	DATE	7-12-90
DESCRIPTION	LOCATION OF SOIL BORINGS AROUND THE OIL/WATER SEPARATOR	DRAWN BY	JNC	APPROVED BY	LJO
		PROJECT NO.	101.38

The third area of concern was an oil/water separator. Waste water from the inside steam cleaning operation discharged to a partially below-ground, two-chambered, concrete oil/water separator located outside the west wall of the building. Black to gray-stained soil around the top of the separator system suggested that the system periodically overflowed. Six soil borings (DP1 – DP6) were advanced around the separator to a depth of 6 feet below ground surface (bgs) with a hand-operated soil auger. One soil sample collected next to the oil/water separator inflow pipe showed TPH at 5,600 mg/kg which is above the current MTCA Method A Cleanup Level for both diesel (TPH-D) and TPH-O of 2,000 mg/kg. The boring log for DP-1 references "continuous gray staining, petroleum odor, and sheen" encountered at 9 feet bgs in the saturated zone.
