PERIODIC REVIEW

**BMW Seattle
Facility Site ID#: 33641566**

**714 East Pike Street
Seattle, Washington 98122**

November 2008

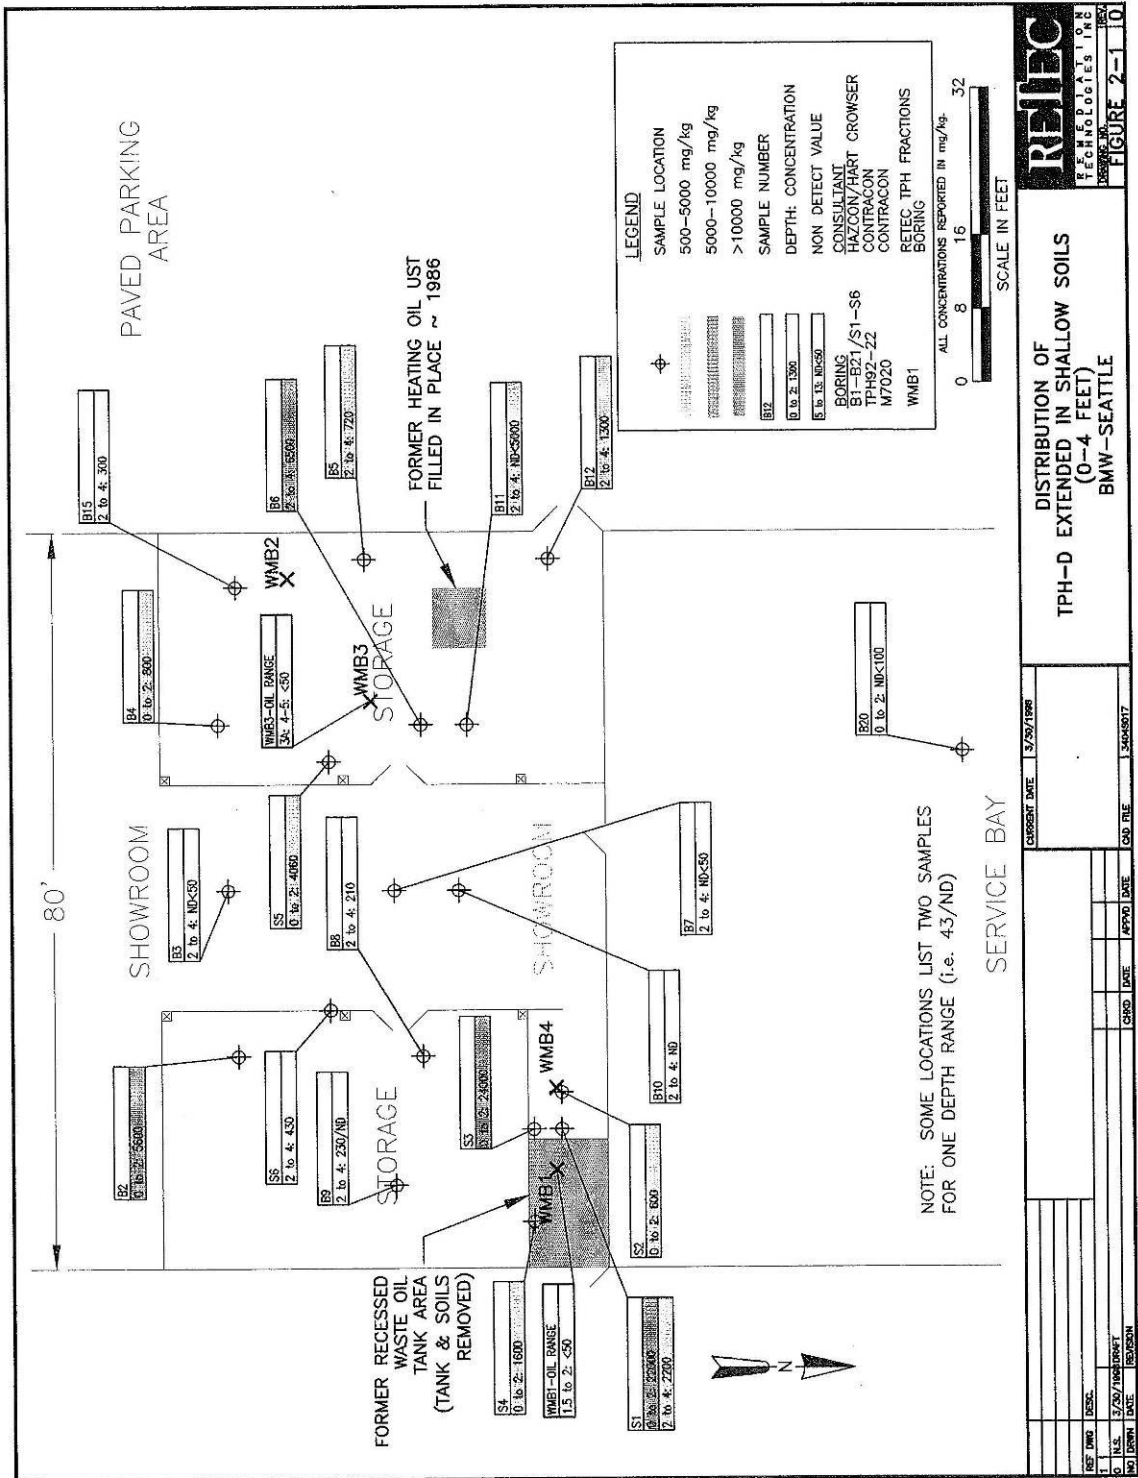
6.3 TPH-Dx Concentration Map

TPH-Dx concentrations above MTCA Method A cleanup levels at several points across the Site. They were detected in shallow soils under the northeast corner of the BMW sales building near the former recessed waste-oil tank at concentrations up to 24,000 parts per million (ppm), near the abandoned UST in the northwest corner of the sales building at concentrations up to 6,500 ppm, and under the north end of the sales building at concentrations up to 5,600 ppm. The contamination decreased significantly with depth, though one sample in the vicinity of the UST had a concentration of 3,200 ppm at 20 feet bgs. A map of TPH-Dx surface concentrations is available as Appendix 6.3.

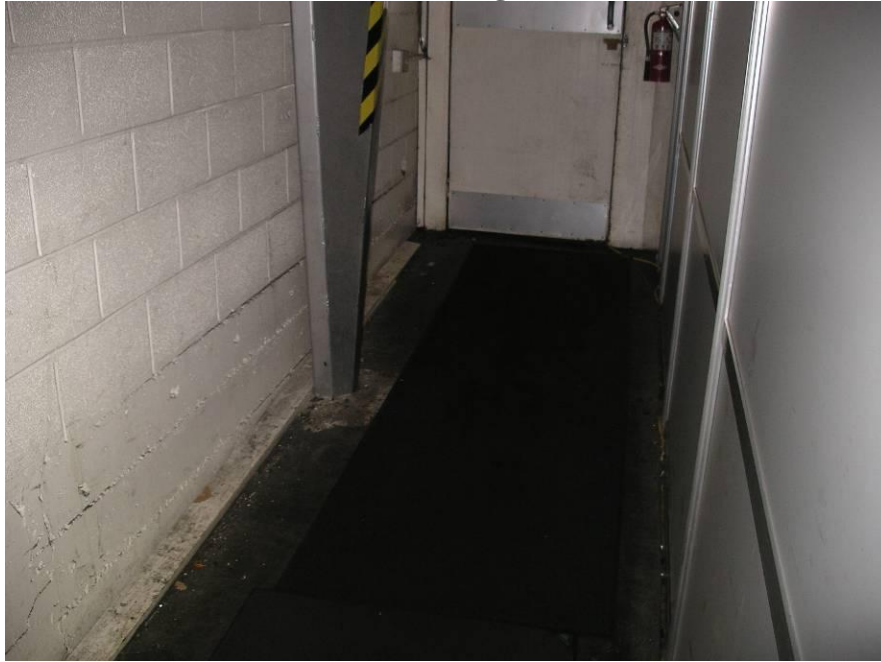
Photo 1: Former Tank Location Between Buildings - from the west

Based upon the site visit conducted on October 2, 2008, the building and asphalt cover at the Site continue to eliminate exposure to contaminated soils by ingestion and contact. The asphalt appears in satisfactory condition and no repair, maintenance, or contingency actions have been required. The Site is still operating as a tire service and automotive repair business. A photo log is available as Appendix 6.5.
