Site Hazard Assessment Recommendation for No Further Action

Lucky's Service 14579 Highway 97A Entiat, Chelan County, WA 998822 NW1/4, NE1/4, Section 9 Township 25 N Range 21 E Latitude 47.68444, Longitude -120.20698 Facility Site ID No. 62249282 TCP Cleanup Site ID No. 9917 January 28, 2014

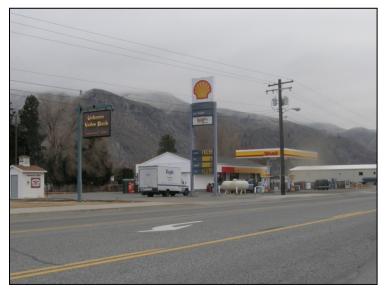
Photo of Lucky's Service, taken 1/23/2014. Photo view looks toward the south east.

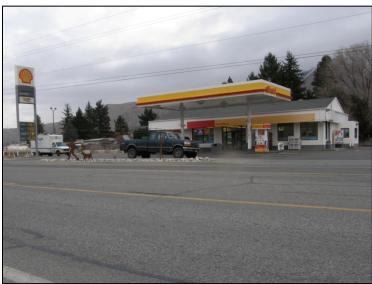
Photo of Lucky's Service, taken 1/23/2014. Photo view looks toward the north east.
