PERIODIC REVIEW

**Eastside Jeep and Eagle (former)
Facility Site ID#: 2497**

**400 116th Avenue N.E.,
Bellevue, Washington**

September 2009

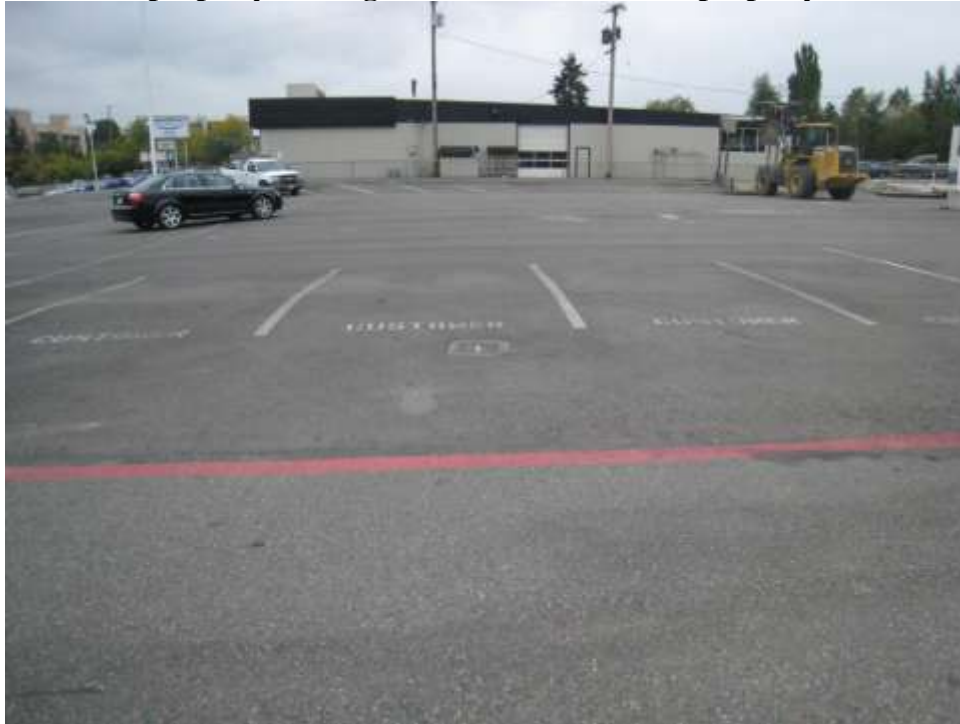
Photo 1: View of the property looking north - from the south property line

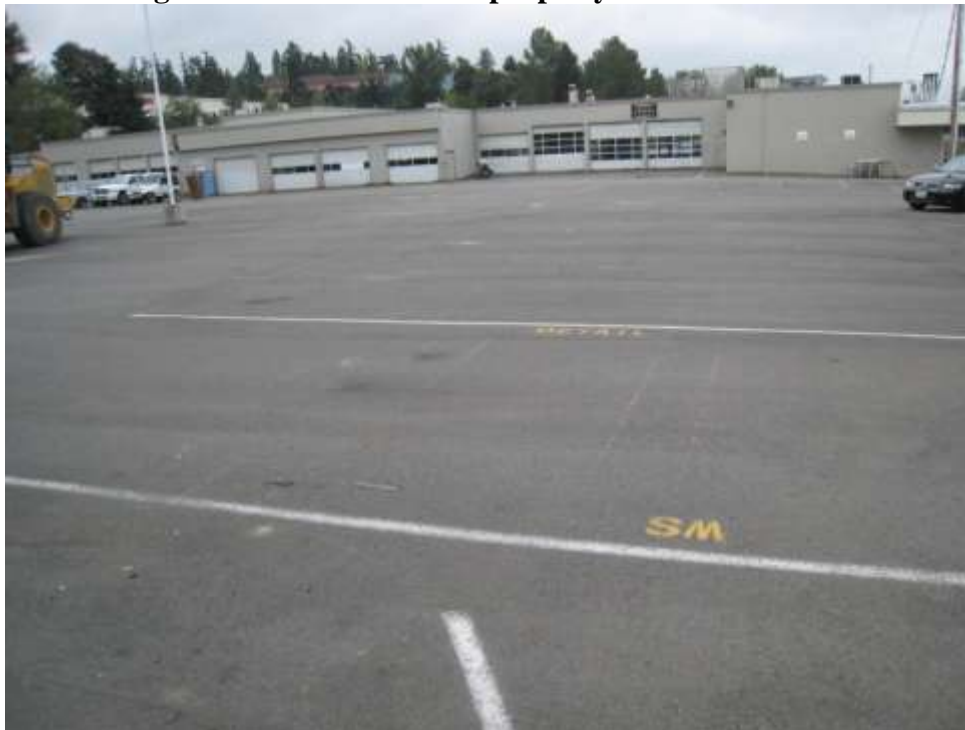
Photo 2: View looking south - from the north property line

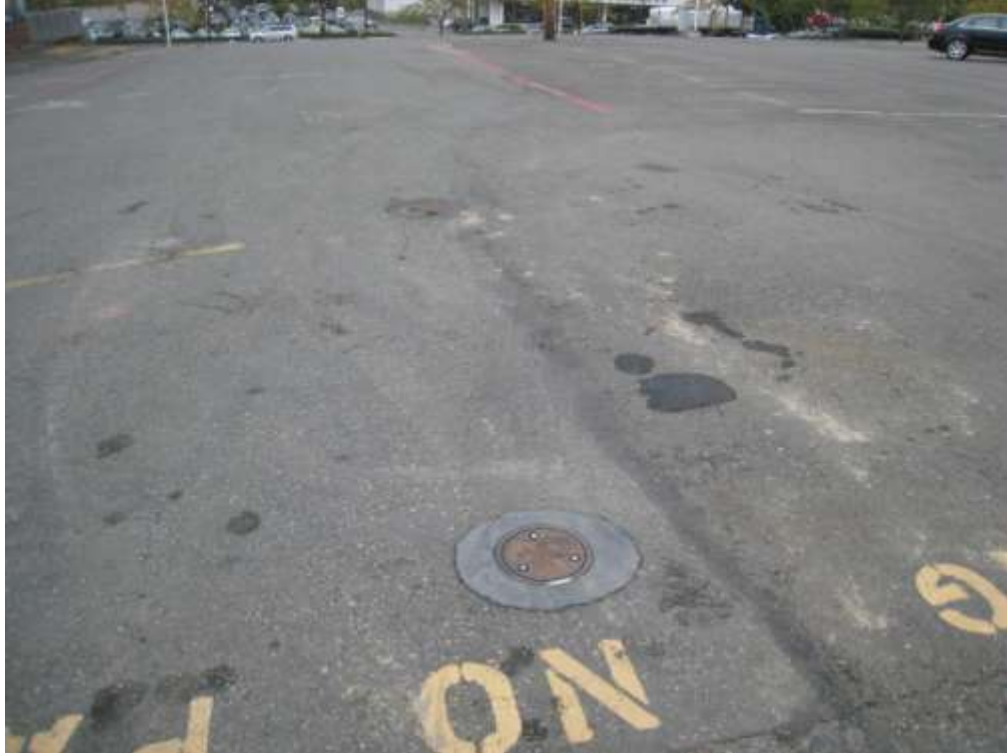
Photo 3: Two monitoring wells (far one barely visible) at south end – looking west

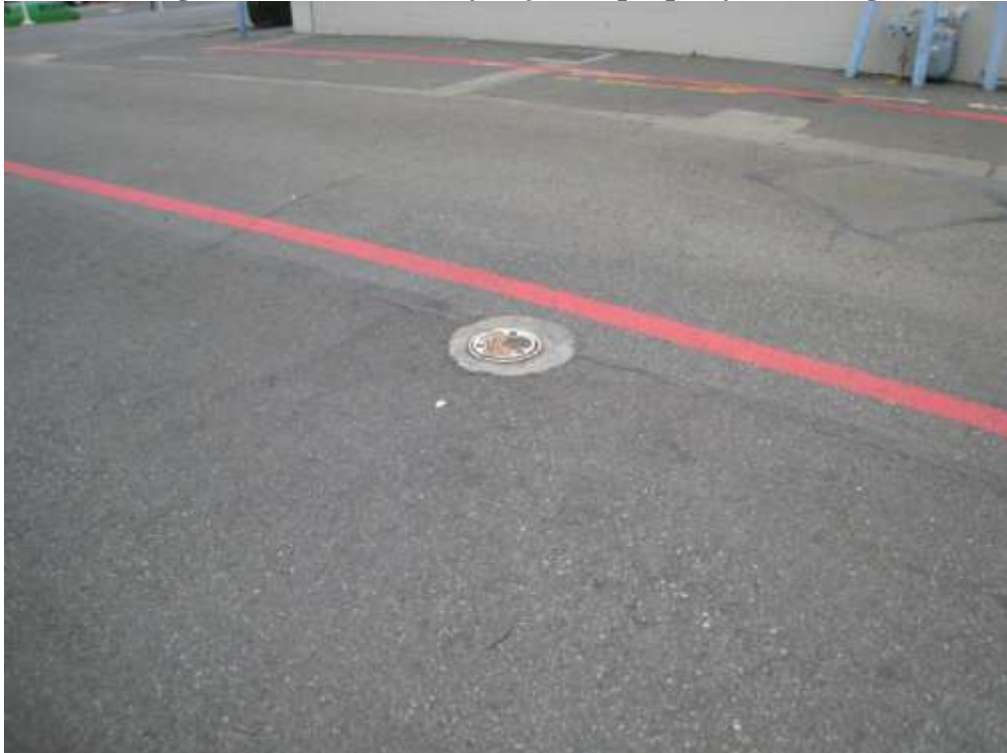
Photo 4: A monitoring well on the northerly adjacent property – looking over a fence
