PERIODIC REVIEW

**Lakeshore Village Apartments
aka Lake Washington Apartments, Seward Park Estates
Facility Site ID#: 2285**

**9061 Seward Park Avenue South,
Seattle, Washington**

February 2010

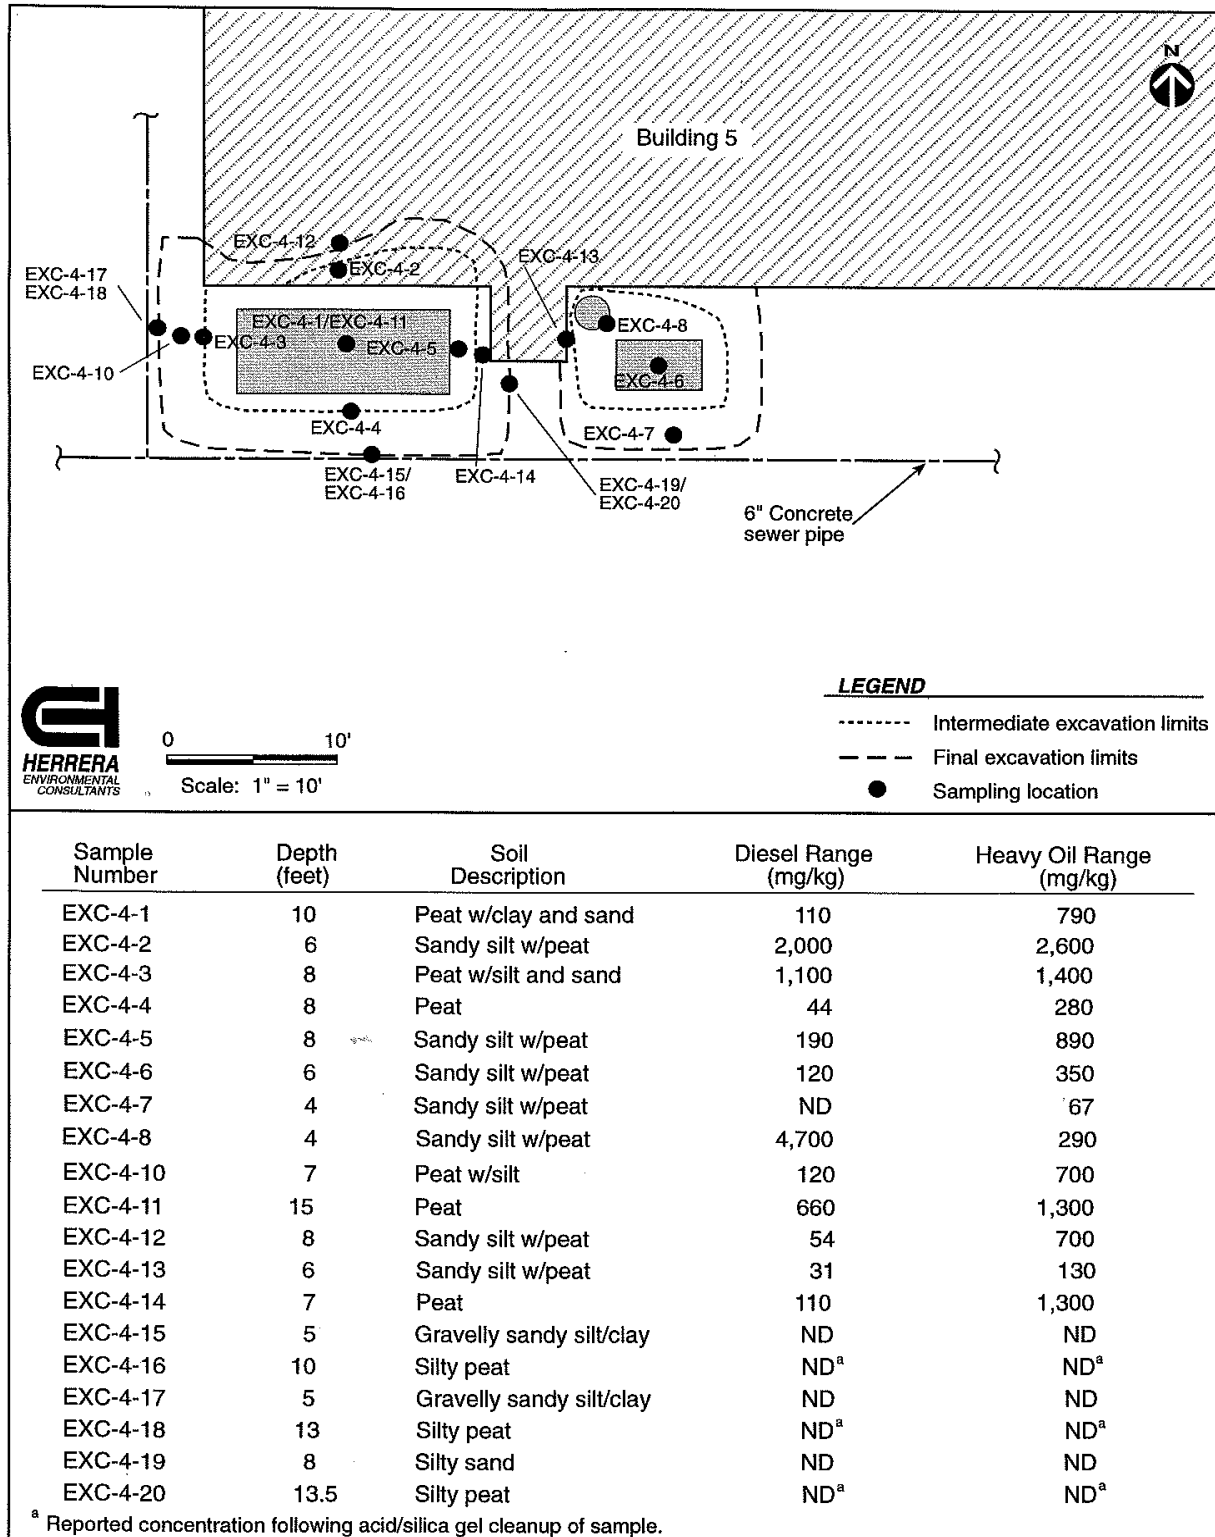
6.3 TPH Location Map, Loc. 4 (one of the worst of the 9 locations)

Figure 8. Tank location 4 sampling locations and TPH results.

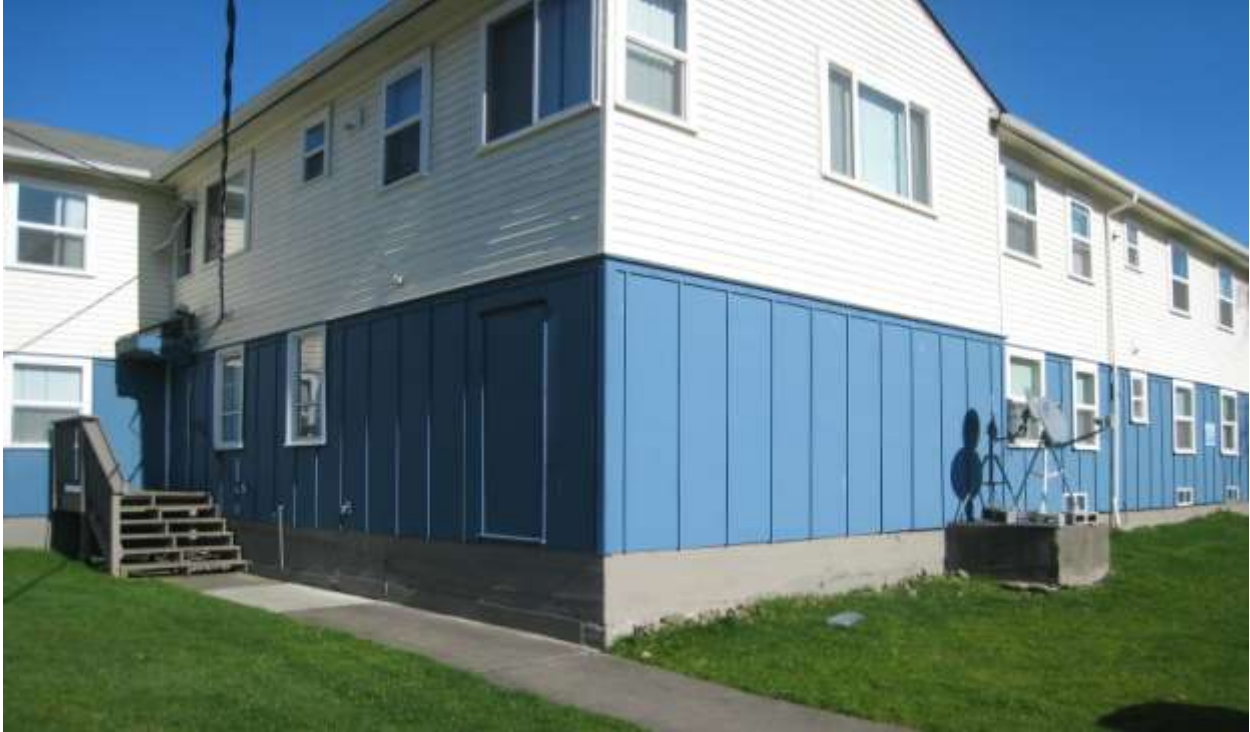
Photo 3: Typical location of tanks removal and excavation– concrete blocks at all locations

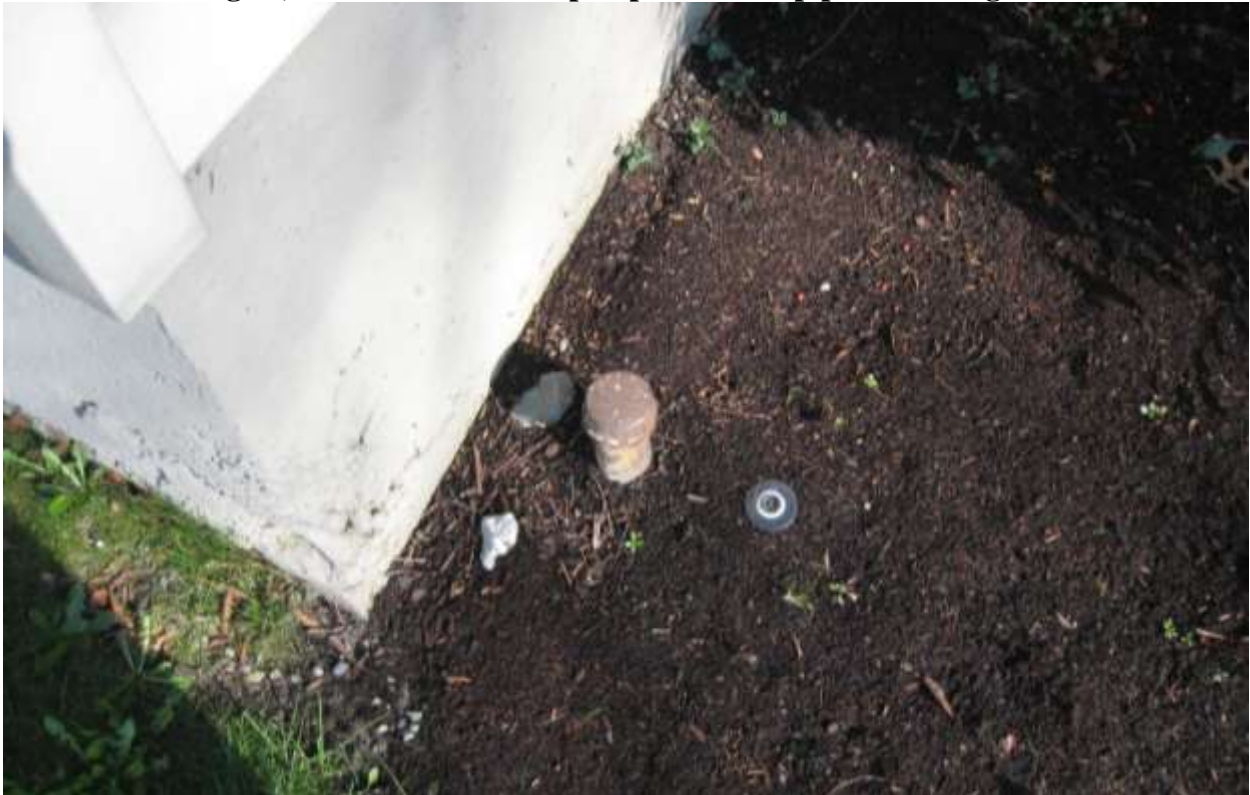
Photo 4: Building 29, Location 7 – close-up of possible fill-pipe remaining
