PERIODIC REVIEW

**Marine Fluid Systems
Facility Site ID#: 76266689**

**801 NW 42nd,
Seattle, Washington**

March 2010

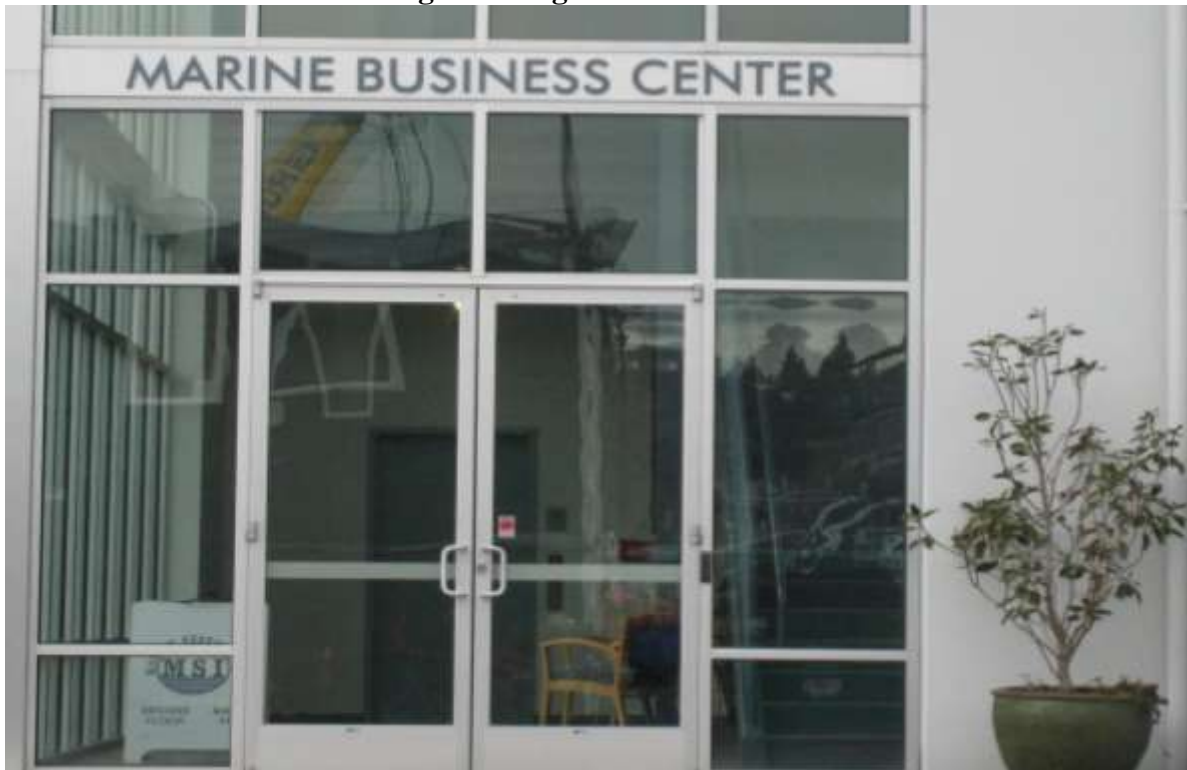
Photo 1: Entrance to new building – looking north

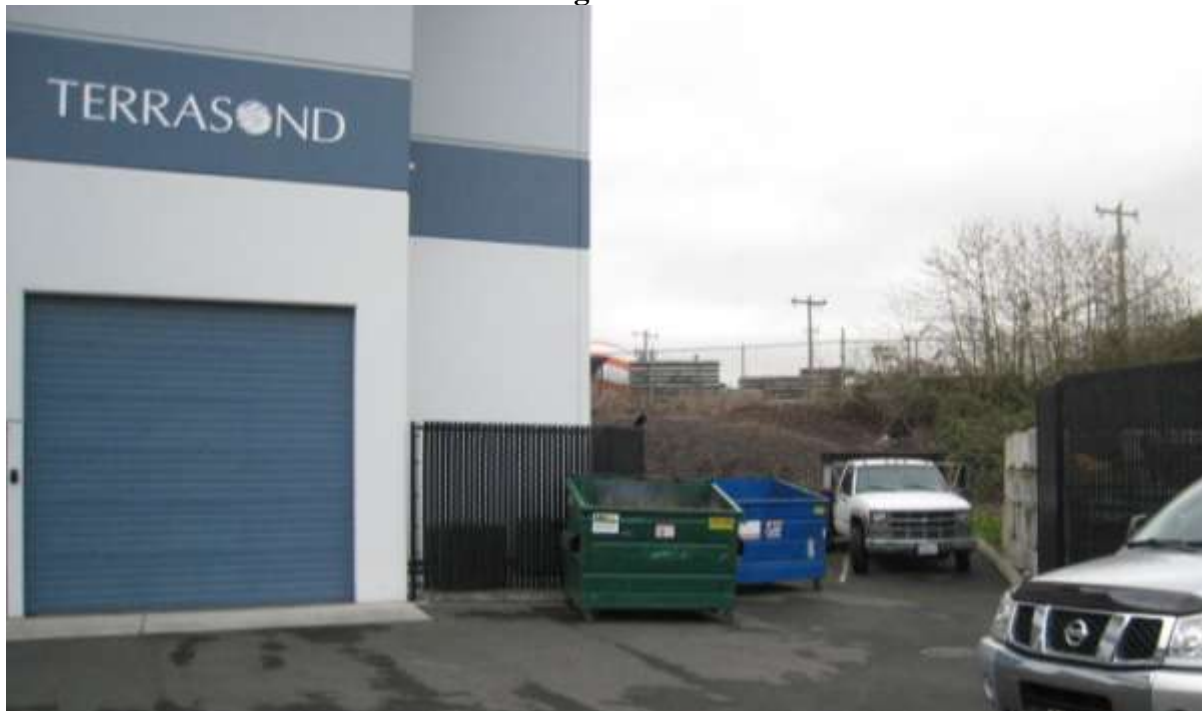
Photo 2: An area of contamination – looking east

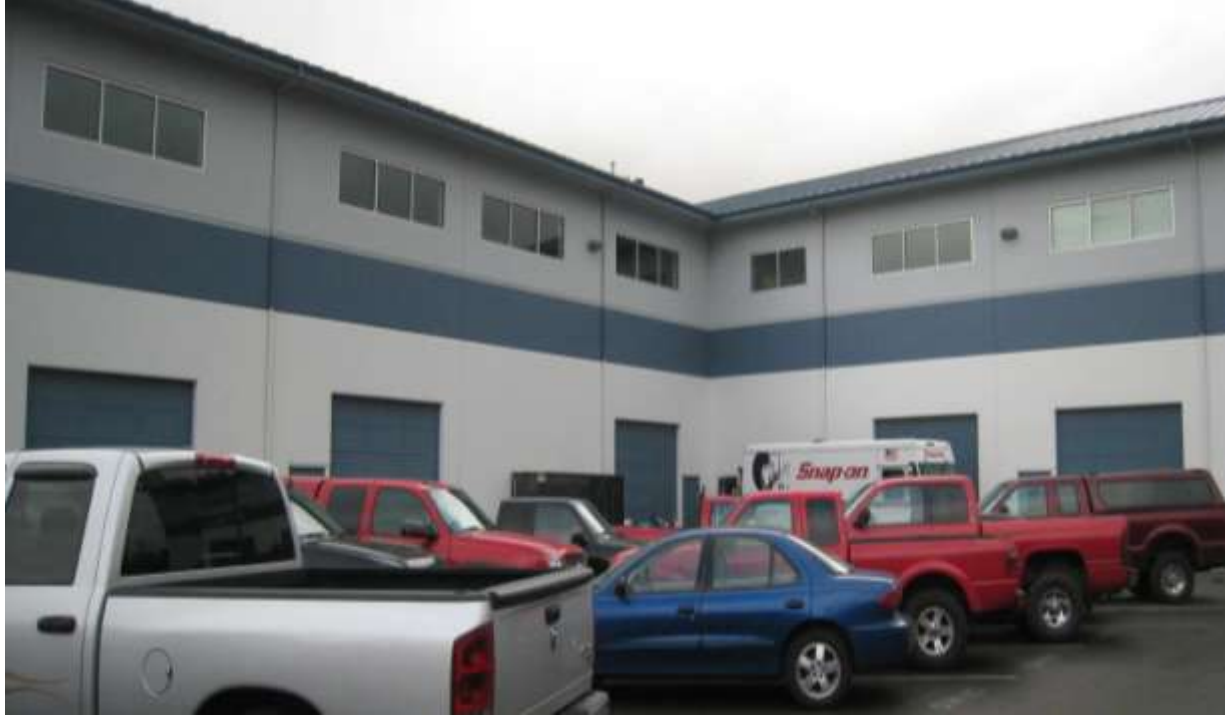
Photo 3: Another area of contamination under corner of new building - looking northeast

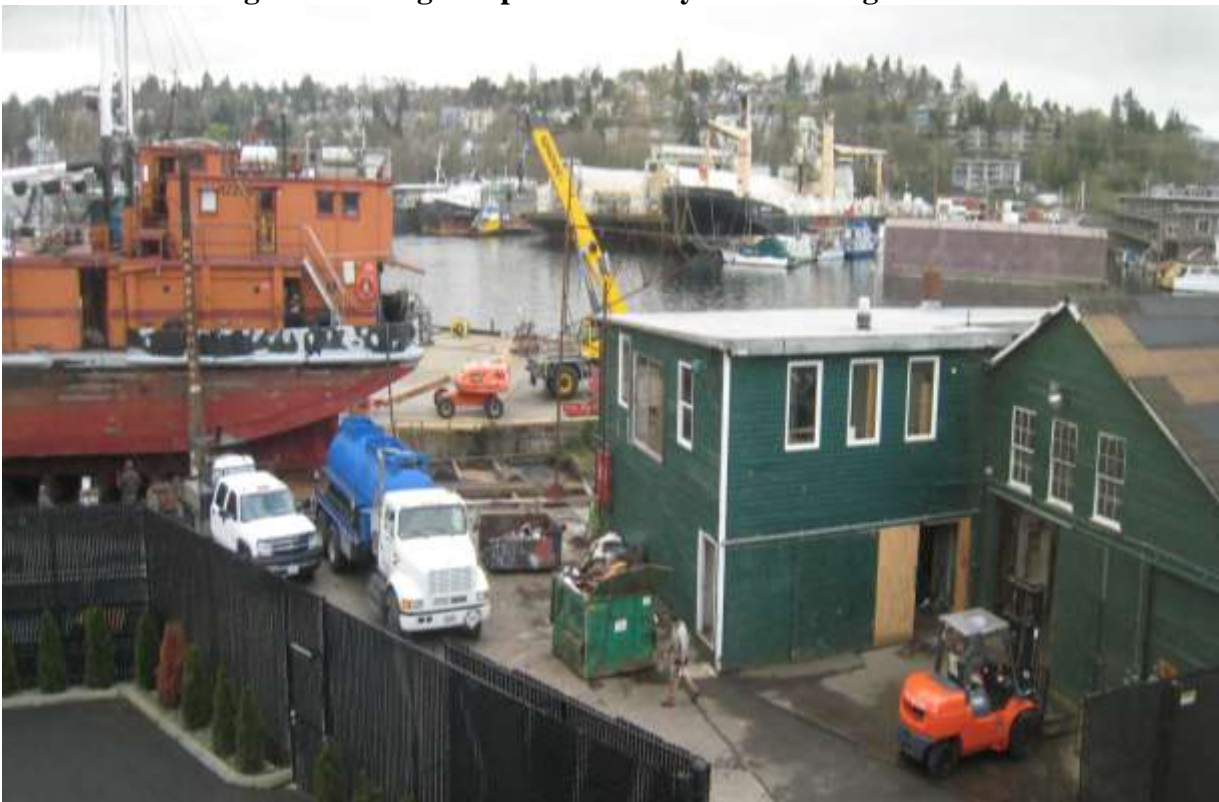
Photo 4: Remaining old building and part of work yard – looking south
