TECHNICAL MEMORANDUM

FROM: Larry Beard, P.E., Landau Associates *LB*

DATE: September 19, 2012

**RE: EMERGENCY ACTION CLEANUP PLAN
STORMWATER TRUNK LINE CLEANOUT AND REPAIR
NORTH MARINA AMERON/HULBERT SITE
EVERETT, WASHINGTON**

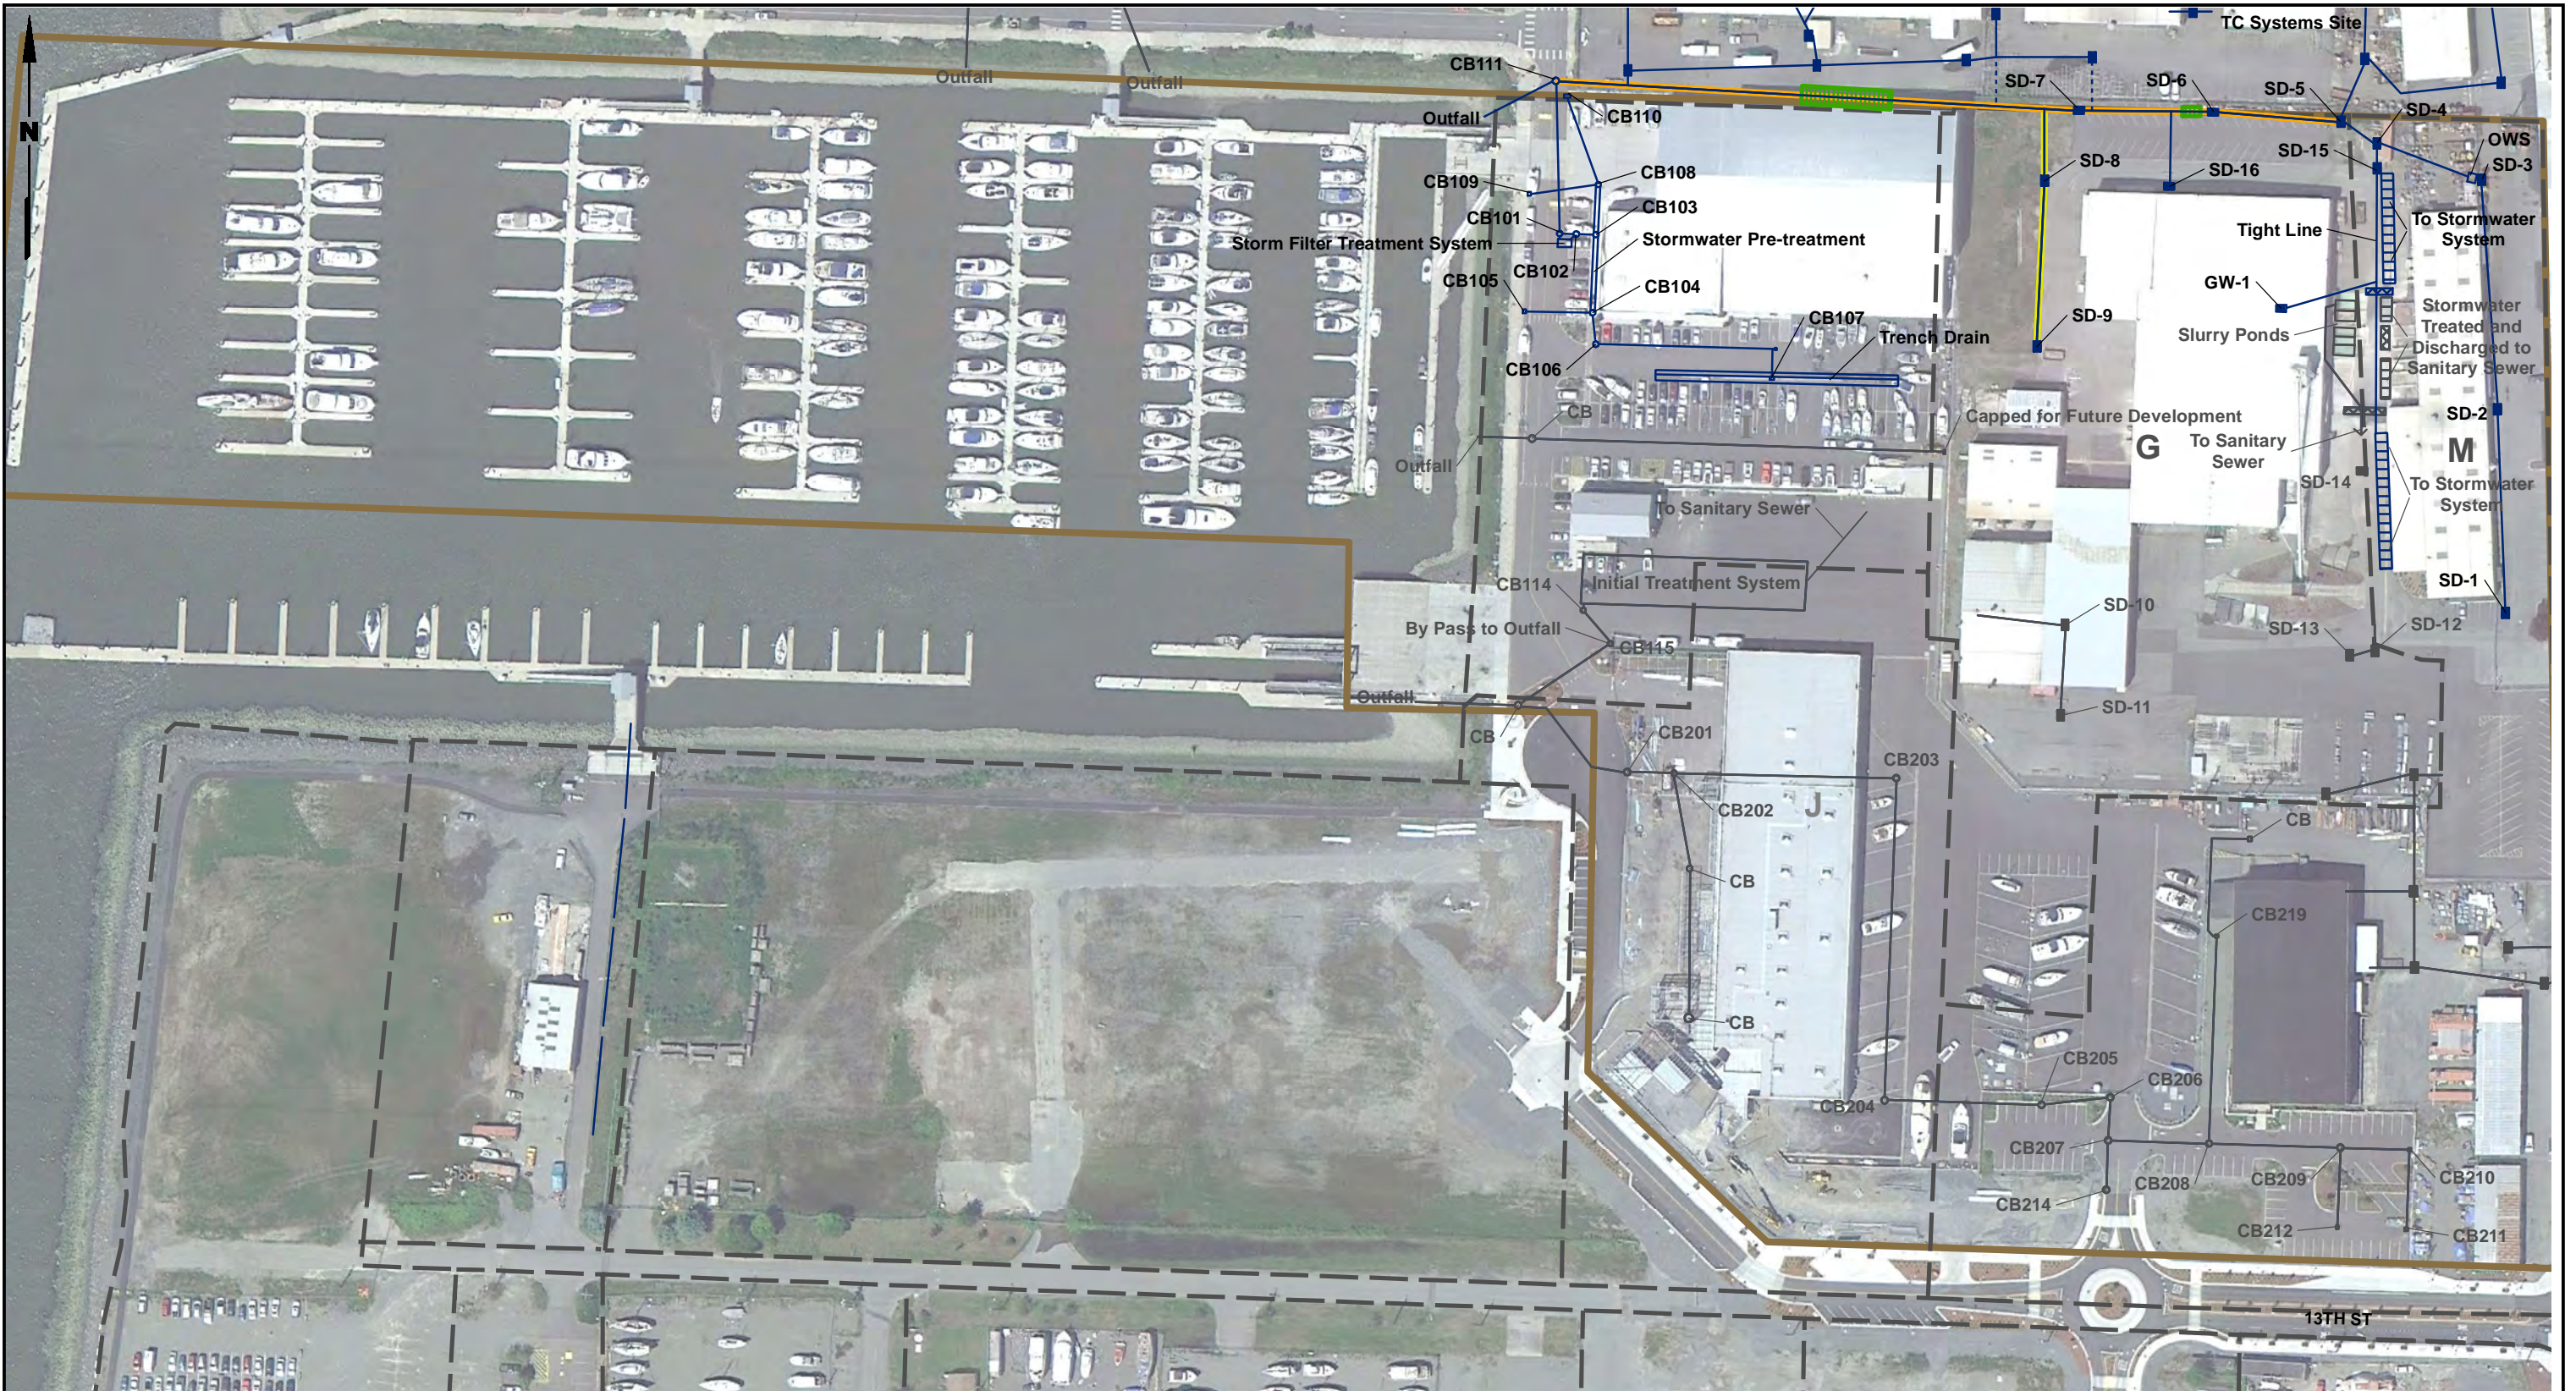
Figure
2

The stormwater trunk line is located near the north property boundary that separates the Site from TC Systems and includes the segment of storm drain pipe between SD-5 and CB-111, as shown on Figure 2. Portions of the trunk line are located on Port property and portions are located on the Norton Industries property to the north (which includes TC Systems), and stormwater from businesses located on both properties discharge to the trunk line, as shown on Figure 2. Solids collected from the trunk line, and the stormwater lateral containing catch basins SD-8 and SD-9, contain elevated concentrations of heavy metals, semivolatile organic compounds (SVOCs), polychlorinated biphenyls (PCBs), heavy metals, and concentrations of dioxins/furans that would be considered a threat to human health or ecological receptors if discharged to marine sediment. Stormwater-trunk line solids analytical data are provided in Table 1.

cleanout segments are: SD-5 to SD-6, SD-6 to SD-7, SD-9 to SD-8, SD-8 to the trunk line, and SD-7 to CB-111.

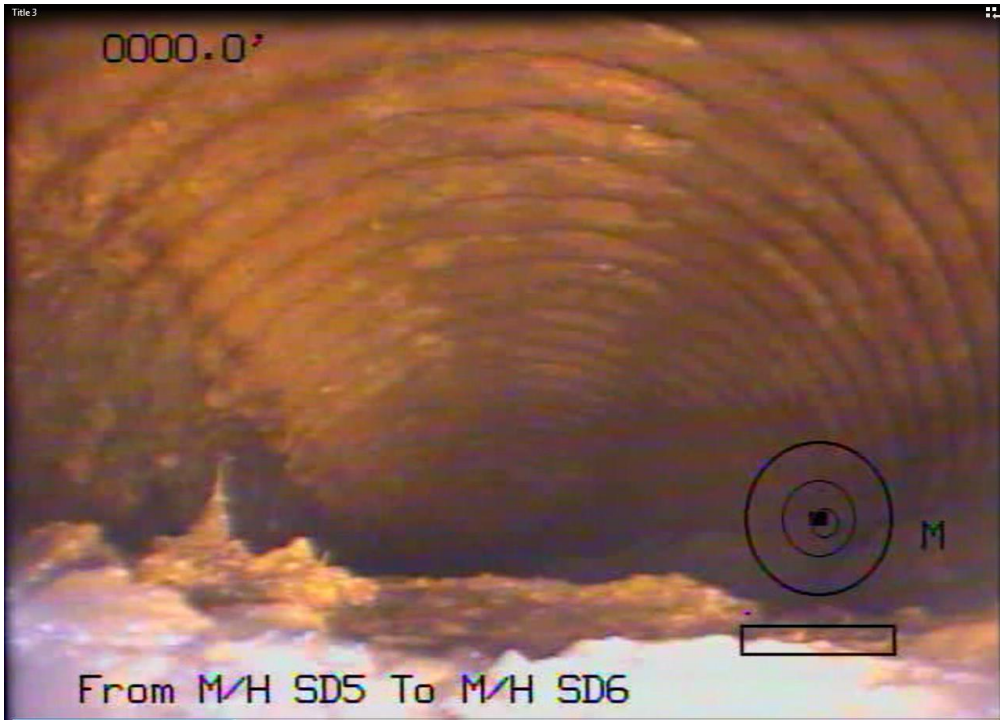
The trunk line was installed sometime between the mid-1970s and the early 1980s. It is constructed of 24-inch diameter corrugated metal pipe (CMP), and contains a large accumulation of solids, as shown in the video survey images provided on Figures 3 and 4. Although camera surveys were attempted in 2008 and 2009, they could not be completed because of accumulated solids in the trunk line. The total volume of accumulated solids in the trunk line is estimated to be about 20 cubic yards (CY)

Photo 1. Contents of trunk line between catch basins SD-5 and SD-6.

The emergency action will consist of: 1) cleaning the trunk line and the SD-8/SD-9 lateral of accumulated solids and, assuming the trunk line is sufficiently competent, 2) repairing the trunk line by slip-lining it with Cured-In-Place-Pipe (CIPP). The CIPP technology uses a resin-impregnated felt liner that is pulled through the existing line, inflated and cured with steam to slip line and reinforce the existing pipe. CIPP is less intrusive, does not require excavation and shoring, and is less expensive than digging a trench and installing a new pipe. However, the CIPP process requires that the existing pipe be sufficiently competent such that it does not exhibit significant deflection that will compromise the strength of the CIPP. The suitability of the trunk line for CIPP cannot be fully evaluated until after it has been cleaned out and a video survey conducted. If the post-cleanout video survey reveals that the condition of the pipe will not allow for use of CIPP, alternatives to repair of the trunk line would be evaluated as either part of the emergency action or the final cleanup action. If the slip lining is completed, a post-repair video survey will be conducted to document the condition of the pipe following repair.

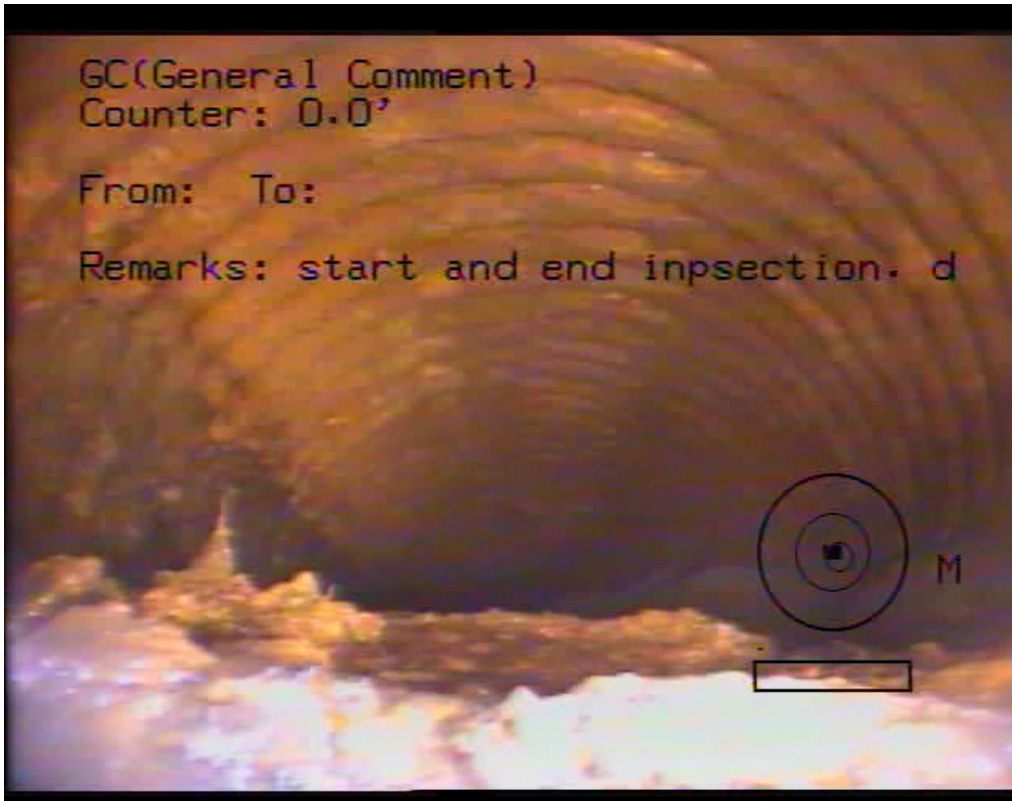
Photo 2. Video survey not completed due to accumulated solids in the trunk line between catch basins SD-5 and SD-6.

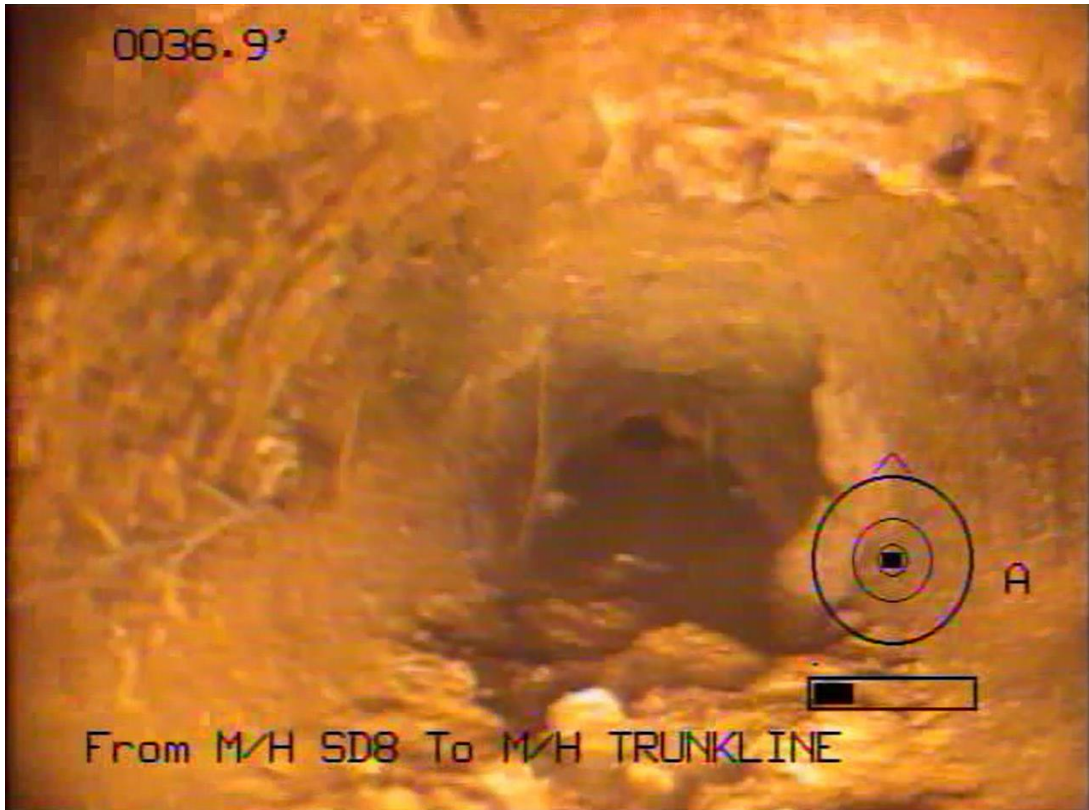
Photo 3. SD-8/SD-9 lateral near connection to trunk line.

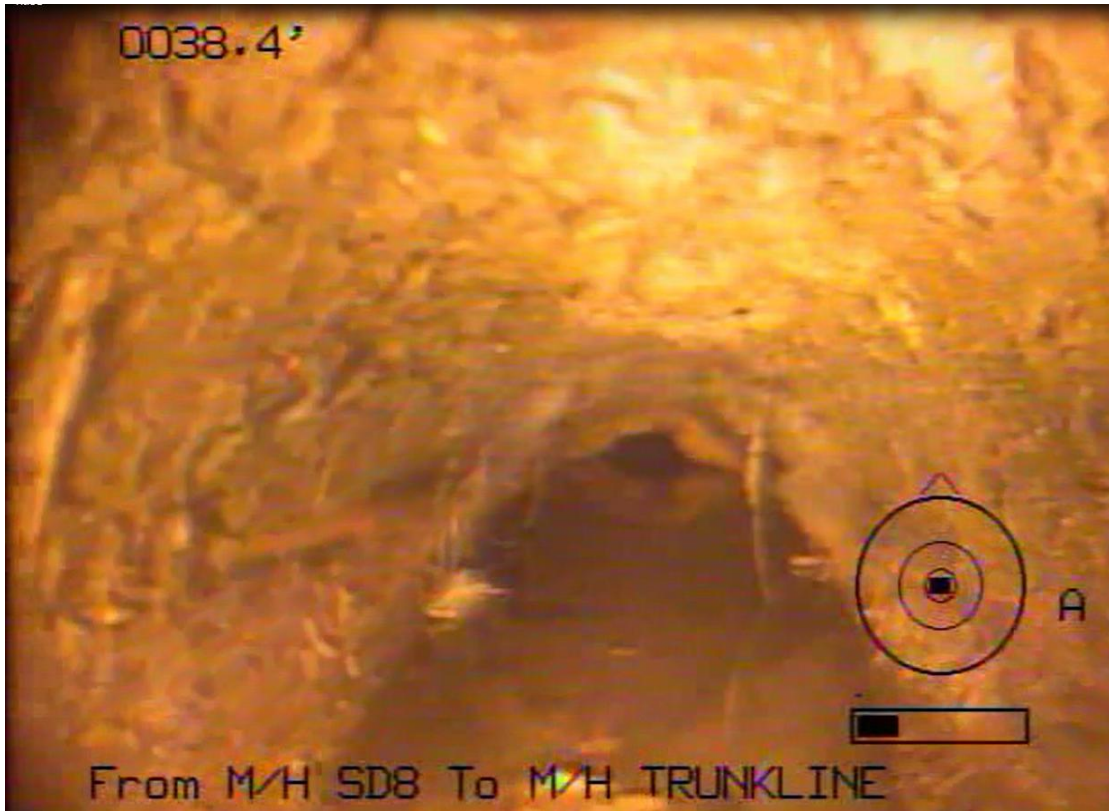
Photo 4: SD-8/SD-9 lateral approaching connection to trunk line.
