PERIODIC REVIEW

**Ricchiazzi Industrial Property
Facility Site ID#: 45819189**

**4424 and 4500 4th Avenue South,
Seattle, Washington**

March 2010

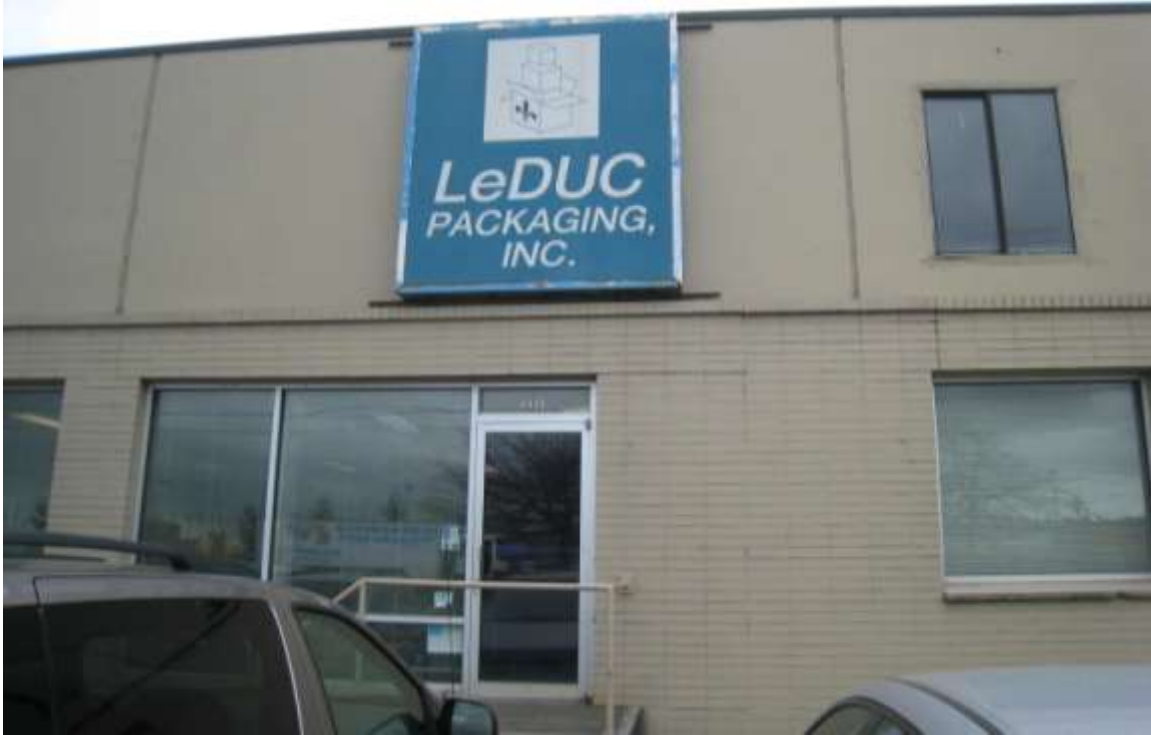
Photo 1: Business at 4424 4th S. , UST removal area below (not visible) - from the west

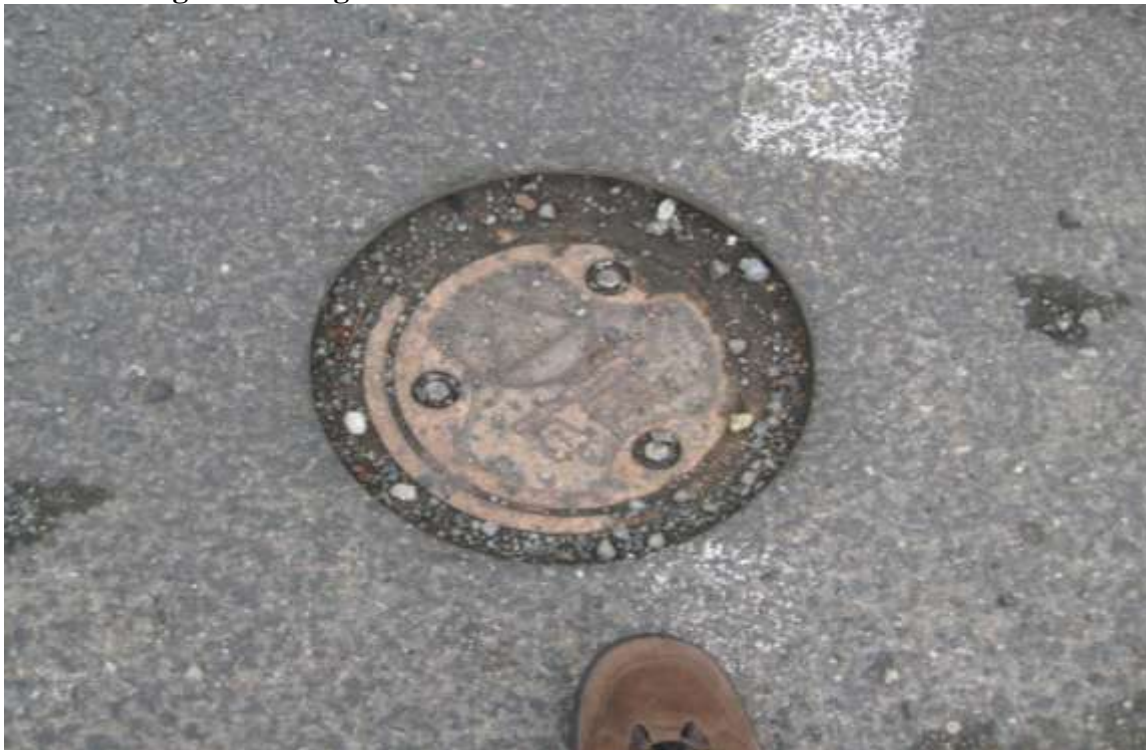
Photo 2: Existing monitoring well in front of 4424 4th S.

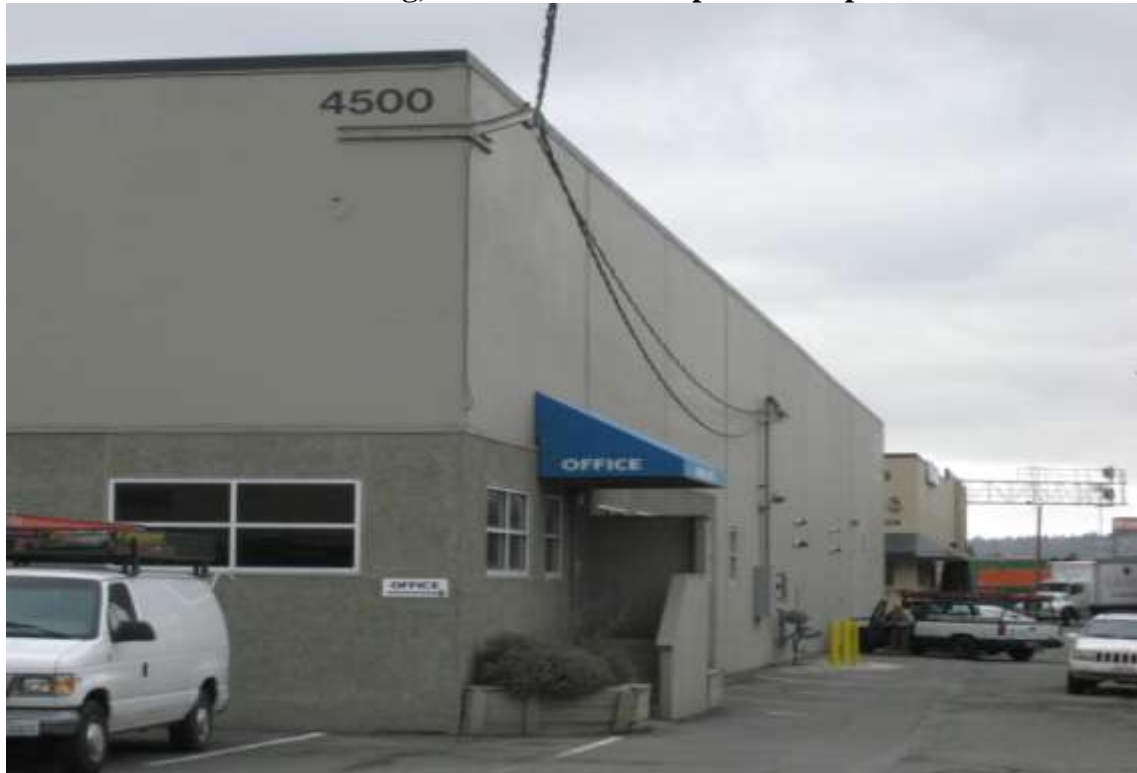
Photo 3: Pederson owned building, UST removal area past the steps - from the north

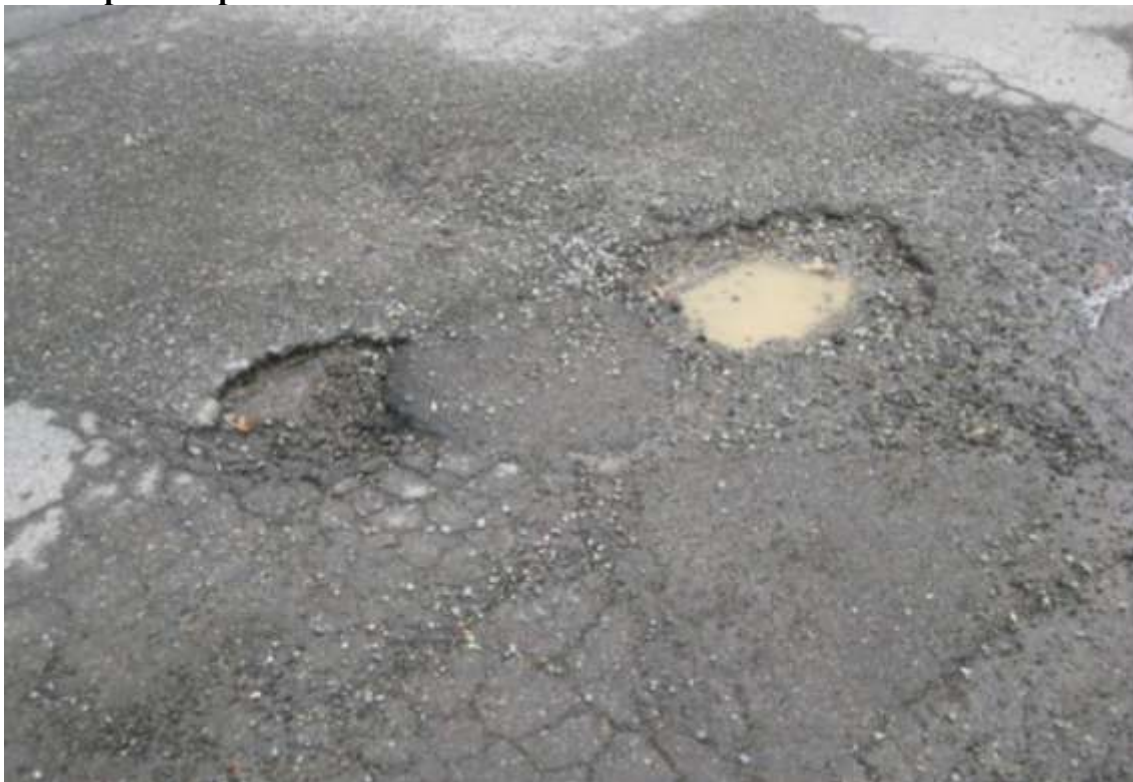
Based upon the Site visit conducted on March 17, 2010, the asphalt cover and 4424 4th S. building at the Site continues to eliminate exposure to contaminated soils by ingestion and contact. The asphalt appears to be deteriorating; however, repair or other contingency actions may not be possible immediately, as the asphalt allegedly is in a city right-of-way. The Site is still operating as commercial/industrial warehousing. A photo log is available as Appendix 6.5.

Photo 4: Asphalt in poor condition in front of 4500 4th S.

Repaving the asphalt cover is recommended for continued protection of human health, and also the environment.
