PHASE I ENVIRONMENTAL SITE
ASSESSMENT

**Phase I Environmental Site Assessment
Former Gas Station
2800 Martin Luther King Way South
Seattle, WA 98144**

**G-Logics Project 01-0356-A
Copyright 2005 G-Logics, Inc.
All Rights Reserved**

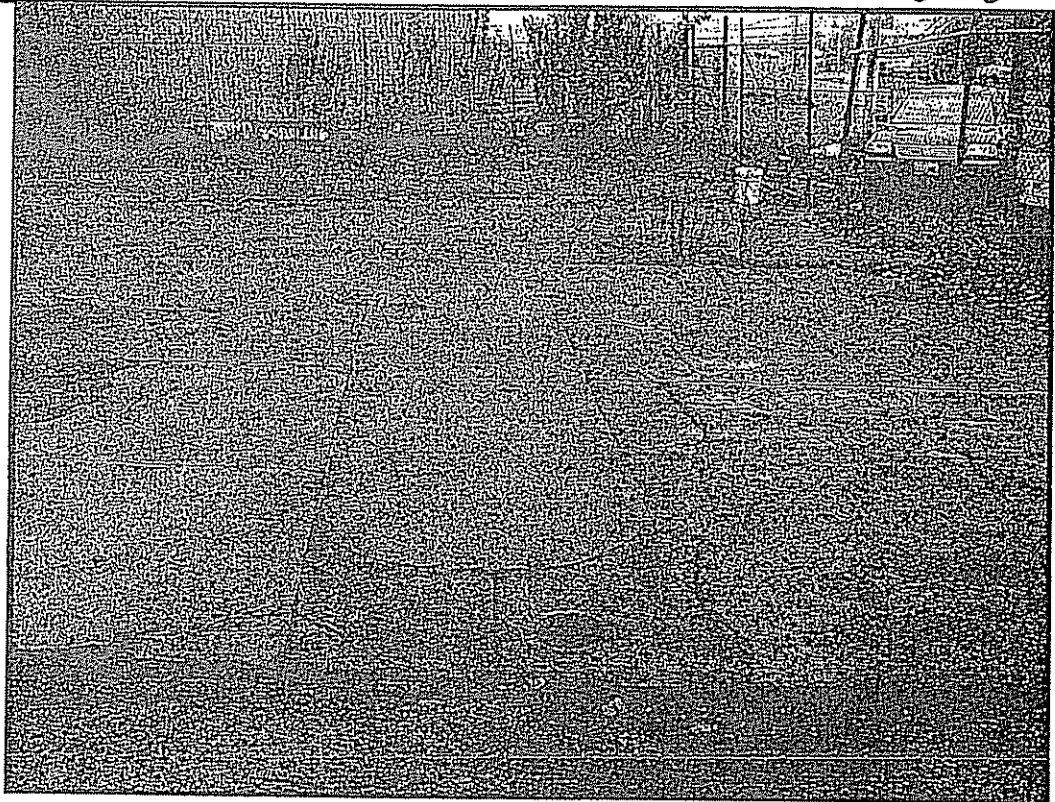
7

Description: The former east pump island location, looking south.

Comments: Pavement on site is aged and cracked. Some staining is present.

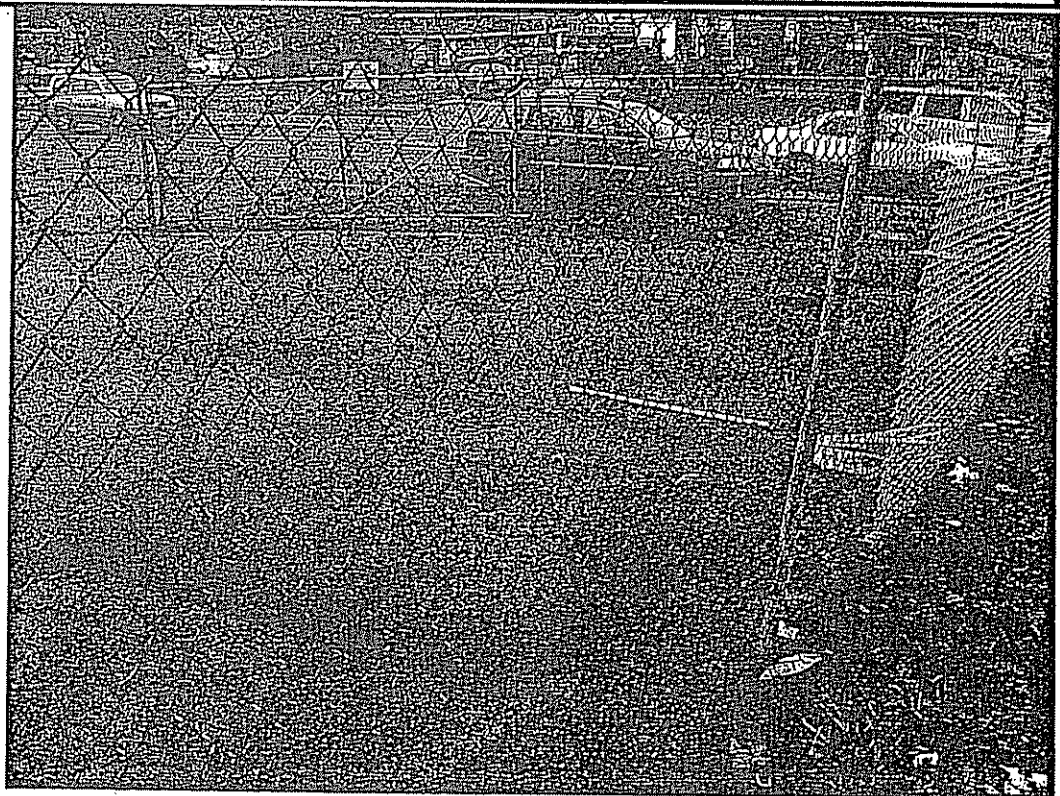
8

Former Gasoline and Oil UST Excavation. Two gasoline USTs (4,000 and 5,000 gallon tanks), and one waste oil UST (approximately 300-gallon tank) were removed from the northwest corner of the property in 1989. One soil sample collected during the removal contained 90 mg/kg gasoline-range Total Petroleum Hydrocarbons (TPH). This sample was identified as "4000 Gal Top". Ecology's Model Toxics Control Act (MTCA) cleanup level for gasoline is 100 mg/kg. Seven other soil samples collected did not contain detectable concentrations of TPH. However, a UST closure report was not prepared (or was not available for review or on file at Department of Ecology). Based on the discovered lab results, it appears that some gasoline had been released. It was not determined if the excavation soils were used as backfill or were disposed off-site. Therefore, some TPH contamination may be present in this area.

Description: Northwest corner of the subject property

Comments: Newer asphalt paving indicates the former location of the USTs removed in 1989.

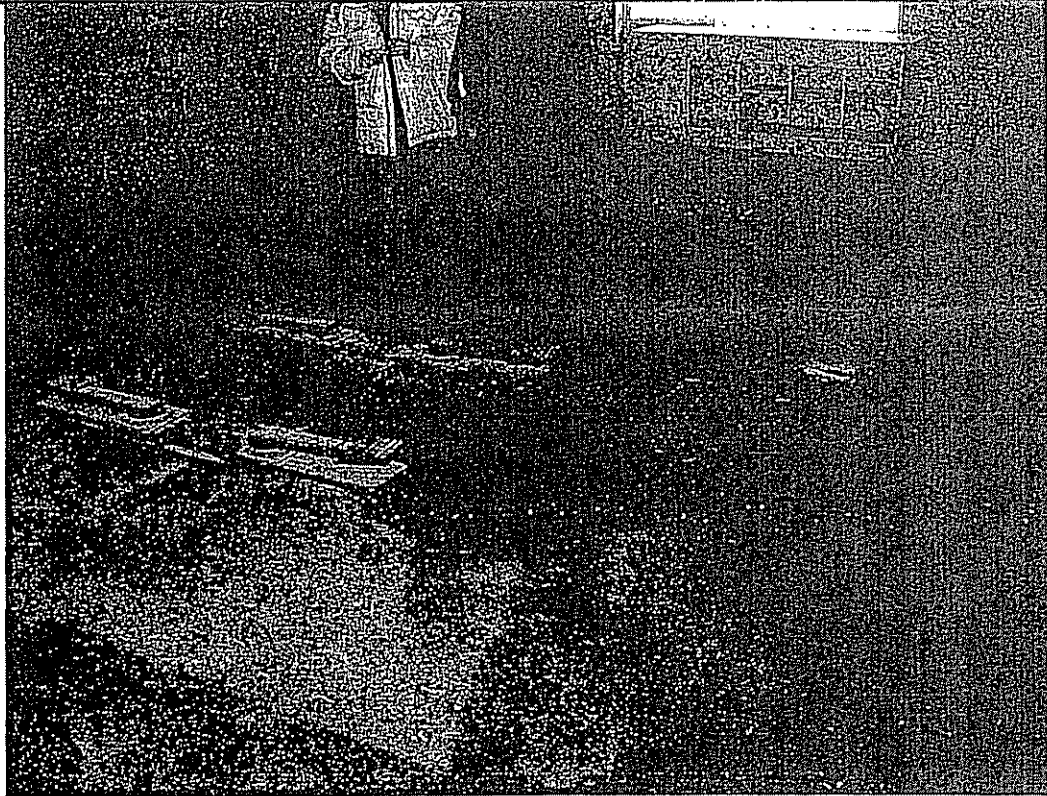
5

Underground Hydraulic Hoists. Two hydraulic vehicle hoists are present in the service bay. Tax archive records indicate that the hoists were installed during building construction in 1955. The most recent tenant of the building indicated to G-Logics that one of the hoists required periodic addition of hydraulic fluid, indicating a potential leak.

Two underground hydraulic vehicle hoists are present in the repair garage (Photo 5). According to former tenant Mr. David Nguyen, the hoists are operational but one of them requires addition of hydraulic oil. The hoists are served by an air compressor located in the mechanical room.

Description: Subject property repair garage.

Comments: Two operational hydraulic vehicle hoists are present

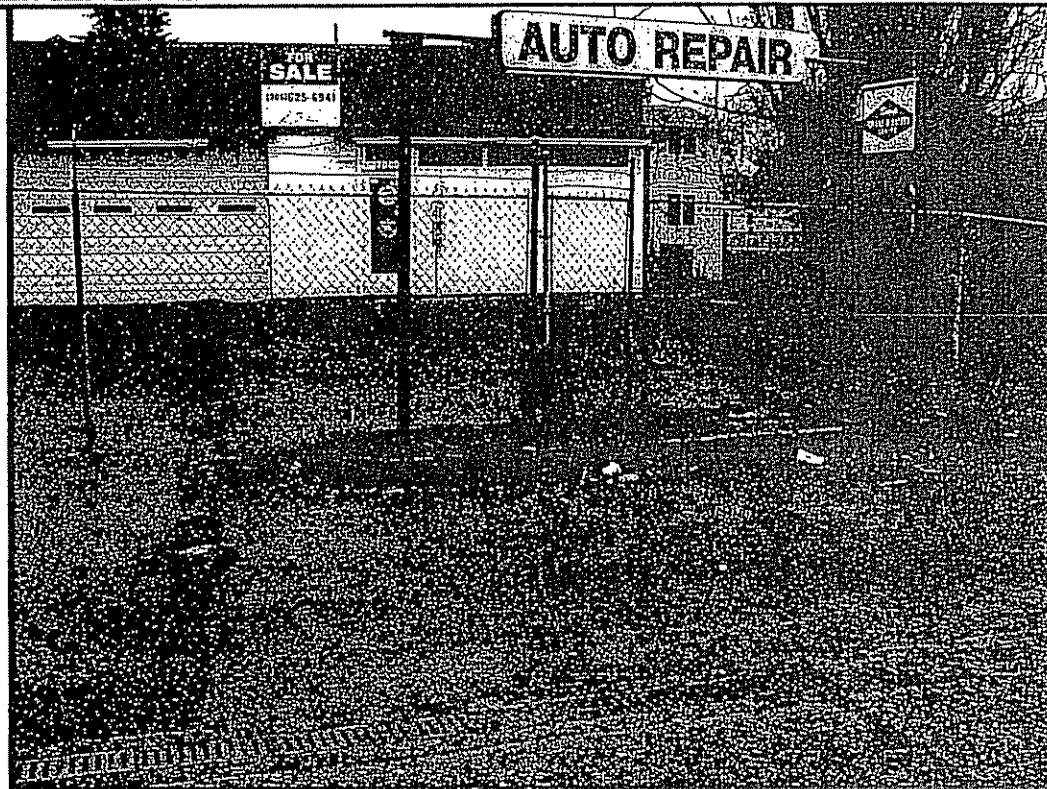
6

Product Piping and Dispenser Island. A fuel pump island is present on the west side of the property. A second pump island just to the east has been removed, though the location has been patched and is still visible. Fuel product lines are still present beneath the west pump island. The east pump island location may also be underlain by abandoned piping. The area surrounding the pump island does not appear to have been excavated during the 1989 UST removal. Fuel dispensers and related product lines can be the source of petroleum leaks at gasoline station sites.

Description: Pump island located on the western side of the property.

Comments: Product piping remains and is visible at the two former dispenser locations (arrows)

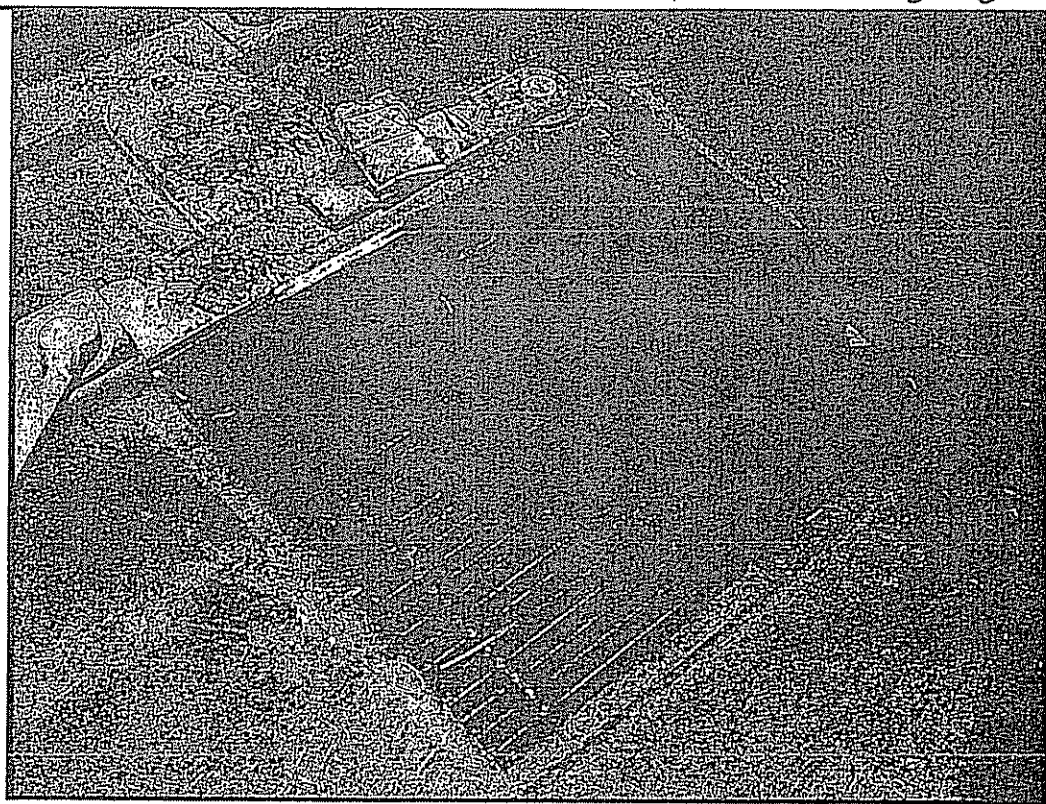
3

Garage Floor Drain Sump and Oil/water Separator. The sump and oil/water separator contain an emulsion or mixture of oil and water. The recent tenant stated that the sump and oil/water separator were not cleaned during the three years he operated at the site.

Description: Floor drain sump located adjacent to north vehicle hoist.

Comments: The sump contained a mixture of oil and water. The sump is connected to the oil/water separator.

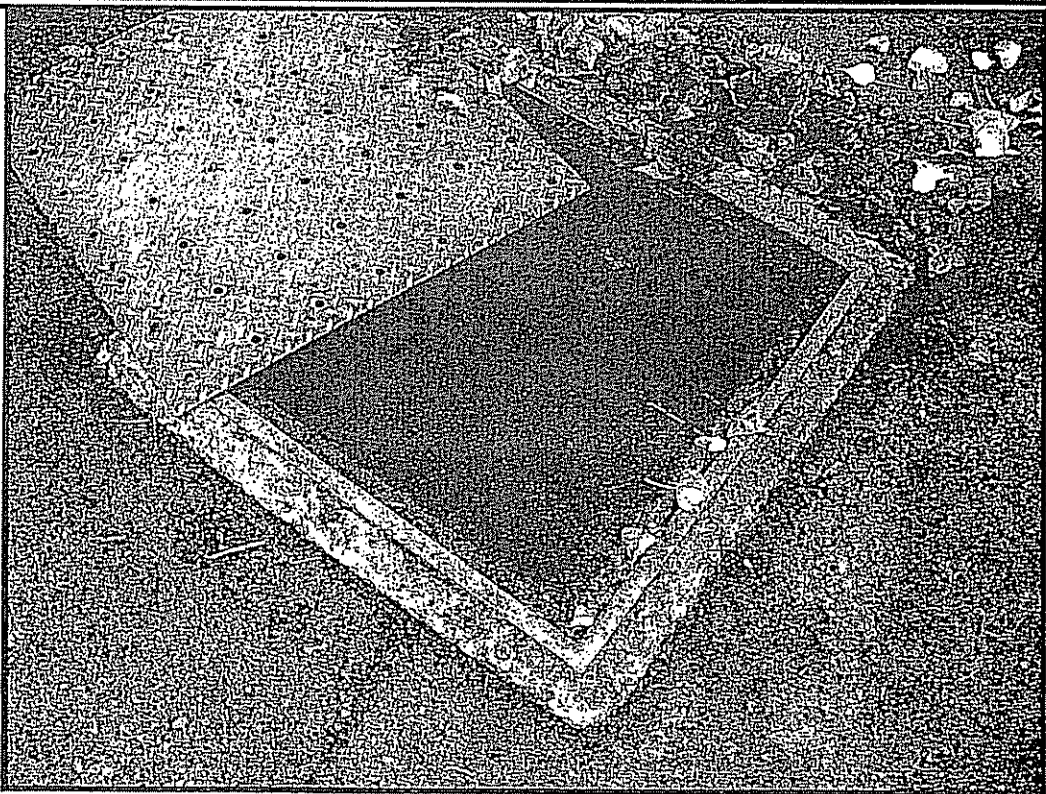
4

Description: Oil/Water Separator located at the northwest exterior corner of the building.

Comments: The separator contained a mixture of oil and water.

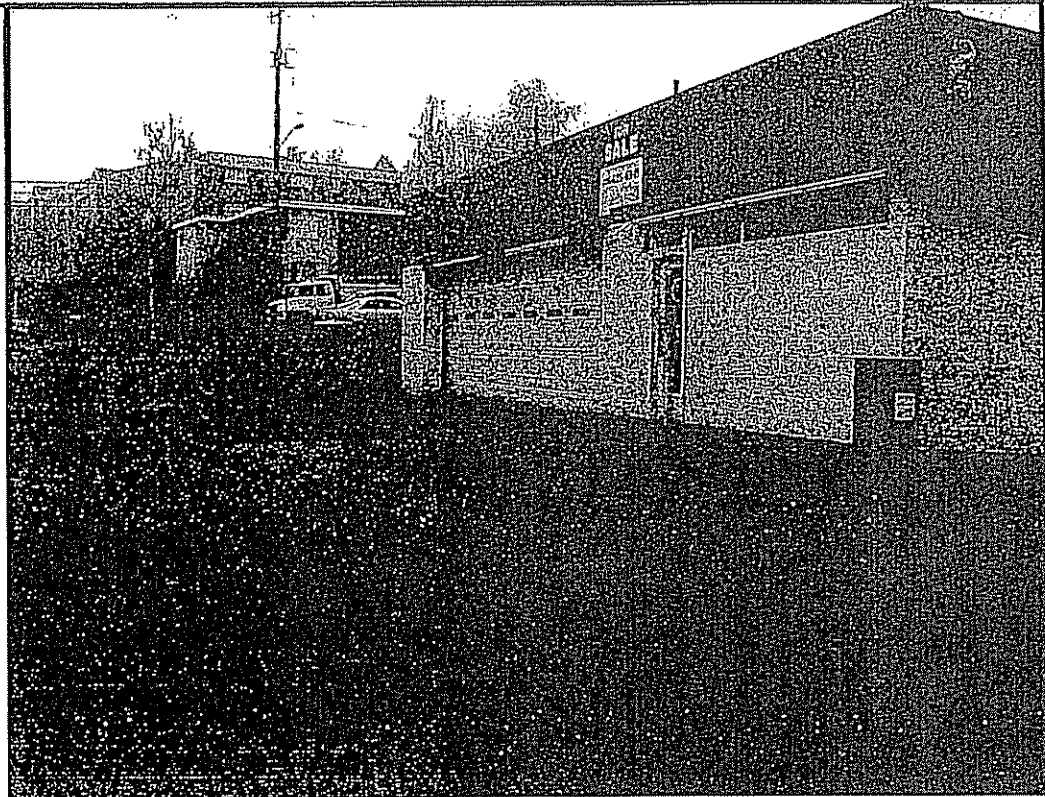
1

The property contains a vacant auto repair building (Photo 1). The building contains a repair garage, an office, two restrooms, and a mechanical room containing an oil furnace and an

Description: Subject property looking northeast.

Comments: The property contains a vacant auto repair shop, formerly a gasoline station. Drum labeled used oil filters is present.

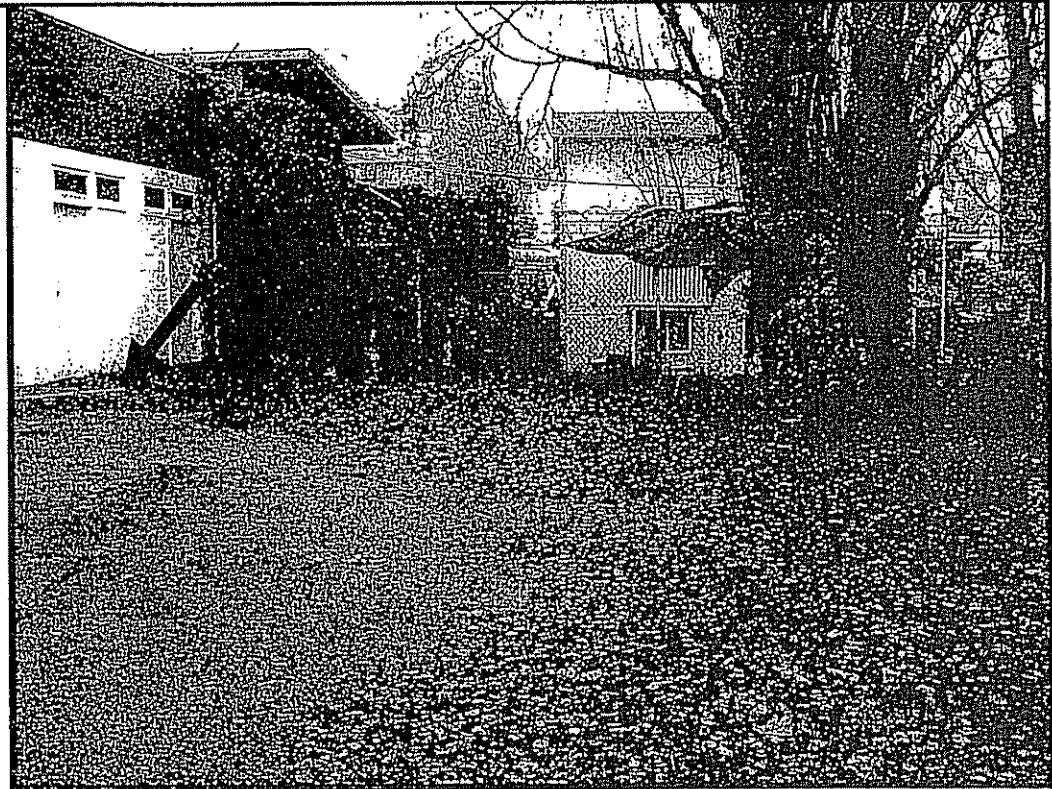
2

Underground Heating Oil Tank. A heating oil UST is present on the south side of the garage building. The exact location was not determined. A fill port is located on the walkway outside of the restrooms. The age of the tank was not determined, however it was likely installed during building construction in 1955.

According to Mr. Cannon, a 500-gallon heating oil UST is located on the south side of the building (Photo 2). A fill port was observed on the curb-edge near the restrooms. Two vent pipes are located at the southeast corner of the building. The tank is operational, and serves an oil furnace located inside the building (Figure 2).

Description: South end of the subject property looking east.

Comments: A heating oil UST is located in this area. A fill port is located on the walkway curb (arrow).
