LANDSBURG MINE COAL MINE HAZARD ASSESSMENT

**Landsburg Mine Site PLP Group
31407 Highway 169
P.O. Box 10
Black Diamond, WA 98010**

**SubTerra, Inc.
PO Box 520
218 East North Bend Way
North Bend, WA 98045**

**Project No. 2001-45
May 2005**

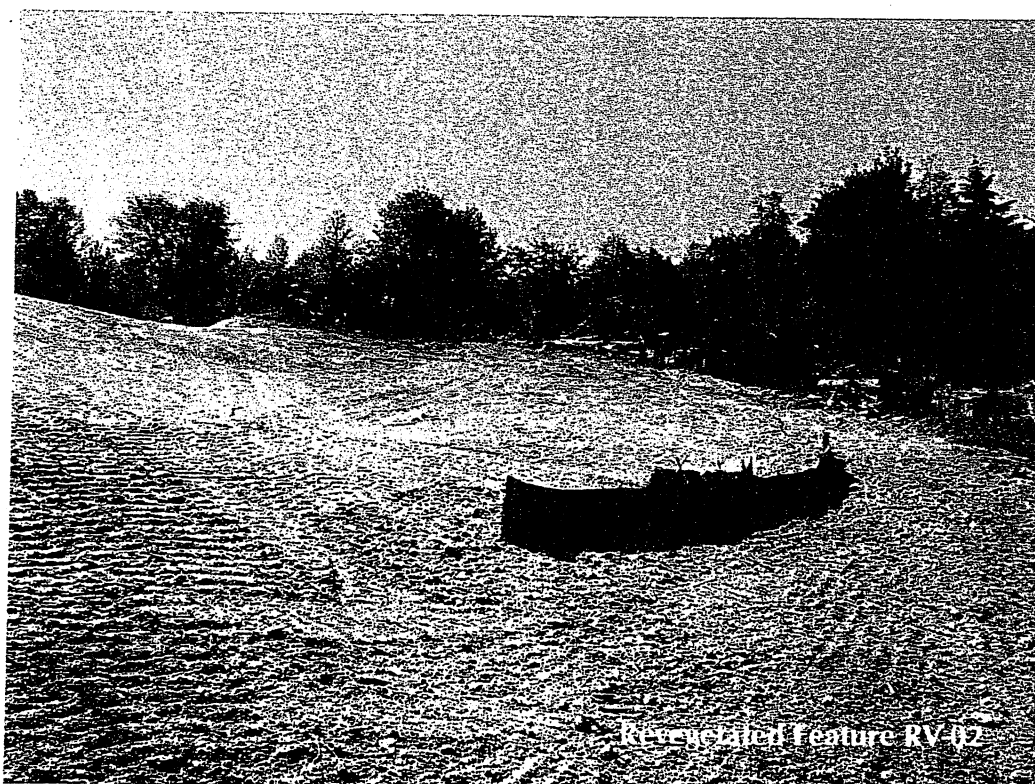
Photograph 8 Feature RV-02 final grade and associated revegetation. Looking southwest.
(WA-009_RV-02_082903a_RevegetatedFeature.jpg)

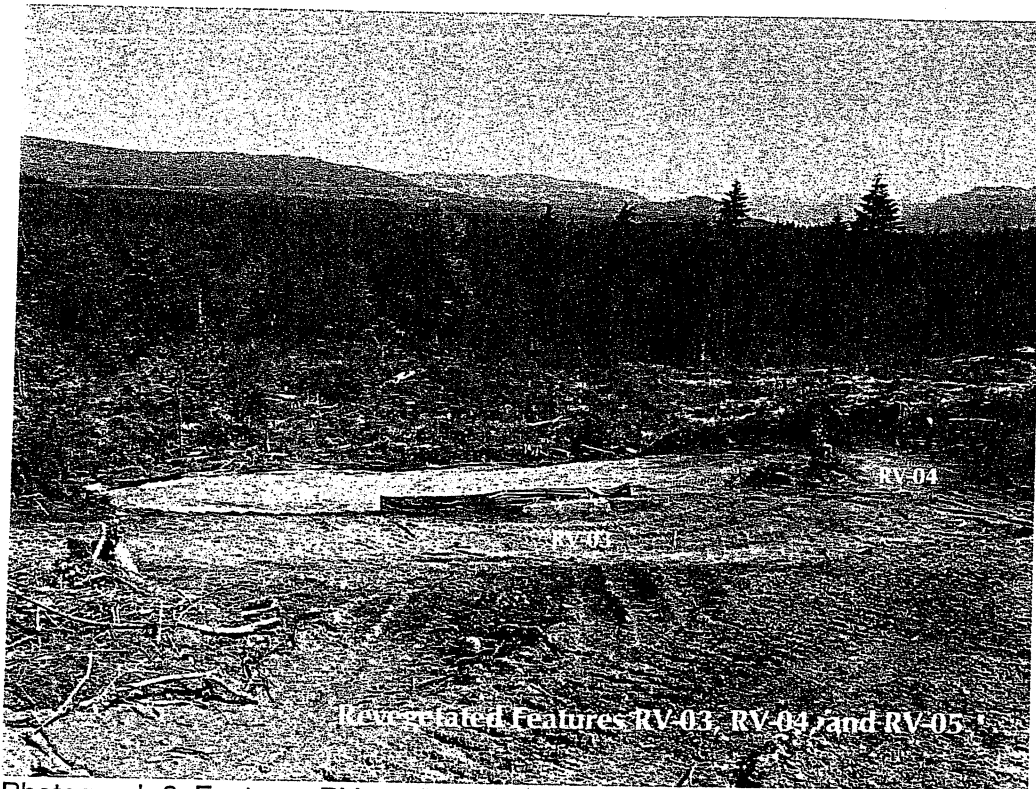
Photograph 9 Features RV-03, RV-04, and RV-05 final grade and associated revegetation. Looking northeast.
(WA-009_RV-03_082903a_RevegetatedFeature.jpg)
