Inspection Summary for the Treoil Industries, Ltd. Site, Ferndale, WA.

Inspectors: Norm Peck (Ecology), Melinda Miller (Whatcom Co. H.D.)

Inspection Date: 7 March, 2000

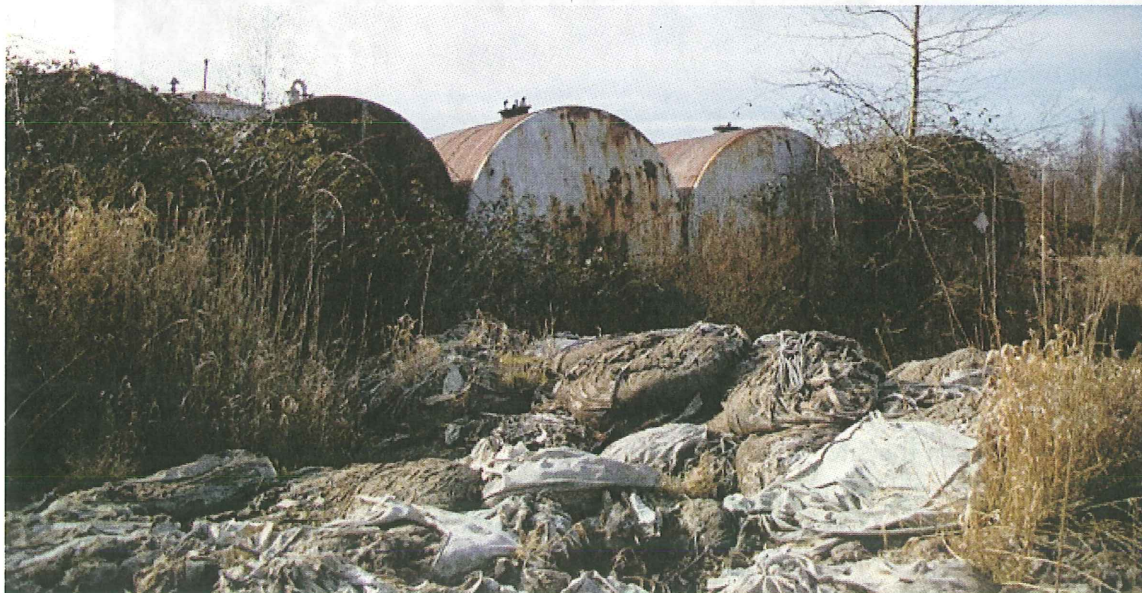
Treoil shows a large pile of what appears to be rosin in deteriorating fabric shipping totes immediately to the north of a row of large horizontal above-ground tanks north of and outside of the fenced area of the site. View is to the southwest. Photos by N. Peck

Treoil2 is a close-up of this pile. Sample Treoil 01 is of this waste. Another large tank (~20,000 gal.) just north of the rosin pile also appears to contain the same material. There are two large panels cut out the this tank making the contents visible. About 40' east of these rosin piles, near the railroad tracks and an abandoned car, are about 17 full 55 gal., bung-type drums and three empty 17-H-type open-top drums. There are also 3-4 empty 17-H drums between the rosin pile and the tank full of rosin totes. This area is accessible from the fenced area of the site through an area near the northeast corner of the site fence that has been removed. There is a track leading to this area from within the fenced area that has obviously been used for vehicle traffic. The area can also be accessed from the railroad tracks by the public.

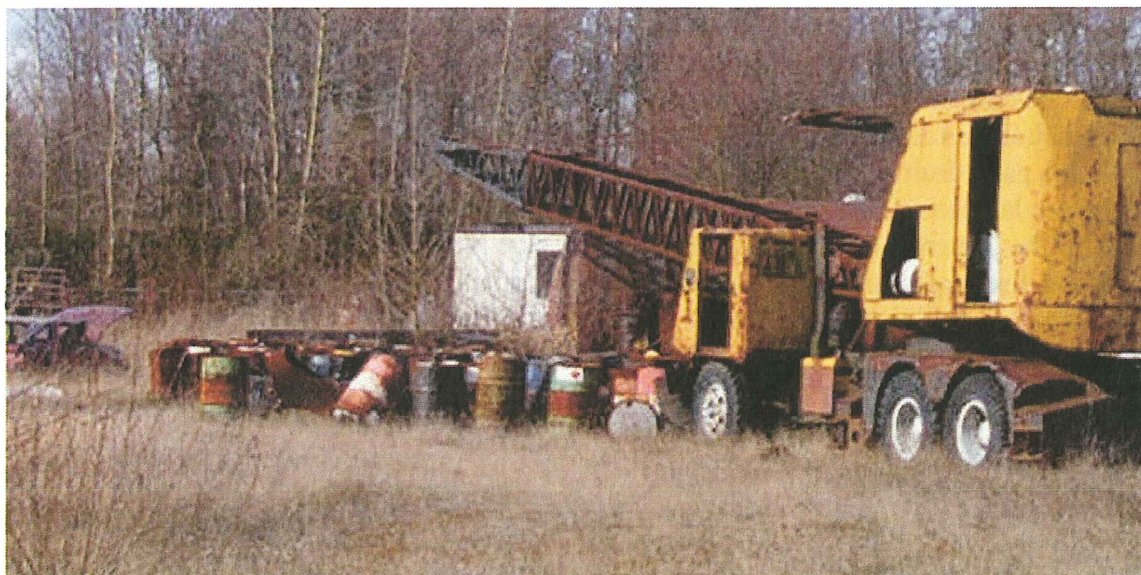
Near the center of the fence at the north side of the fenced area is a horizontal aboveground tank surrounded by about 200 drums. This area is about 125' west of the back fence opening at the northeast corner of the fence. See photo Treoil6 and Treoil6a. Several drums in this area have leaked, and much of the area is overlain with a layer of what appears to be hardened spilled material. Near the middle of the drums on the east side of this tank/drum area (Treio17) is an area of spilled material that is not hardened. It is a thick, viscous, dark brown to amber liquid or semi-solid. This material was samples as Treoil 02. See also Treoil7-9 at the end of this report.

Treoil6a *Some of the 200 drums at this location are visible to the right of the truck-mounted crane. The south end of the lab trailer is visible behind the drums and approximately 20,000 gal. tank the drums surround. The area of extensive spillage and location of Sample Treoil02 is just in front of the crane. View is to the west from near the north opening in the chain link fence.*

- 2.) Sample and characterize contents of full drums at the site. Note that this is an "unknowns" characterization requiring Level B protective gear. At a minimum, overpack compromised or leaking drums and consolidate drum storage, preferably inside a structure.
- 3.) Sample and characterize spilled wastes/materials at the site.
- 4.) Sample and characterize nature and extent of groundwater contamination and/or surface water contamination associated with the site.
- 5.) Possible containment of spilled wastes at the site.

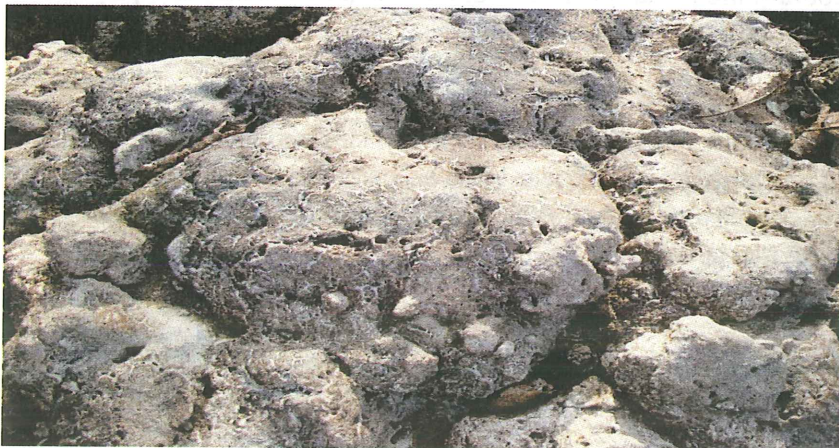
Treoil2: Close-up of rosin pile in Treoil1

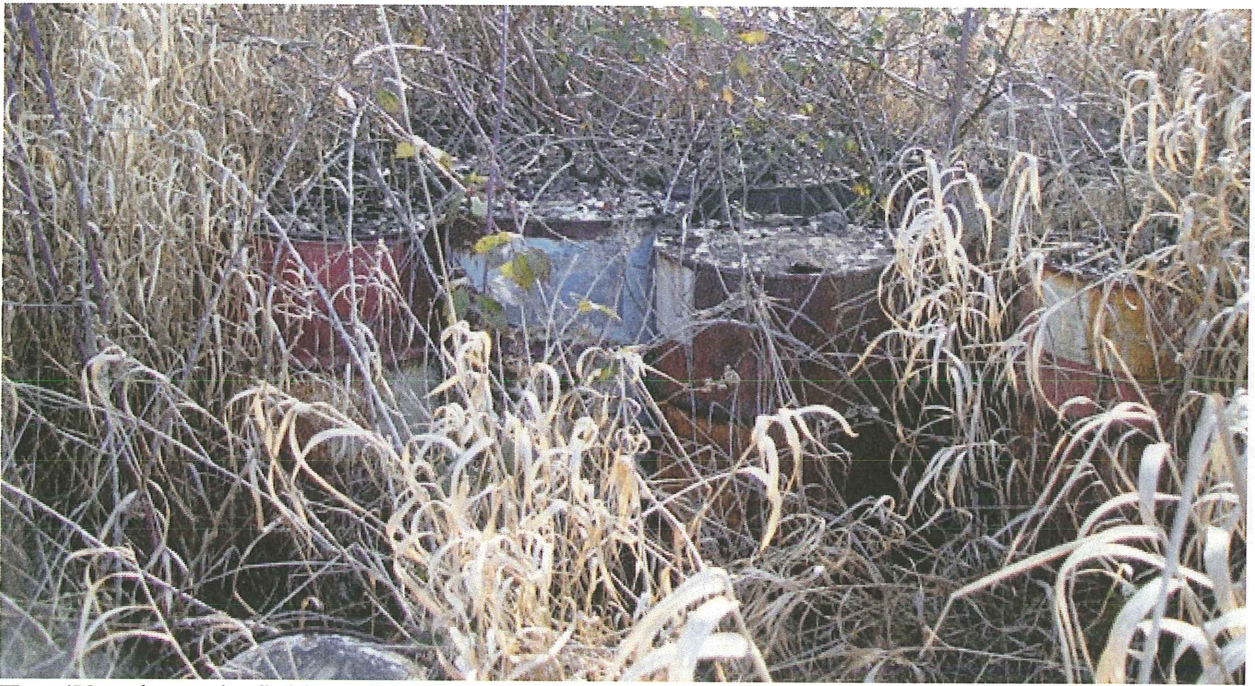
Treoil3a: drums in field north of fenced area near railroad tracks. Contents unknown. This photo is a cropped version of Treoil3. View is to the southeast.

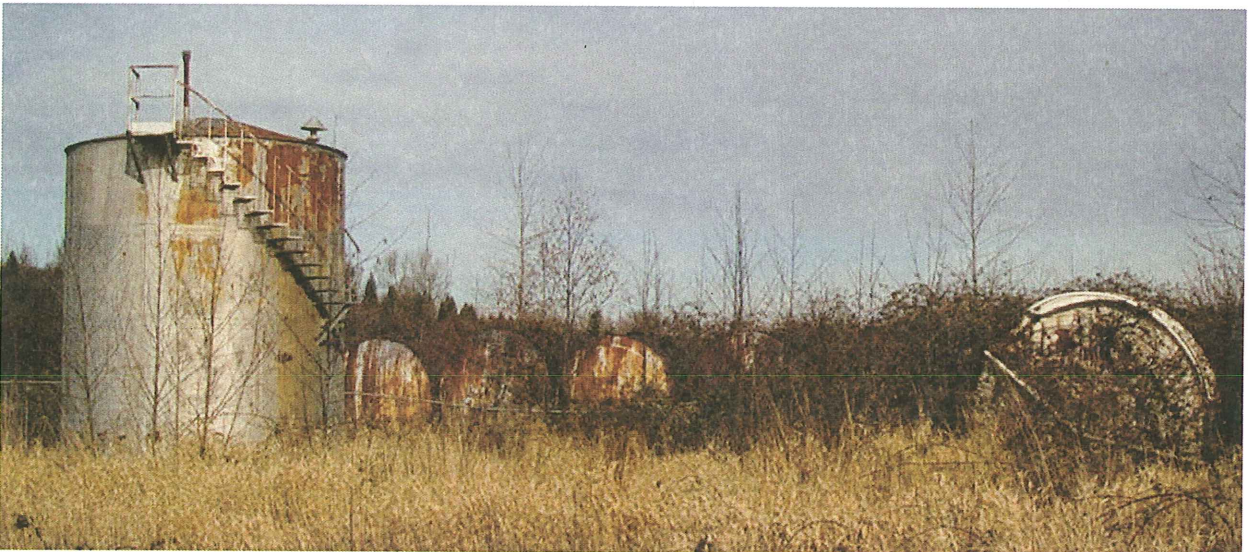
Treoil4a: Abandoned ASTs at the site. Tanks in the background are also visible in Treoil1. The rosin pile in Treoil1 is just north of the background tanks. This photo is a cropped version of Treoil4. View is to the north. The north side of the site chain link fence is visible between the tanks in the foreground and the background tanks.

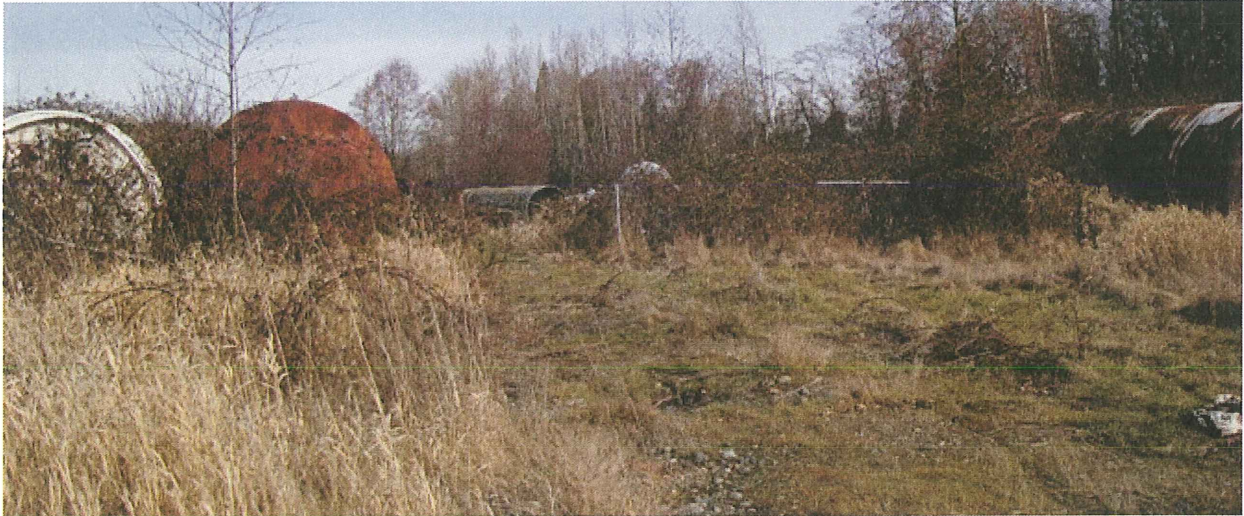
Treoil5a: Photo of opening at northeast corner of fenced area showing opening in the chain link fence that allows access to the site even when the entry gate is locked. Additional abandoned ASTs are shown in this photo. The drums outside the fenced area shown in Treoil3a are near the large section of fiberglass pipe in the upper center of this photo. View is to the north.

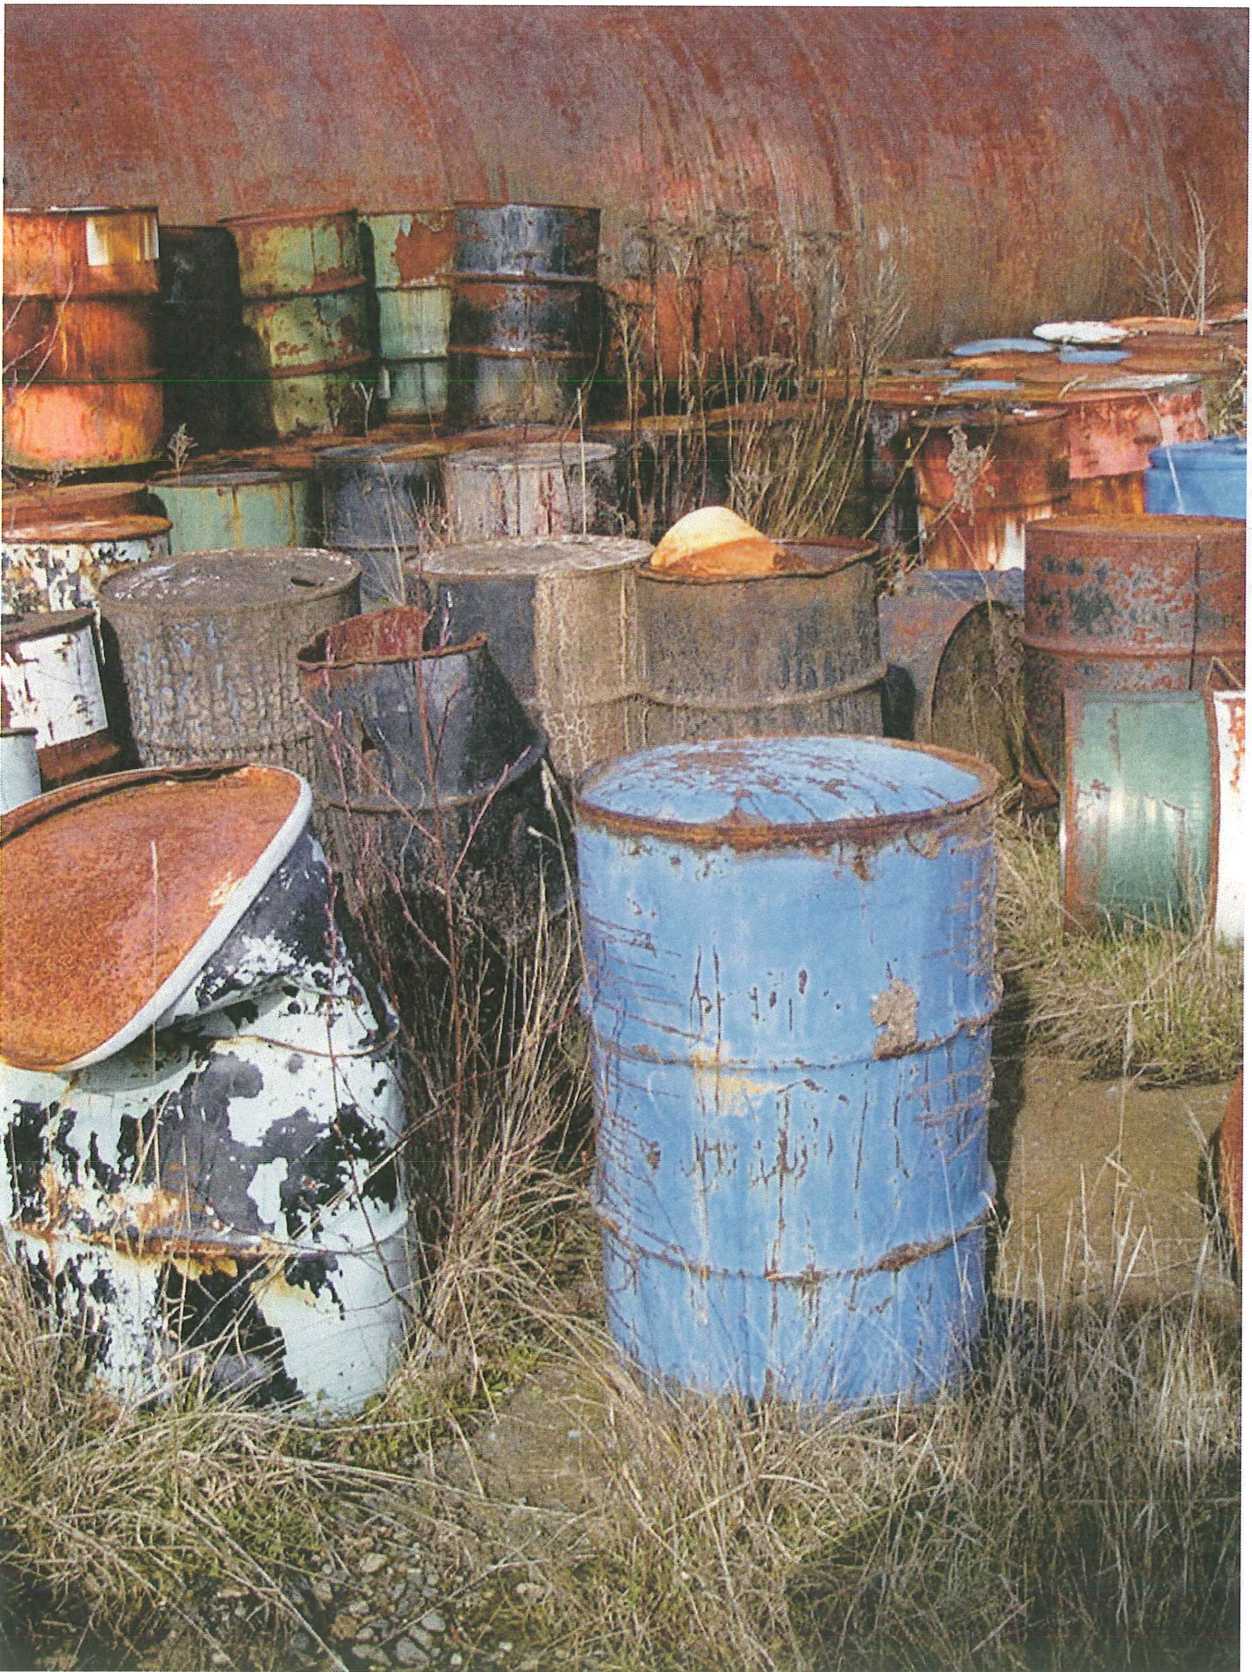
Treoil7: Detail of drums shown in Treoil6a, and spillage to the ground from drum leakage. Note bulging and leaking drums. View is towards the northwest.

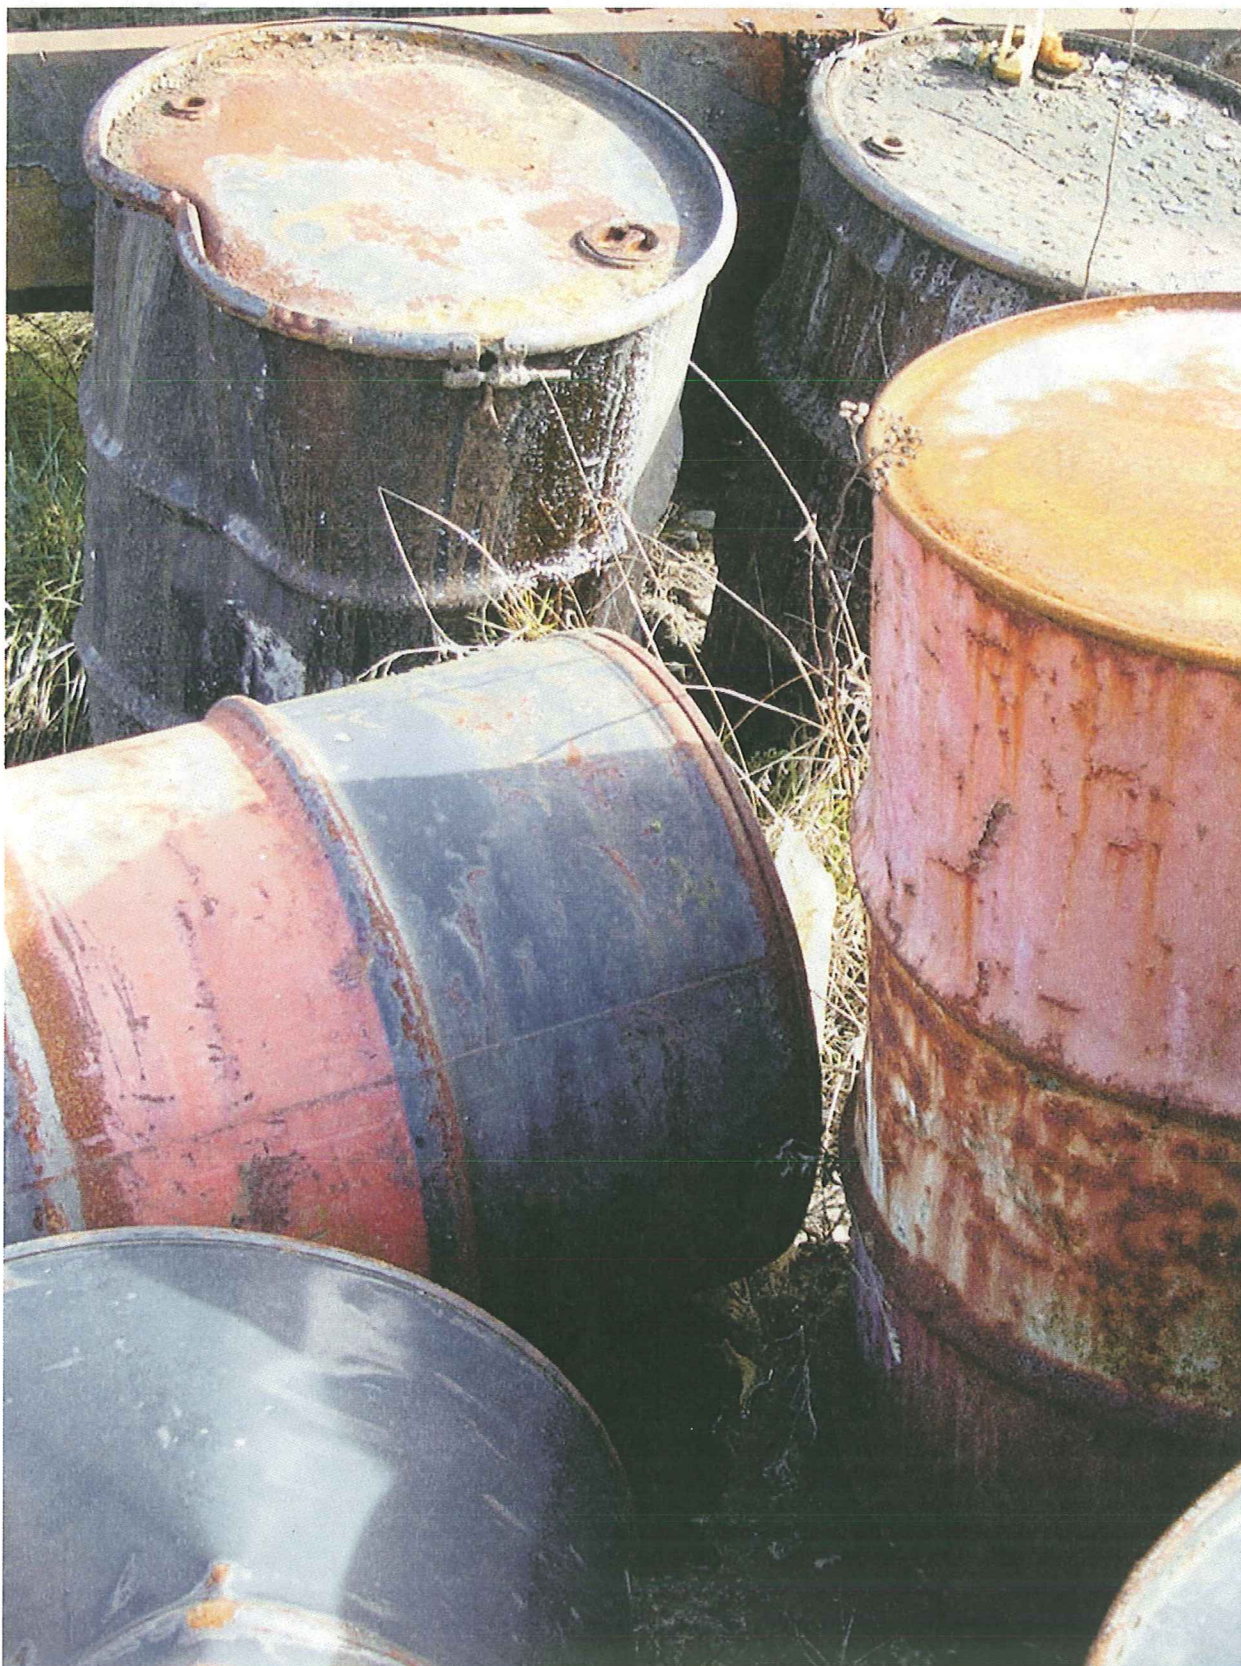
Treoil8: More bulging and leaking drums in the “200 Drum Area” shown in Treoil6a and 7. View is to the northeast.

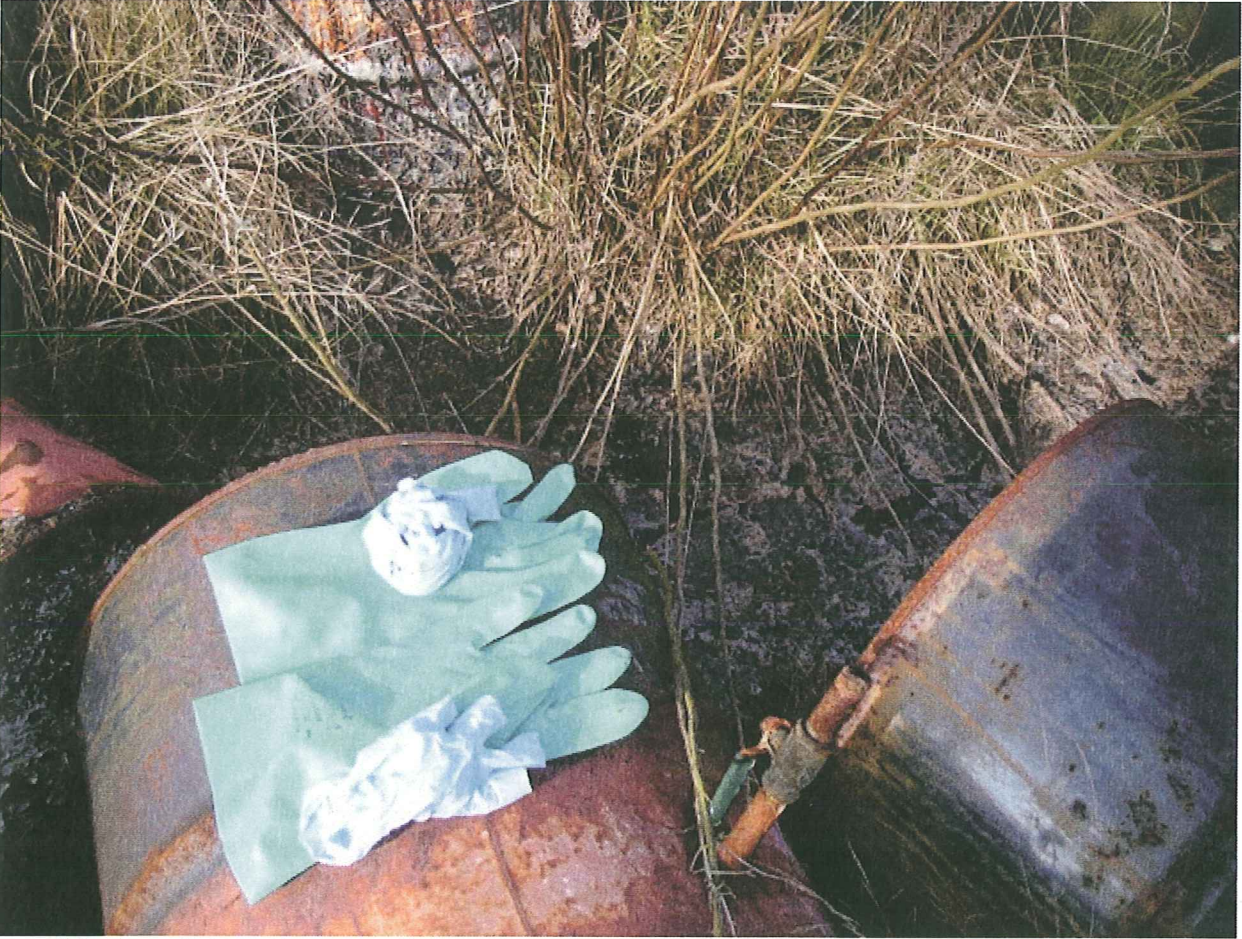
Treoil9: Sample Treoil2 was collected from the dark brown/amber viscous liquid/semisolid in the “V” between the two drums in this photo. This location is within the 200 Drum Area. View is to the northwest.
