PERIODIC REVIEW

**Sparks and Buttercup Subdivision
Facility Site ID#: 695**

**12th Avenue and Eastern Street
Spokane Valley, Washington 99212**

TOXICS CLEANUP PROGRAM

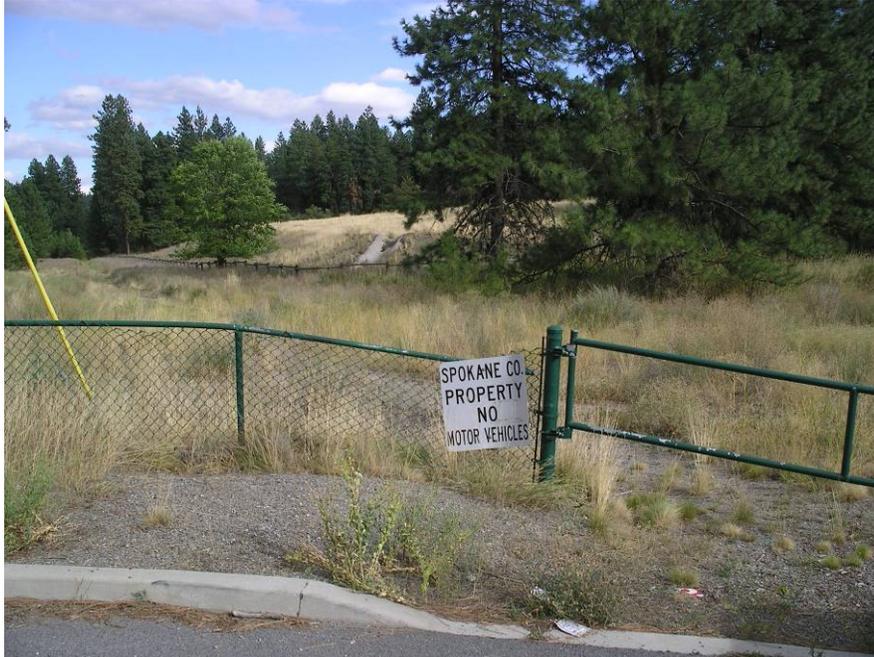
Photo 1: Entrance to Property – from the southeast

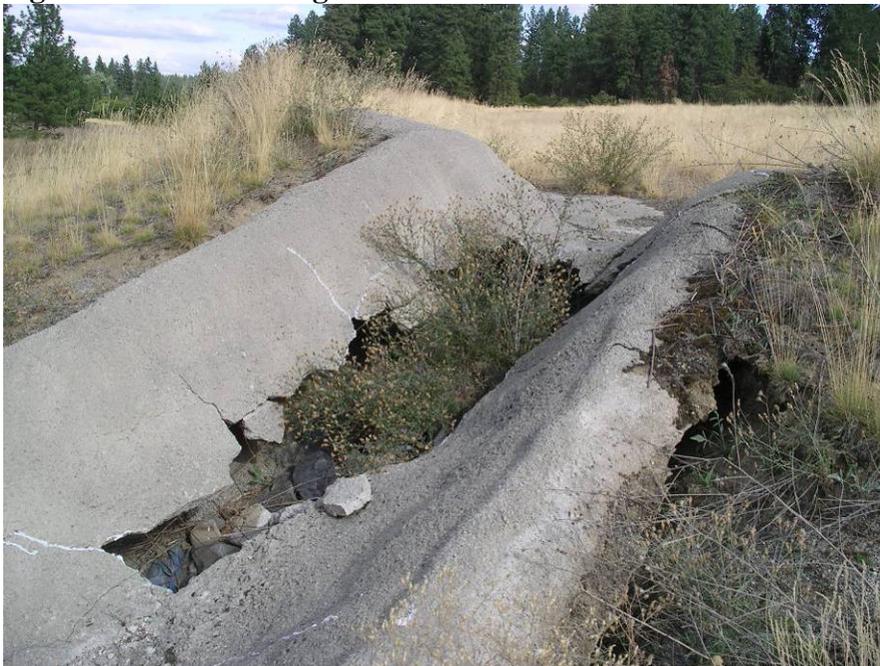
Based upon the site visit conducted on August 29, 2008, the soil cap at the Site continues to eliminate exposure pathways (ingestion, contact) to contaminated soils. The majority of the cap appears in satisfactory condition, though the concrete drainage channel at the southeast corner of the landfill appeared to be damaged and undermined. This area will likely continue to erode during significant precipitation and snowmelt events. The Site continues to remain undeveloped. A photo log is available as Appendix 6.4.

Soils with TPH and metals concentrations higher than MTCA Method A cleanup levels are still present at the Site. However, the clean soil cap prevents human exposure to this contamination by ingestion and direct contact with soils. The Restrictive Covenant for the property ensures the integrity of the cap will be protected by maintaining the current use of the Site. Section 5 of the Restrictive Covenant is not being followed. Written notifications of cap inspections have not been submitted to Ecology, and erosion is taking place under the concrete drainage channel at the southeast corner of the landfill.

Photo 2: Damaged Concrete Drainage Structure – from the southeast

Based on this periodic review, the Department of Ecology has determined that the requirements of the Restrictive Covenant are not being satisfactorily met. The property owner is required to inspect and maintain the soil cap and submit annual written notification to Ecology of these activities. The property owner will be notified that in order for the No Further Action determination to remain in effect, the cap must be repaired and inspected annually and the inspection reports must be submitted to Ecology.

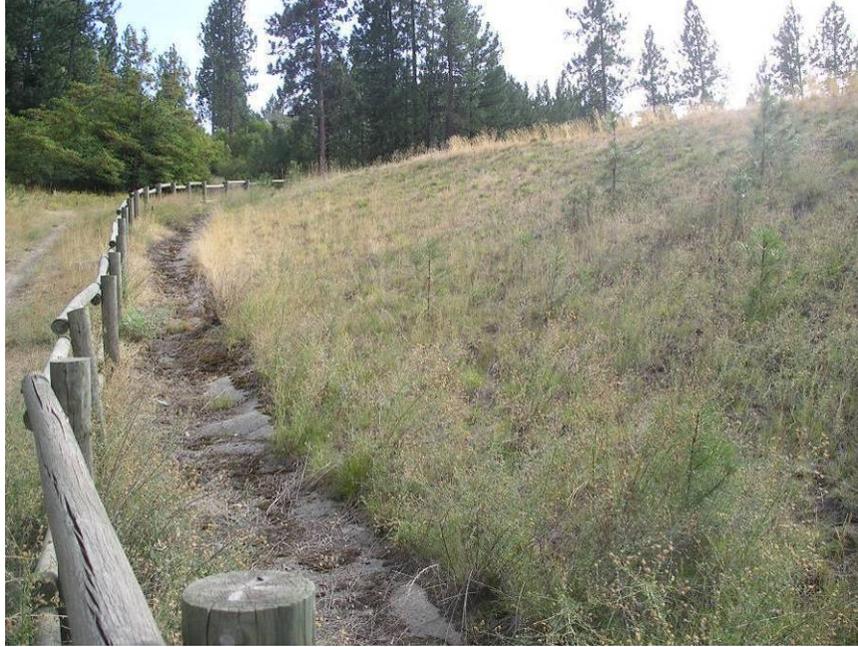
Photo 3: West Side of Landfill - from the south

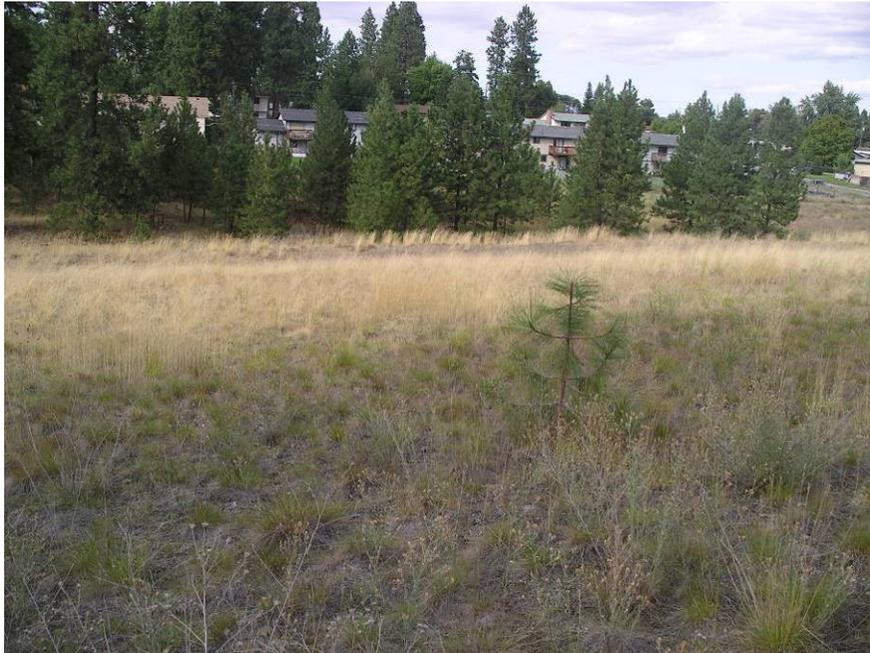
Photo 4: Landfill Surface – from the north
