STATE OF WASHINGTON  
DEPARTMENT OF ECOLOGY

**Re: Opinion under WAC 173-340-515(5) on Remedial Action(s) for the following Hazardous Waste Site:**

- Name: Brinnon General Store
- Address: 306413 U.S. Highway 101, Brinnon, WA
- Facility/Site No.: 96498799
- VCP No.: SW0759

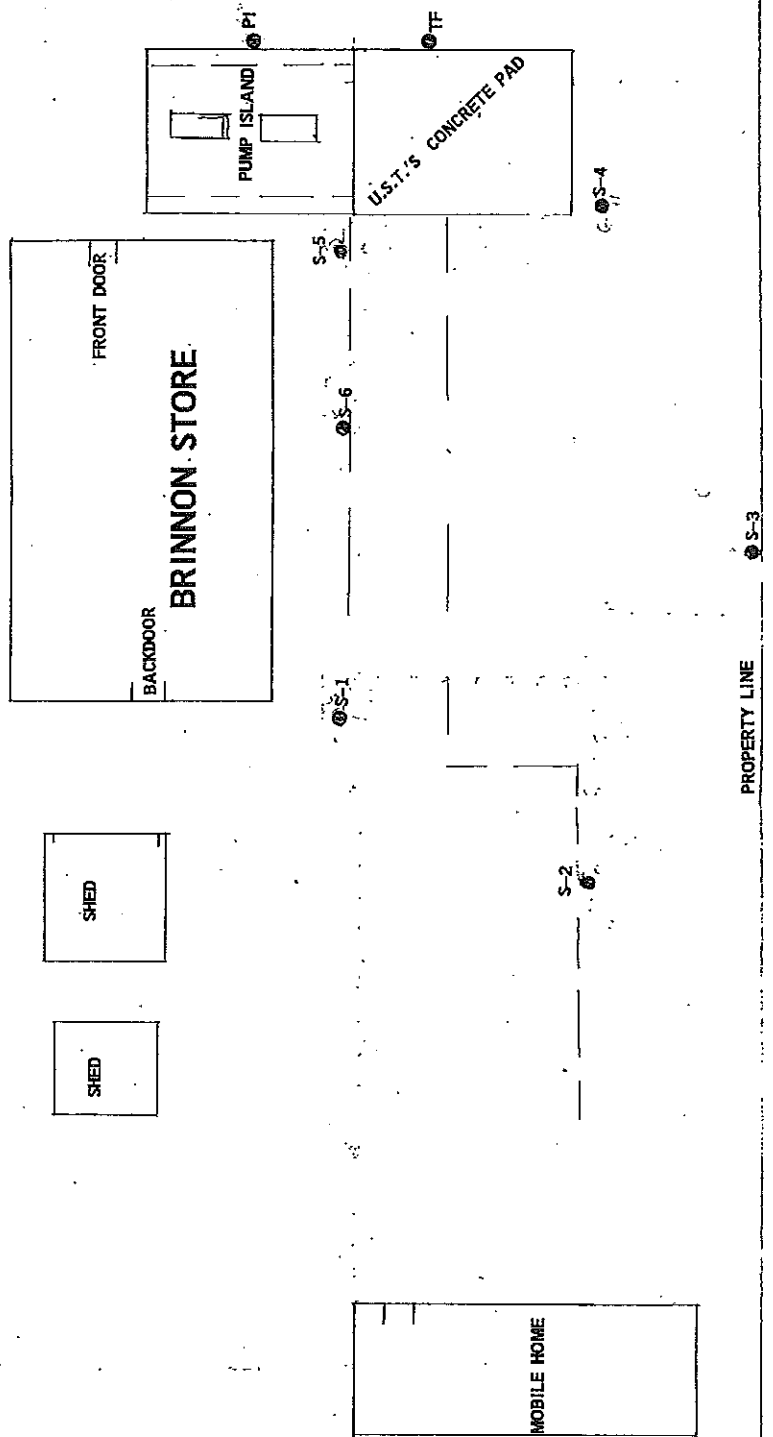
Figure 1  
Soil Sample Location  
Sketch

These concentrations were confirmed in 2002 by Stemen Environmental, Inc. Soil samples collected in the area of the former excavation (S-5 and S-6) and from the area to the east of the former excavation (S-1 and S-2) from about 7 to 12 feet below ground surface (bgs) contained concentrations of gasoline-range petroleum hydrocarbons (TPH-G), benzene, ethylbenzene, and xylenes above MTCA Method A cleanup levels. In the area of the former excavation, S-5 contained TPH-G (170 mg/kg) and benzene (1.6 mg/kg), and S-6 contained TPH-G (32 mg/kg) and xylenes (38 mg/kg). To the east, S-1 contained TPH-G (200 mg/kg) and benzene (1.7 mg/kg), and S-2 contained TPH-G (530 mg/kg), benzene (3 mg/kg), and ethylbenzene (6.3 mg/kg). Please refer to the attached figure for the estimated locations of these samples.

- Grab groundwater samples collected by Stemen Environmental, Inc. in 2002 identified concentrations of TPH-G [1,700 micrograms per liter ( $\mu\text{g/L}$ )] and benzene (22  $\mu\text{g/L}$ ) in S-1 and TPH-G (12,000  $\mu\text{g/L}$ ) and benzene (66  $\mu\text{g/L}$ ) in S-2. The MTCA Method A cleanup levels for TPH-G and benzene are 800  $\mu\text{g/L}$  and 5  $\mu\text{g/L}$ , respectively. Please refer to the attached figure for the estimated locations of these samples.

Analytical results of the discrete soil samples indicated the presence of TPH-G, benzene, ethylbenzene, and xylenes at concentrations in excess of their respective Model Toxics Control Act (MTCA) Method A cleanup levels of 30 milligrams per kilogram (mg/kg), 0.03 mg/kg, 6 mg/kg, and 9 mg/kg. Concentrations of TPH-G ranged from 32 mg/kg to 530 mg/kg; benzene ranged from 1.6 mg/kg to 3 mg/kg; and ethylbenzene and xylenes were detected at 6.3 mg/kg and 38 mg/kg, respectively. The highest concentrations were detected at locations S-1 and S-2, which are located downgradient of the former excavation.

Analytical results of the groundwater samples indicated the presence of TPH-G and benzene in excess of their respective MTCA Method A cleanup levels of 800 micrograms per liter ( $\mu\text{g/L}$ ) and 5  $\mu\text{g/L}$ . The exceedances occurred in S-1 [TPH-G (1,700  $\mu\text{g/L}$ ) and benzene (22  $\mu\text{g/L}$ )] and S-2 [TPH-G (12,000  $\mu\text{g/L}$ ) and benzene (66  $\mu\text{g/L}$ )].

No additional soil data has been provided to Ecology from these areas since 2002. A substantive requirement of MTCA is to define the areal and vertical extent of contamination. Additional soil samples will need to be collected from the site define the area of residual soil contamination beneath the site.

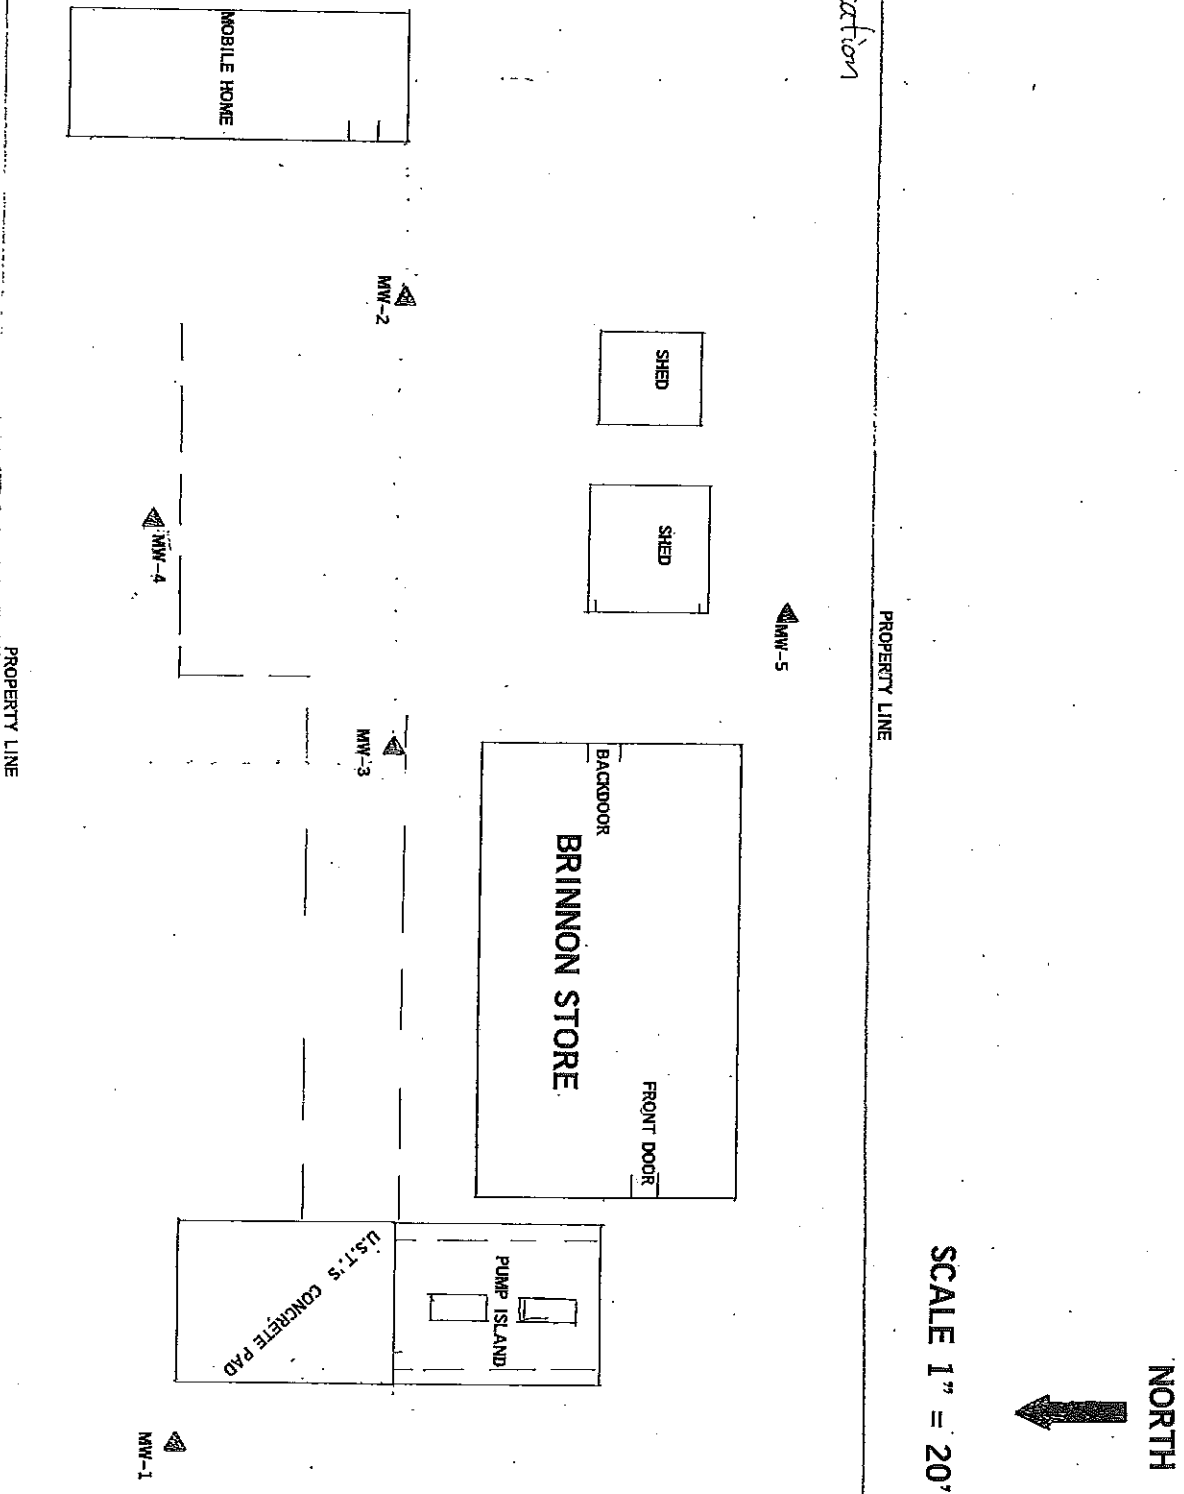
Figure 2  
Monitoring Well Location  
Sketch

However, these groundwater samples were only analyzed for TPH-G and BTEX, and not the full suite of contaminants required under MTCA Table 830-1 (Required Testing for Petroleum Releases). Furthermore, Ecology's May 2006 Opinion Letter noted that four out of five of these wells were screened at least 3 feet below where the water table had been encountered, and that if petroleum contamination existed in groundwater, the highest concentrations would likely exist at the surface of the water table. It could not be discerned from the report which well did bracket the water table. As a result, Ecology requested that additional wells be installed at the site to bracket the water table in an effort to provide more reliable groundwater data. Based on well logs provided to Ecology's Water Resources Program, four new wells were installed in July 2006.

- The May 2007 report indicates that all nine monitoring wells were used at the site to determine the direction of groundwater flow. It should be noted that four of these wells are screened below the water table and if there was any component of vertical flow beneath the site, then the head elevations would not match up and the direction of groundwater flow would be off. Ecology suggests comparing the direction of groundwater flow using the four wells screened below the water table and the five wells bracketing the water table to see if a component of vertical flow exists for the site. Due to the proximity of the site to Hood Canal, some vertical flow may exist. Also, for each monitoring event, please provide Ecology with a potentiometric surface map of the site showing the measured groundwater elevations, equipotential lines, and the resulting direction of groundwater flow.

In June 2002, five permanent monitoring wells (MW-1 through MW-5) were installed throughout the site. The wells were screened from 10 to 20 feet bgs, except for MW-1, which was screened from 4.5 to 14.5 feet bgs. The depth to groundwater in the wells ranged from 6.29 feet bgs in MW-1 to 8.0 feet bgs in MW-2. Groundwater samples were collected from MW-1 through MW-4 using disposable polyvinyl chloride (PVC) bailers and submitted for laboratory analysis for TPH-G by Ecology Method NWTPH-Gx and BTEX compounds by EPA Method 8021B. MW-5 could not be sampled due to a parked vehicle restricting access.

Analytical results did not detect the presence of any contaminants above laboratory detection limits. *It should be noted that due to the installation of the well screens below the water table in four out of five of the wells, any light non-aqueous phase liquid (LNAPL) floating near the surface of the water table is not likely to show up in these wells.*

These four new wells were sampled in May 2007 and analyzed for the appropriate contaminants of concern required under MTCA Table 830-1. No contaminants were detected above MTCA Method A cleanup levels. Ecology requires that at least four rounds of quarterly groundwater sampling be conducted showing concentrations of contaminants below MTCA Method A cleanup levels to meet the substantive requirements of MTCA. The reason for this is to determine any seasonal variations in the contaminant concentrations, so that Ecology can determine whether the implemented remedy is permanent. At least three additional rounds of sampling needs to be conducted from the four new wells.

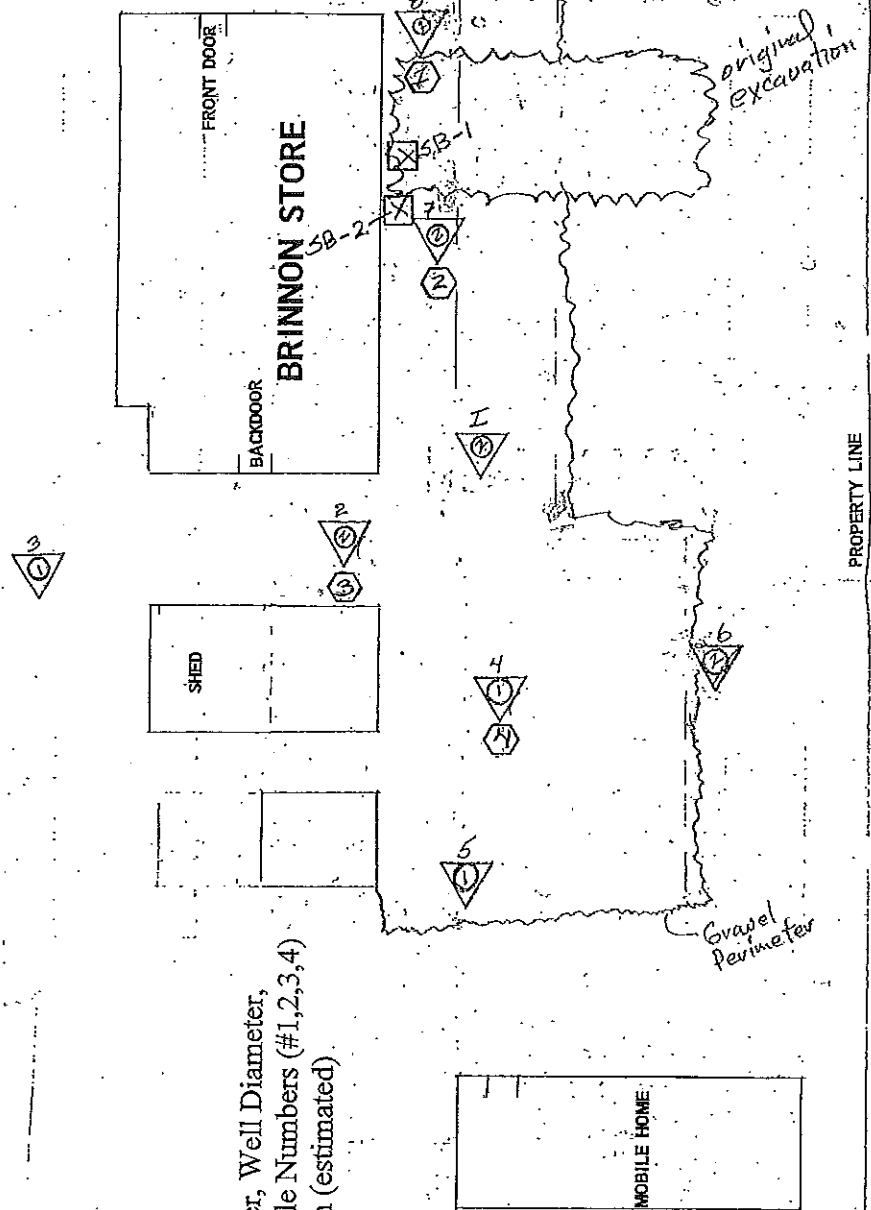
Site Sketch B

In May 2007, three soils samples were collected from two locations along the northern perimeter of the convenience store building using a hand auger. Two samples were collected from 4 feet bgs and one sample from 5 feet bgs. Refusal with the hand auger occurred at 5 feet bgs due to a piece of wood and the boring was not advanced any deeper. No contaminants were detected in these samples.

Ecology does not feel that these soil samples are adequate to show that residual soil contamination does not exist adjacent to and/or beneath the convenience store building. Contaminants detected in soil by Stemen Environmental, Inc. were encountered at depths of 7 to 12 feet bgs. An evaluation of the extent of soil contamination at the site should include deeper samples adjacent to the building and former excavation and, if possible, beneath the building.

In July 2007, Ecology received a remedial investigation report from the site owner's new consultant. As part of this investigation, the four new monitoring wells were sampled and three soil samples were collected from two locations along the northern side of the convenience store building. The soil and groundwater samples were analyzed for TPH-G by Ecology Method NWTPH-Gx, volatile organic compounds (VOCs) by EPA Method 8260, 1,2-dibromoethane (EDB) by EPA Method 8011, and lead by EPA Method 7420 (soil) and 239.2 (groundwater). No contaminants were detected in the samples at concentrations above MTCA Method A cleanup levels.

Well Locations, Well Number, Well Diameter,  
Soil Boring Locations, Sample Numbers (#1,2,3,4)  
Original Excavation Location (estimated)
