Second Periodic Review

Sparks and Buttercup Subdivision 12th Avenue and Eastern Street Spokane, Washington 99212

Prepared by:
Washington State Department of Ecology
Eastern Region Office
Toxics Cleanup Program

May 2014

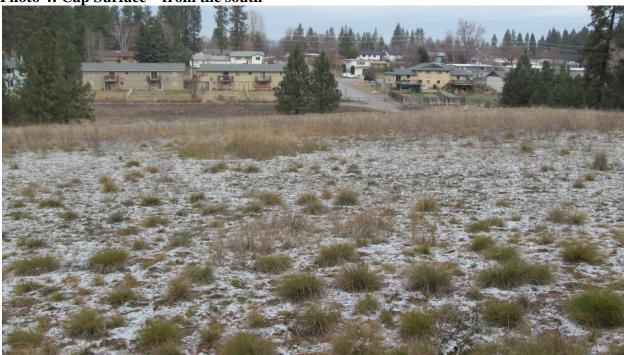
Photo 4: Cap Surface – from the south

Based upon the Site visit conducted on December 11, 2013, the soil cap at the Site continues to eliminate exposure pathways (ingestion, contact) to contaminated soils. The cap appears in good condition. The concrete drainage channel identified as being cracked and undermined during the 2008 review has been repaired and appears sound. The Site remains undeveloped. There is evidence of human foot traffic and wildlife use on the cap and surrounding slope. This traffic does not appear to be adversely impacting the cap or posing a risk of exposing contaminated soils contained at the Site. A photo log is available as Appendix 6.4.
