STATE OF WASHINGTON  
DEPARTMENT OF ECOLOGY

Re: Approval with Ecology Modifications of Engineering Design Report-Vapor  
Intrusion Mitigation System, dated October 19, 2007

## 1.0 Introduction

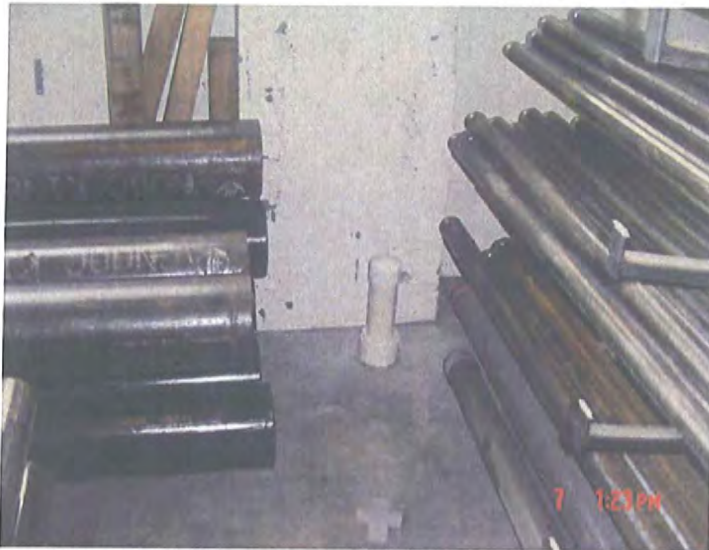
6-7-07 VIMS-1 Puget Sound Pipe (Facing North) – Capped Riser after excavation of sump

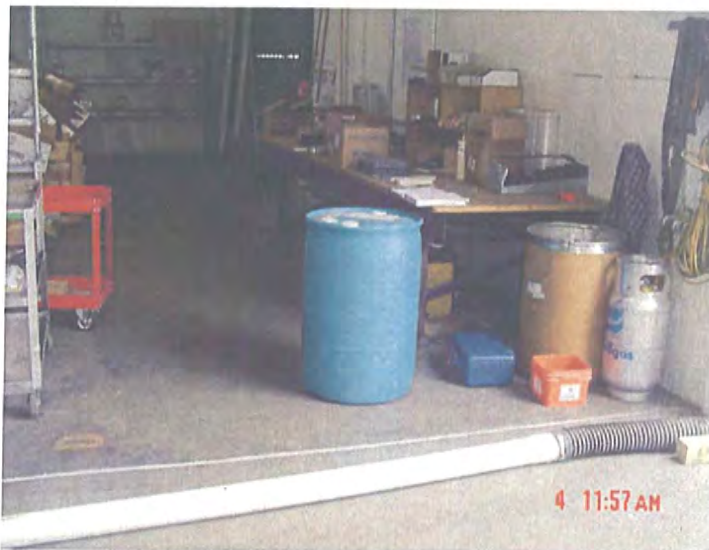
6-4-07 VIMS-1 Puget Sound Pipe Warehouse (Facing North) – Shows polyurethane sealing and installation vent piping from vacuum blower.

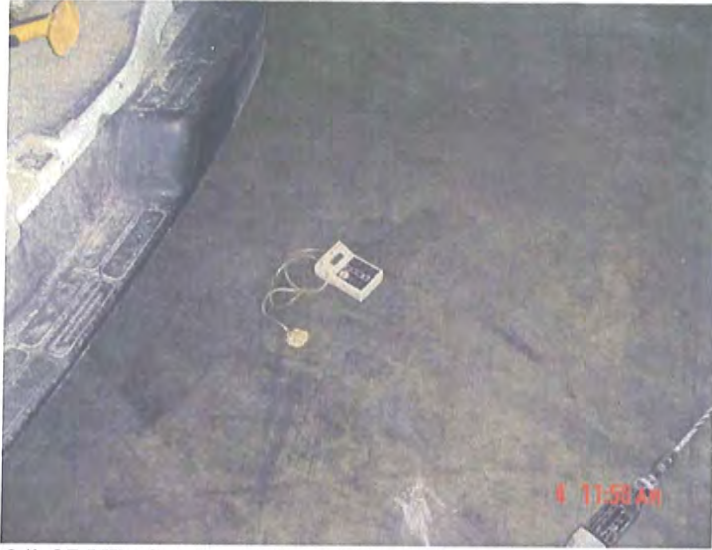
6-4-07 VIMS-1 Puget Sound Pipe Warehouse– Shows Digital Micromanometer recording the negative pressure differential over a test hole

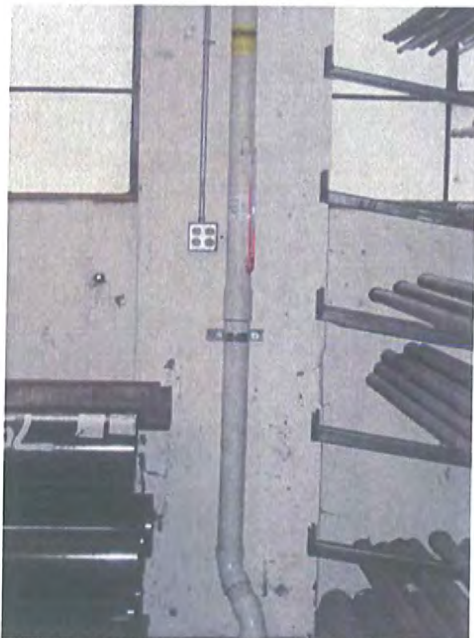
8-7-07 VIMS-1 -Puget Sound Pipe (Facing North) - shows manometer and signs attached indicating contacts regarding the system

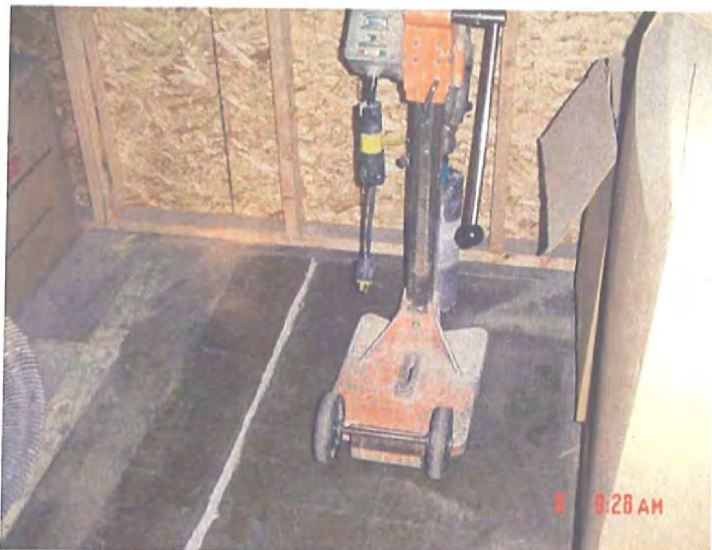
6-6-07 VIMS-3 Hudson Bay Warehouse (Facing West) - Drill set up to core out concrete

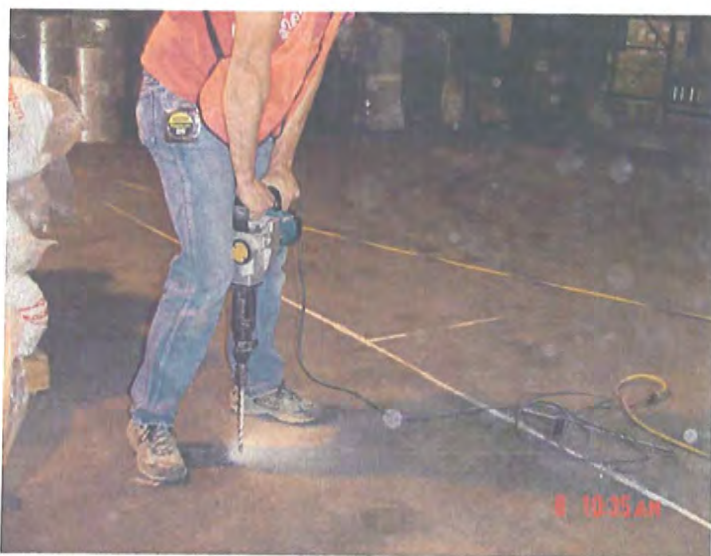
6-6-07 VIMS-3 Hudson Bay Warehouse (Facing North) – ART contractor drilling TH-8

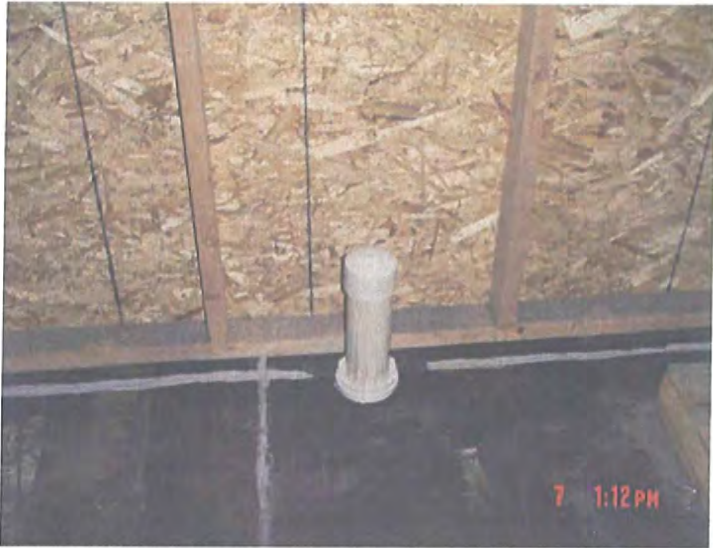
6-6-07 VIMS-3 Hudson Bay Warehouse (Facing West) – Capped Riser after excavation of sump

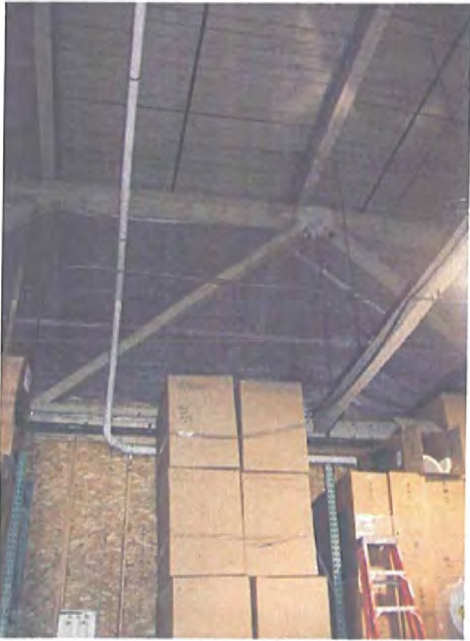
8-2-07 VIMS-3 Hudson Bay Warehouse (Facing West) - Piping from exhaust fan to VIMS-3

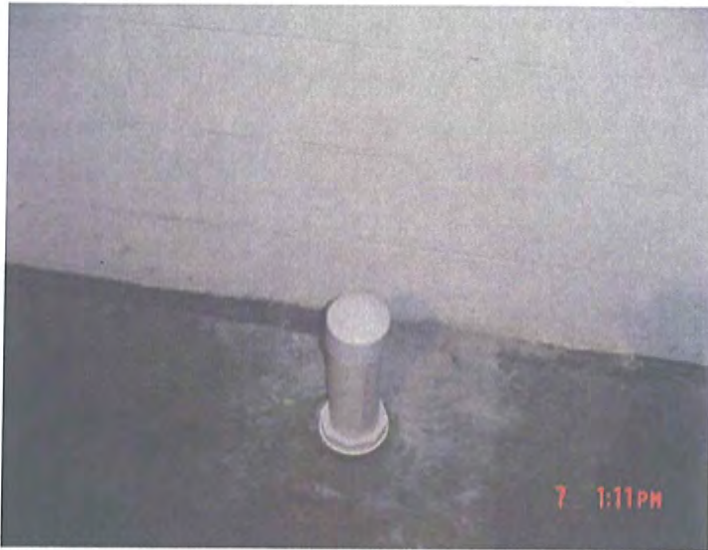
6-7-07 VIMS-4 Hudson Bay Warehouse (Facing North) – Capped Riser after excavation of sump

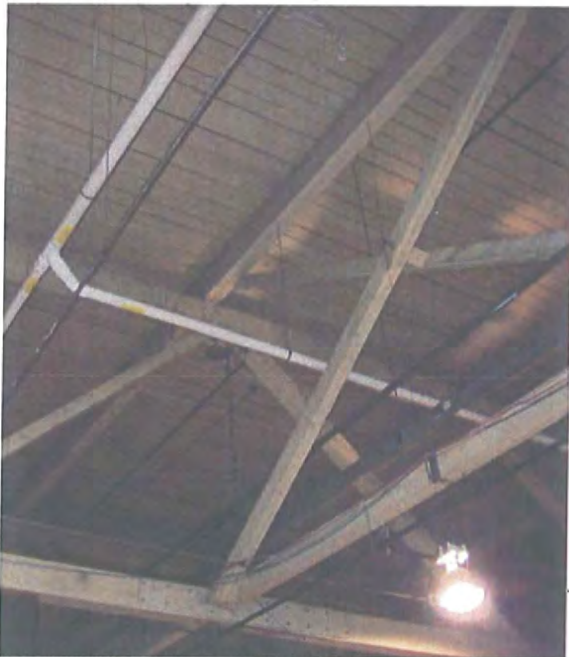
8-6-07 VIMS-4 Hudson Bay Warehouse (Facing West and up) – Piping connecting VIMS-3 and VIMS-4

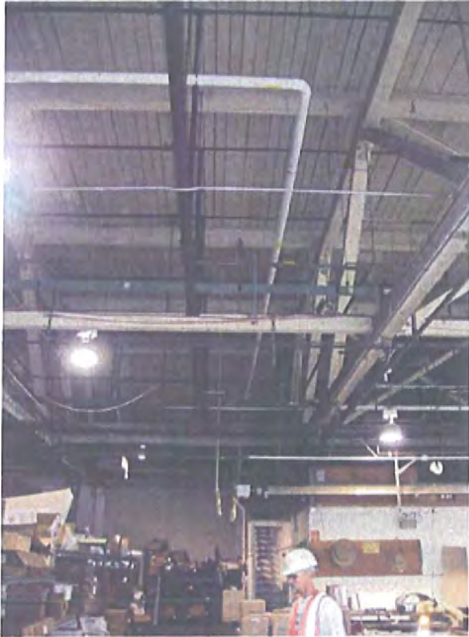
8-6-07 VIMS-4 Hudson Bay Warehouse (Facing North) – Piping network from exhaust fan to VIMS-5B

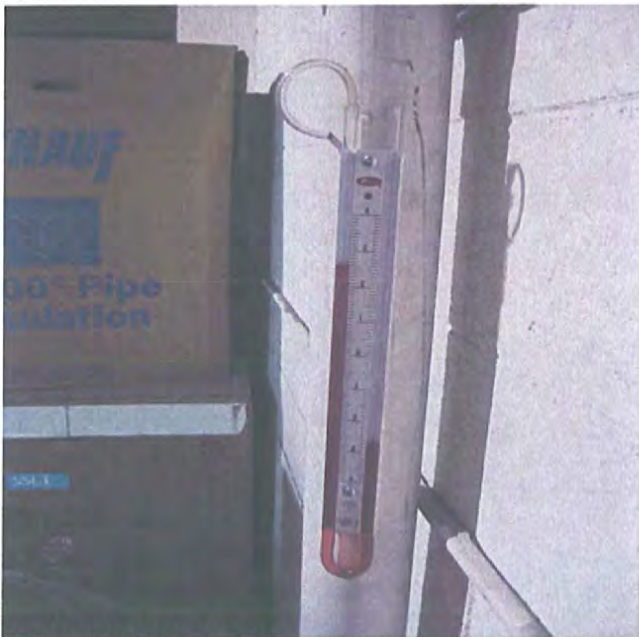
8-6-07 VIMS-4 Hudson Bay Warehouse (Facing Northwest) – Manometer installed

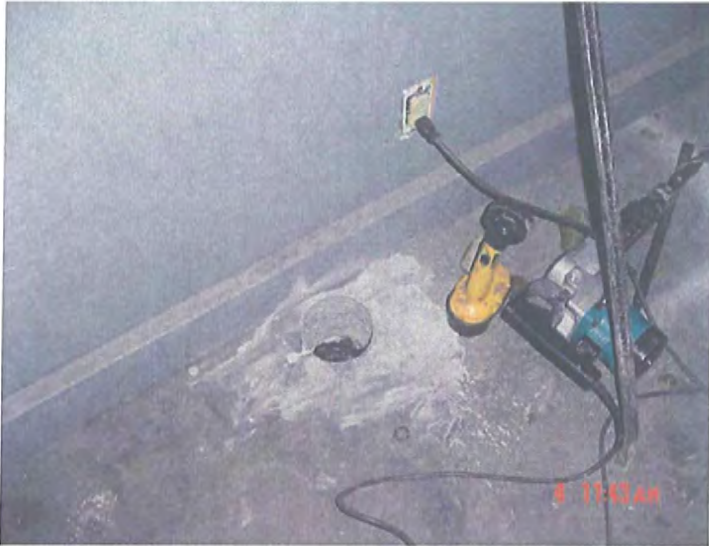
6-4-07 VIMS-5A Puget Sound Pipe (Facing South East) - Drilled concrete sump

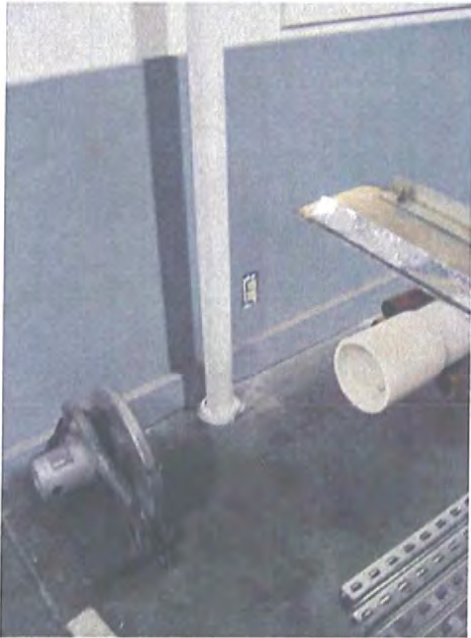
8-3-07 VIMS-5A Puget Sound Pipe (Facing South-East) – VIMS-5A Piping connecting to sump location

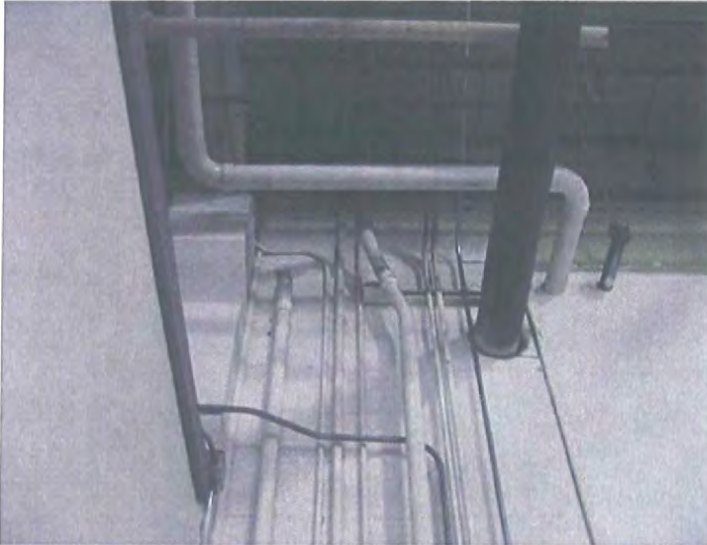
8-3-07 VIMS-5A Puget Sound Pipe (Facing South and Up) – Piping coming through Hudson Bay internal wall to Puget Sound Pipe.

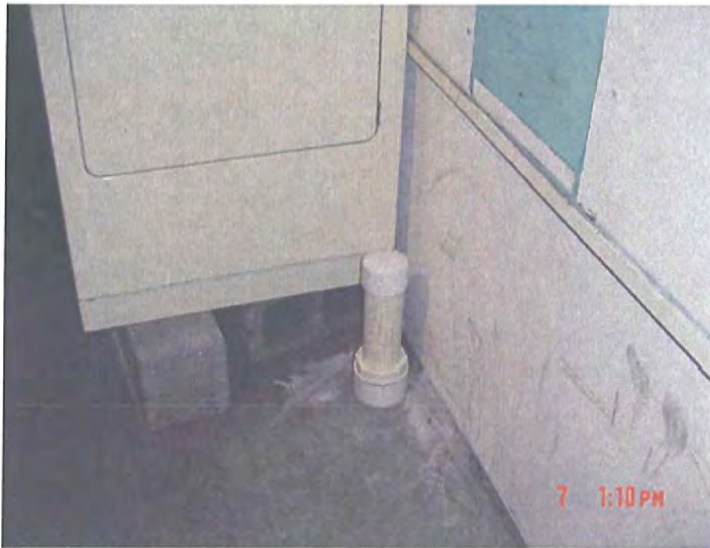
6-7-07 VIMS-5B Hudson Bay Warehouse (Facing Northeast) – Capped Riser after excavation of sump

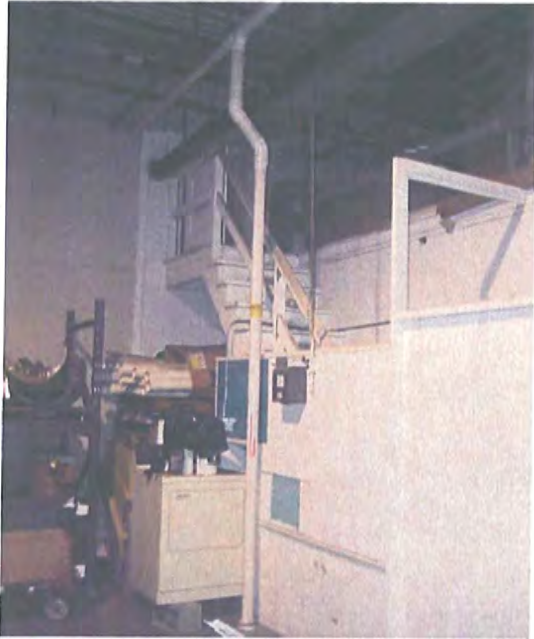
8-6-07 VIMS-5B Hudson Bay Warehouse (Facing North East) – Piping installed to the sump at VIMS-5B.

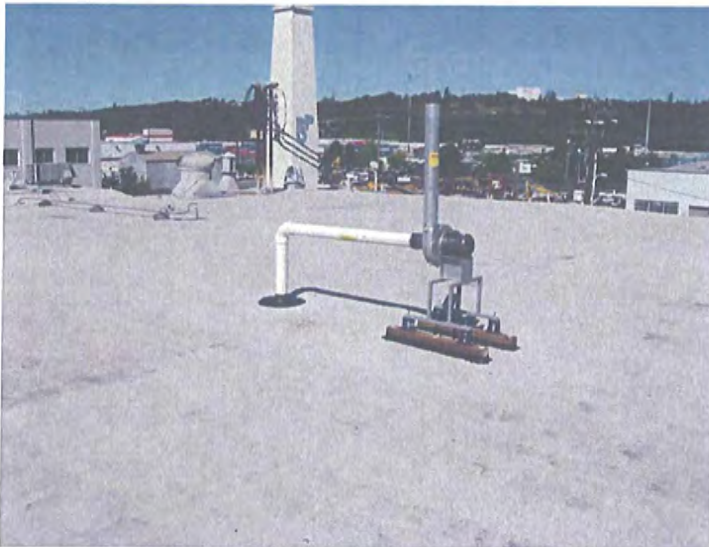
7-31-07 Exhaust fan unit - Mounted on roof of Hudson Bay Warehouse (Facing North-East)

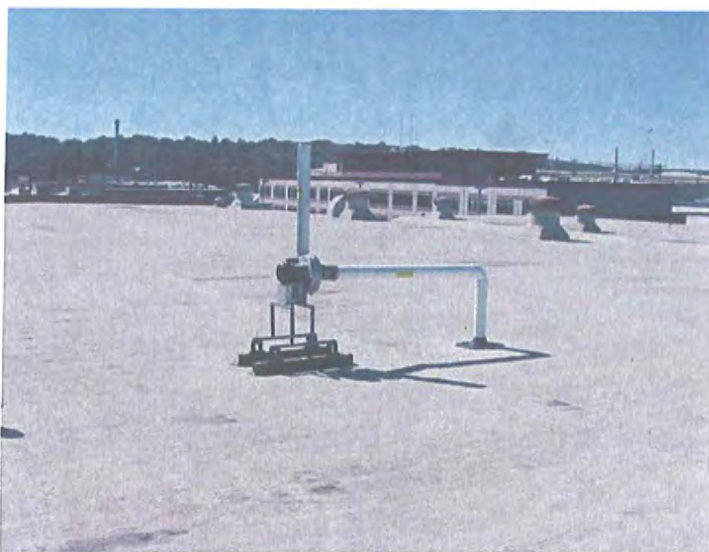
7-31-07 Exhaust fan unit - Mounted on roof of Hudson Bay Warehouse (Facing North-West)

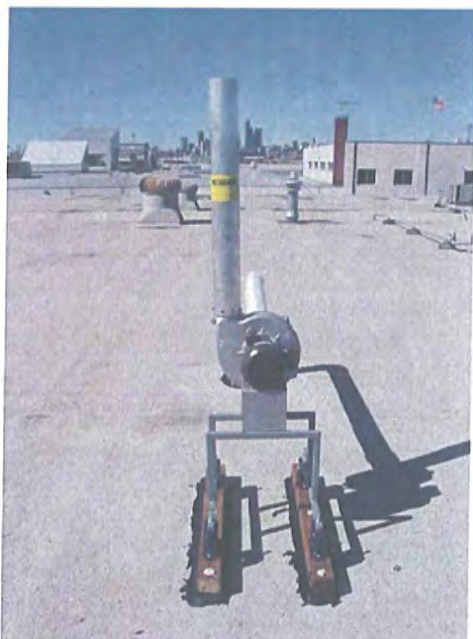
7-31-07 Exhaust fan unit - Mounted on roof of Hudson Bay Warehouse (Facing North)

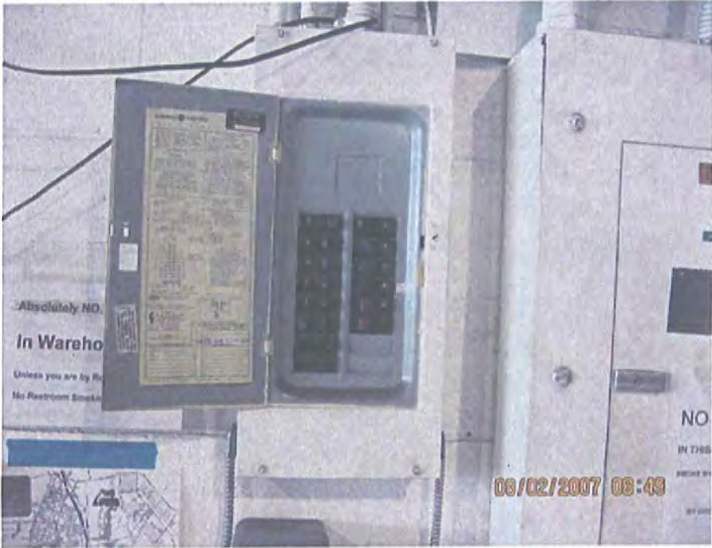
8-2-07 Hudson Bay Warehouse (Facing South) -Electrical box for exhaust fan

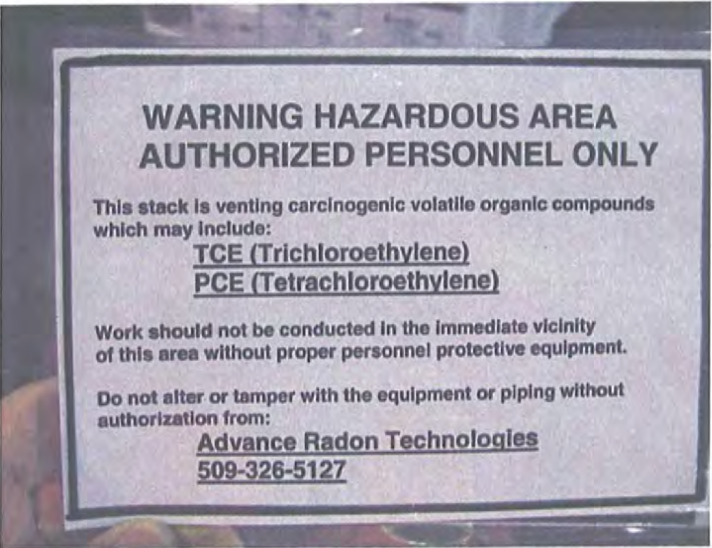
8-6-07 Exhaust Fan- Sign placed on PVC exhaust pipe
