PERIODIC REVIEW

**US West Communications
FS ID#: 777**

**102 East Alder Street
Walla Walla, Washington 99362**

September 2009

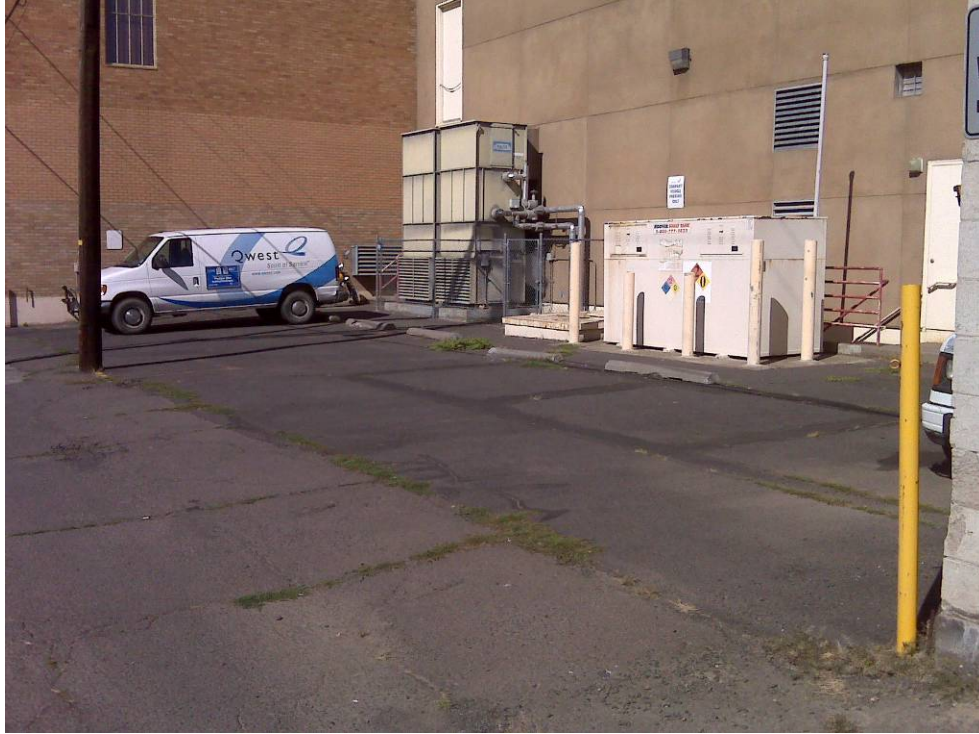
Photo 3: Former UST Location - from the east

Probable sources of the release were the UST system previously located near the southeast corner of the Site and/or the UST located in the basement near the elevator shaft. These assumed release sources were removed over 20 years ago. Remaining soil contamination is confined to the basement subsurface area and adjacent to the building. Ground water monitoring has shown that ground water contamination did not migrate off site. Five consecutive quarters of ground water monitoring did not detect petroleum concentrations exceeding Method A cleanup levels in ground water.
