SOIL REMOVAL ACTION
Rainier Avenue Facility Remediation
Seattle, Washington
Prepared for: Darigold, Inc.

Project No. 090066-005-03 • December 8, 2011

Aspect Consulting, LLC

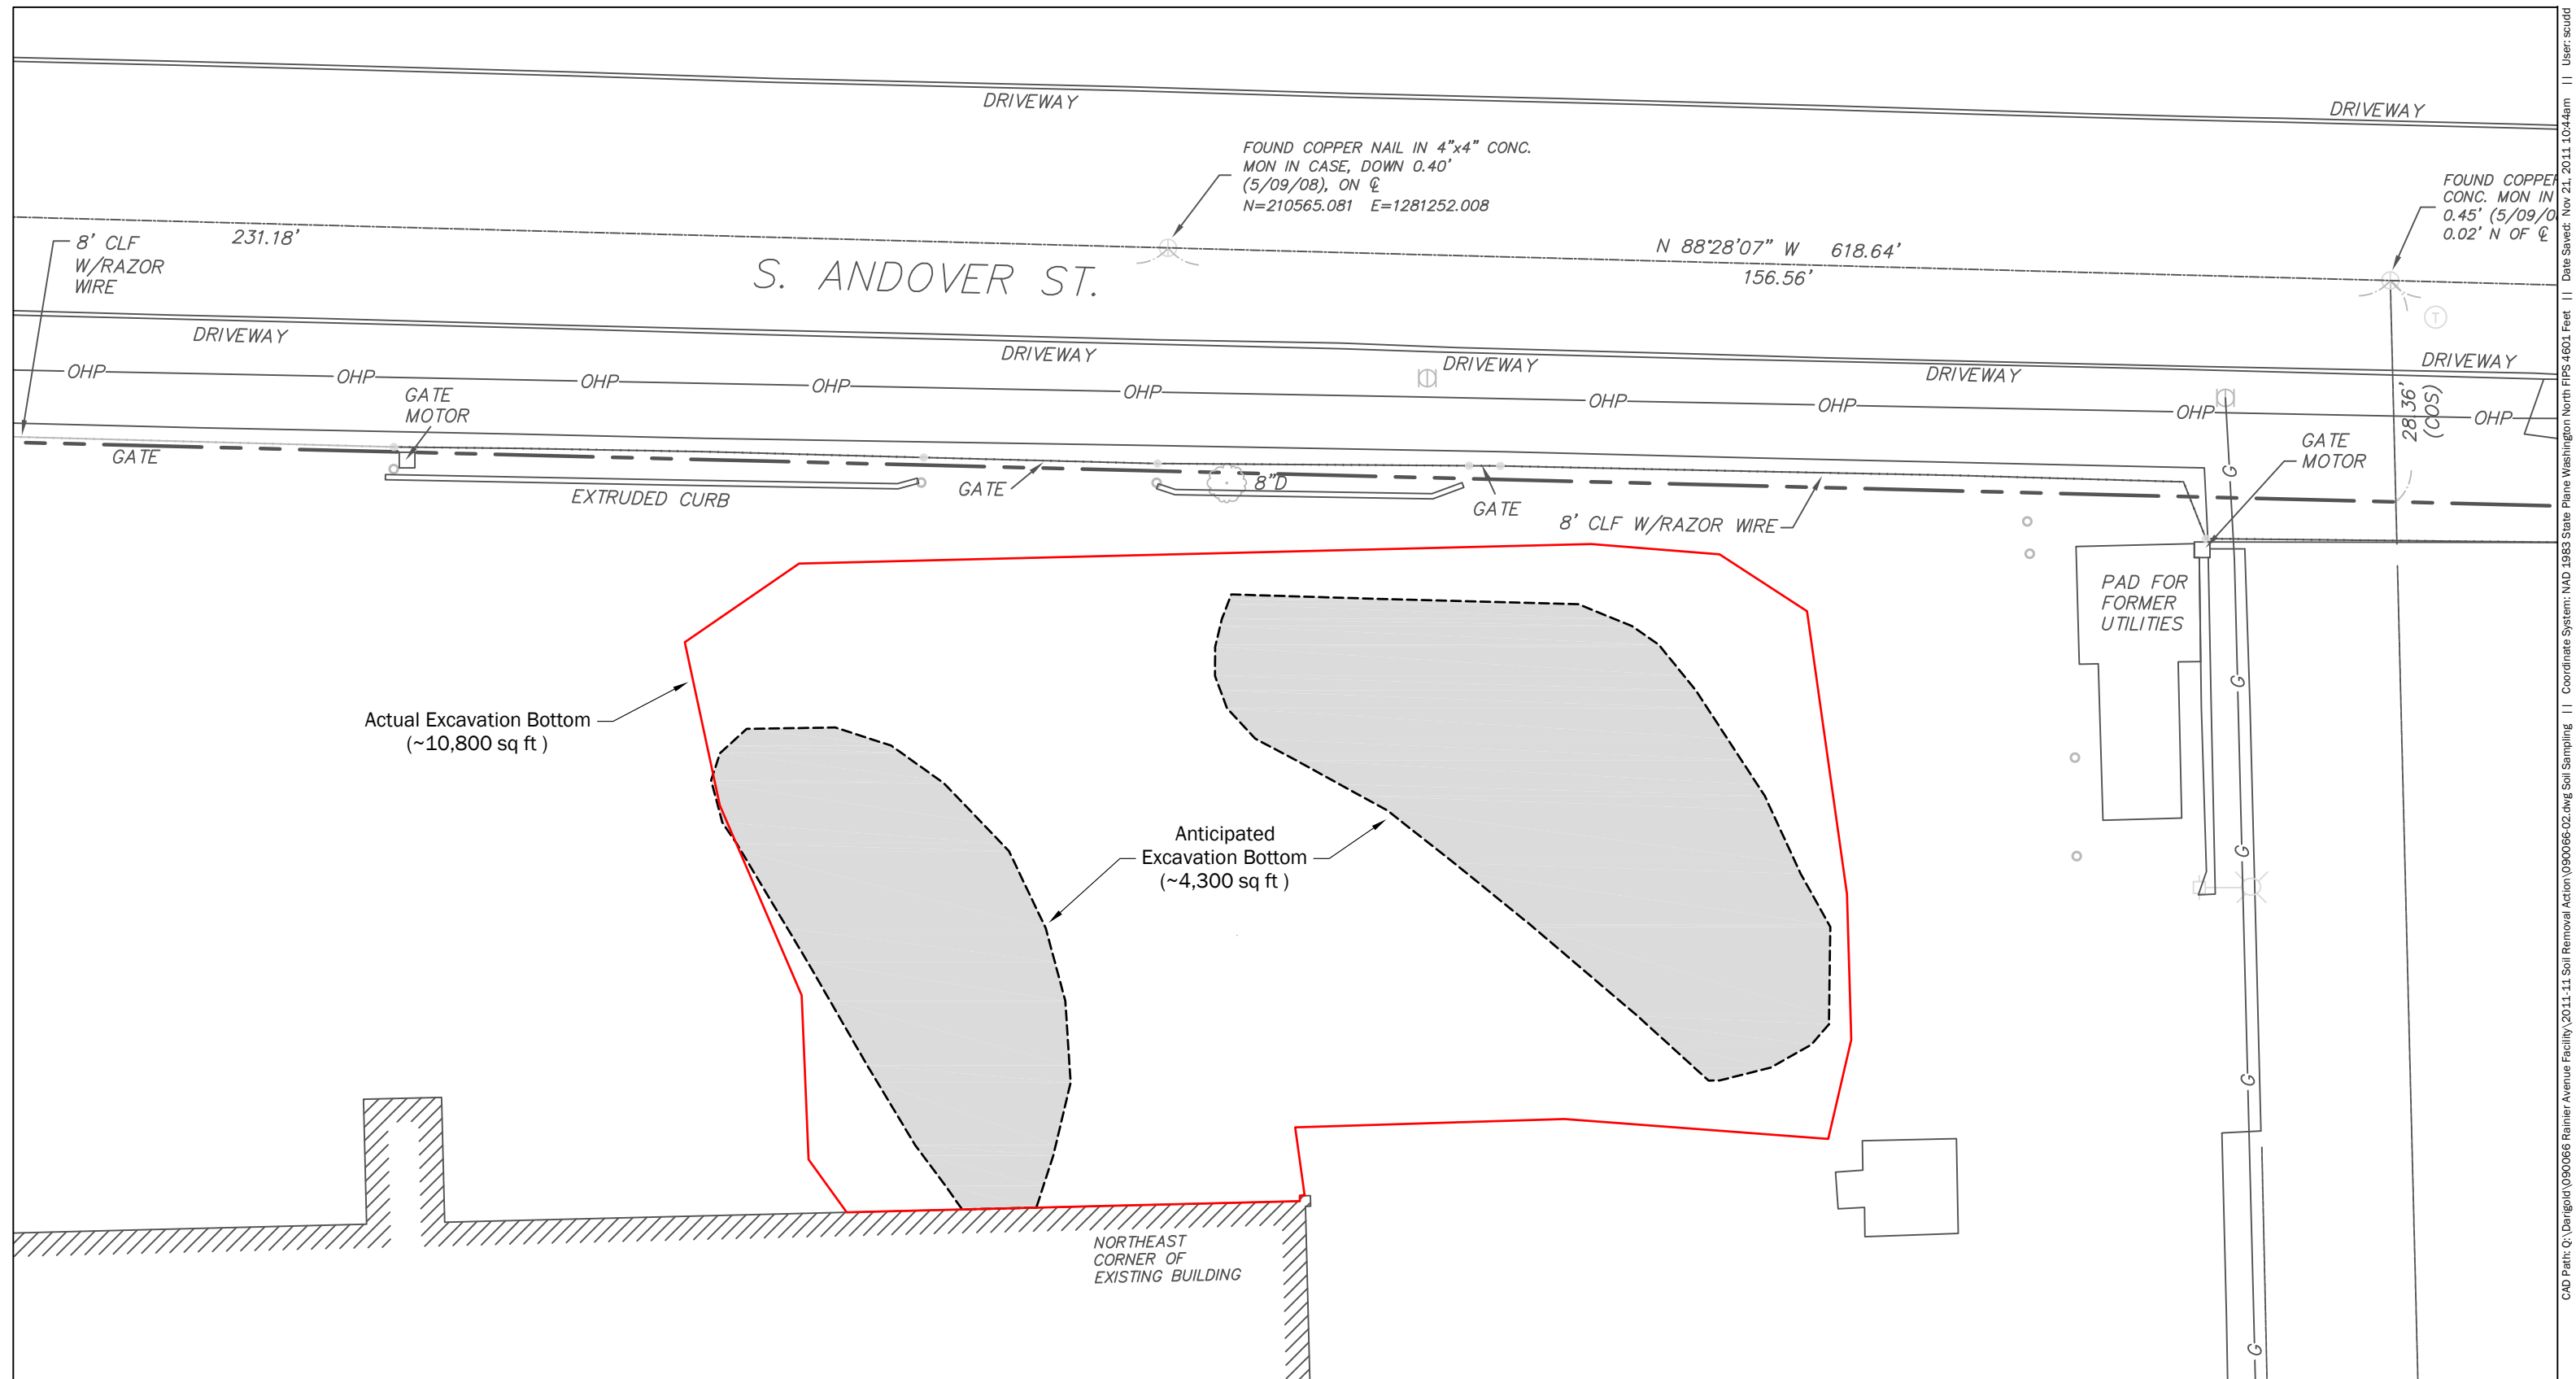
NOV-2011	BY: MV/SCC	FIGURE NO. 2
	PROJECT NO. 090066	REV BY: SCC

Approximately 7,900 tons of soil were excavated, roughly 60 percent more than anticipated in the *CAP/EDR*. This was due to the fact that soils in areas adjacent to the anticipated excavation areas were found to be more highly impacted than expected, resulting in a larger-than-anticipated areal extent of excavation. Excavation expanded primarily into areas that, at the time the *CAP/EDR* was developed, were judged to be marginally impacted, and were slated for remediation via enhanced *in situ* degradation. Since contaminant concentrations were higher than anticipated, excavating these soils rather than relying on an *in situ* remediation technology ensured that the cleanup met substantive requirements under the MTCA regulations, that enhanced *in situ* degradation of contaminants in the remainder of the impacted area would be effective, and that cleanup levels would be achieved within a reasonable and cost-effective timeframe. Excavation also extended into limited areas that were thought to be “clean” (i.e., contaminant concentrations below MTCA Method A soil cleanup levels) based on interpretation of data previously collected at the site, but that field screening indicated were, in fact, contaminated.

Site Plan Showing Excavation Bottom Areas: Anticipated Versus Actual
 Summer 2011 Soil Removal Action
 Darigold-Rainier Avenue Facility
 Seattle, Washington

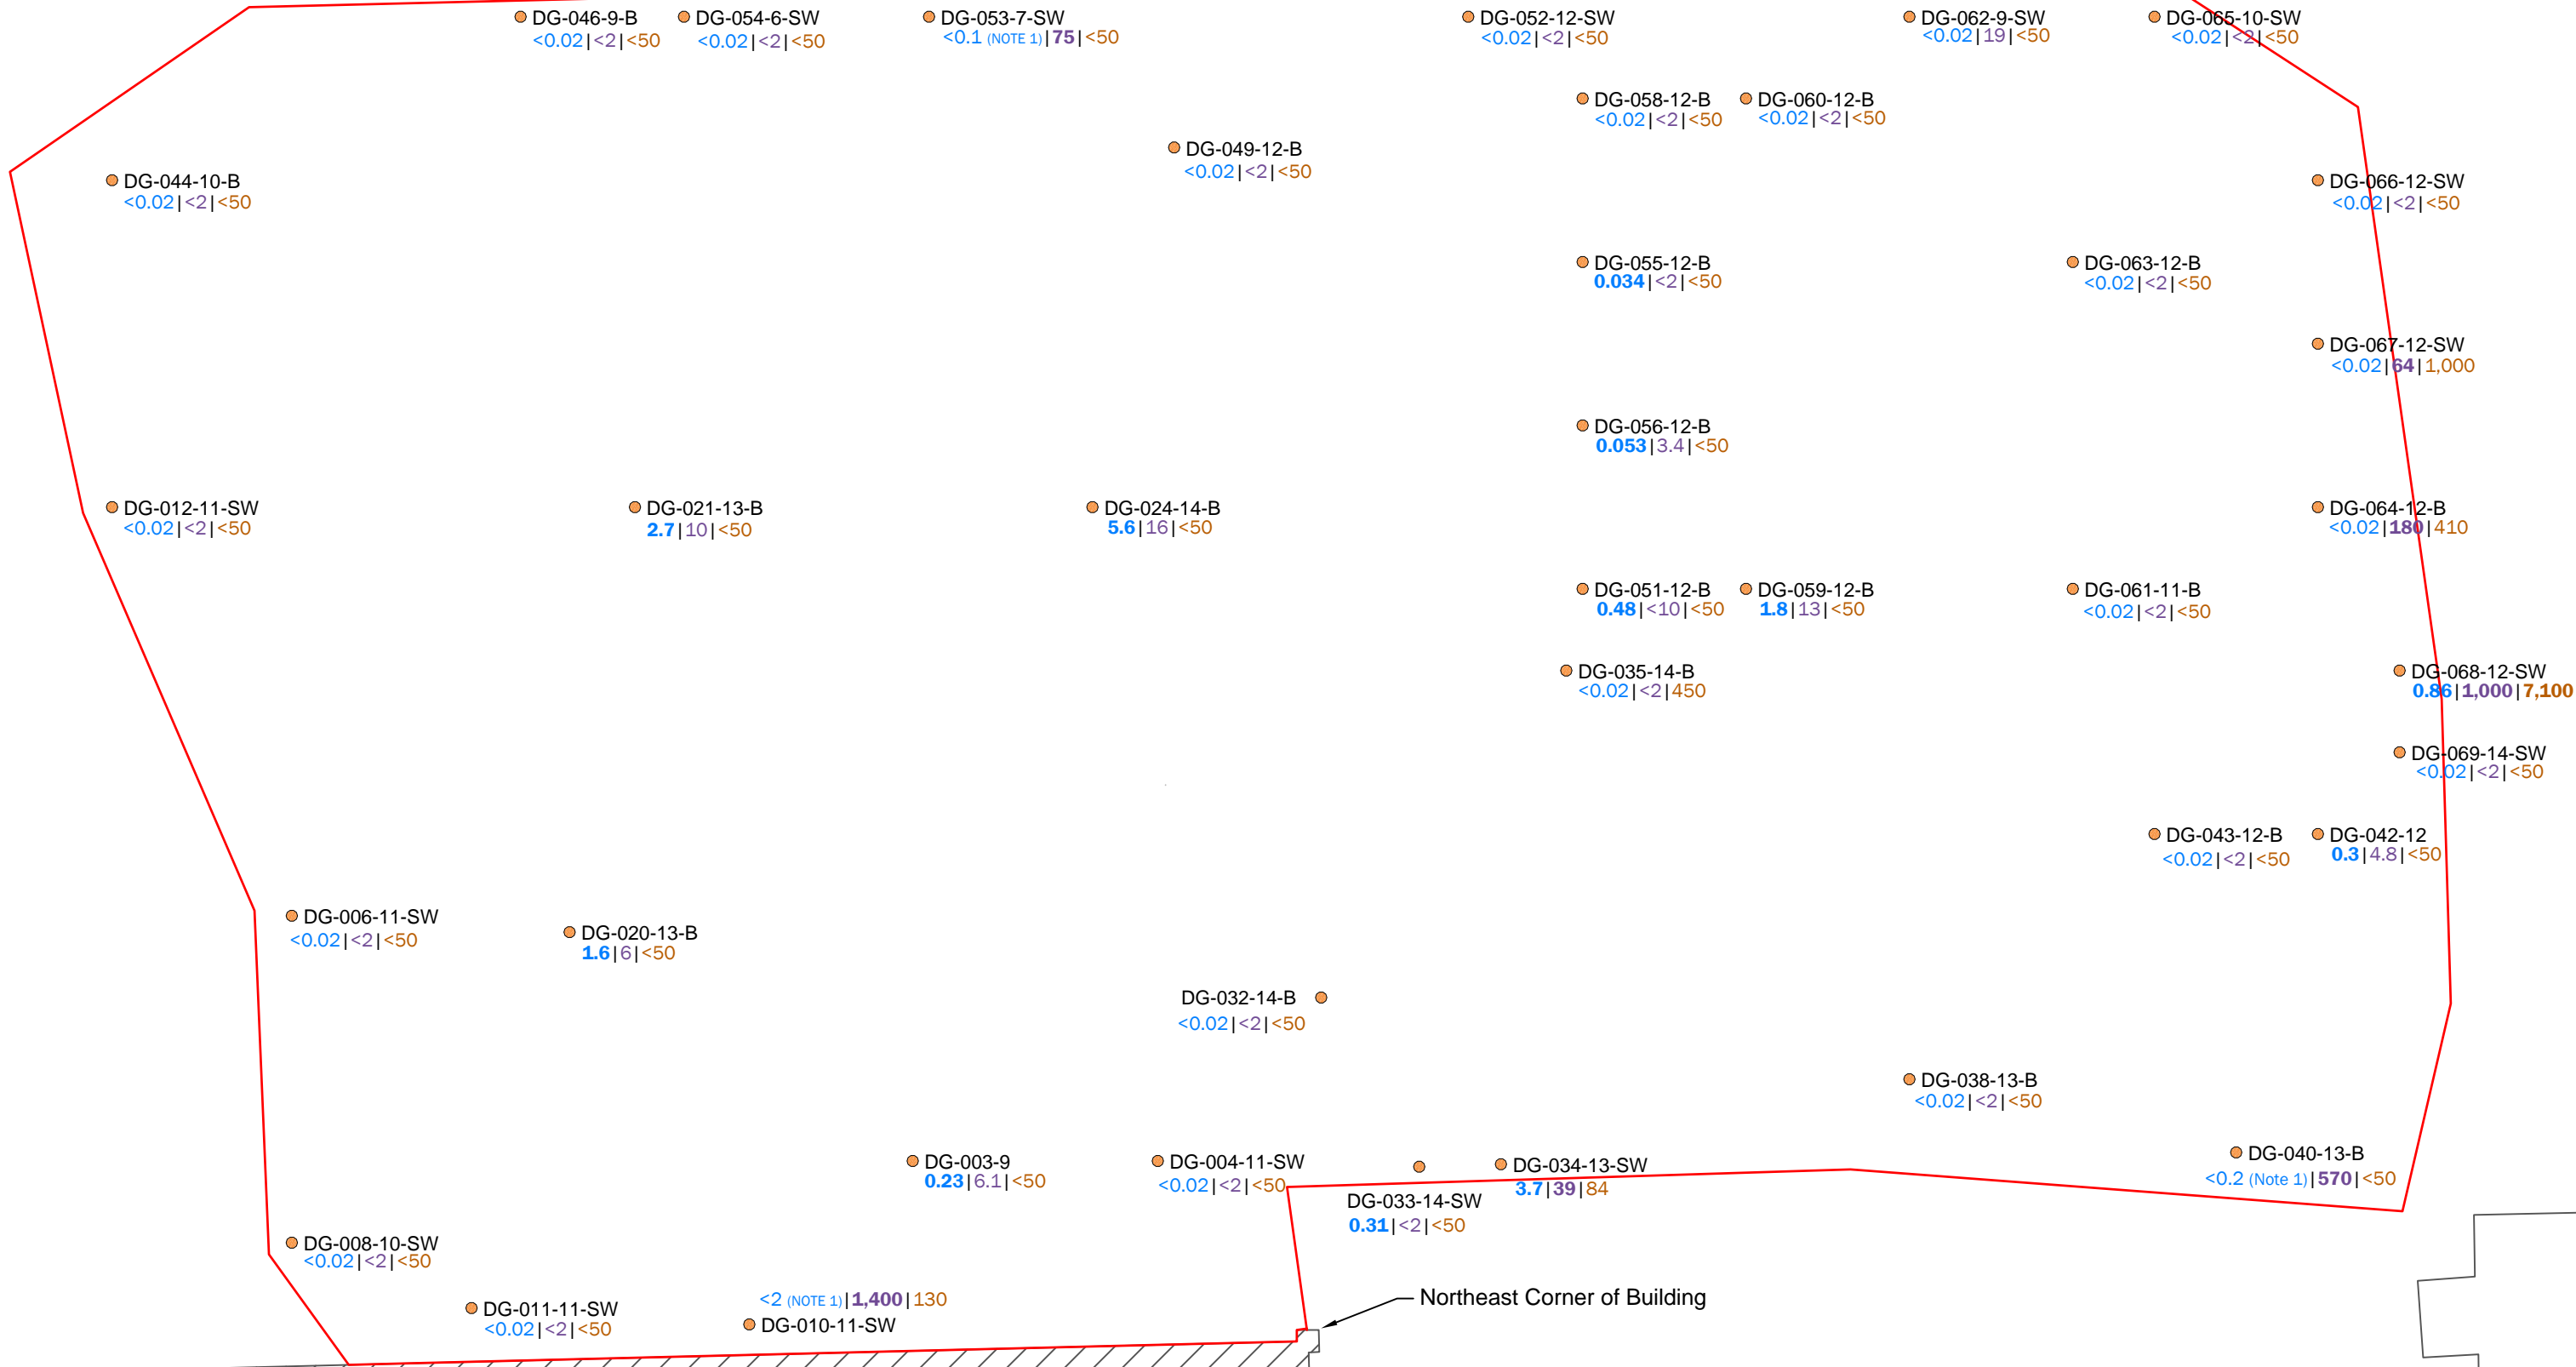
Locations and Results Summary for Excavation Bottom and Sidewall Samples

- Sidewall sample DG-010-11-SW is along the building's north wall, where the excavation depth was limited by the need to protect the building's structural stability. The higher dose of RegenOx™ (along with ORC Advanced®) was applied in this area (see Figure 4). Results of future quarterly groundwater monitoring at well MW23 will provide an indication of how effectively the Regenesis product applications remediate residual contamination in this area. Additional chemical injections may be needed to further enhance *in situ* degradation of gasoline-range TPH.

- Bottom sample DG-064-12-B and sidewall samples DG-067-12-SW and DG-068-12-SW are in the central portion of the excavation's eastern edge. This is the former UST area, and the last area to be excavated in the removal action. Additional lateral excavation to the east was not pursued due to a combination of difficult excavation conditions (sloughing of the gravel that was used to backfill the former UST area) and schedule concerns. Residual contamination in the excavation bottom may be adequately addressed by the Regenesis product applications completed during the removal action. In addition, the gasoline-range TPH exceedence at DG-067-12-SW is relatively minor and should naturally attenuate within a few years. However, the unexcavated area east of DG-064-12-B and DG-068-12-SW should be considered for enhanced *in situ* degradation. The eastward extent of residual contamination appears to be limited because petroleum hydrocarbons have not been detected during recent groundwater monitoring rounds at MW05, a well located less than 20 feet east of the excavation sidewall.

Two of the three sidewall samples with benzene exceedences (DG-033-14-SW and DG-034-13-SW) were collected from the central portion of the excavation's south sidewall. There were no field indications of sidewall contamination at this location, and sampling results confirm that the TPH loading is low. In addition, nearby excavation bottom sample results suggest that contamination has been completely removed from the upgradient area. Therefore, we also expect aerobic conditions to develop at this sidewall location, leading to rapid biodegradation of residual benzene.

The other sidewall sample exceedence was detected at DG-068-12-SW. As noted in Section 5.2.2, because that sample had a relatively high TPH loading, the unexcavated area to the east will be considered for enhanced *in situ* degradation.

The Method A soil cleanup level for toluene (7 mg/kg) was exceeded in only one sample, sidewall sample DG-010-11-SW. The Method A cleanup levels for ethylbenzene (6 mg/kg) and total xylenes (9 mg/kg) were also exceeded in this sample, as well as in bottom sample DG-040-13-B and sidewall sample DG-068-12-SW. As discussed in Section 5.2.2, these three samples also had significant gasoline-range TPH exceedences. Gasoline-range TPH is expected to be the remediation "driver" at these locations. That is, as concentrations decline over time due to either enhanced *in situ* degradation or natural attenuation, the cleanup level for gasoline-range TPH will likely be the last to be achieved.

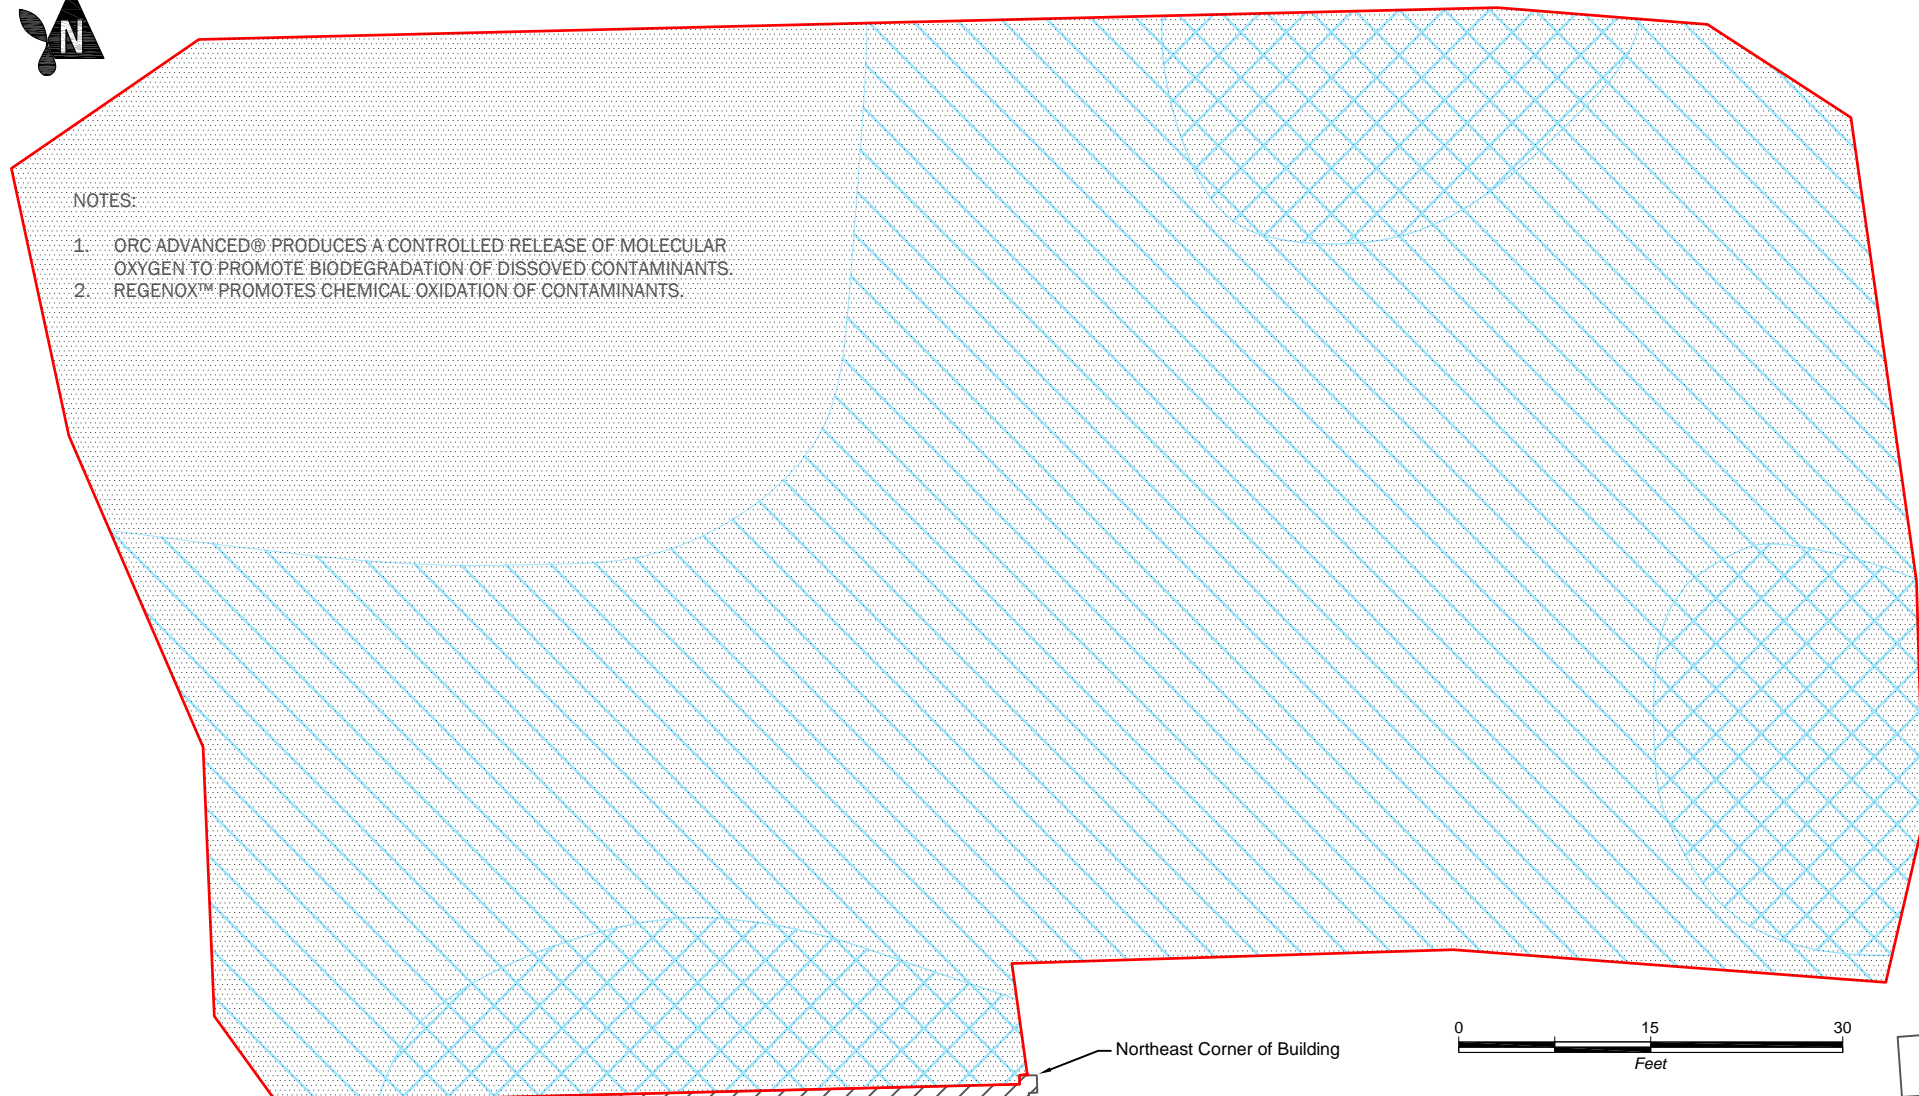
4

Two proprietary remediation products supplied by Regeneration were spread on the excavation bottom prior to backfilling, to promote chemical oxidation and bioremediation of residual contamination. Application areas are shown on Figure 4. ORC Advanced[®], which produces a controlled release of molecular oxygen to promote biodegradation of dissolved contaminants, was spread evenly over the entire excavation bottom. RegenOx[™], a two-part formulation that promotes chemical oxidation of contaminants, was applied in selected areas where field screening indicated residual soil contamination. A low dose was applied over a large portion of the excavation bottom (roughly 6,800 ft²), where field screening indicated potential low-level residual contamination. A higher (2x) dose was applied in the following three areas:

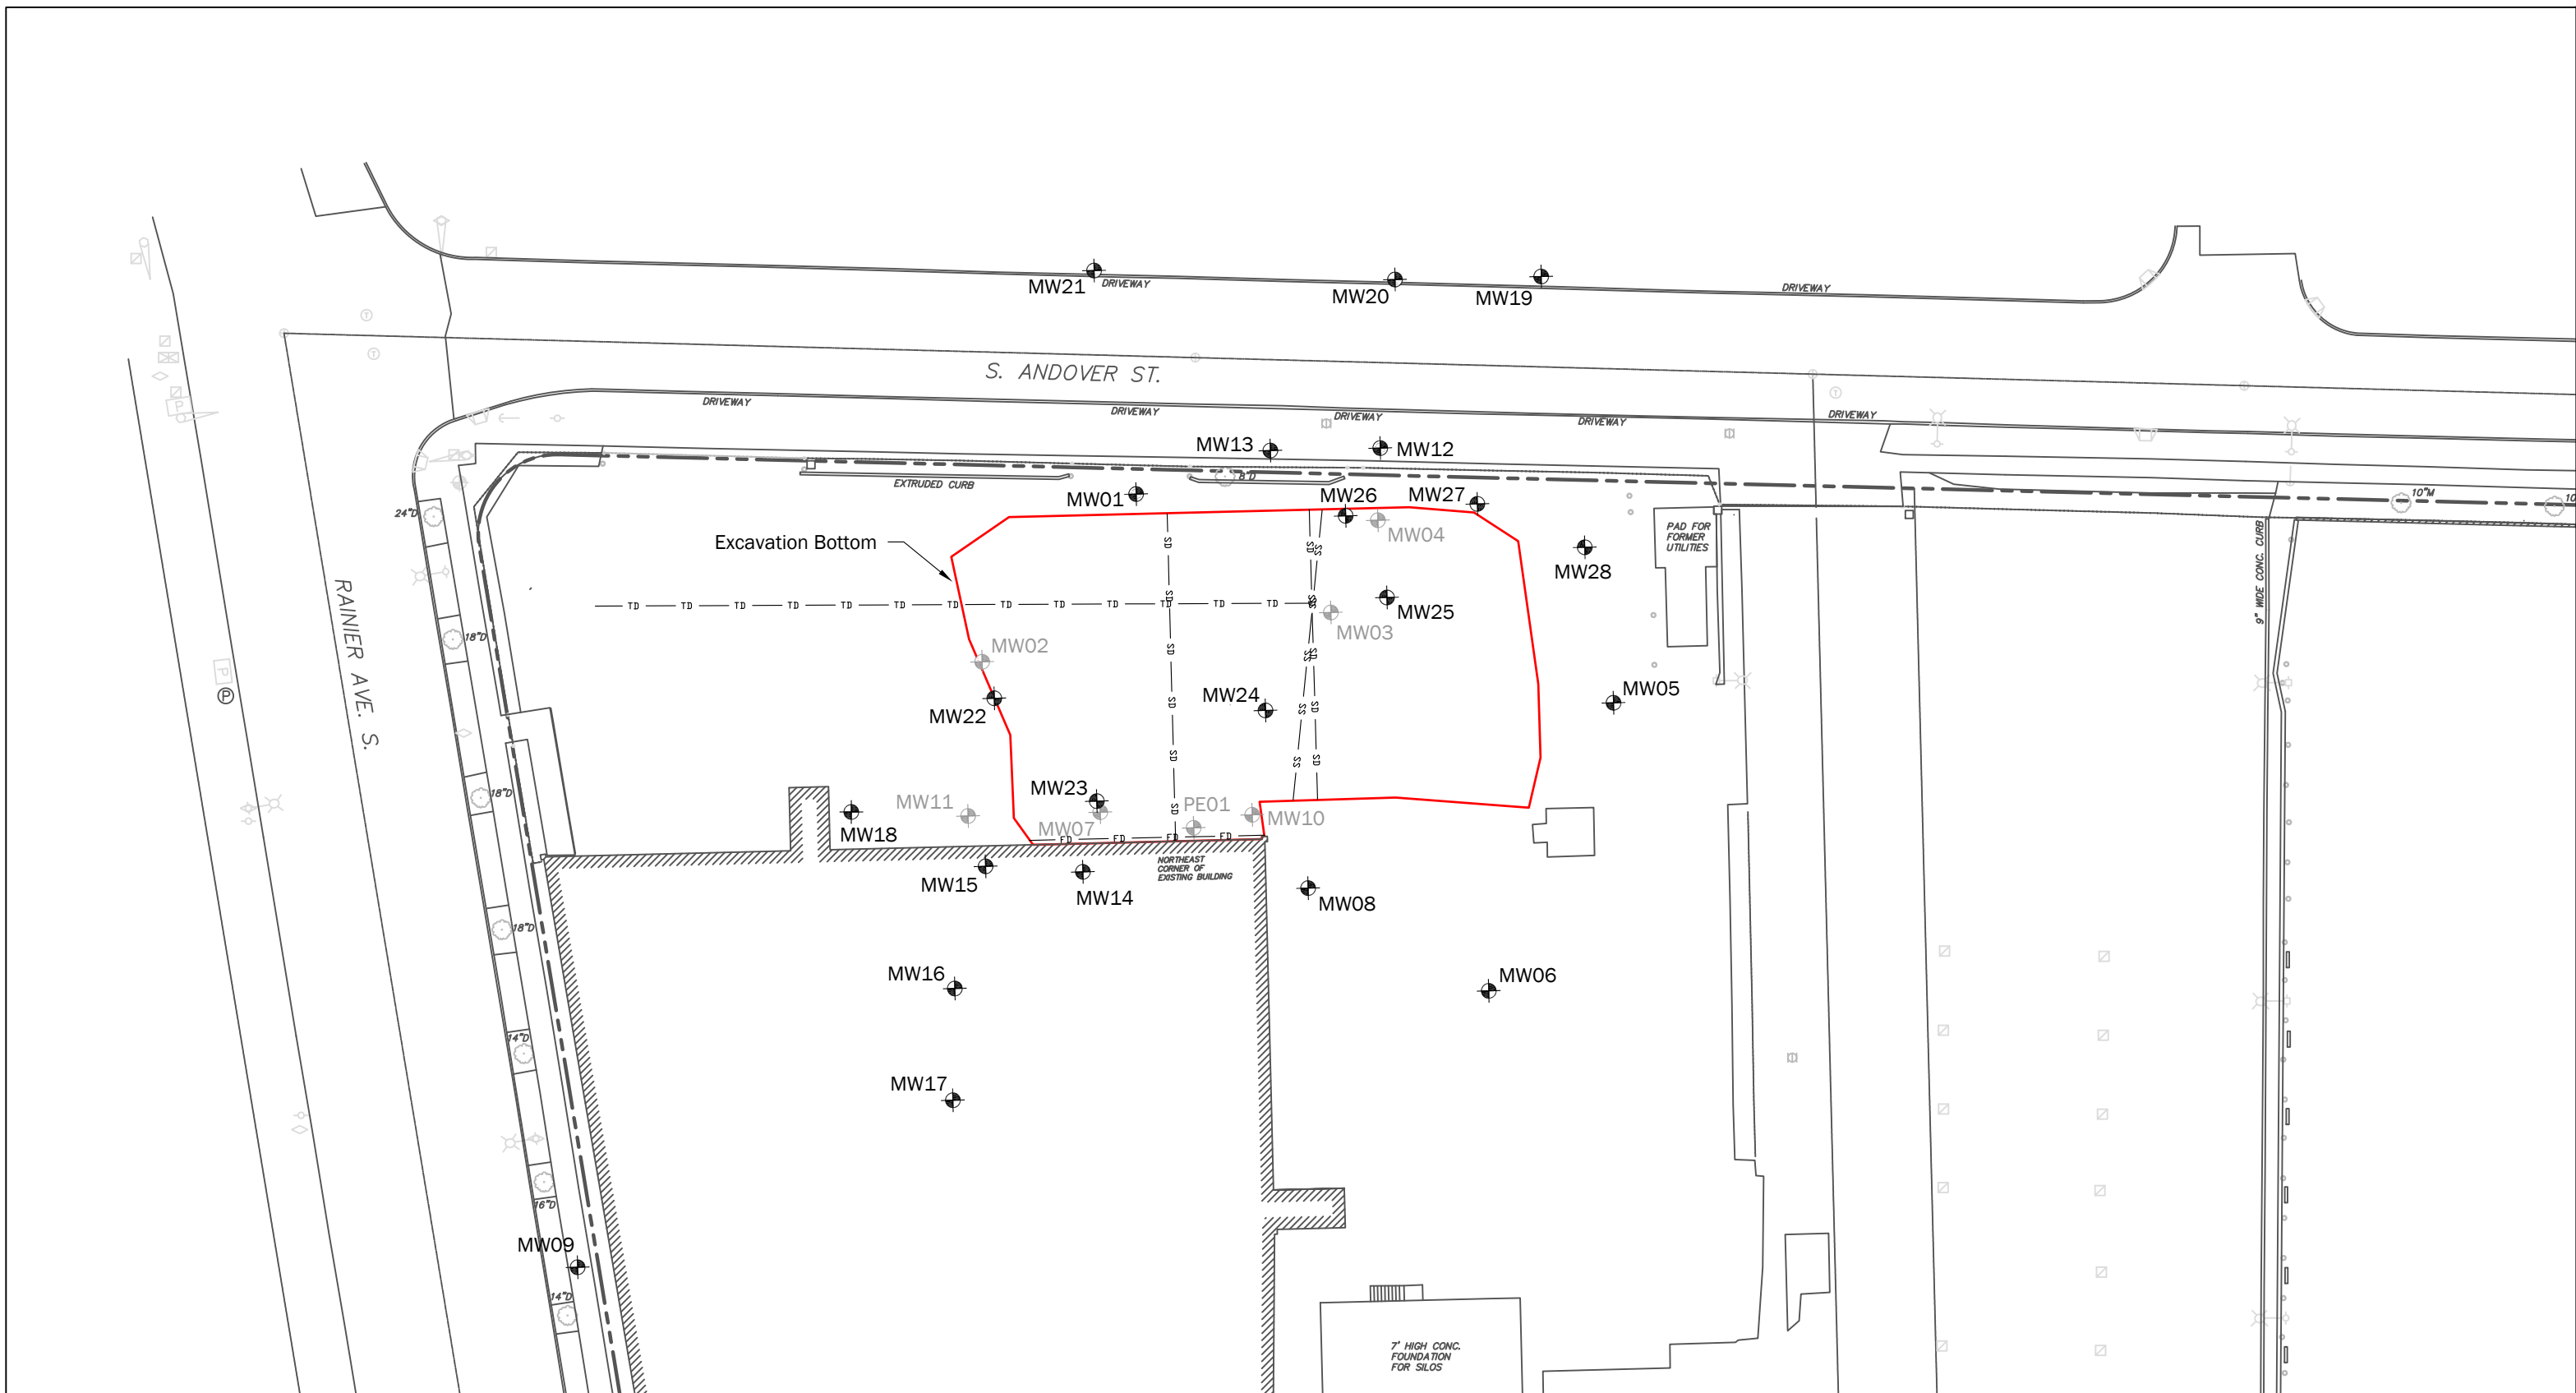
Excavation activities encountered one footing drain and two storm drain lines, which were removed and subsequently replaced. A sanitary sewer line was also encountered, which was protected in place during construction. The approximate locations of these lines are shown on Figure 5.

Figure 5 shows the approximate locations of utilities intercepted by excavation activities. The sanitary sewer line was protected in place during construction. The two storm drain lines and the footing drain line were removed as excavation proceeded and subsequently replaced. A Side Sewer Permit, a copy of which is provided in Appendix E, was obtained for the storm drain line replacement work. It is noteworthy that the intercepted portion of the footing drain line was not perforated, although the 1987 foundation plumbing plan for the basement and milk cooler addition appears to specify perforated pipe.

- FD — FOOTING DRAIN (REMOVED AND REPLACED)
- SD — STORM DRAIN (REMOVED AND REPLACED)
- SS — SANITARY SEWER (PROTECTED IN PLACE)
- TD — TRENCH DRAIN (REMOVED AND REPLACED)

Finally, a replacement trench drain was installed at the approximate location shown on Figure 5, and its eastern terminus piped into the sanitary sewer line. The purpose of the trench drain is to route to sanitary sewer any leakage from trailers stationed at the truck bays along the north end of the building.

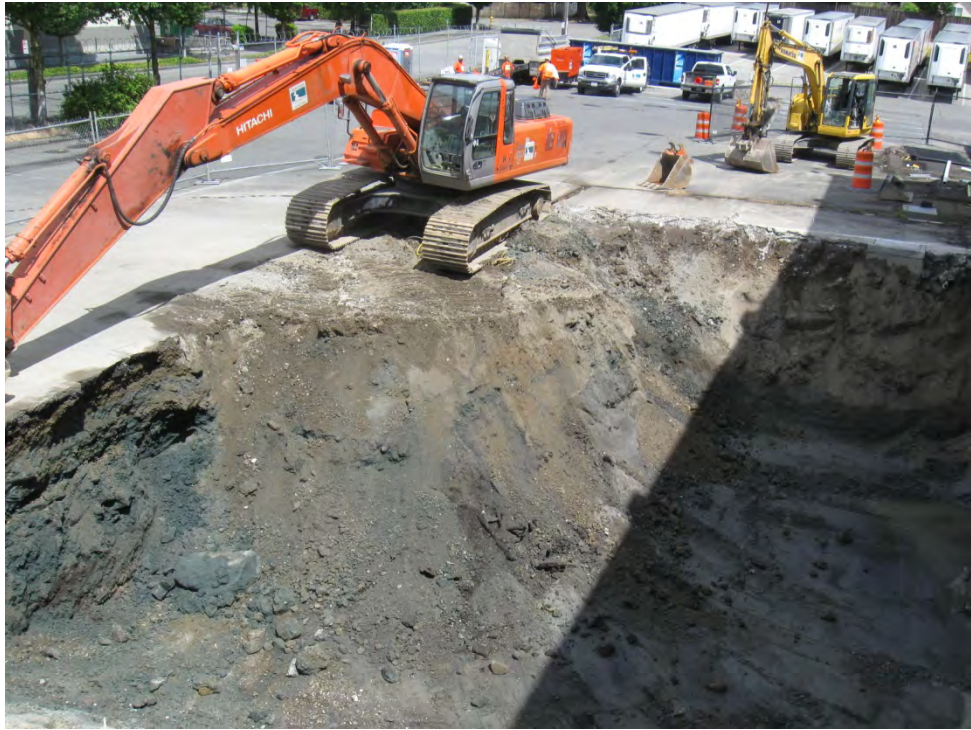
Photo 1: Initial Excavation in the Vicinity of Former Monitoring Well MW07, 7/16/2011

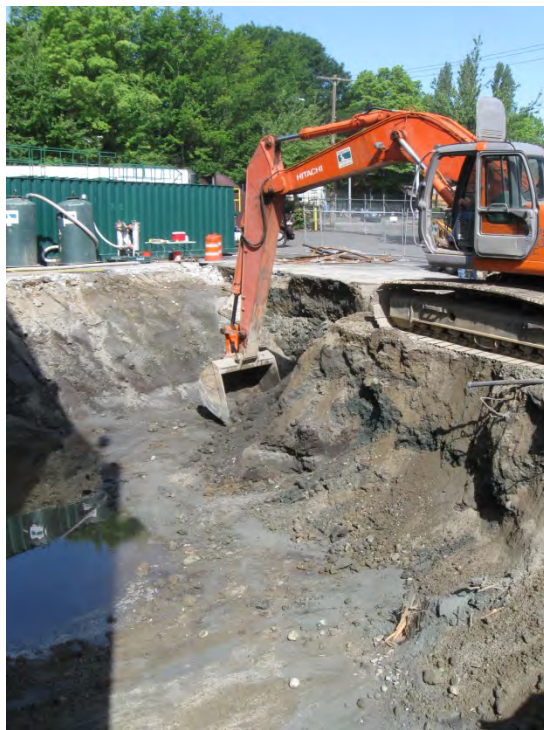
Photo 2: Southwest Corner of Excavation with Water Treatment System in Background, 7/18/2011

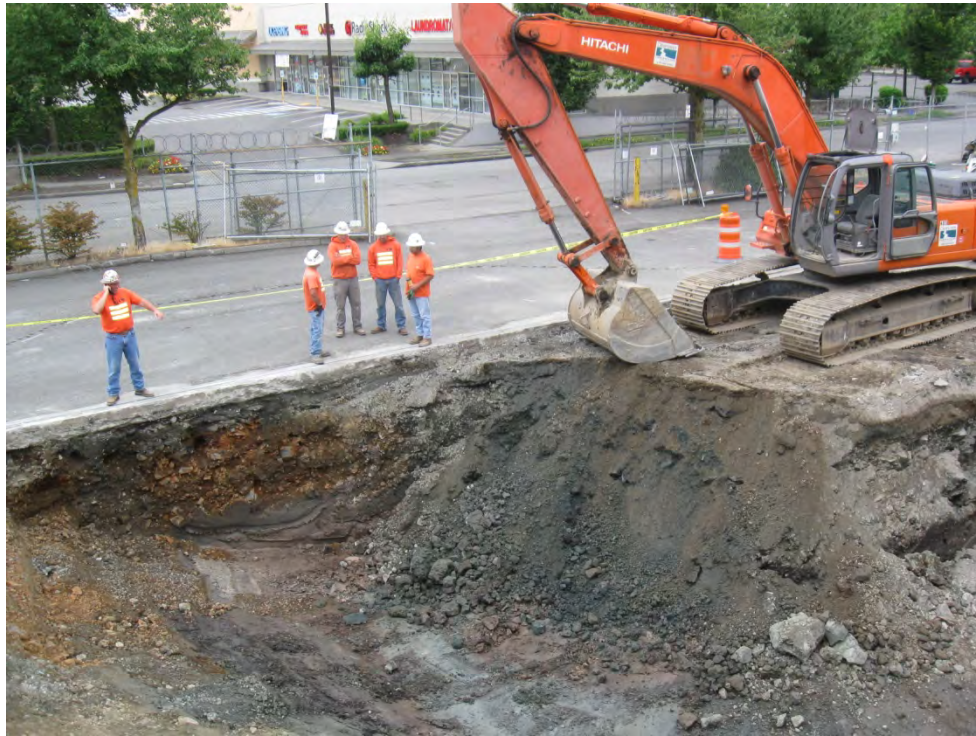
Photo 3: Excavation East of Former Monitoring Well MW02, 7/19/2011

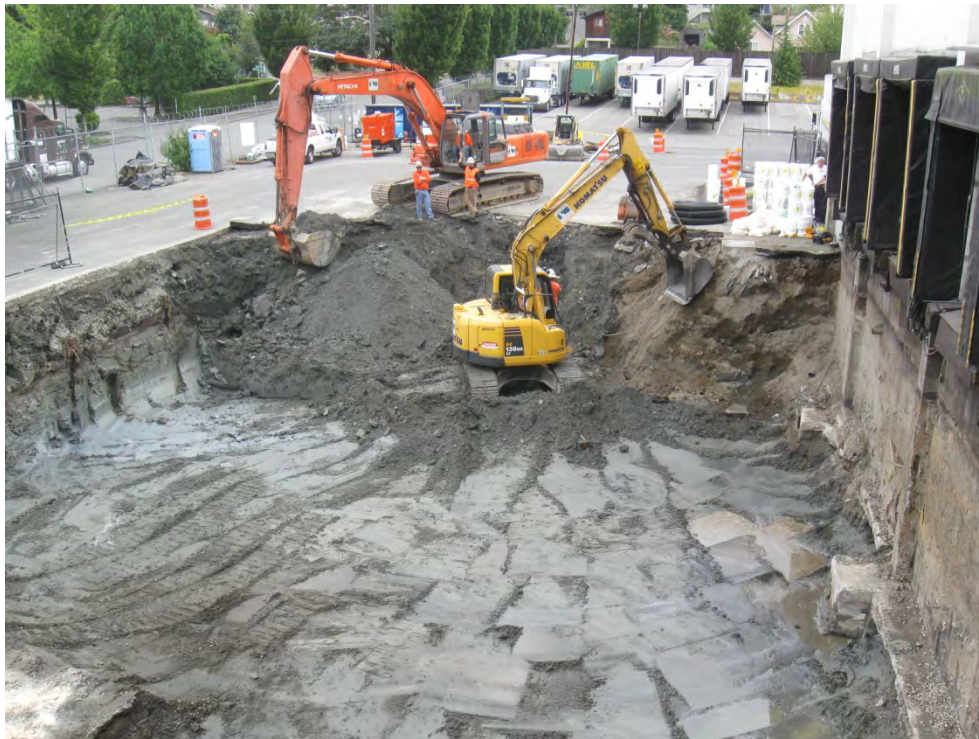
Photo 4: Excavation Showing Exposed North Wall Beneath Truck Bays, 7/20/2011

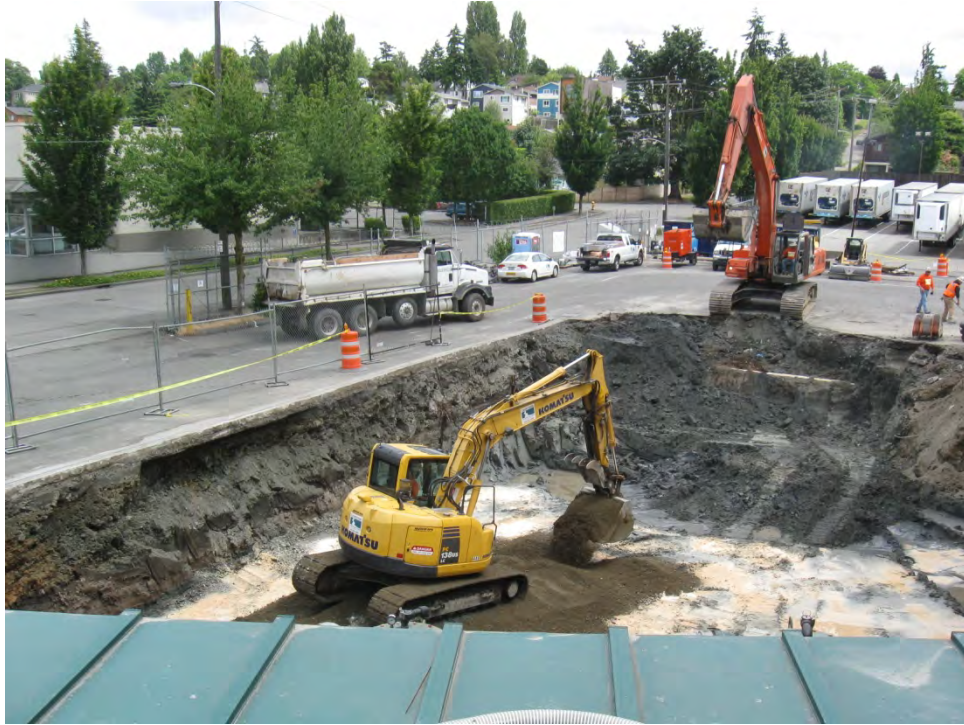
Photo 5: Start of Backfilling Activities (Note Regenesis Products Spread on Excavation Bottom), 7/20/2011

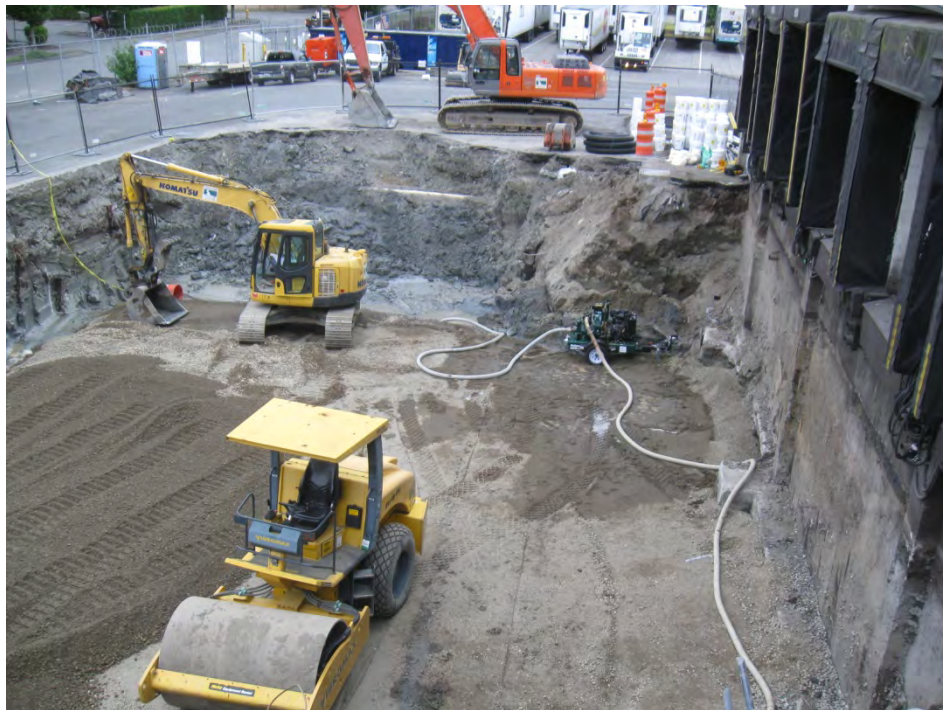
Photo 6: Excavation Backfilling and Compaction, with Dewatering Pump, 7/21/2011

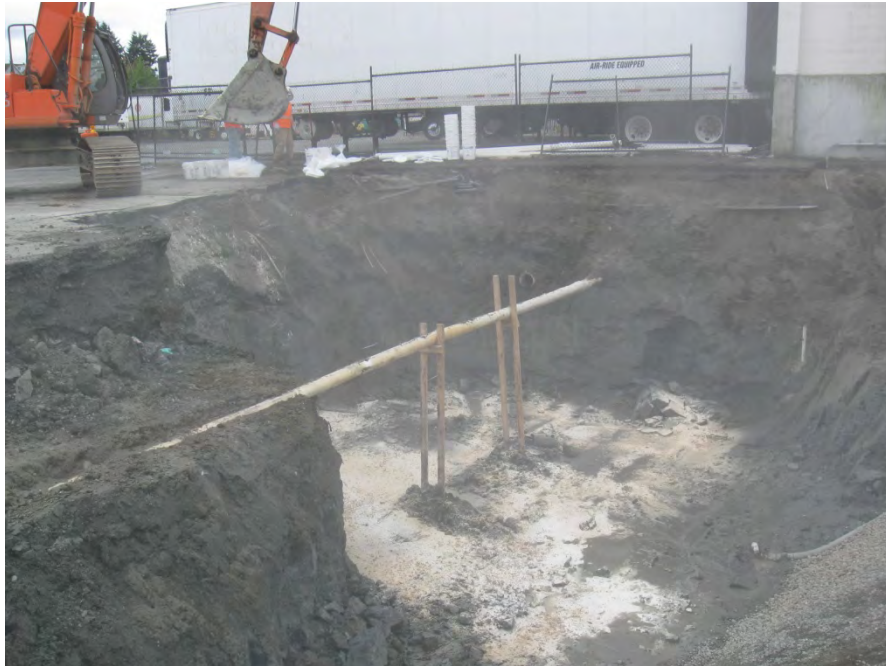
Photo 7: Sanitary Sewer Line Protected during Construction (Note Regenesis Products Spread on Excavation Bottom), 7/26/2011

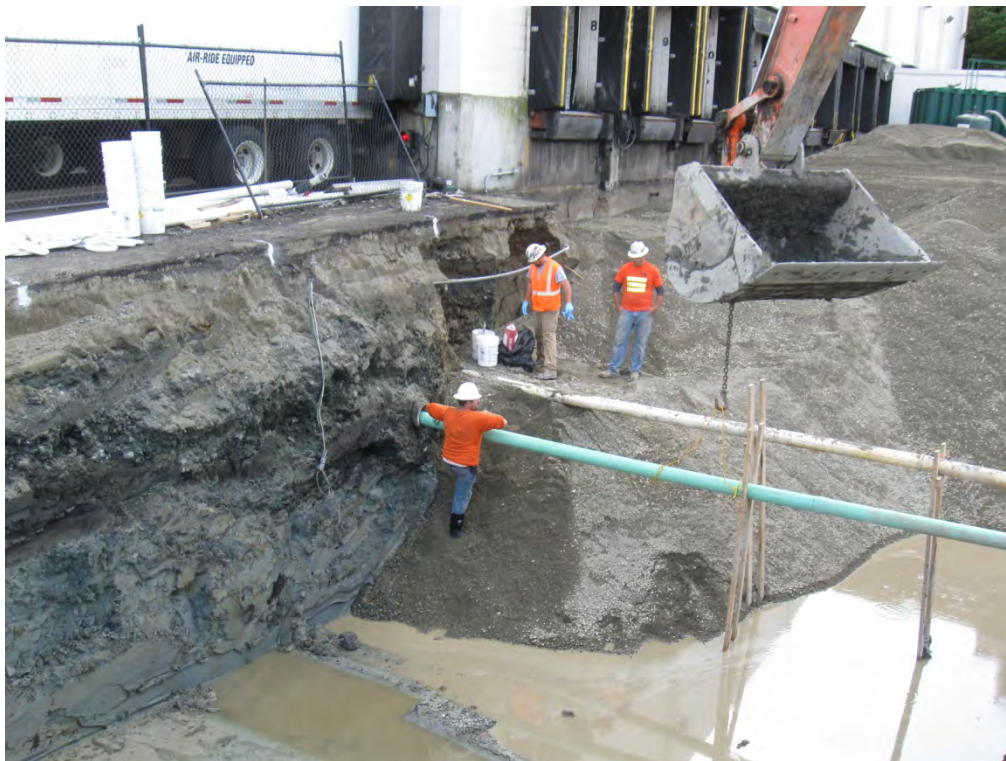
Photo 8: Storm Drain Line Replacement (Green Pipe), 7/26/2011

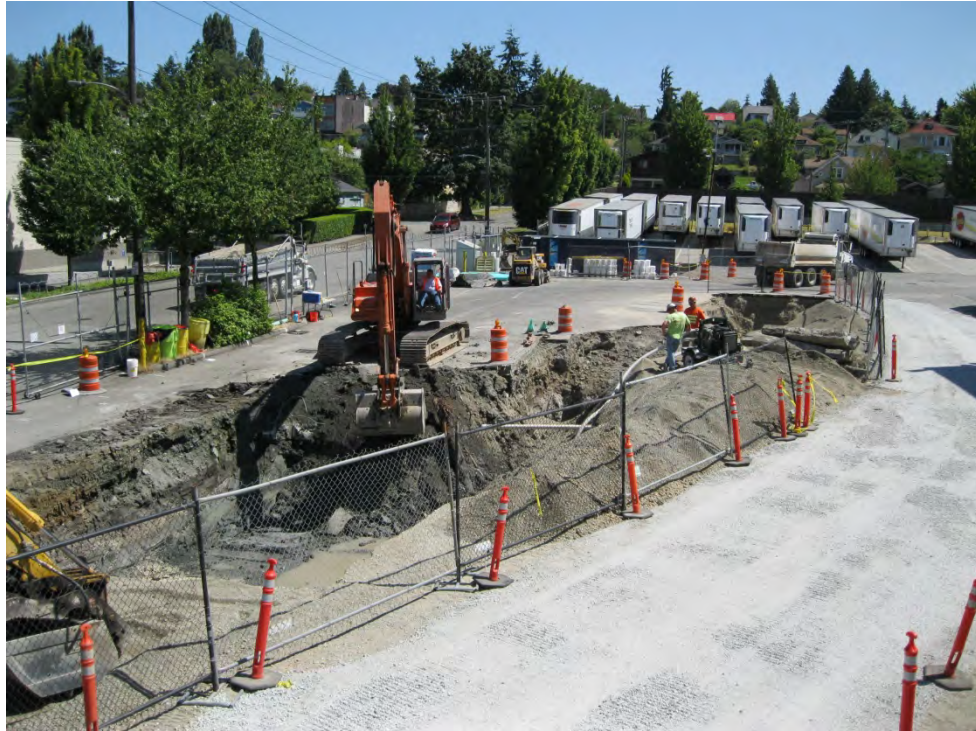
Photo 9: Excavation in Northwest Corner (Note Temporary Truck Lane Over Backfilled Southern Portion of Excavation), 7/30/2011

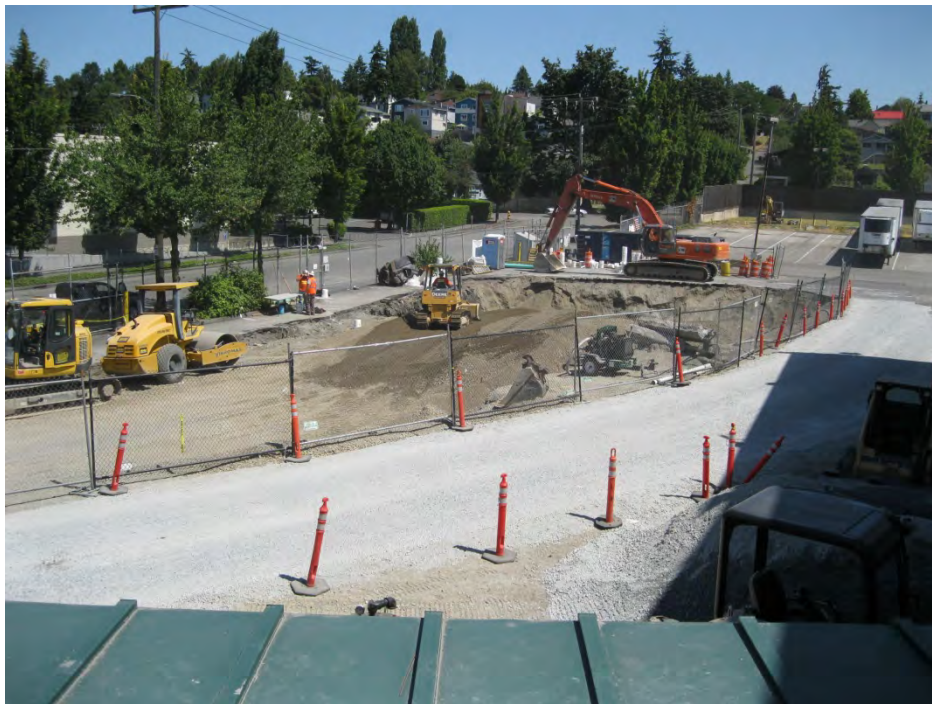
Photo 10: Backfilling and Compaction in Northeast Corner of Excavation, 8/4/2011

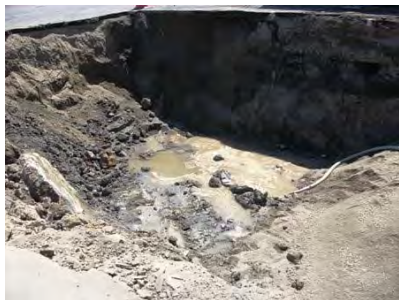
Water From Existing Storm Drain
At Bottom Grade Elevation

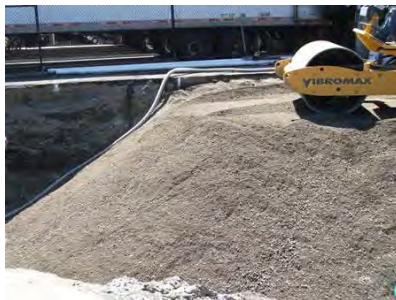
Type 17 Being Compacted @
00+10 Grid / South View

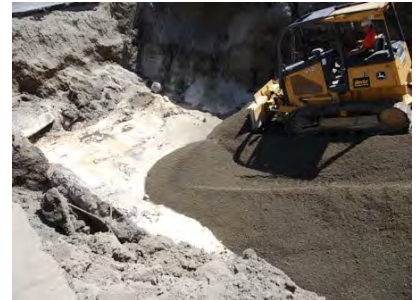
Type 17 Being Placed Over Top Of
ORC /Oxygen Release Compound
