# UNDERGROUND STORAGE TANK Closure and Site Assessment Notice

Site/Business Name MAIN STREET GROCERY  
Street

**ENVIRONMENTAL ACTIONS REPORT  
Historical and Recent Activities**

**"Main Street Grocery"  
Formerly a Shell Gas Station  
901 MLK Jr. Way  
Tacoma, Washington 98405**

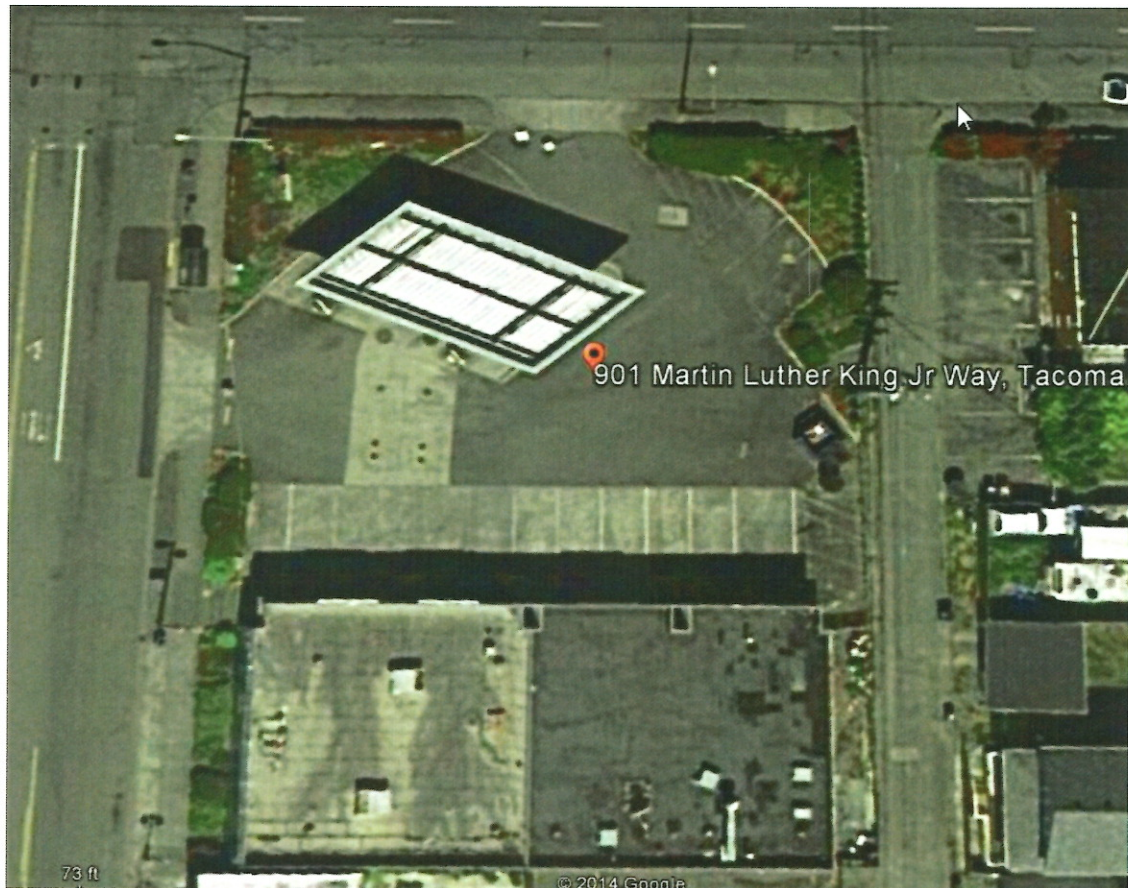
This site is on the Southeast corner of Martin Luther King Jr. Way and South 9<sup>th</sup> Street. The structure extends from the street to the alley, with white painted car parking spaces marked on the asphalt in front of the structure. The site slopes toward the Northeast, and there are a few feet of "drop-off" on the Eastern edge of the site along the alleyway. The bright white and pinkish-tint trapezoidal shaped metal structure is the Canopy over the Pump Island. The Pump Island concrete pad outline may be seen beneath the Canopy. A concrete "strip" exists between the parking spaces and the Pump Island. Six small dark circles show in that concrete "strip". Those are the steel lids that cover the holes of the two 10,000 gallon UST's that lay in a North - South direction. Most all of the remaining site surface is covered with asphalt or landscaping. The gray rectangle to the Northeast of the Pump Island is the steel top of the "Oil/Water" separator. The structure is being remodeled as Market and Convenience Store at this time.

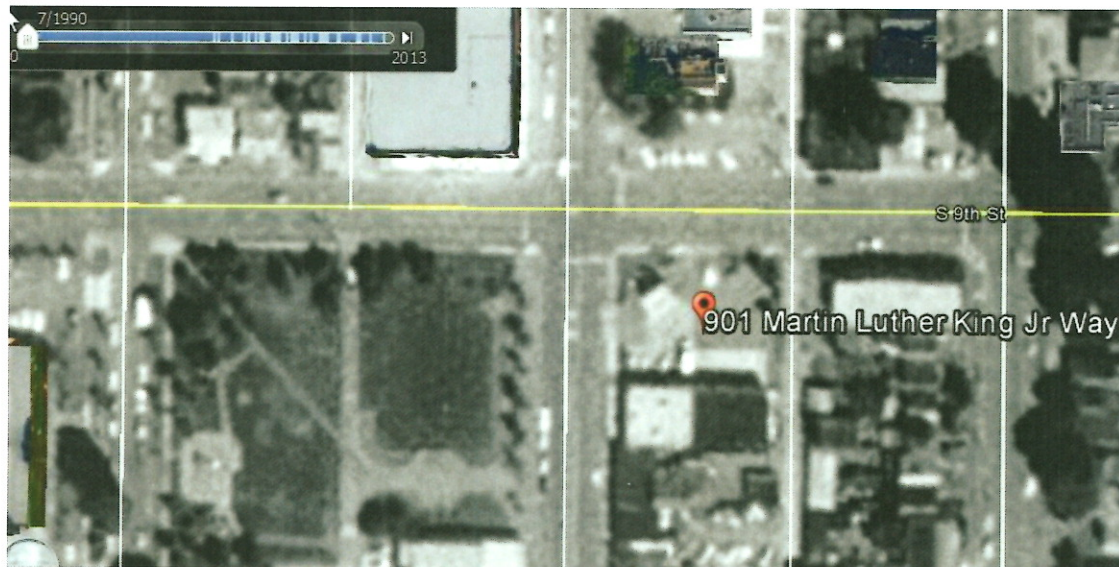
July 1990 aerial view of the site. The "quality" of this photo is "poor", and this is the best focus possible. You may also see on the blue strip (top left of the photo), that there were not any additional photos taken for about 10 years. BUT, note the differences between the present site photo on the precious page and this photo. It "may be seen" (with magnification) that the concrete "strip" atop the three UST's extends toward the East more than is presently there. That was the cover atop the third UST.

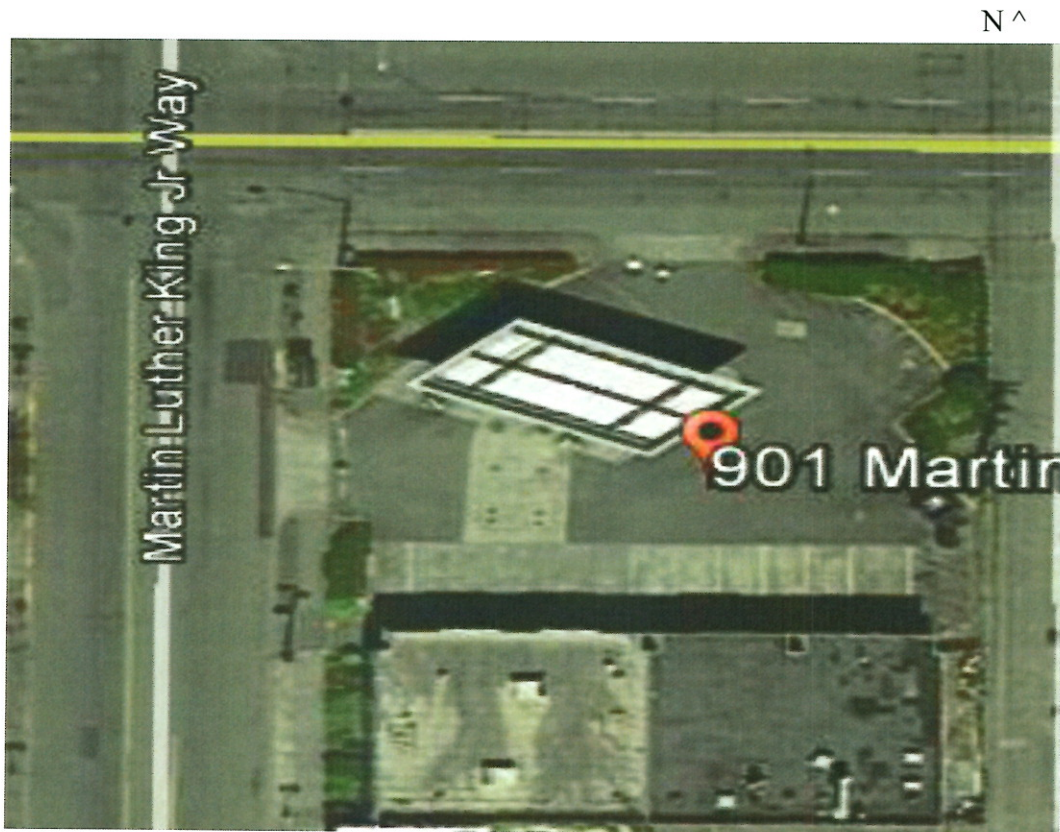
Two angled "Islands" having four gas pumps are located beneath the white parallelogram shaped canopy roof. The site slopes slightly toward the NE and the rectangular steel lid of the Oil-Water Separator may be seen near the green landscaping in the NE corner of the asphalt area. Also in the above aerial photo it may be seen, that the two 10,000 gallon single wall Fiberglass Underground Storage Tanks (UST's) are lying in front of the building structure, in a North-South direction under the grayish concrete surface, between the canopy roof structure and the "marked" car parking spaces. These two UST's can be identified by the six small round tank openings (lids) located in the gray concrete pad area.

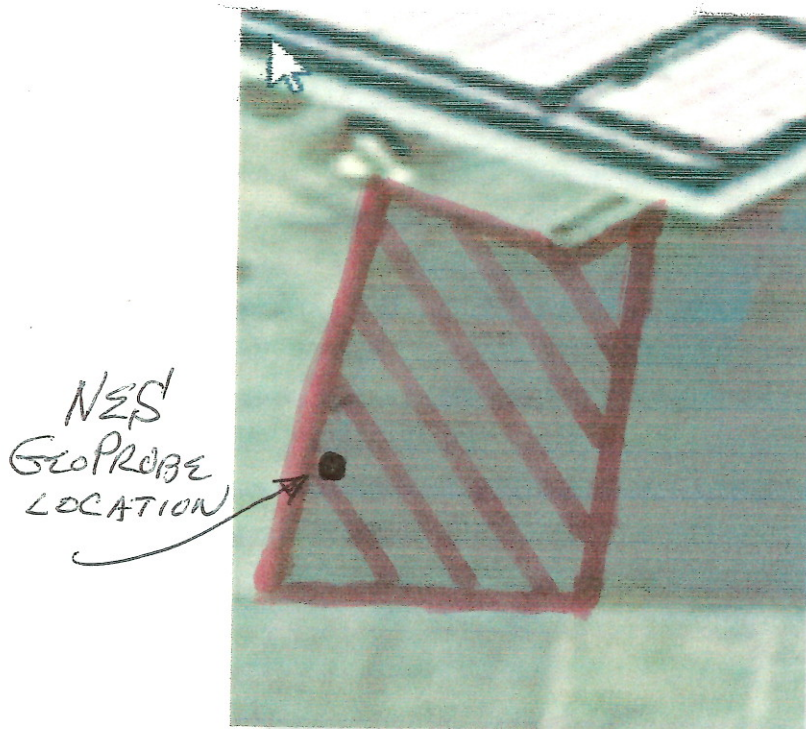
The third UST, which had been "Decommissioned-In-Place" in 1999, had been located to the East side of concrete pad covering those two remaining UST's. The work area of the Benzene "hit" is located on the East side of the concrete pad covering the two existing UST's. That area had been resurfaced with asphalt after Decommissioning. An enlargement of that "third UST" asphalt paved work area is shown within the red cross-hatched area.

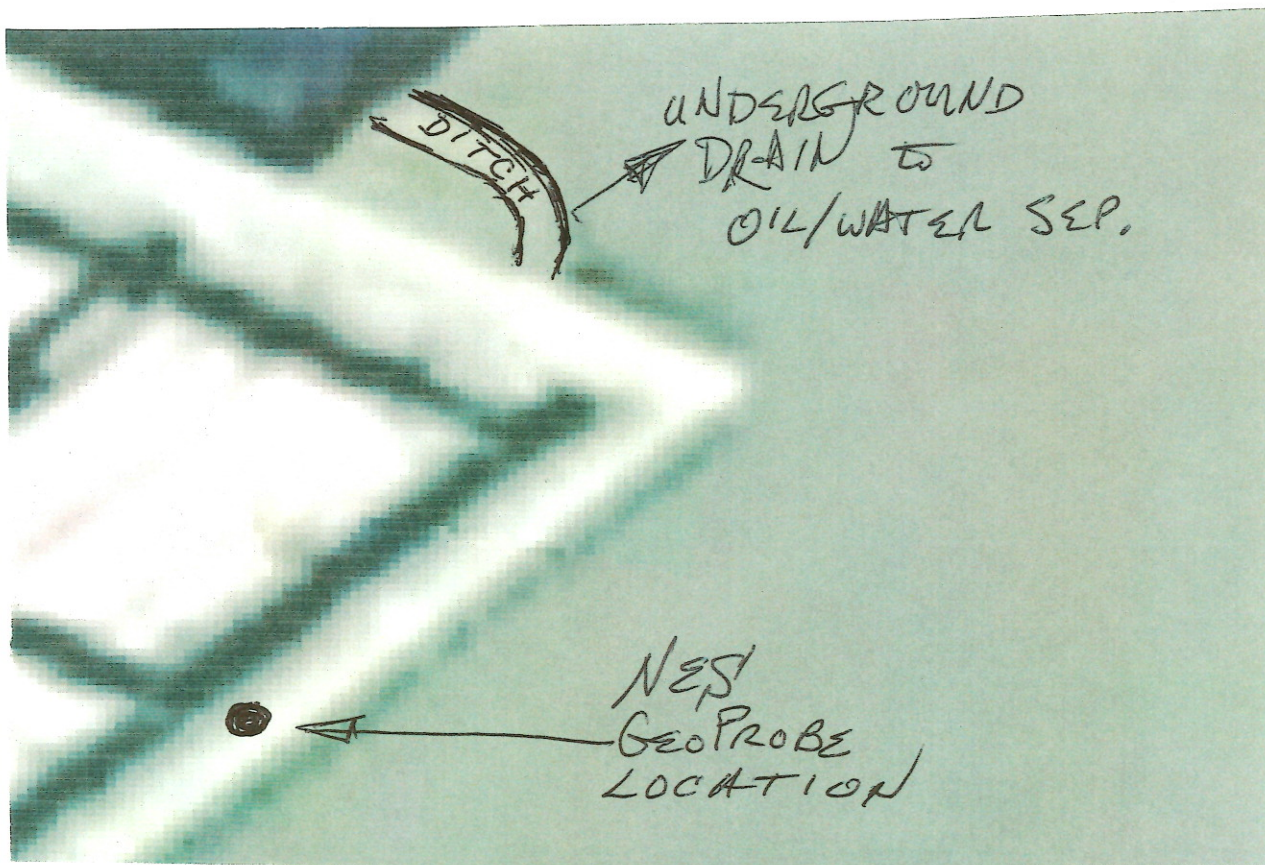
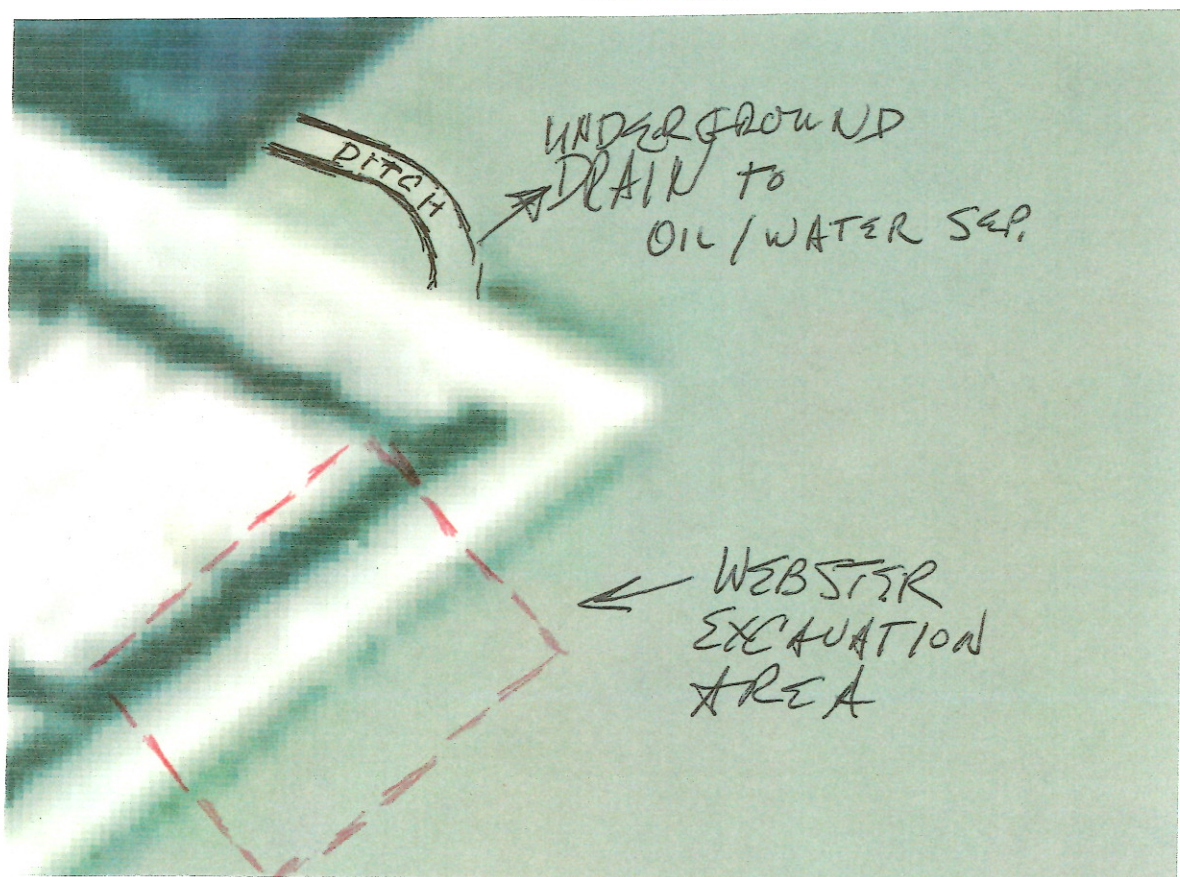
On the following page are aerial photos that depict the location of the NES sample (3N) GeoProbe boring location, and the Webster excavation location shown in RED marked outline.

The same area where NES had made the GeoProbe boring, and took Sample number (3N), was stripped of the asphalt with use of the Backhoe breaker. Layers of soil were carefully excavated with the Backhoe and tested with the PID. A number of changes in soil colorizations were observed at different depths. No PID hydrocarbon responses were obtained in any of the excavations down to about six feet deep, (which was deeper than the NES boring). As the "dig" progressed, one soil Sample (#1) had been taken of the most discolored soil from the Backhoe bucket. That soil Sample had been located at the depth of approximately four feet. This grab sample was sent to the Lab for testing by NWT PH-HCID.

Asphalt resurfacing was made of the compacted soil at the excavation made at the NE corner of the Pump Island, and the owner was reminded to repair the concrete drainage ditch and replace the slotted metal tops.
