***Level I Environmental  
Site Assessment  
Clinic Property  
Yakima, Washington***

*July 1996*

***Central Washington Comprehensive Mental Health***

**RE: PHASE 1 ENVIRONMENTAL SITE ASSESSMENT, CLINIC PROPERTY IN  
YAKIMA, WASHINGTON**

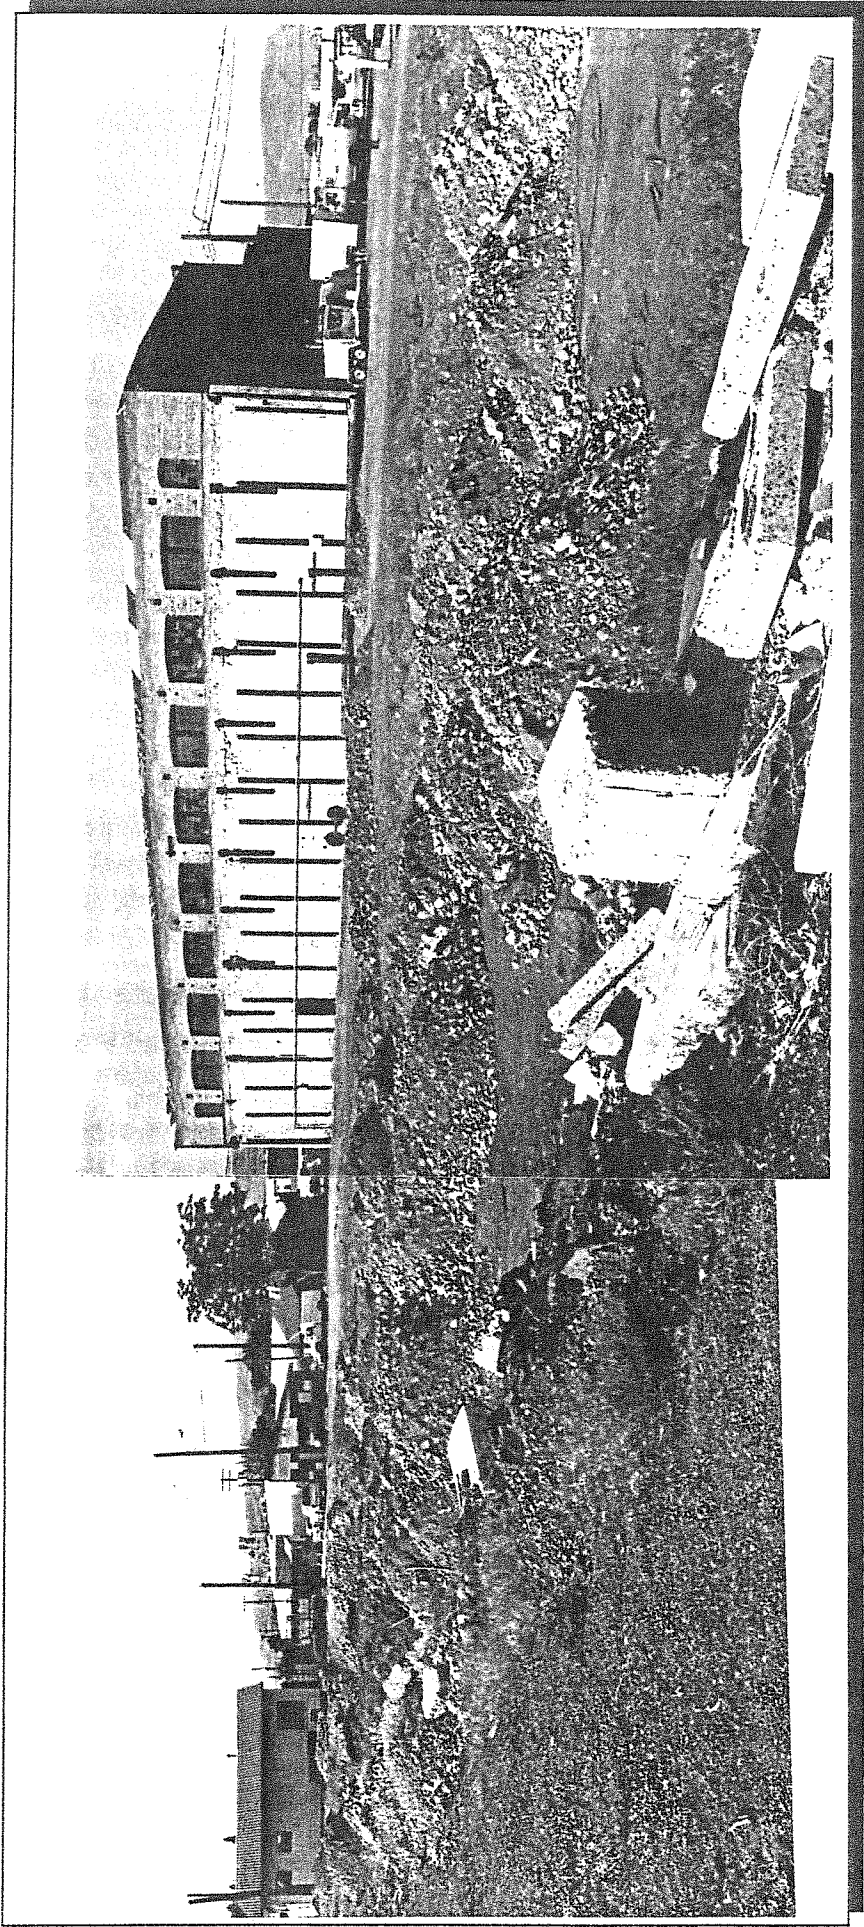
Piles of fill materials containing gravelly soil and broken concrete were observed along the western side of the site (Photo 1). The area formerly contained railroad tracks, which have been removed. The tracks were used to move cars into and out of a storage barn located south of the site, and was at a lower elevation than the surrounding area. Mr. Pitney indicated that the fill materials may have been brought to the site by Tri-Ply Construction, the contractor for the upcoming expansion project. We contacted Tri-Ply and spoke with Mr. Jake Jundt and Mr. Mike McGuire regarding the fill. Both individuals indicated that Tri-Ply has not been placing fill at the site. Mr. McGuire indicated that he has been involved with the Comprehensive Health project for about two years. He indicated that some of the fill has been on site for over two years, and some has been placed more recently.

**Photo 1** East parcel of site looking toward northeast. Trolley barn in background; miscellaneous fill in foreground.

- ▶ Sample near-surface soils at the location of the debris pile, and analyze for PAH and total metals.
- ▶ Excavate test pits in the area of the former car barn to look for indications of former drywell(s) and stained soil. Field screen soils with a Hanby™ kit that is capable of identification and approximate quantification of petroleum hydrocarbons. Submit selected samples for analytical testing, if appropriate, for TPH, PAH, PCB, metals, and/or solvents.

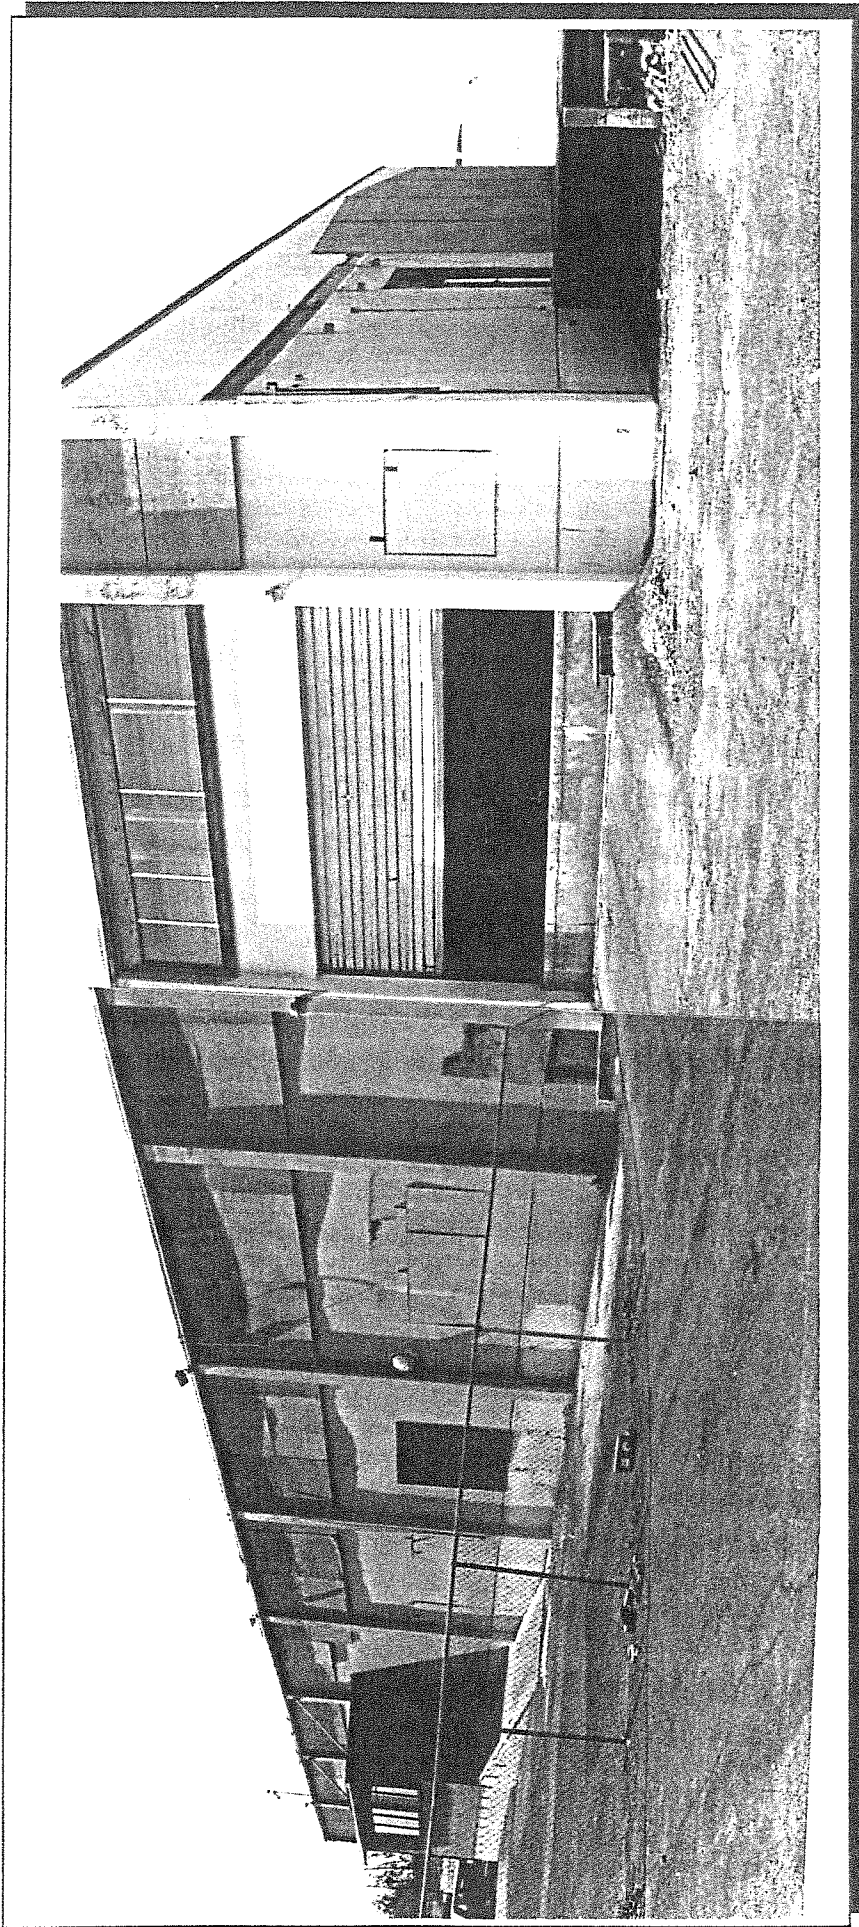
The Comprehensive Health building at 401 South 5th Avenue is a concrete structure with a flat roof (Photo 2). The west part of the building, facing South 5th Avenue, houses

**Photo 2** Central Washington Comprehensive Mental Health facility on west parcel of site, looking toward northwest.

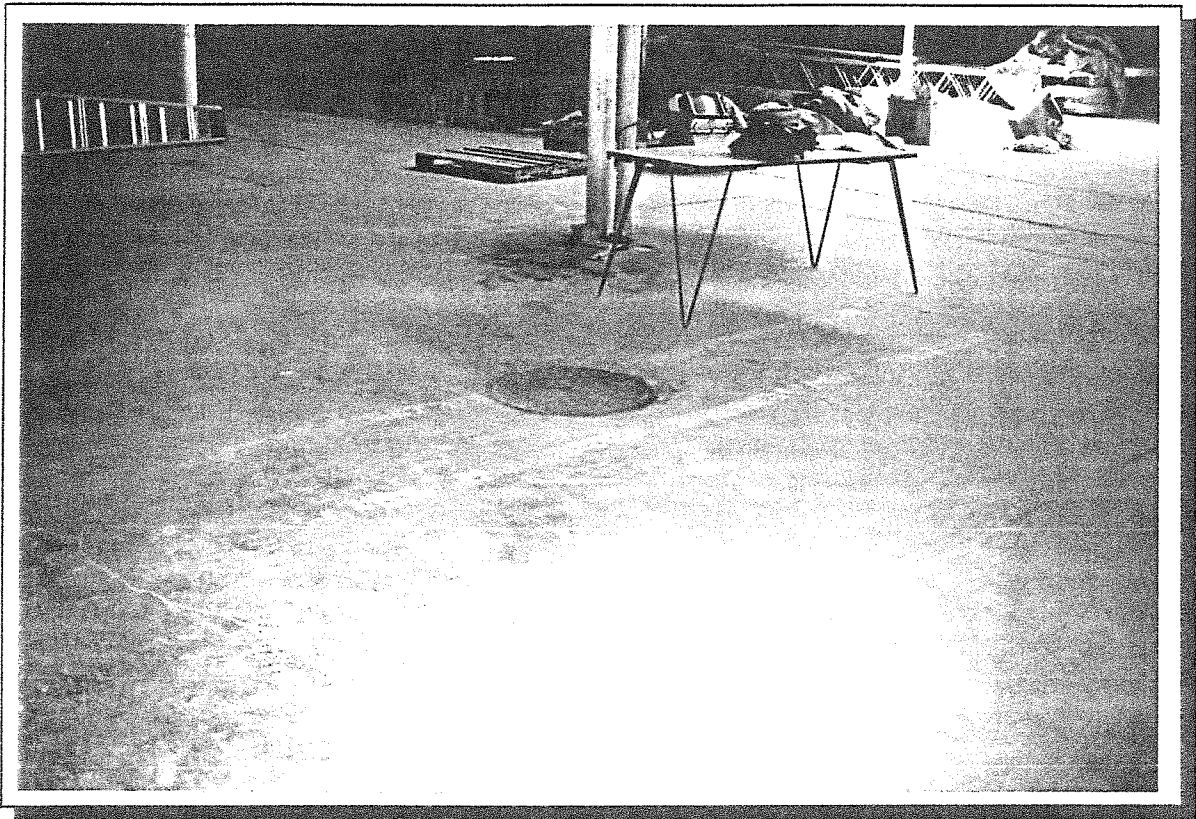
**Photo 3** Manhole cover over sanitary sewer line, inside the Comprehensive Health building.

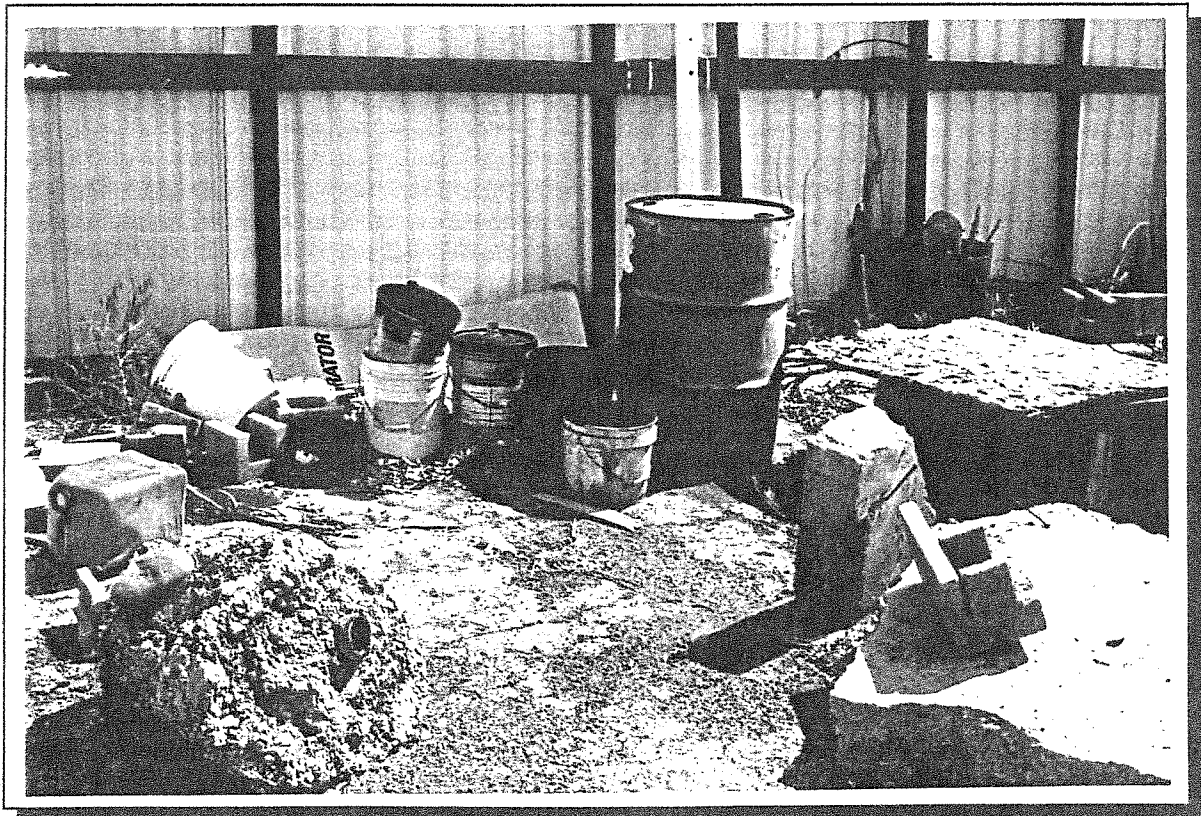
Parking areas at the site (located to the west, south, and north of the building) were observed to be covered with asphalt surfacing. Some miscellaneous debris, including a 55-gallon drum, some buckets, and concrete pieces, were observed at the southeast area of the property (Photo 4). The drum was apparently at least partially filled, and some of the buckets were observed to be about half full of unidentified liquids and/or dark-colored sludges.

One 55-gallon drum and several buckets with unknown contents were observed at the site.

**Photo 4** Drum, buckets, and broken concrete on asphalt-paved parking area, located near southeast corner of west parcel.

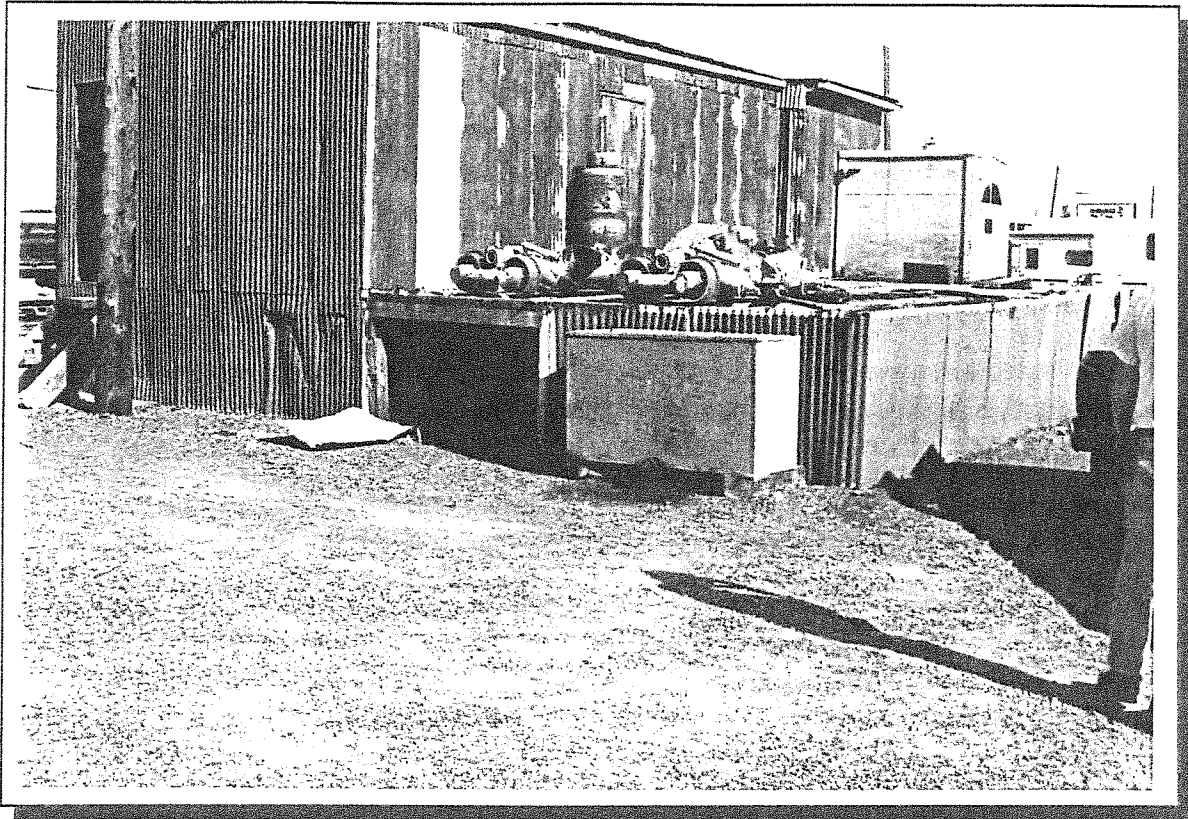
The portion of the Yakima Trolley (Trolley) site that is considered to be on site for the purposes of this ESA was observed to contain a metal shed (Photo 5), miscellaneous debris in a pile (Photo 6), and fill materials (Photo 1). A metal tank next to a platform connected to the metal shed was observed to contain several inches of what appeared to be used oil, and stained soil near the tank outlet was noted (Photo 5). The surface area of stained soil was estimated to be about 4 square feet. Mr. Tom Shelnutt, vice-president of the non-profit organization that operates the Yakima Trolley and Museum, indicated that the tank had been used to store bolts, and that it was going to be removed from the site. Mr. Shelnutt also indicated that the debris pile was also going to be removed from the site. The pile was observed to contain railroad ties, telephone poles, and some scrap metal, and was estimated to be about 27 by 17 feet wide and about 3 or 4 feet high.

A metal tank that reportedly contained waste oil and had been used for bolt storage was located at the site. A small area of stained soil, with an estimated surface area of 4 square feet, was observed near the tank outlet.

**Photo 5** Metal shed on east parcel of site. Waste oil tank in foreground.

- ▶ Sample near-surface soils in the area of stained soil at the tank reported to contain waste oil. Recommended analyses include TPH, PCB, and metals.

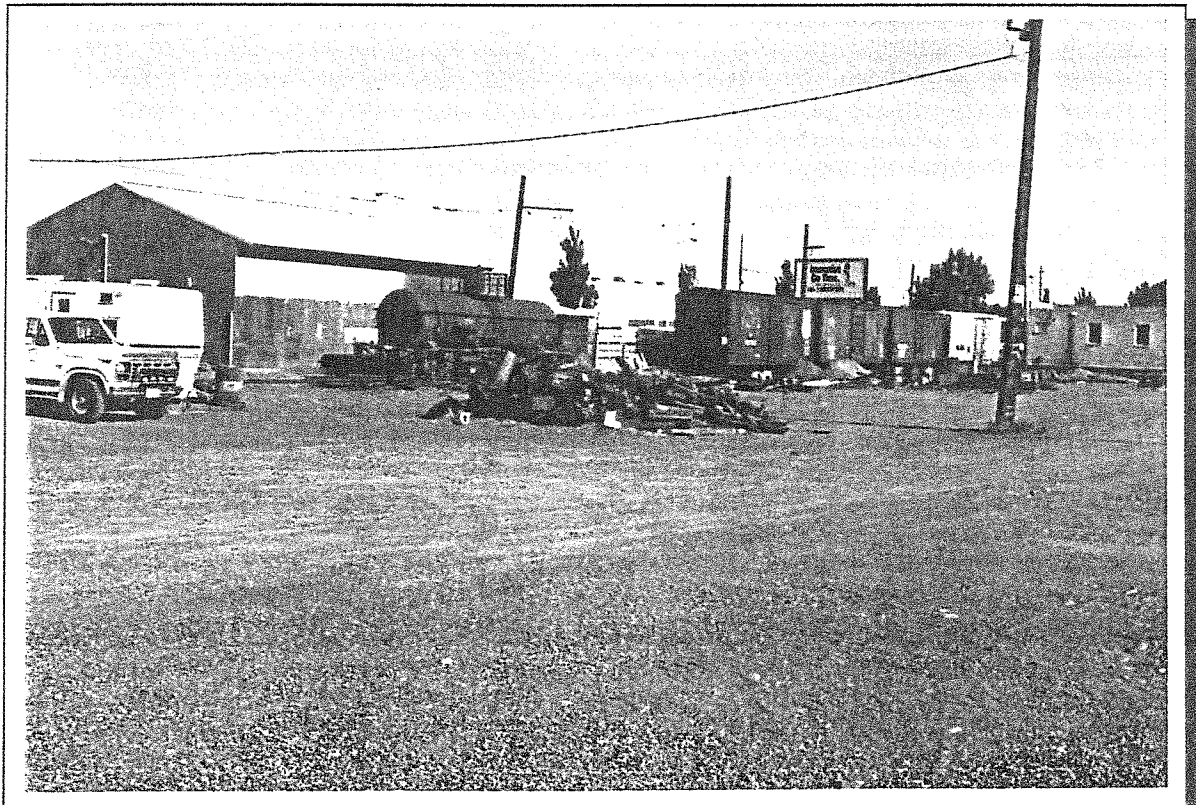
A miscellaneous debris pile containing railroad ties, telephone poles, and scrap metal was observed at the site. Wood products that have been treated with creosote or penta-polycyclic aromatic hydrocarbons (PAH) may contaminate the soil underlying the treated timber. Soil in areas that have been used for storage of such materials, or underlying railroad tracks, could also have been affected. Soil beneath railroad tracks may also be subject to petroleum product contamination from dripping undercarriages and connectors, particularly where cars sat on siding tracks.

**Photo 6** Debris pile containing railroad ties, telephone poles, and scrap metal, located on east parcel of site.
