LEVEL II INVESTIGATION

PORT of OLYMPIA

WEST BAY DRIVE SITE

September 20, 2000

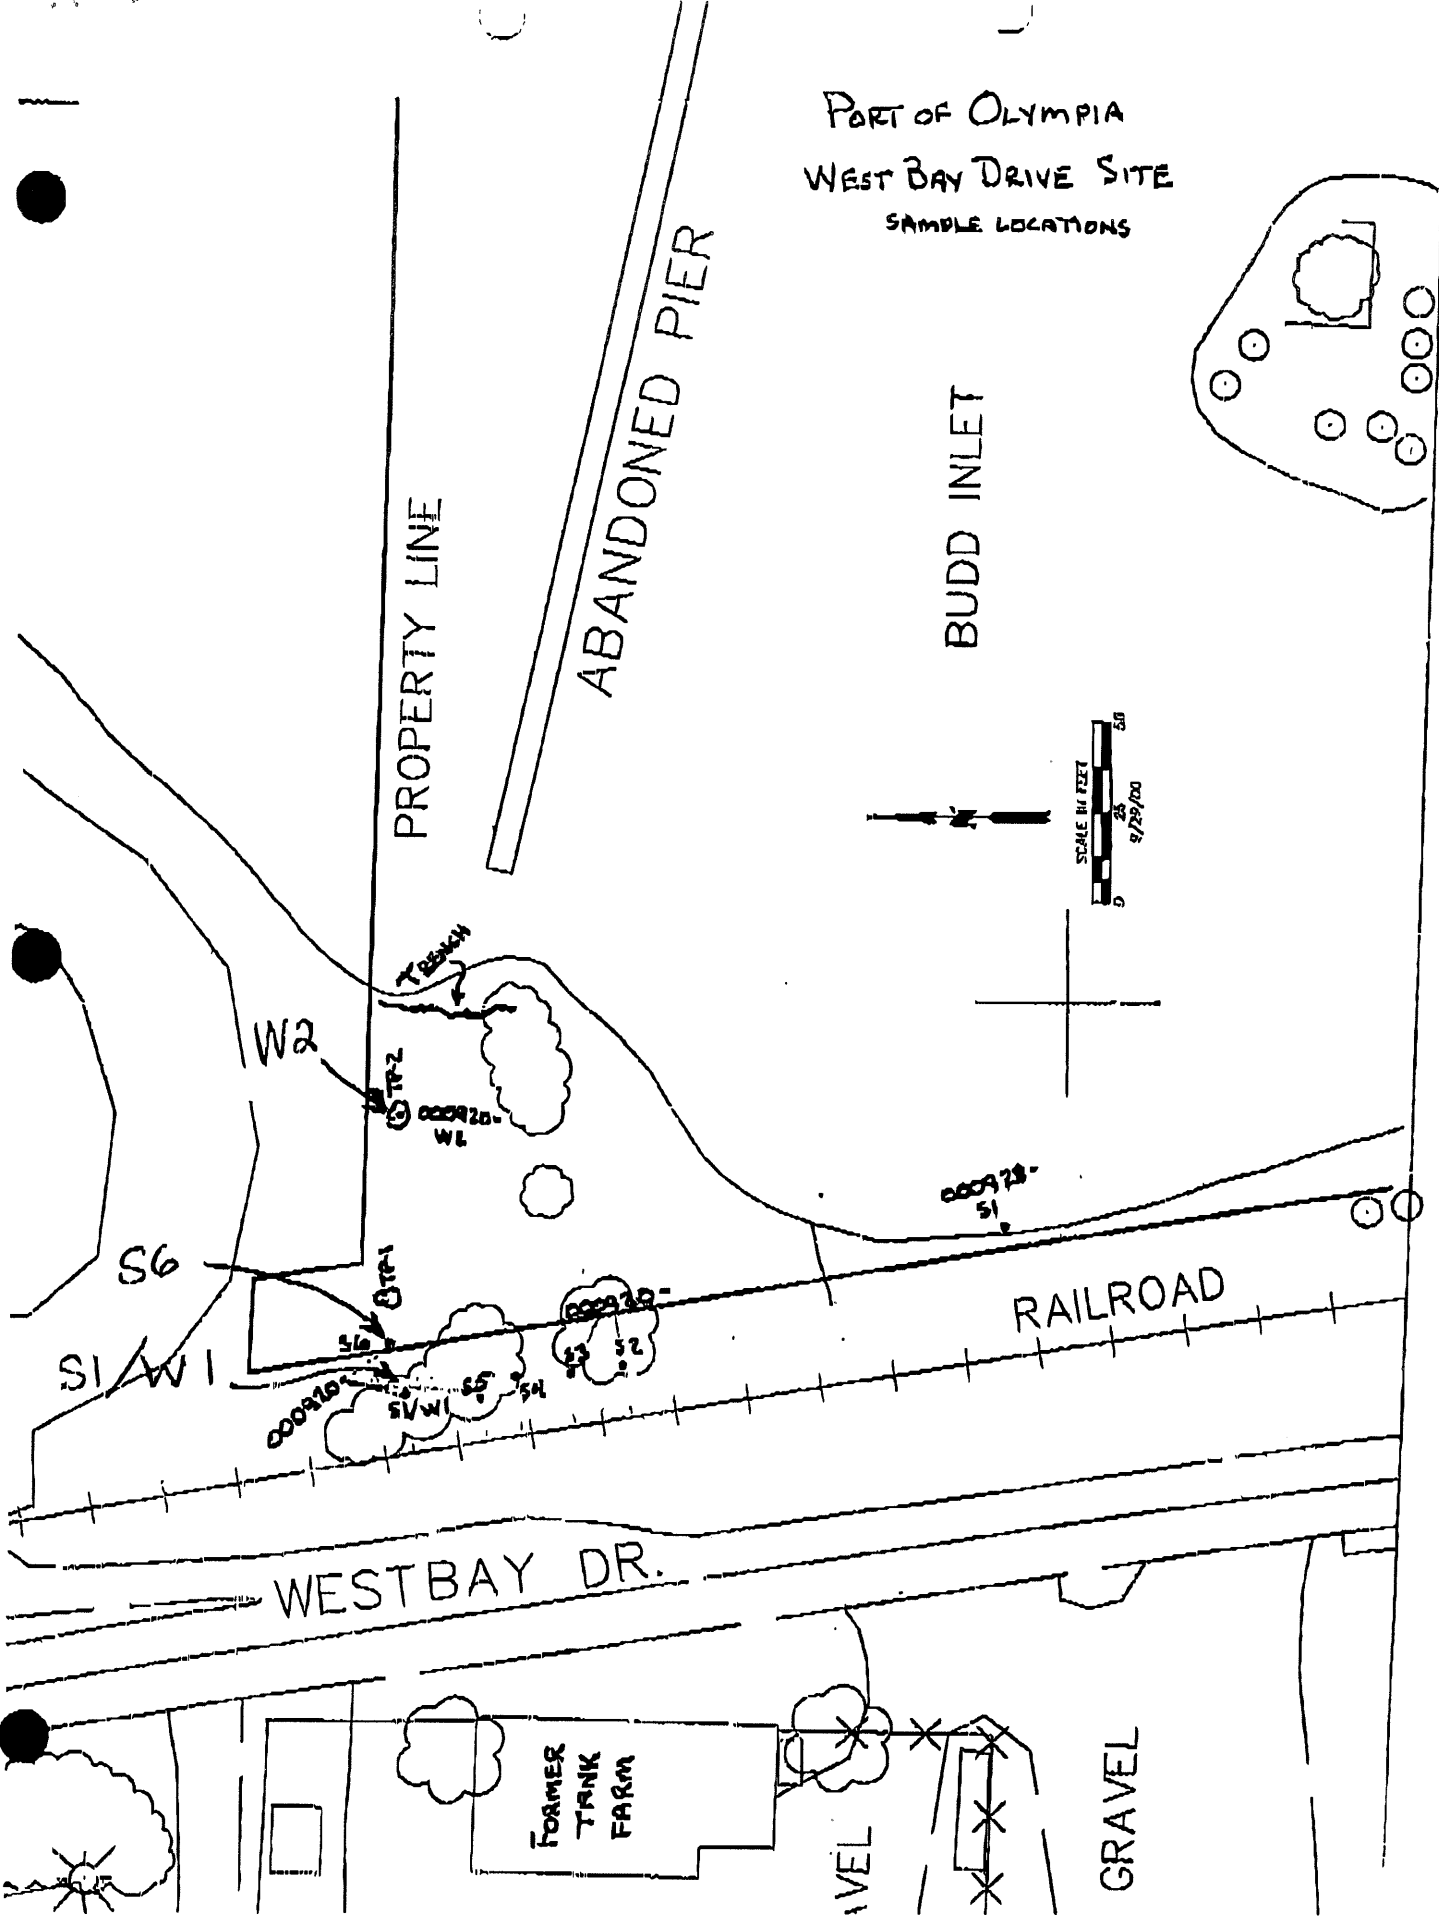
PORT OF OLYMPIA
WEST BAY DRIVE SITE
SAMPLE LOCATIONS

Three additional excavations were made adjacent to the product pipe path, south side (see figure 1). Soil contamination was confirmed in excavation S6, 30' east of the railroad centerline. Groundwater contamination was confirmed at the final excavation TP2, 94' east of the railroad centerline. While soils were not tested in this area, soil contamination is suspected here as well. Soil and groundwater contamination was suspected in location TP1 (see attached figure 1). Notable in the excavations along the pipeline route was a thick layer of sawdust at approximately 48" bgs. This layer was found in excavations S6, TP1, and TP2. This porous sawdust layer has offered an easy path for lateral migration of the product.

Samples were selectively analyzed for gasoline and extended diesel range hydrocarbons, BTEX, and for total lead. Elevated levels of diesel range petroleum contamination were found in subsurface soils at test locations S1 and S6. Significantly elevated levels of xylenes were also found in groundwater at location TP-2, with slightly elevated levels of xylenes (still over the 20-ppb Method A cleanup limits) found at location S1. While the levels of diesel contamination in soils were found to be higher at location S6, it is suspected that this was due to the more porous nature of the soils in this area. Heavy contamination was visually noted in excavation S1. Lead levels were found to be slightly elevated in samples S1 and S6, but within the 250 ppm cleanup levels allowable.
