**Subject: Preliminary Subsurface Sampling and Testing
Marketplace Plaza Gas Station & Dry Cleaner
18001 Bothell-Everett Highway Southeast
Bothell, Washington 98012**

**PRELIMINARY SUBSURFACE
SAMPLING & TESTING**

Marketplace Plaza Gas Station & Dry Cleaner
18001 Bothell-Everett Highway Southeast
Bothell, Washington

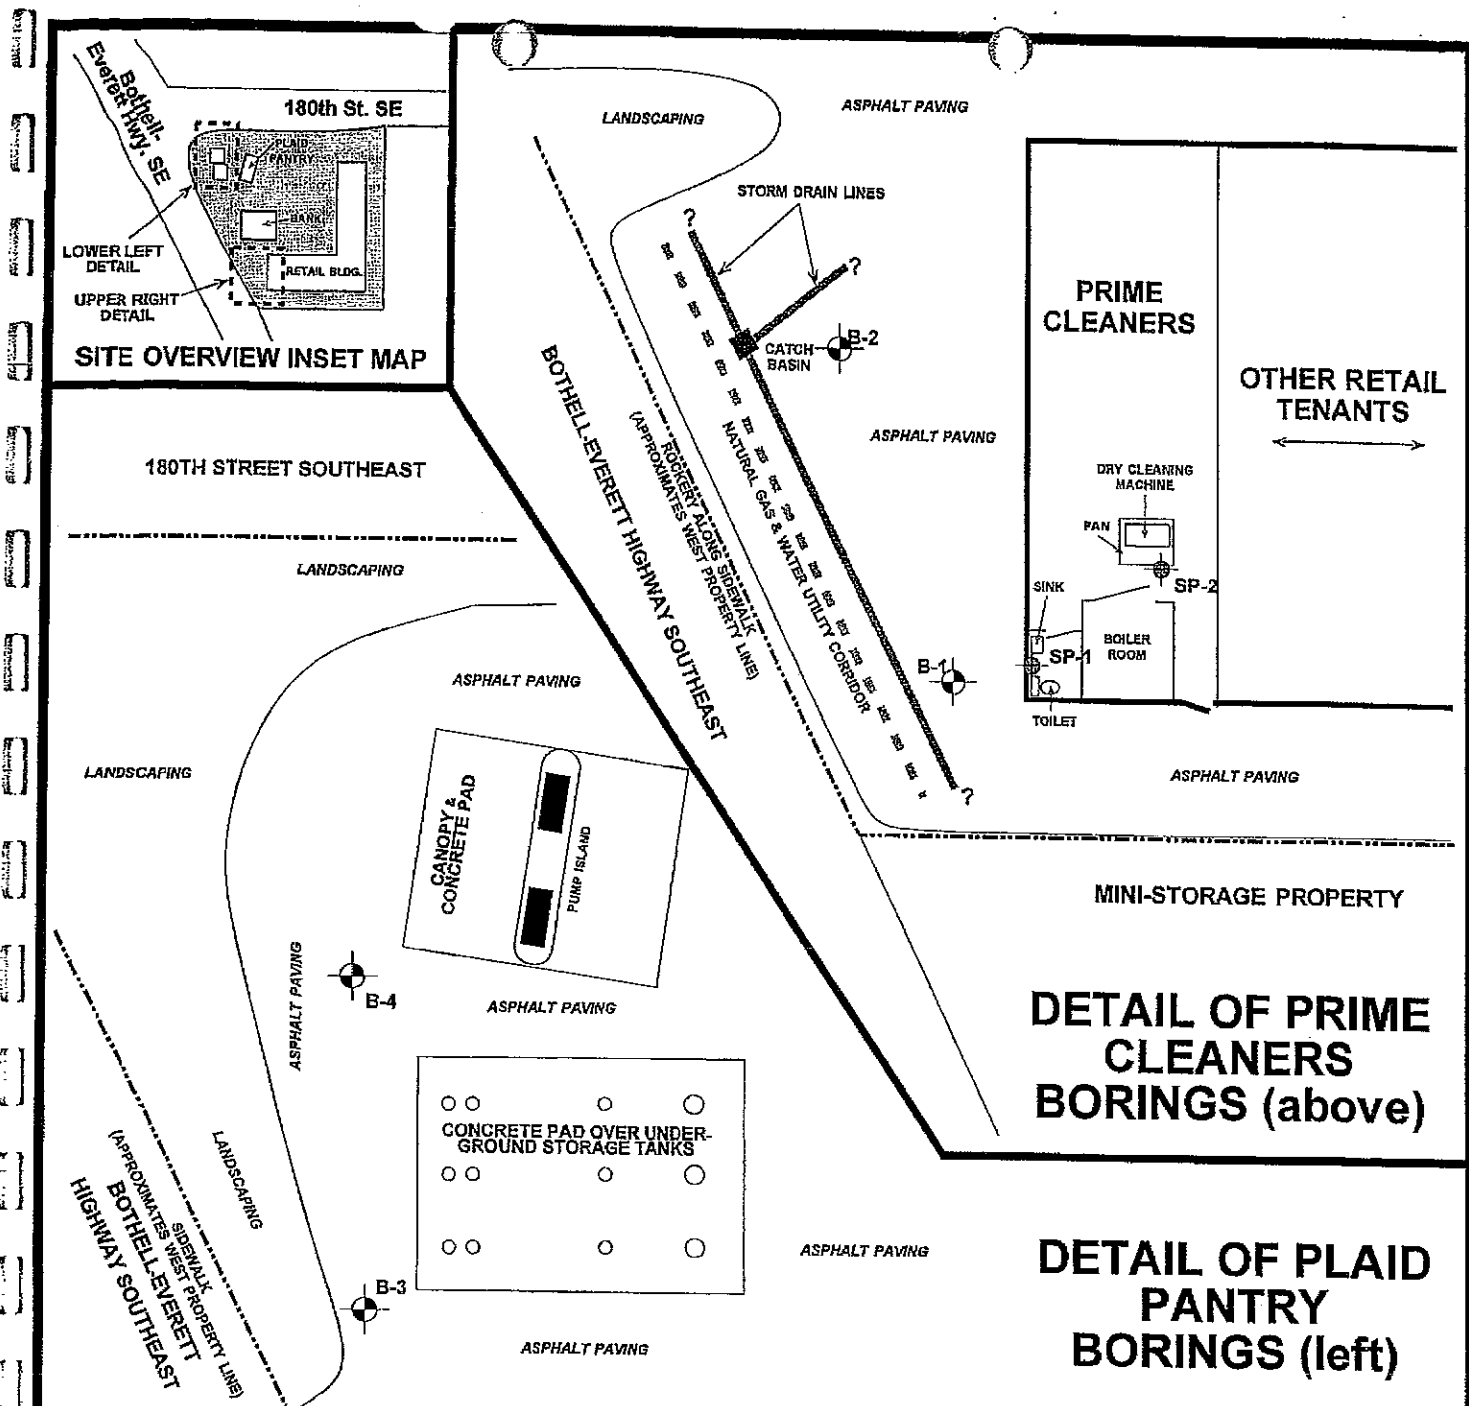
SITE EXPLORATION PLAN

Four (4) soil borings were completed by us on March 9, 1999 at the approximate locations noted as B-1, B-2, B-3 and B-4 on the Site Exploration Plan, Plate 2. The boring locations were chosen based upon the proximity to the dry cleaning machine and restrooms at the dry cleaner (boring B-1), a potential receptor area along a utility corridor near the dry cleaner (boring B-2), proximity to the underground storage tanks at Plaid Pantry (boring B-3), and proximity to the

As summarized in Table 1 above, tetrachloroethene was detected in samples obtained from borings B-1, SP-1, and SP-2. B-1 was located just west of the restrooms at the dry cleaner, SP-1 was located in the restroom of the dry cleaner, and SP-2 was located adjacent to the dry cleaning machine. Cis-1,2,-dichloroethene, a degradation product of tetrachloroethene, was detected only in the sample obtained from boring B-1. No volatile organic compounds were detected in boring B-2. With the exception tetrachloroethene in sample SP-2-0'-2', obtained from adjacent to the dry cleaning machine, all reported concentrations are below the Method A cleanup level. Sample SP-2-0'-2' contained a concentration of tetrachloroethene slightly in excess of the Method A cleanup level. Please note that the concentration at SP-2 is below the Method B cleanup level (19.6 mg/kg).

With respect to soil conditions in the vicinity of Prime Cleaners, based solely upon the results of analysis of soil samples obtained from the vicinity of the dry cleaner, it appears that tetrachloroethene is present in low concentrations in the vicinity of the dry cleaning machine and restrooms at the site. Only one sample obtained as a part of this project, sample SP-1-0'-2' obtained from immediately beneath the slab floor of Prime Cleaners, contained a concentration of tetrachloroethene in excess of the Method A cleanup level, however, the reported concentration of 0.56 mg/kg in the sample is only slightly above the Method A cleanup level of 0.5 mg/kg. The concentration is well below the Method B cleanup level of 19.6 mg/kg. A degradation product of tetrachloroethene, cis-1,2-dichloroethene was present in sample B-1-5 (at a depth of 22.5 feet), but the concentration reported (0.33 mg/kg) is well below the Method B cleanup level of 800 mg/kg (no Method A cleanup level has been established for this compound). These findings confirm that a release has occurred at the Prime Cleaners facility, however, it does not appear that soil at the site has been significantly impacted, based upon the low concentrations reported.

In an effort to prevent any additional release through the sewer system at the property, we would strongly recommend that all process water waste (with the exception of regular water-based washing machine, toilet and hand washing wastewater) be considered to contain tetrachloroethene, be handled as a regulated (hazardous) waste, and be lawfully recycled by an EPA-registered hazardous waste handler and transporter (for example, Safety-Kleen). Additionally, it may be prudent to consider a review of site sewer integrity via a video camera "sewer survey" in an effort to document the condition of the sewer lines, and to repair any documented breaches in the sewer system as needed. The owner of the property should monitor to assure compliance.
