## TECHNICAL MEMORANDUM

RE: **CONSTRUCTION DOCUMENTATION  
STORMWATER TRUNK LINE CLEANOUT AND REPAIR EMERGENCY ACTION  
NORTH MARINA AMERON/HULBERT SITE  
EVERETT, WASHINGTON**

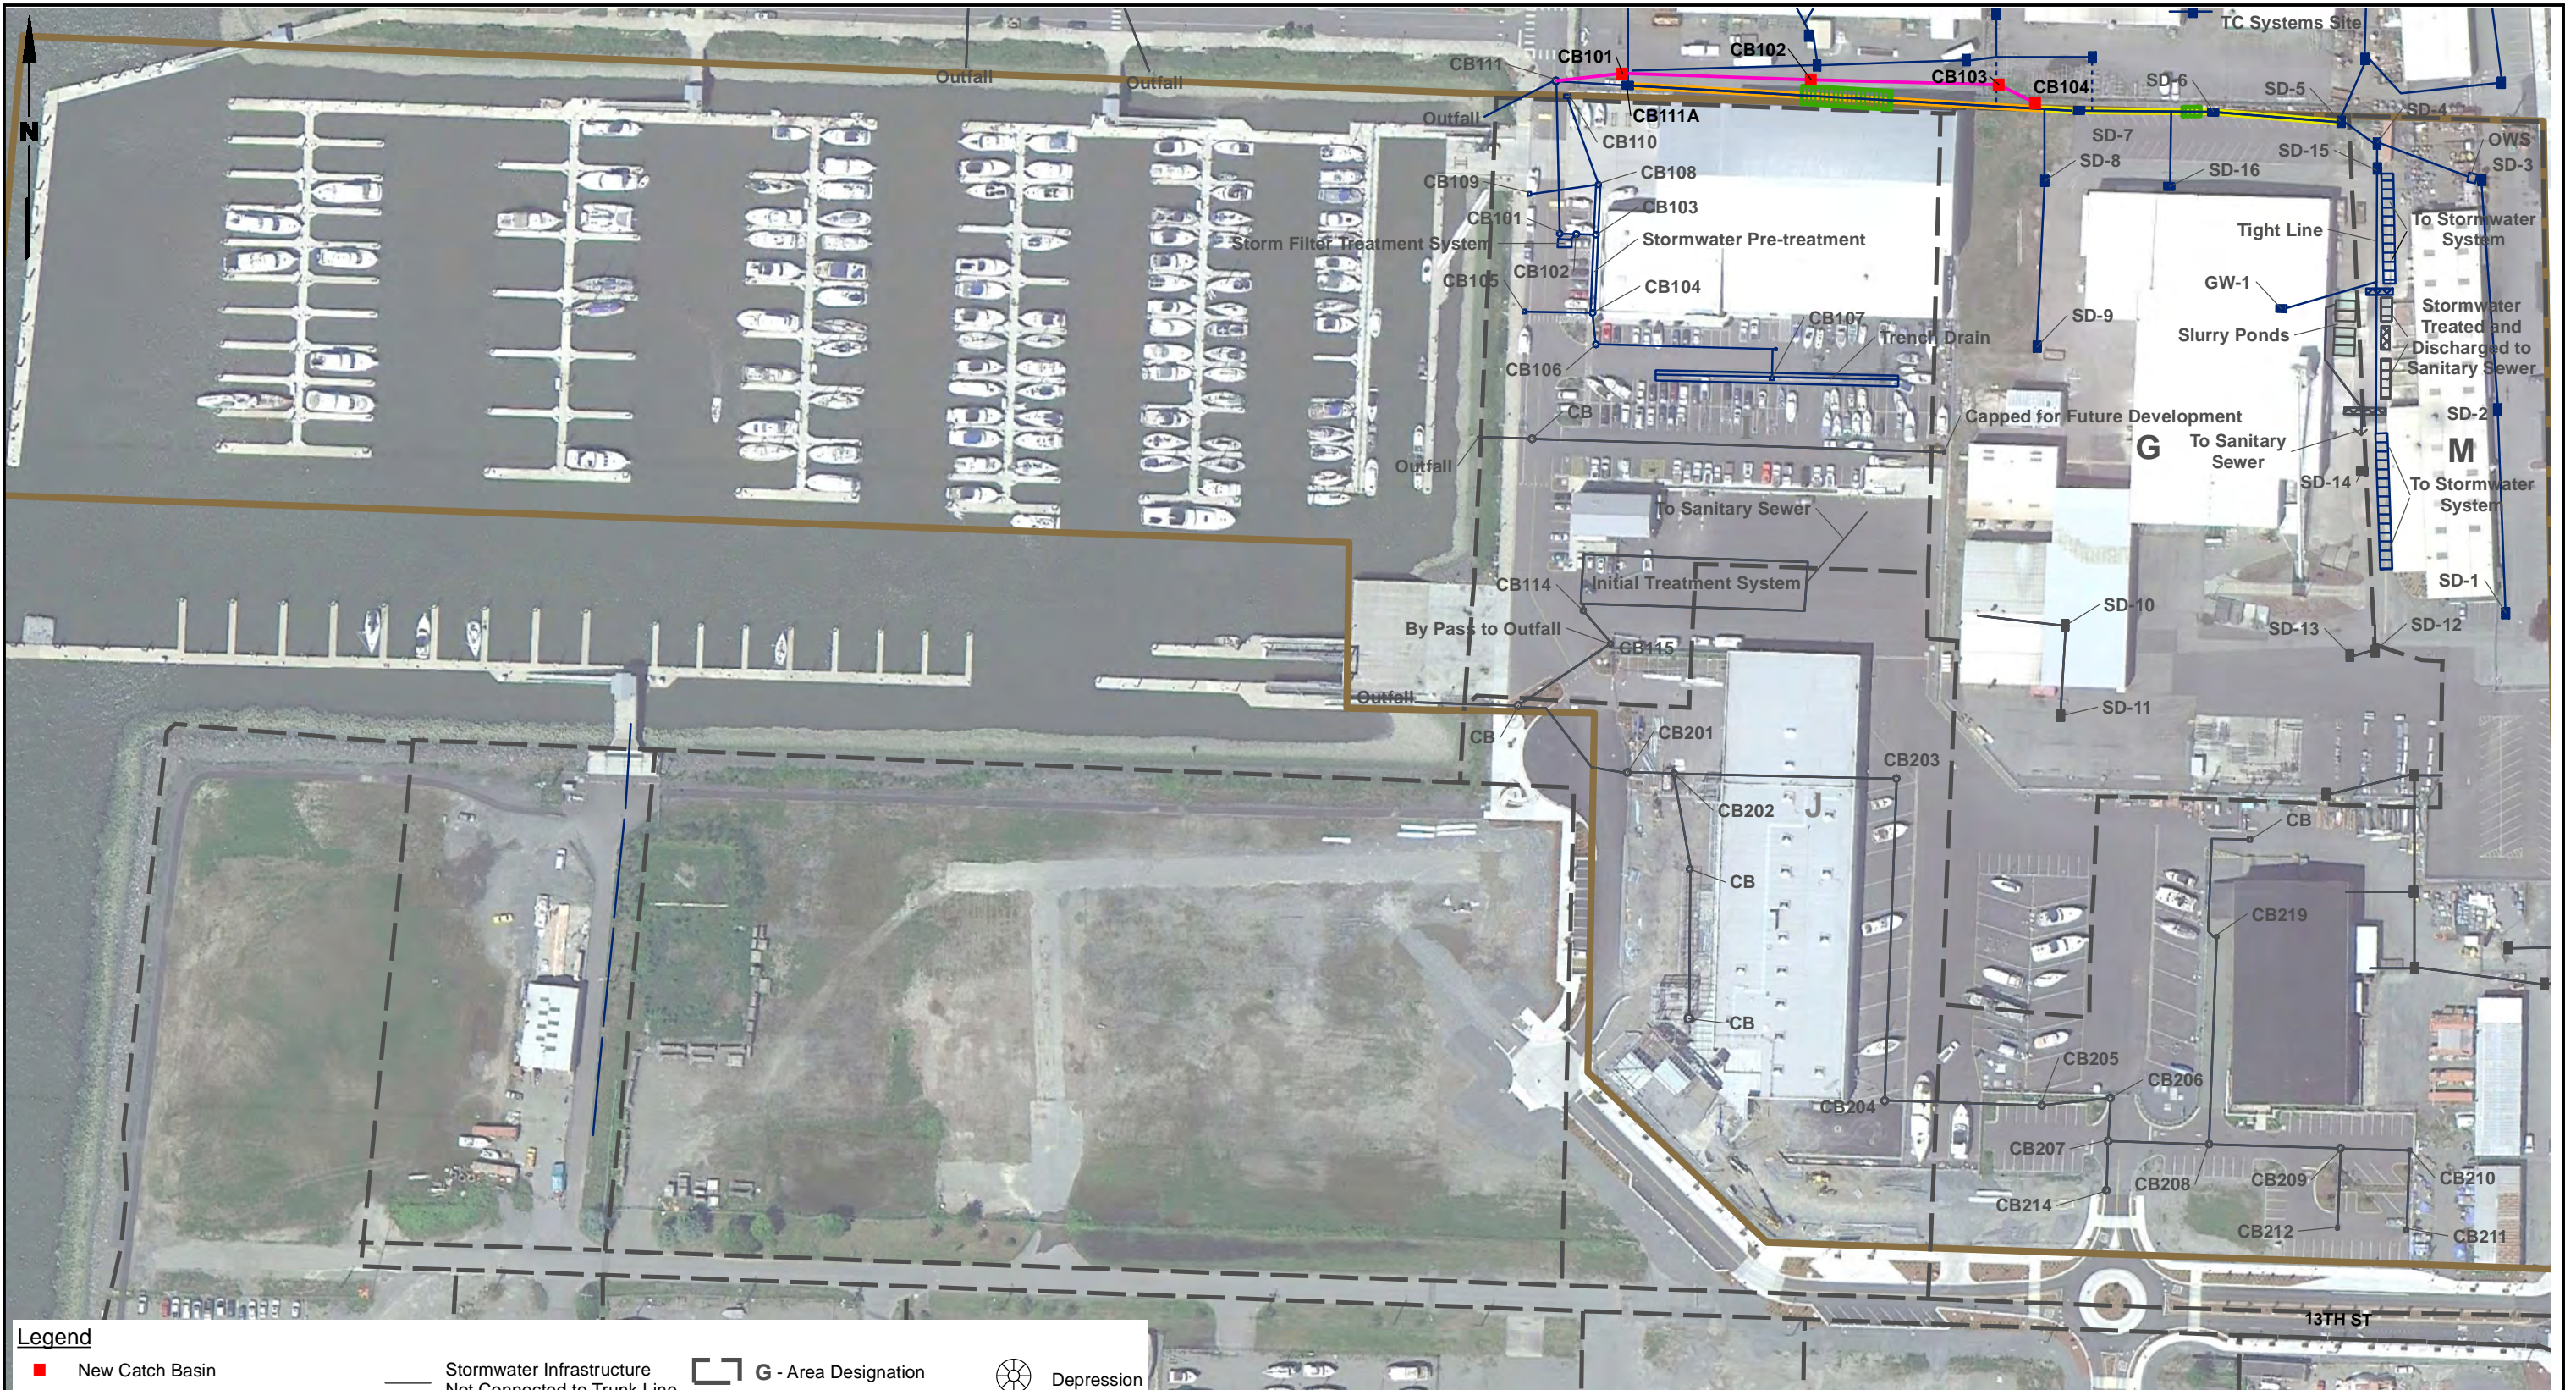
Figure 2: Site Plan

of, the existing trunk line between catch basin CB-111 and eastward to the point where the SD-8 lateral connects to the trunk line as depicted in Figure 2. As previously indicated, the portion of the existing trunk line located east of the SD-8 lateral connection to catch basin SD-5 will be replaced as part of the final cleanup action for the Site and was not addressed (with the exception that it was cleaned out) as part of this EA. Construction activities included excavation of a trench for the new trunk line, completion of new sections of trunk line (and associated catch basins), management of excavated soil, backfilling the newly constructed trunk line, and abandonment of the old section of trunk line.

Placement of the new trunk line occurred as each section of trenching was completed. The new trunk line was constructed of 24-inch-diameter high-density polyethylene (HDPE) pipe and connected to all stormwater laterals served by the former trunk line. Construction of the new line was completed in substantive compliance with all local and state requirements, as described in the *Emergency Action Amendment Stormwater Trunk Line Cleanout and Repair* (Landau Associates 2013). The new trunk line alignment is shown on Figure 2 and in the as-built drawing for this project (Drawing C1.1), included as Attachment 1.
