Historical Site Development Analysis
North Marina Ameron/Hulbert Site
Everett, Washington

The North Marina Ameron/Hulbert Site PLP Group

May 11, 2010

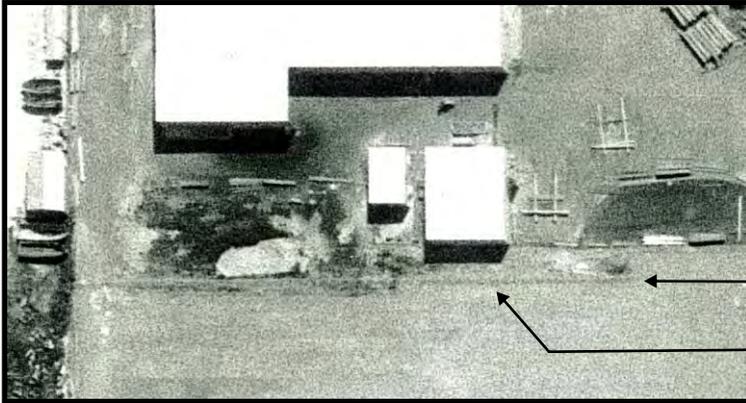
6/16/1982

The fence is clearly evident in this photograph. When viewed in stereo the presence of the fence is more striking.

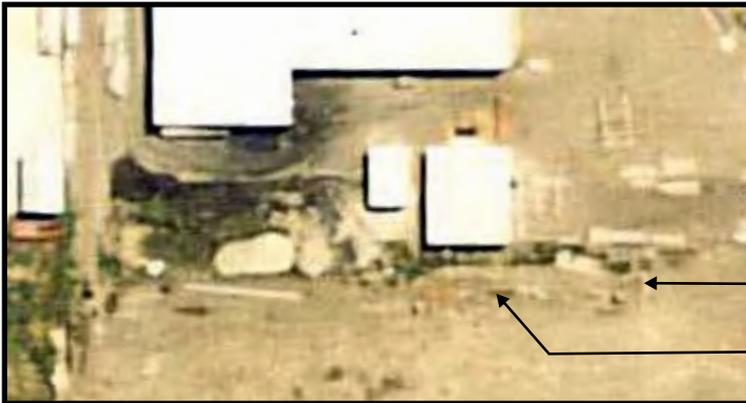
5/11/1983

There is no clear evidence of the fence in this photograph. This is because of the poor resolution and the high sun angle. As a result this example is inconclusive even though the fence is present at the time of this photograph.

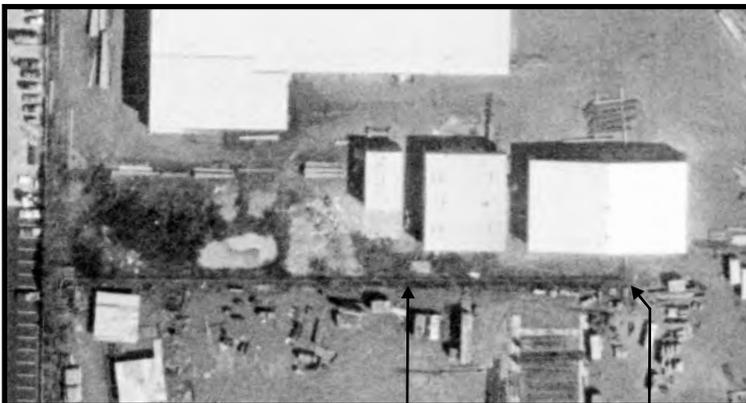
8/14/1985

The fence is clearly evident in this photograph.

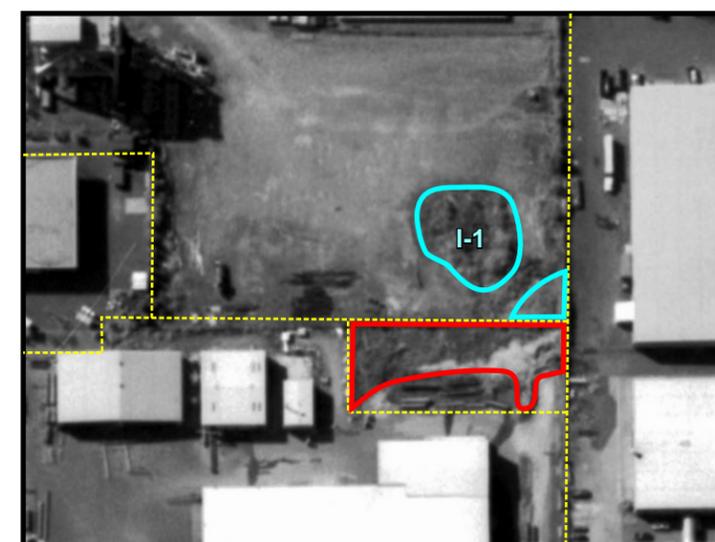
1999

- 1999:** Stockpile I-1 is present on Area I. A stockpile covered with vegetation is present at the northeastern corner of Area I. The fill on Area G-1 has been moved some and vegetation has grown over most of it. This fill remains at the site until 2006.

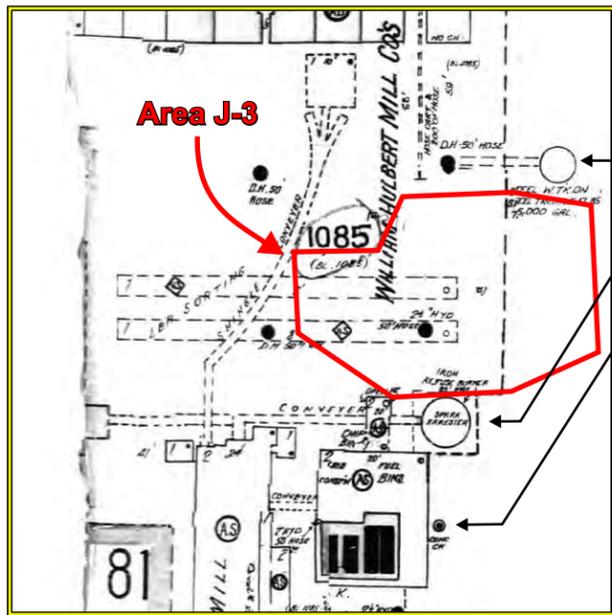
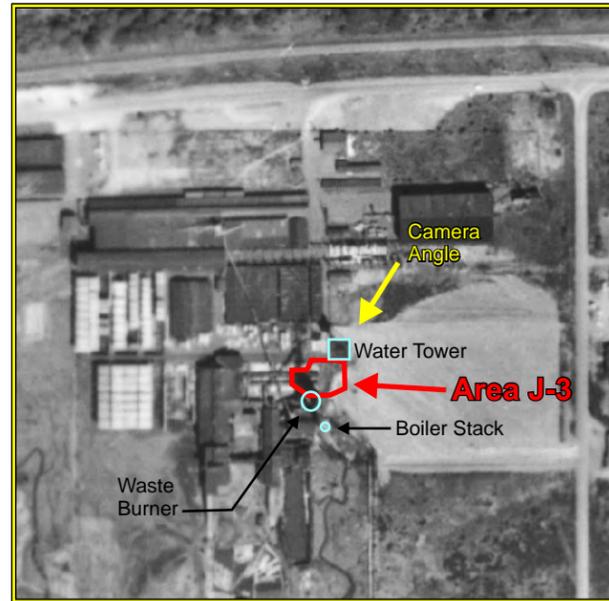
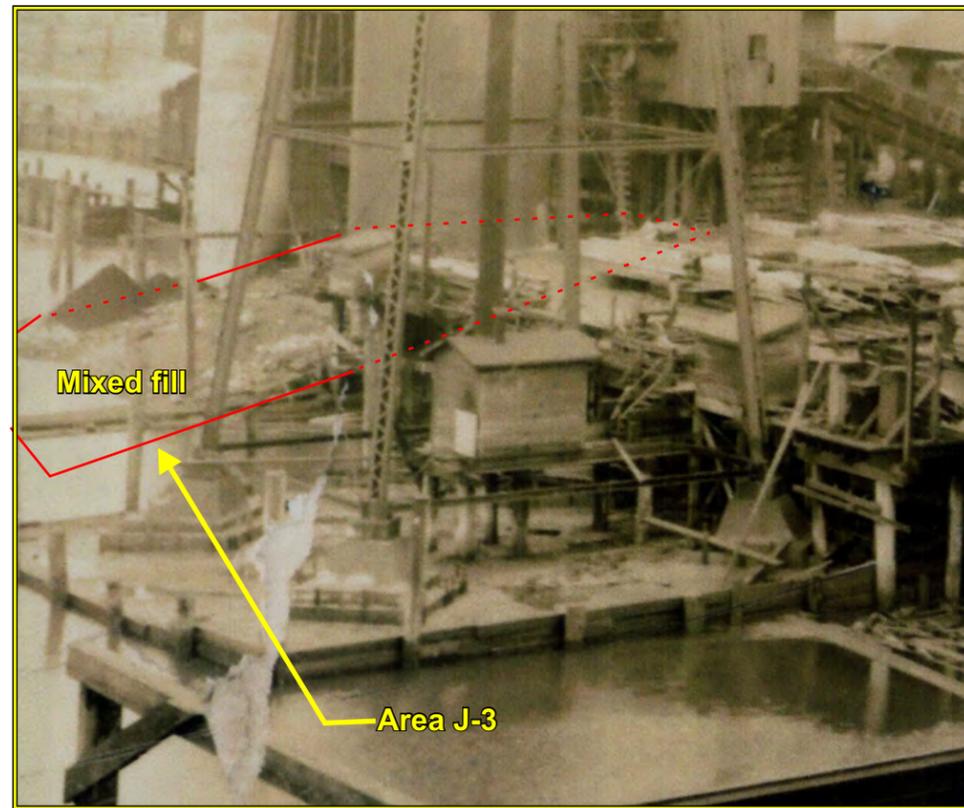
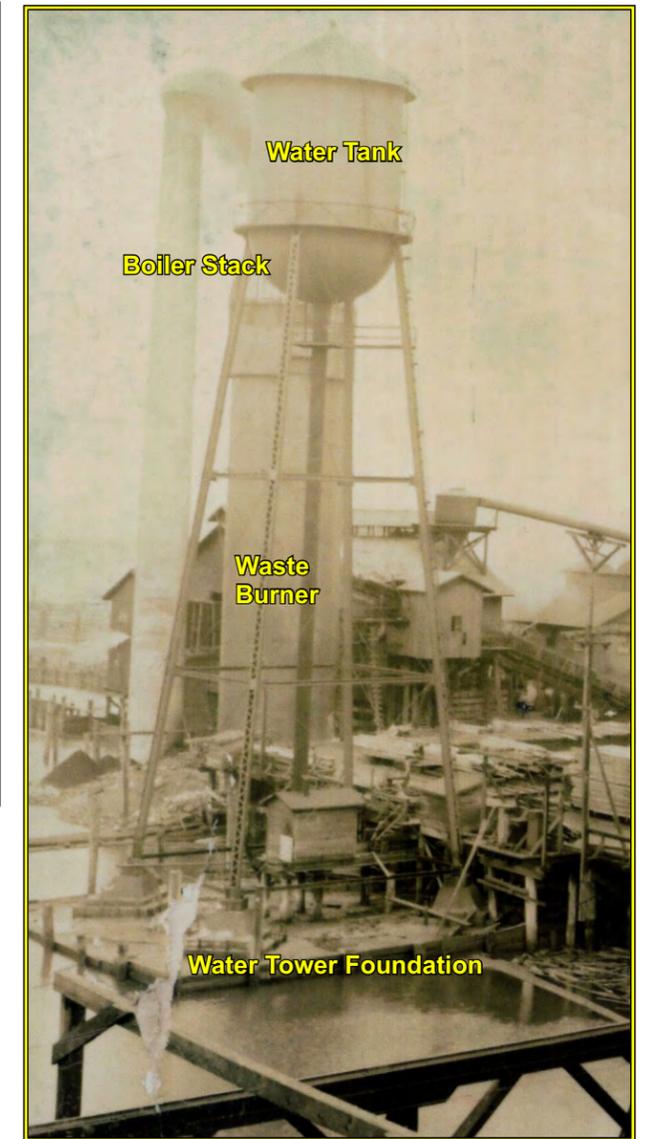
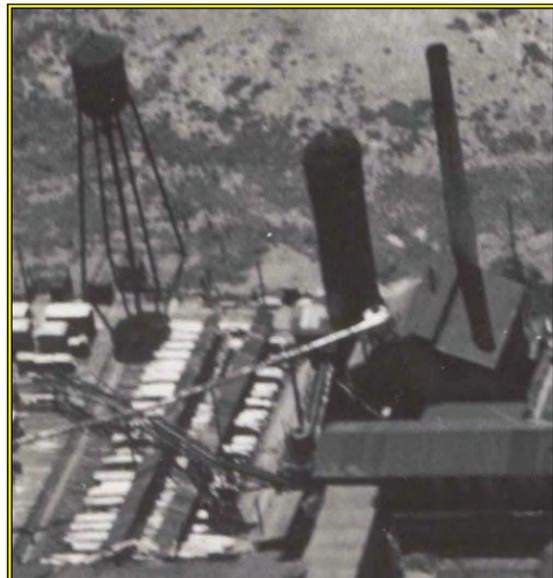
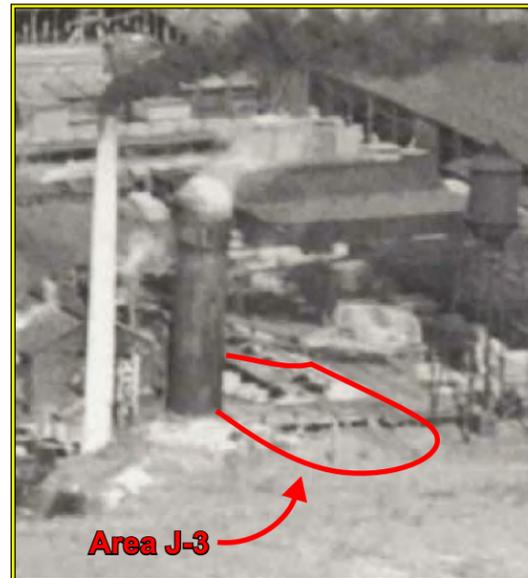
Figure 11
Historic Features in Area J-3
North Marina Ameron/Hulbert Site
Everett, Washington

A photograph from the mid 1930s (shown in part in Figure 11) shows small-scale, non-systematic filling around the bases of the smokestack and refuse burner with several different materials, including a very dark, comparatively fine-grained material, and a lighter-colored rubble material with pieces visible up to 1 or 2 feet in diameter. A square feature is visible at the base of the water tower with a smooth upper surface about 8 feet below dock level, probably a concrete pile cap. Four smaller concrete footings are visible on top of this structure, each supporting one leg of the water tower (Figure 11).

A small, irregularly shaped area of debris and granular fill is visible around the bases of the Hulbert Mill smokestack, the refuse burner and the water tower in the 1947 photographs. A very similar accumulation of fill is evident in the same photograph at the base of the refuse burner at the mill to the north of the subject site. This fill is also clearly visible in the photograph from the mid 1930s (see Figure 11). This fill may be comprised, in part, by bottom ash from the refuse burner. Refuse burners were primarily used for burning sawdust, bark, edgings and other wood debris associated with milling operations.

The locations of the smokestack, the refuse burner and the water tower structures relative to Area J and J-3 and historical photographs are shown in Figure 11. Since the pile cap foundations for these structures would have been at least ten feet below the filled grade it is unlikely that they were removed. The foundation for the refuse burner would have encroached upon the northwestern corner of area J-3.

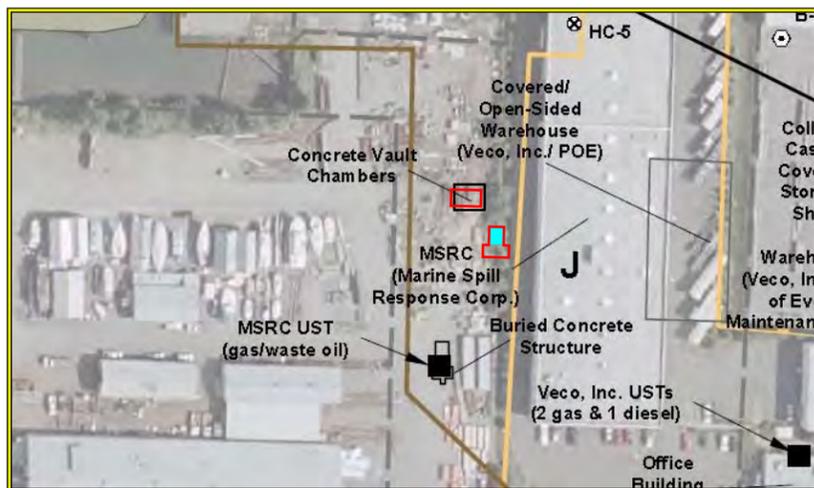
prepared by Reid Middleton Associates for the 12th Street Channel Barge Terminal, identifies this feature, along with other features as "Old concrete foundations to be removed." This drawing places that feature at the same location of the irregular vault shown in the Sanborn map and in the aerial photography. Figure 12 provides an overlay of these locations on the pertinent part of Figure 8 from the Landau 2009 report.

- Red: Concrete pit locations as shown in the 1957 Sanborn Map.
- Blue: Concrete foundation to be removed (Reid Middleton drawing).

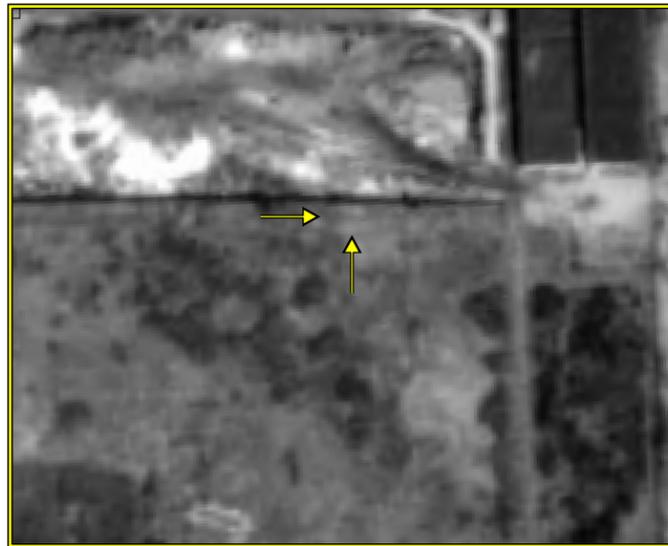
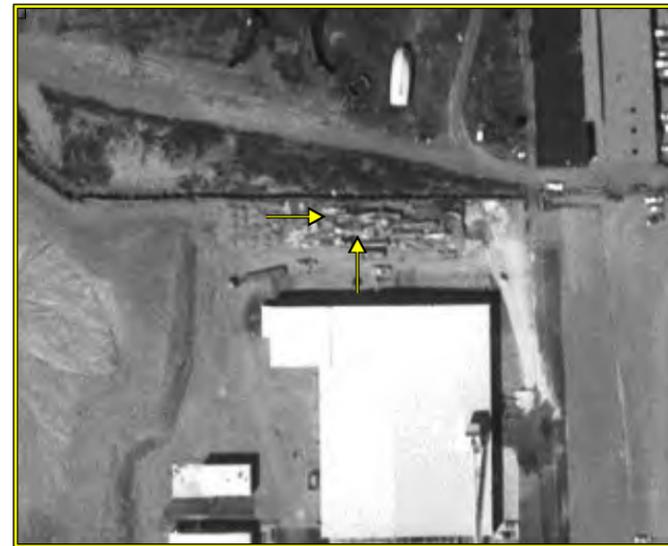
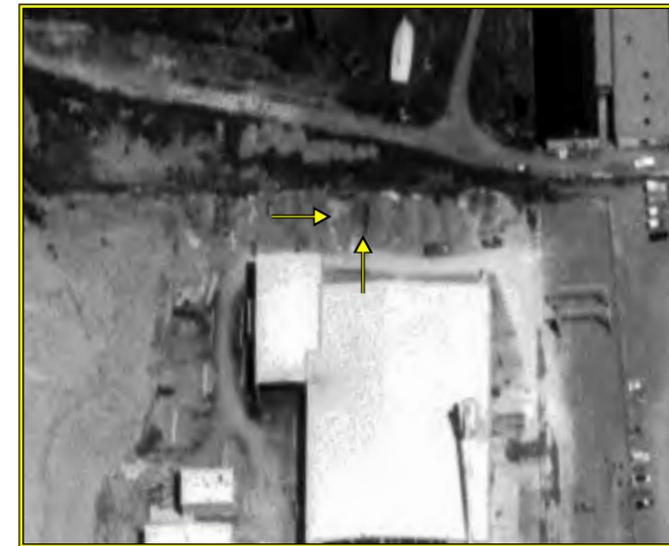
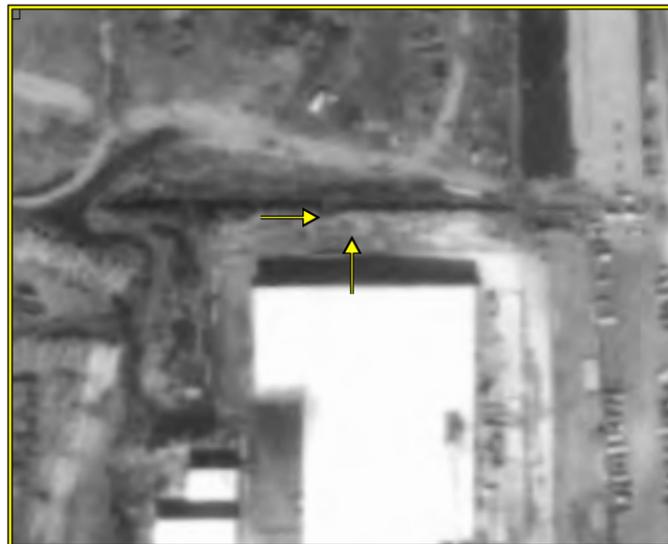
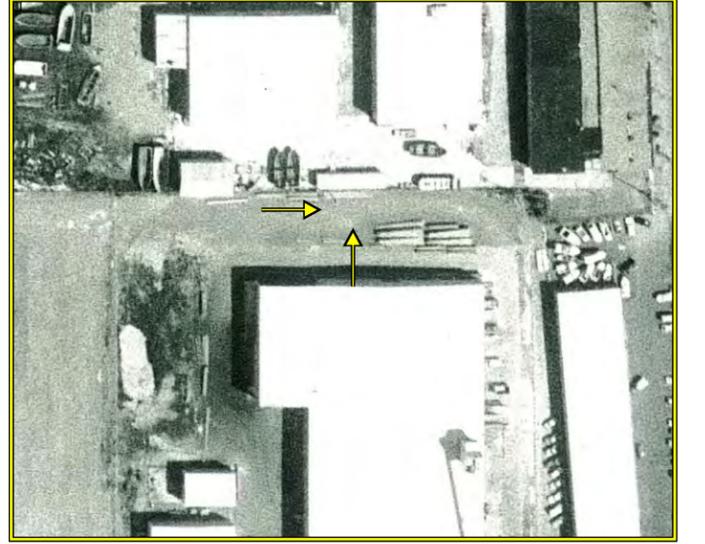
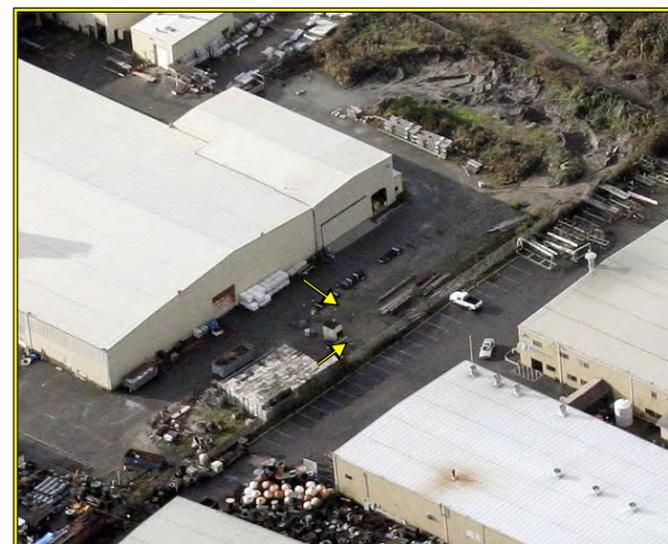
Figure 13
Sewer Line Repair Area on
Northern Area G
North Marina Ameron/Hulbert Site
Everett, Washington

The northern boundary of Area G is presently occupied by an underground storm sewer line. In late 2004 a repair was made to a storm drain line and evidence of contamination was noted in excavated soils. The location of this repair is shown in Figure 13. Analytical testing of the soil stockpile from the excavation showed low concentrations of mid-range to heavy-range petroleum hydrocarbons, several PCB aroclors and cPAHs. Furthermore, the soils encountered included concrete fragments and mixed fill suggesting that this area was used for disposal of demolition debris. Follow up testing by Landau Associates shortly after the repair (early 2005) encountered the mixed fill and found the contamination to be localized to the general area of the repair excavation. Samples tested by Landau found evidence of PCBs, PAHs and low concentration petroleum contamination. PCBs and PAHs were found in a soil sample from the initial excavation stockpile. Relatively high concentrations of volatile organic compounds were found in a sample obtained from a depth at or near the top of the storm drain line, close to the repair area. The suite of analyses performed was not consistent from sample to sample so it is difficult to identify patterns between different samples evaluated.

These aerial photographs show a series of differing uses of the property north of the current Ameron building where the storm drain break occurred. The first photograph shows the original fill placed at the time the site was occupied by the sawmill. Subsequently the area has been used for storage of fill, laydown of equipment, and as a roadway. The buried storm drain line was installed in about 1982. The approximate location of the repair is identified by the two arrows in each photograph.
