**Site Hazard Assessment
Recommendation for No Further Action**

Dave's Pit Stop
6195 Van Giesen
West Richland, WA 99353

Parcel ID: 136074012156001
Section/Township/Range: 36/10N/27E
Latitude: 46.30271
Longitude: -119.36785
Ecology Facility Site ID No.: 73274126
UST Site ID: 100981
VCP ID No.: CE0279

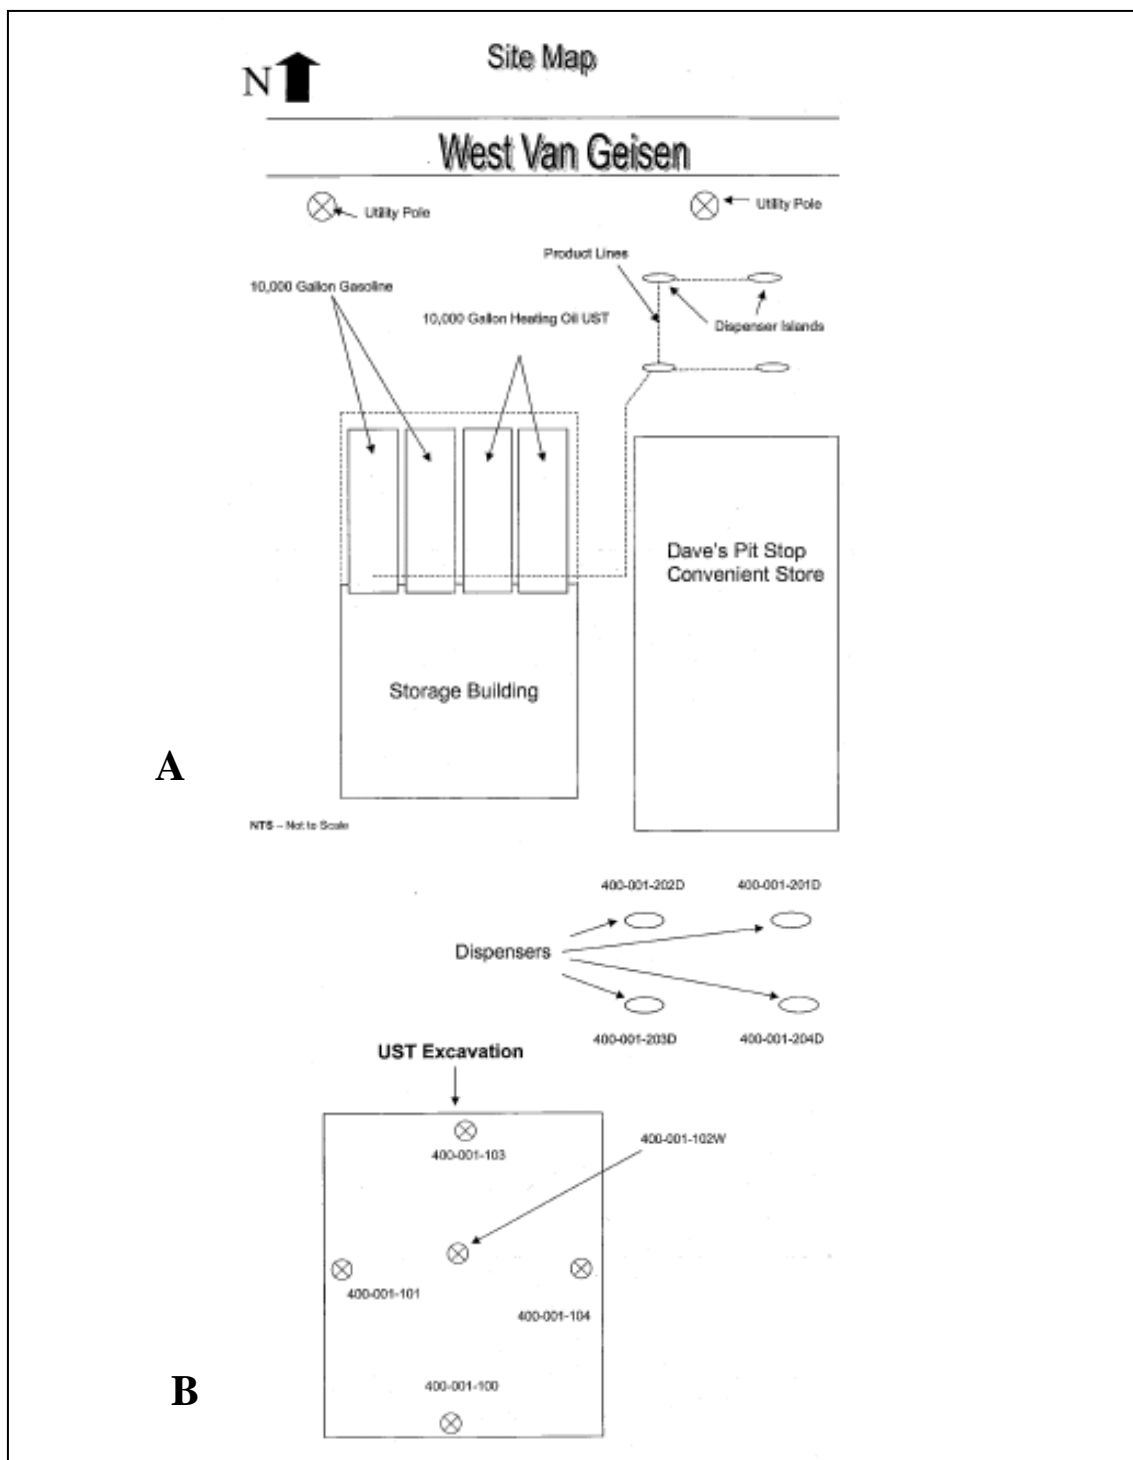
Figure 2. Diagram of Location of Underground Storage Tanks (Panel A) and Sampling Sites (Panel B). Source (1)

During the excavation Rick Funderburk of White Shield, Inc. (WSI) inspected all of the tanks. He noted that both of the oil USTs were in fair condition with minor corrosion and no visible holes. He also noted that there was some soil staining along the east side wall where the one of the oil tanks had been removed. In the report Mr. Funderburk did not described the condition of either gasoline UST but he did mention that there was soil staining at the soil/groundwater interface. When the pumping dispensers were removed it

Results are shown in Tables 1-3. The majority of the samples did not contain contaminants. However, soil samples taken from the east side of the excavation wall and the water sample did contain contaminants that exceed present Model Toxic Control Act (MTCA) standards for soil and water (see Tables 2 and 3). Based on the sampling results, WSI recommended that all of the excavated soil be handled as a petroleum contaminated soil (pcs) waste and properly disposed. All of the stockpiled material (~109 cubic yards) was taken to Lower Valley Remediation in Mabton, Washington. The WSI report stated that contaminants were still present within the confines of the excavation site and recommended that more remediation be performed. The report also stated that groundwater monitoring should be performed at the site since contaminated water was encountered at the site. On April 25, 2000 the excavation hole was backfilled. The report did not specify where the backfill material came from.

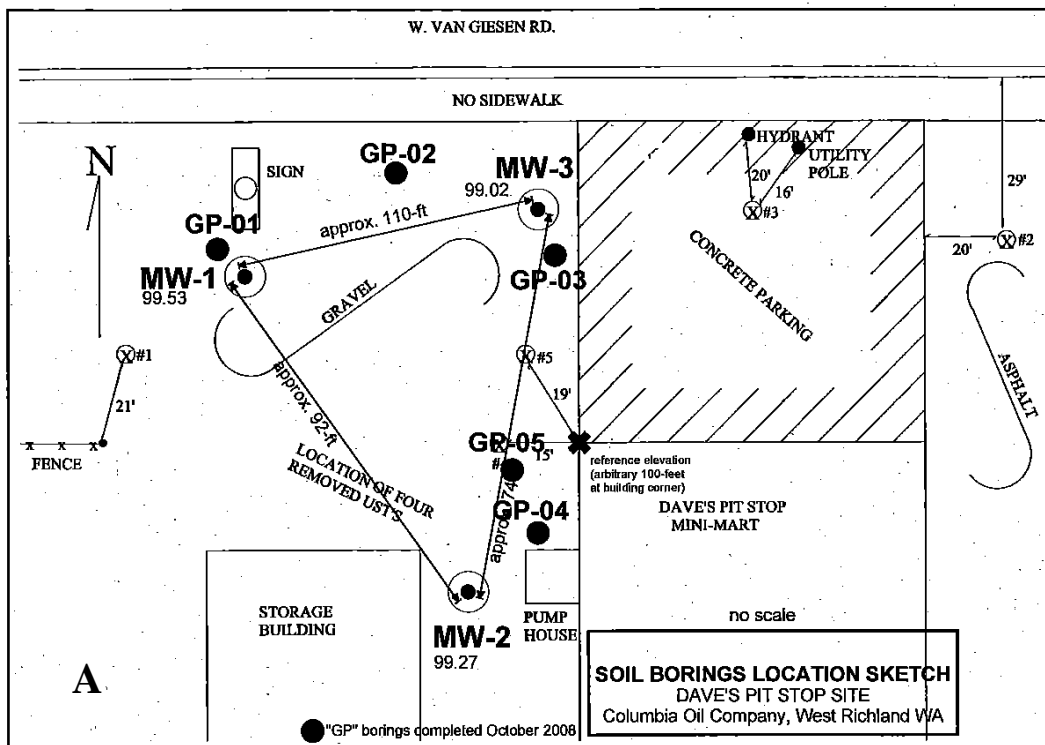
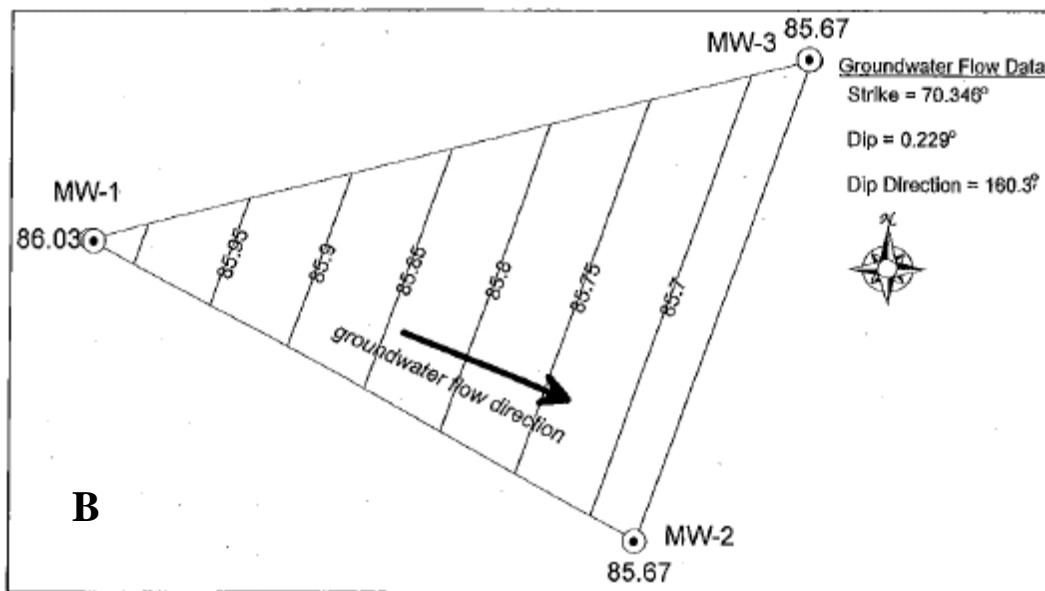
Figure 3. Diagram Showing Location of Ground Water Monitoring Wells and Soil Sampling (Panel A). Ground Water Gradient Map for November 2005 (Panel B). Sources (3,6)

In May 2005 GeoPro Geologic Services (Battle Ground, WA), acting as a sub-contractor for Blue Mountain Environmental Consulting (Waitsburg, WA), was hired to install three groundwater monitoring wells at the site and to implement a groundwater monitoring program (see Figure 3A and 3B). Wells were drilled and installed on May 24, 2005 using a Geoprobe GP-40 drill rig (2). Monitoring Wells MW-1 and MW-2 were 19 feet below ground surface (bgs) and MW-3 was 16 bgs. Depth to groundwater ranged from 14.2 to 14.8 bgs. Groundwater samples were collected on May 28, 2005 using a peristaltic pump. Water samples were sent to OnSite Environmental Inc. and analyzed for TPH-Gas, BTEX, and MTBE. Results are shown in Table 5 (First Quarter). GeoPro completed a total of four quarters of groundwater sampling at the site on August 24, 2006 (see Table 4). All water samples tested were below the Practical Quantification Limit (PLQ) for all analytes for all four quarters. All four reports prepared by GeoProbe were received by Ecology as evidenced by date stamps. The last report was received by Ecology on November 13, 2006.

On October 20, 2008 five borings were drilled to a depth of 10 feet and soil samples were taken. The borings were performed by Environmental West (Spokane, WA). The ground borings were drilled to the north and east of the original tank excavation site (see Figure 2A "GP"). The soil samples were sent to OnSite Environmental Inc. and analyzed for TPH-Gas and BTEX. The results are shown in Table 5. All five samples were below PQL for all analytes and well below MTCA cleanup standards for unrestricted land use. A report documenting the soil sample was prepared by Blue Mountain Environmental (6). However, the report was not immediately made available to Ecology. A miscommunication existed between Blue Mountain Environmental and the new owners of the site in regard to payment for the work that was performed. As a result, Ecology did not receive the soil boring report and on July 20, 2009 the site was terminated from the VCP due to lack of cleanup activity at the property. The termination letter was sent to Mr. Bleiler and it is unclear if notification was ever sent to Mr. and Mrs. Han. On May 6, 2010 Mr. and Mrs. Han received an official notice from Ecology that a Site Hazard Assessment (SHA) would be conducted.
