SITE HAZARD ASSESSMENT  
WORKSHEET 1  
Summary Score Sheet

Columbia Park Marina (a.k.a The Boat Shop)  
1238 Columbia Drive SE  
Richland, WA 99352

*Site scored/ranked for the August 3, 2010 update  
July 22, 2010*

### **Site Hazard Assessment**

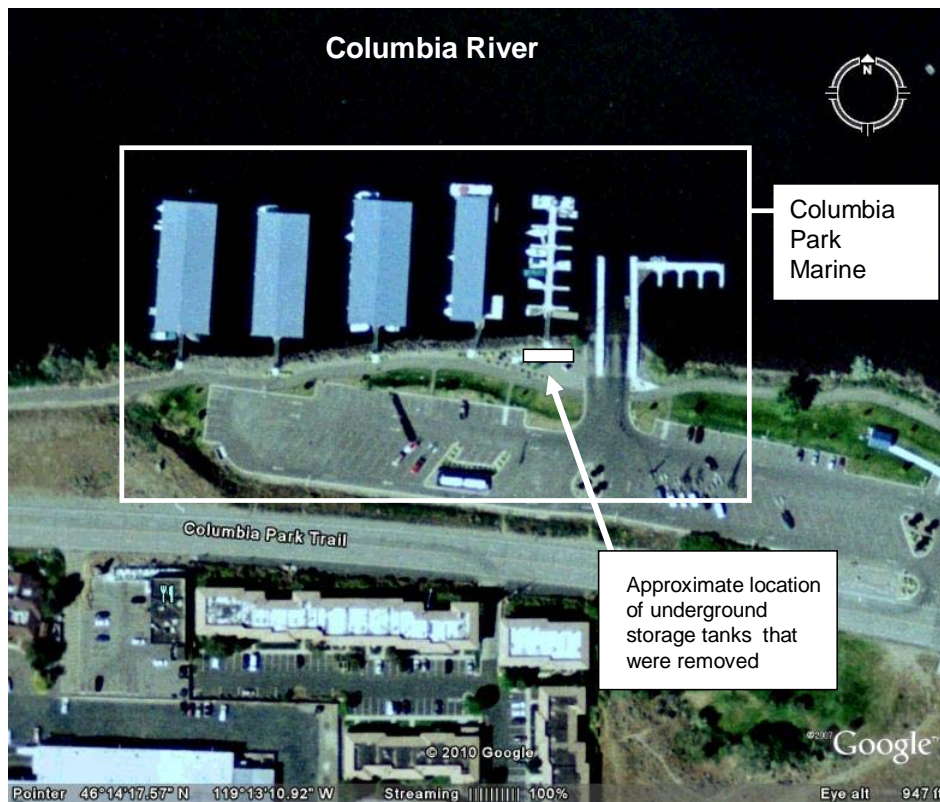
A site hazard assessment (SHA) was performed on May 18, 2010 by James Coleman of the Benton-Franklin Health District. Also present during the SHA was Amy Ford, one of the current lessees, and Lynn Koehler, lessee of the property when the USTs were removed from the property. Mr. Coleman informed Ms. Ford and Mr. Koehler of why a SHA was being performed and provided them some handouts describing the process. Mr. Coleman also provided Ms. Ford a copy of the cleanup report prepared by White Shield Incorporated because she indicated that she had not seen the report. Mr. Koehler was asked if he recalled the exact area where the UST had been removed. He said could not identify the exact location because the tanks were removed sixteen years ago and many of the previous landmarks like the boat shop, power pole, and chain link fence (see Figure 2) were no longer present. Some landmarks, such as the boat launch, were still present. Measurements were taken and the approximate location of the old excavation site was noted (Figure 1).

Figure 1. Aerial photo of Columbia Park Marine. Arrow shows the approximate location of the underground storage tanks (UST) that were removed in April 1994.

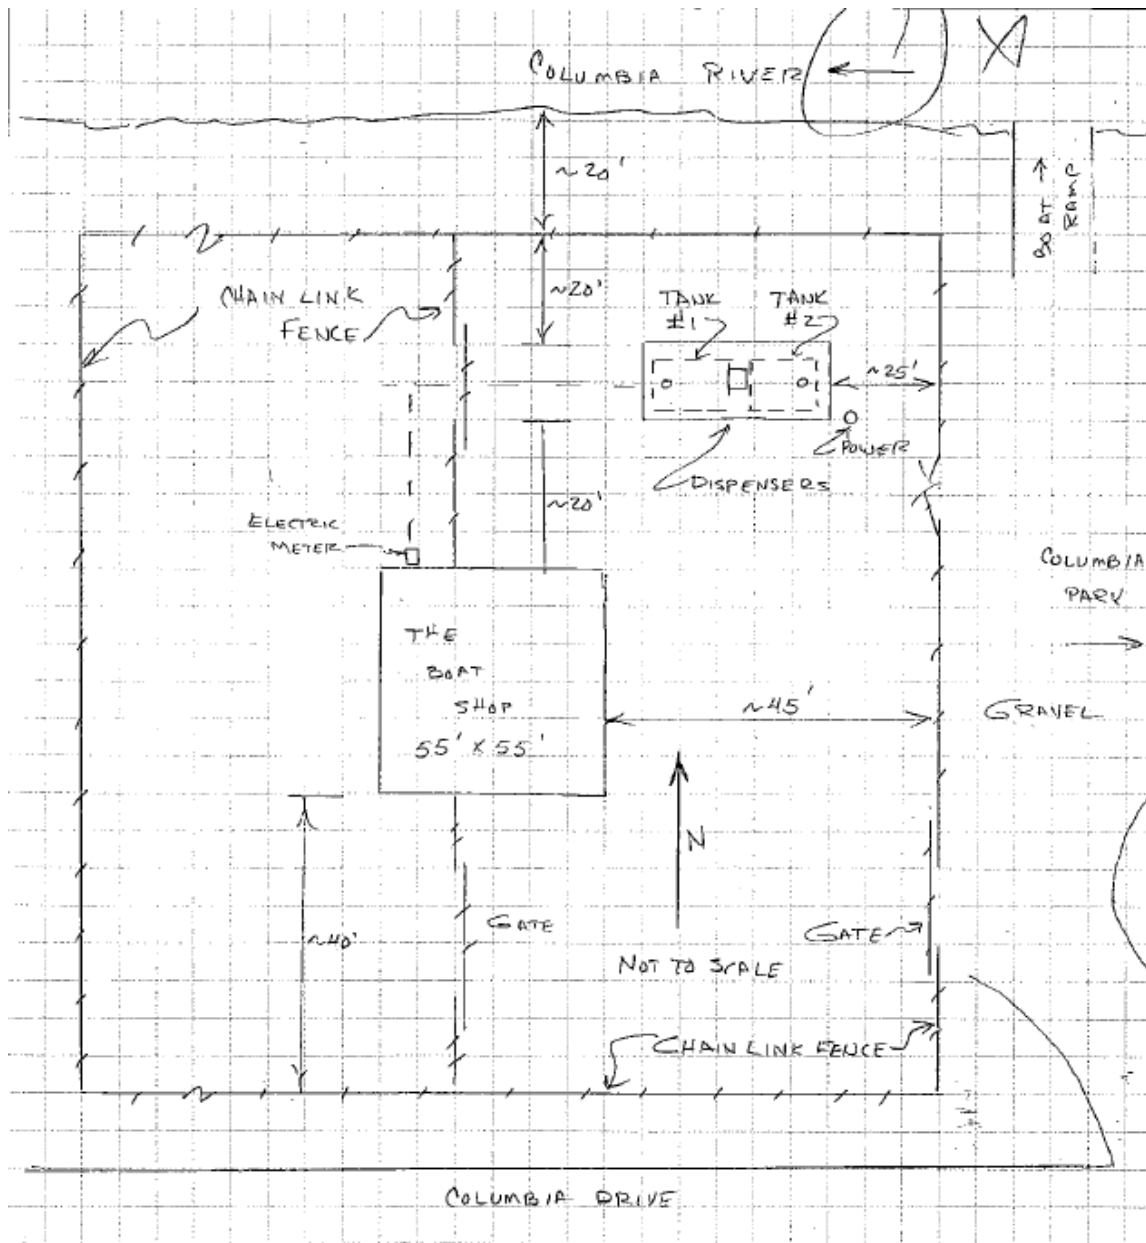
Based on the final sampling results WSI concluded petroleum contaminants remaining in the soil and groundwater within the confines of the excavation did not exceed MTCA cleanup levels. The report indicated that holes were found in tank #2 and the gas may have been leaking into the ground water for an extended period of time. WSI recommended that ground water monitoring wells be installed at the site to meet the requirements of the MTCA (WAC 173-340-450 (3)(a)(iii). Ground water monitoring wells were never installed and the site was backfilled and covered.

Figure 2. Site diagram showing underground storage tanks #1 and #2 and other landmarks on the site. Source of diagram is the White Shield Report (see reference 1)

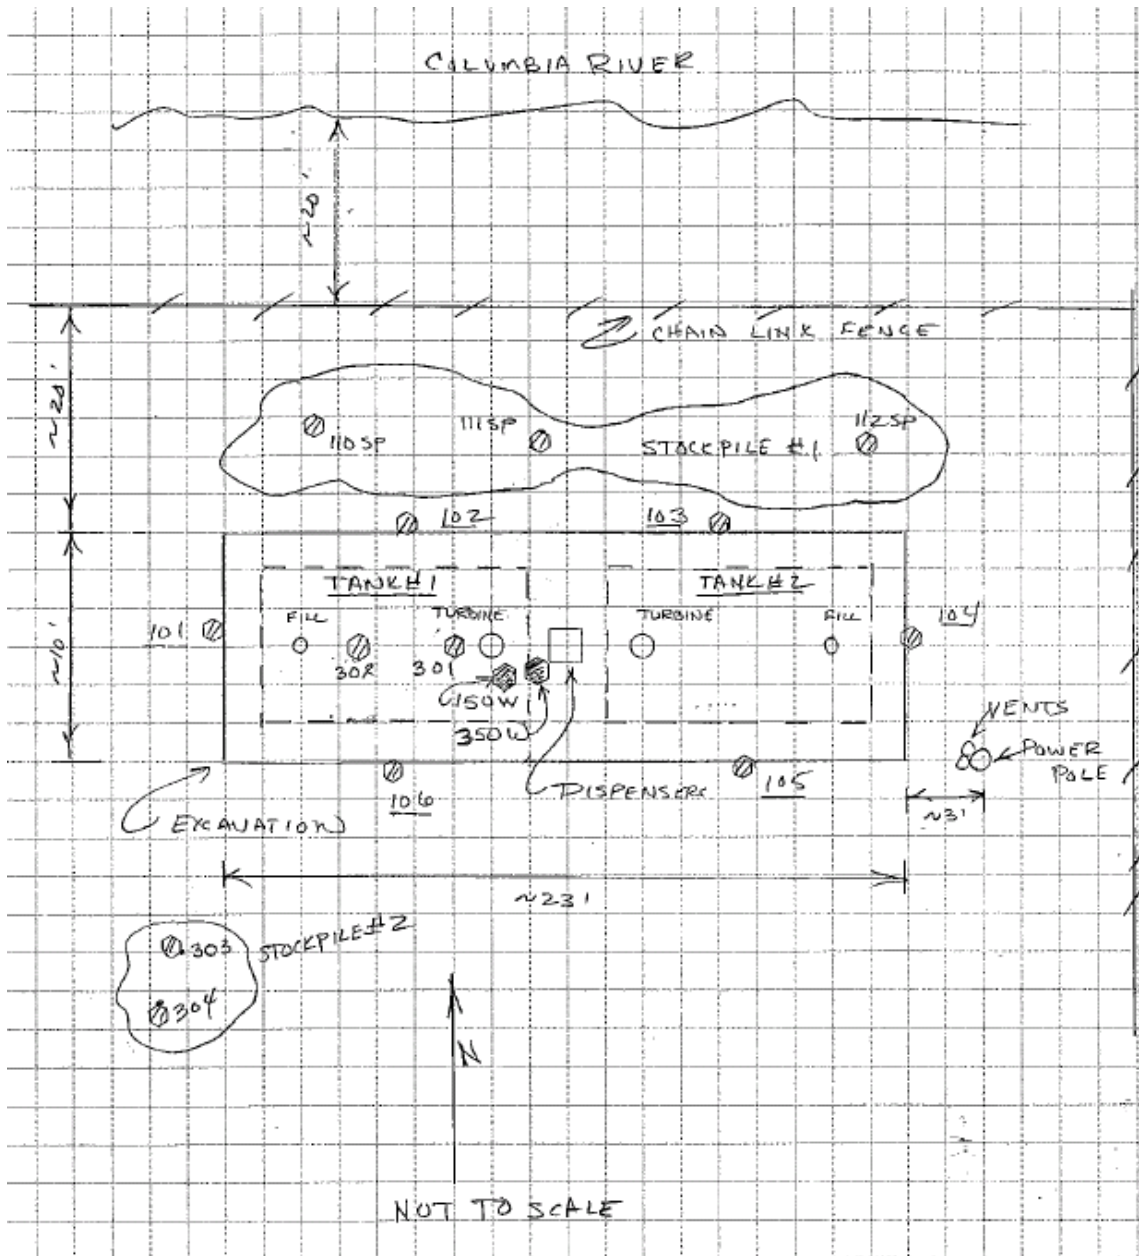
Smith employees stockpiled soil from the excavation on the north side of the hole (see Appendix I, Figure 3). WSI employees collected soil samples from the stockpile and analyzed for contaminants. In addition, soil samples were taken from both ends and the sidewalls of the excavation hole.

Figure 3. Diagram showing the location of environmental sampling sites. All samples are soil samples except for those with sample number identification followed by a “w”.

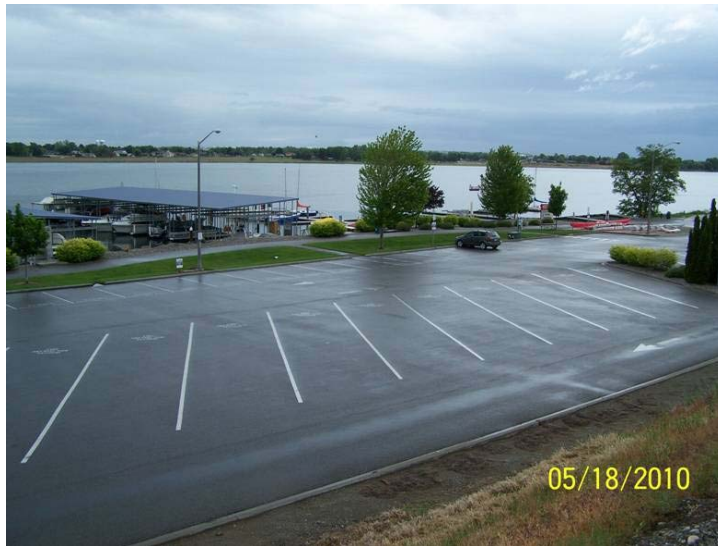
Photo 1

Photo 1. Looking to the NE towards the marina.

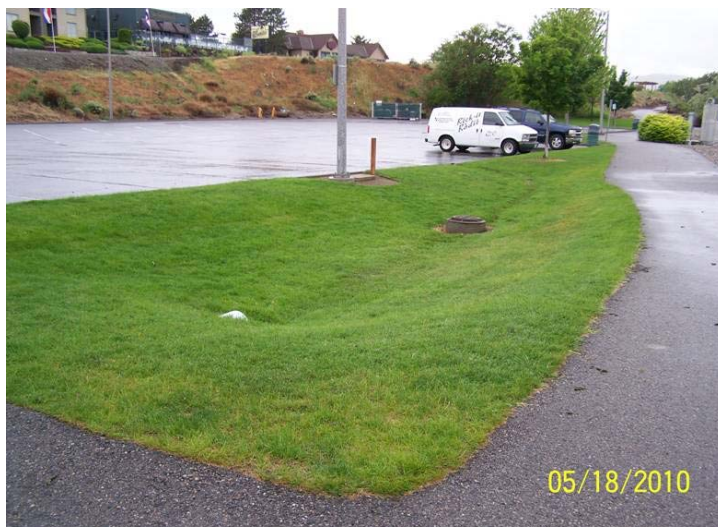
Photo 2

swale and an asphalt bike path. The surface water from the parking drains to the grassy swale where two storm drains/catch basins are located. The drain pipe from both catch basins terminates in the riverbank along the Columbia River (see Appendix III, photos 2-4). The catch basins are located approximately 173 feet and 190 feet west and east of the old excavation site. Farther to the west and east of the site is an undeveloped park area known as Columbia Park. The current above ground storage gasoline storage tanks (2) are located centrally in the south part of the parking lot. Farther to the south are apartment complexes and a commercial district. Major residential areas are found approximately 0.5 mile south of the site. Photos were taken during the SHA (see Appendix III). No groundwater wells were found on the property. According to Washington State Department of Ecology, Water Rights Application System (WRATS), there are numerous domestic groundwater wells and five municipal wells within a two-mile radius of the site. However, some the wells, including three of the municipal wells, are located on the opposite side of the Columbia River (cross-gradient) from the SHA site. The two municipal wells located near the site are no longer being used for domestic purposes (personal communication with Nancy Aldrich at City of Richland). City water is now supplied to many of homes surrounding the site although some residences nearby still use groundwater for drinking purposes.

Photo 2. Looking to the west. Photo shows swale with drain.

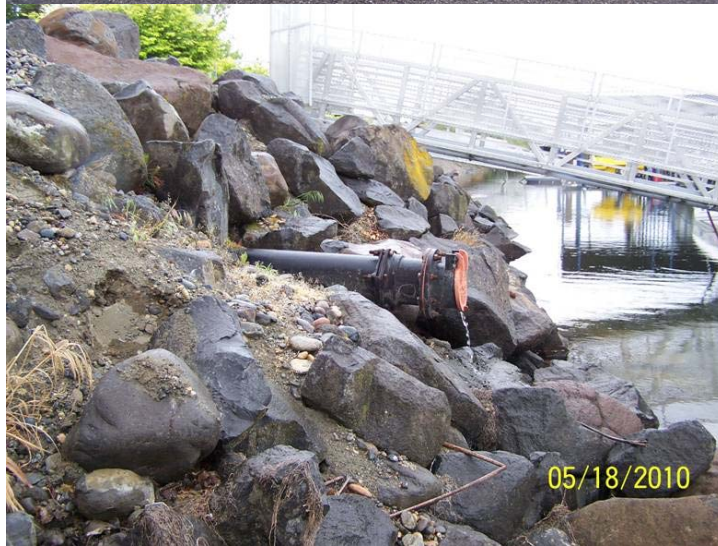
Photo 3

Photo 3. Photo showing drain outlet flowing in the Columbia River.

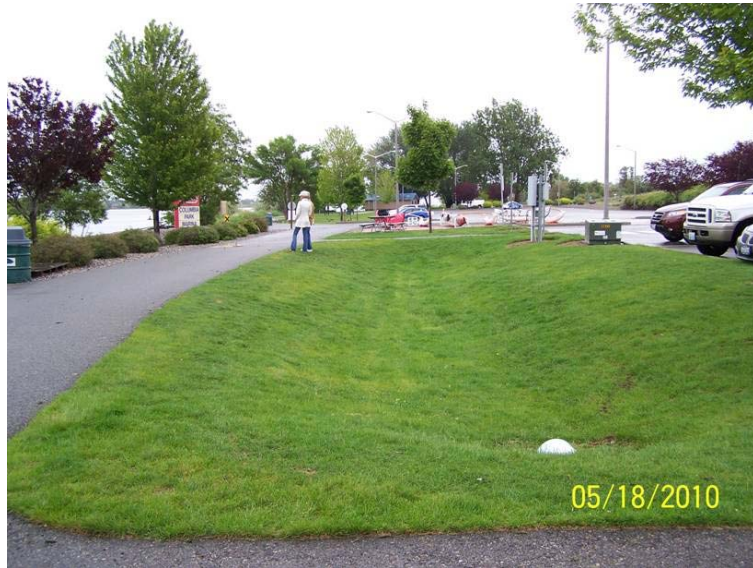
Photo 4

Photo 4. Looking to west. Shows swale, bike path, and Columbia River

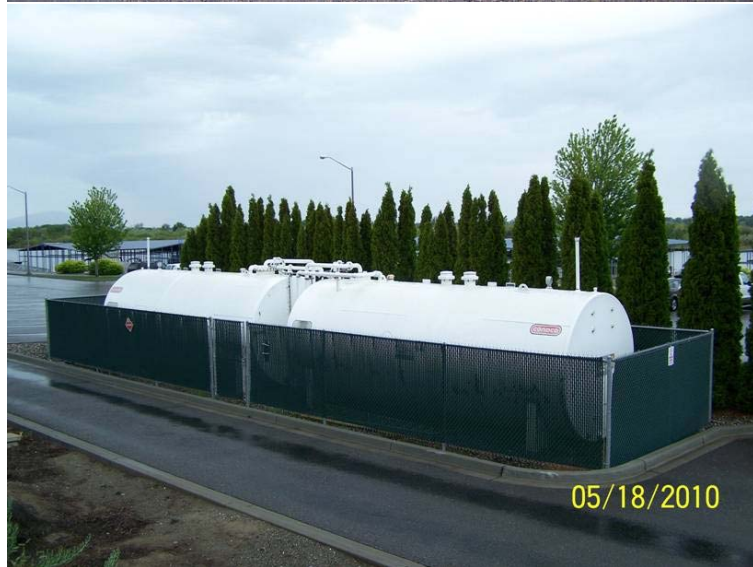
Photo 5

Photo 5. Current above ground gasoline storage tanks on site.
