STATE OF WASHINGTON
DEPARTMENT OF ECOLOGY

Re: No Further Action at the following Site:

- **Site Name:** Tri City Battery Goodyear
- **Site Address:** 601 George Washington Way, Richland
- **Facility/Site No.:** 43737443
- **VCP Project No.:** CE0292

Description and Diagrams of the Site

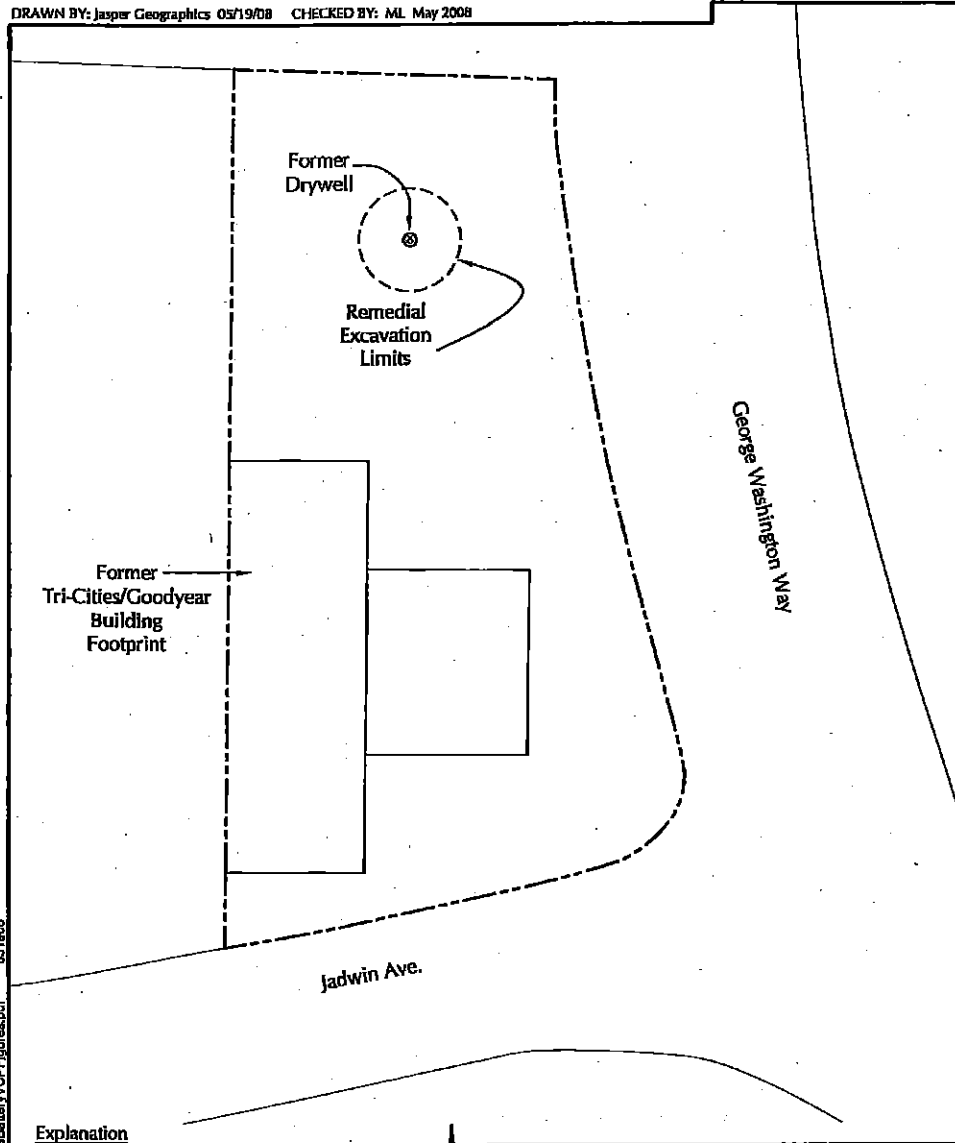
Figure 2

The site is located within SW1/4 SE1/4 of Section 11, T9N, R28E, at 601 George Washington Way, Richland. The site includes Benton County parcel numbers 111983020558010 and 111983020558015. The original building, which has since been demolished, housed an automotive service shop which was constructed in the late-1960s. The site was the former location of Tri City Battery/Goodyear and similar automotive service businesses. The service shop had a concrete floor and included six vehicle lifts and a sump, which were sampled and removed prior to demolition of the building. The asphalt parking lot, which was located in the northern portion of the site, contained a drywell for stormwater drainage. The former drywell is the source of contamination at the site.

The drywell was sampled and analytical results indicated PAHs, PCBs, Diesel Range Organics and Heavy Oils, and metals present in soil. Subsequent excavation and soil sampling indicated that residual contaminated soil is located below the former location of the drywell. The depth of the original drywell is reported to have been 16 feet. The results of sampling indicate soil contamination is limited to an area below the former drywell to an estimated depth of approximately 30 feet below ground surface, with a lateral extent at this depth of up to approximately 20 to 25 feet in circumference.
