PERIODIC REVIEW

Park 90/5 Office Park, now Airport Way Office Park Facility Site ID#: 76316149

> 2203 Airport Way South, Seattle, Washington

December 2010

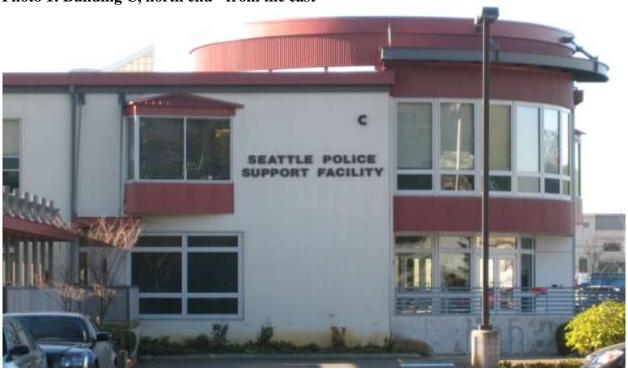
Photo 1: Building C, north end - from the east

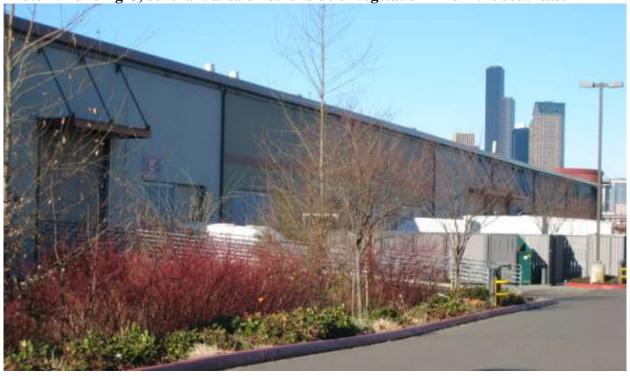
Photo 2: Building C, covenant area on other side of vegetation - from the southeast
