PERIODIC REVIEW

**Ballard Auto Wrecking
Facility Site ID#: 2346**

**1515 Northwest Leary Way,
Seattle, Washington**

October 2010

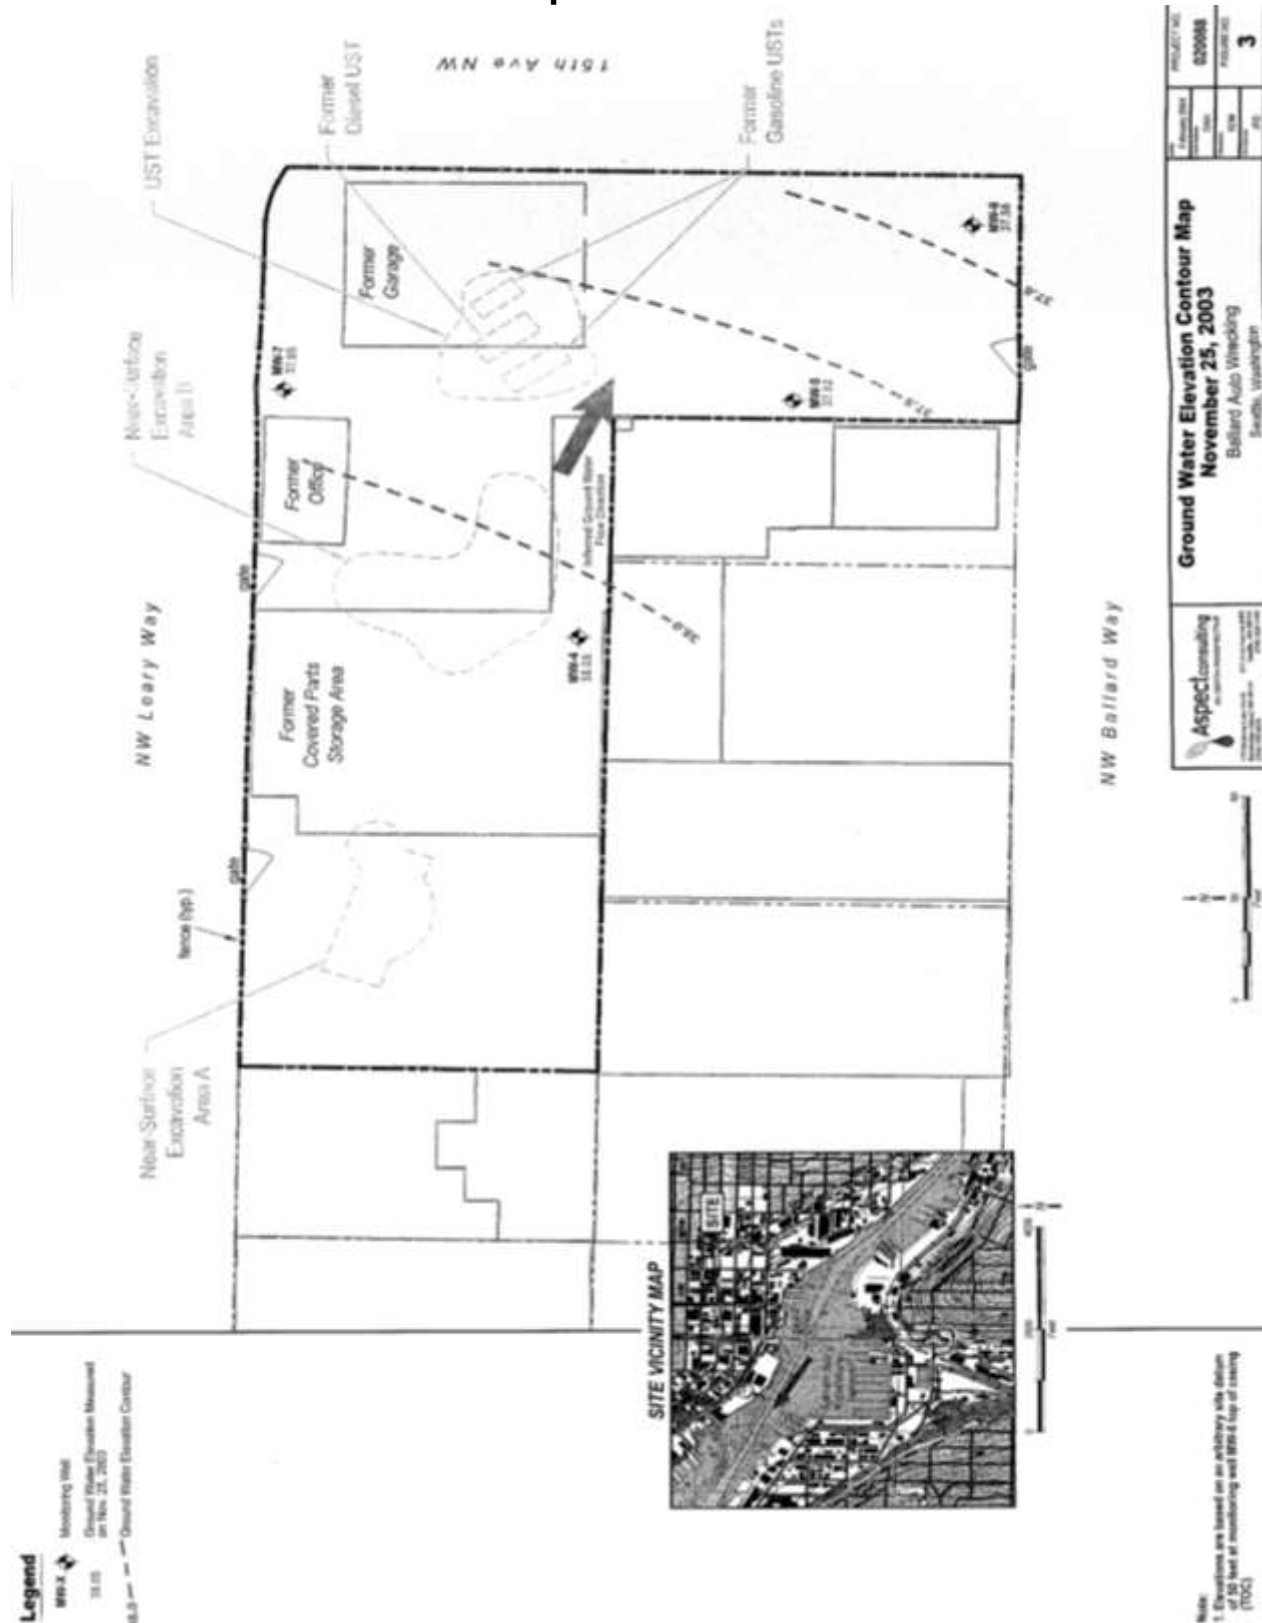
6.3 Groundwater Contour Map

Groundwater elevations measured in these wells since monitoring was initiated (2003) have consistently indicated a flow direction toward the south southeast. Given this flow direction, it was decided to install MW-8 to monitor groundwater quality at the property boundary downgradient of the former UST area. Furthermore, since monitoring well MW-4 was considered cross- to up-gradient of the former UST area, Ecology allowed the removal of that well from the monitoring program, as long as the groundwater flow direction continued to be measured in a roughly southeasterly direction.

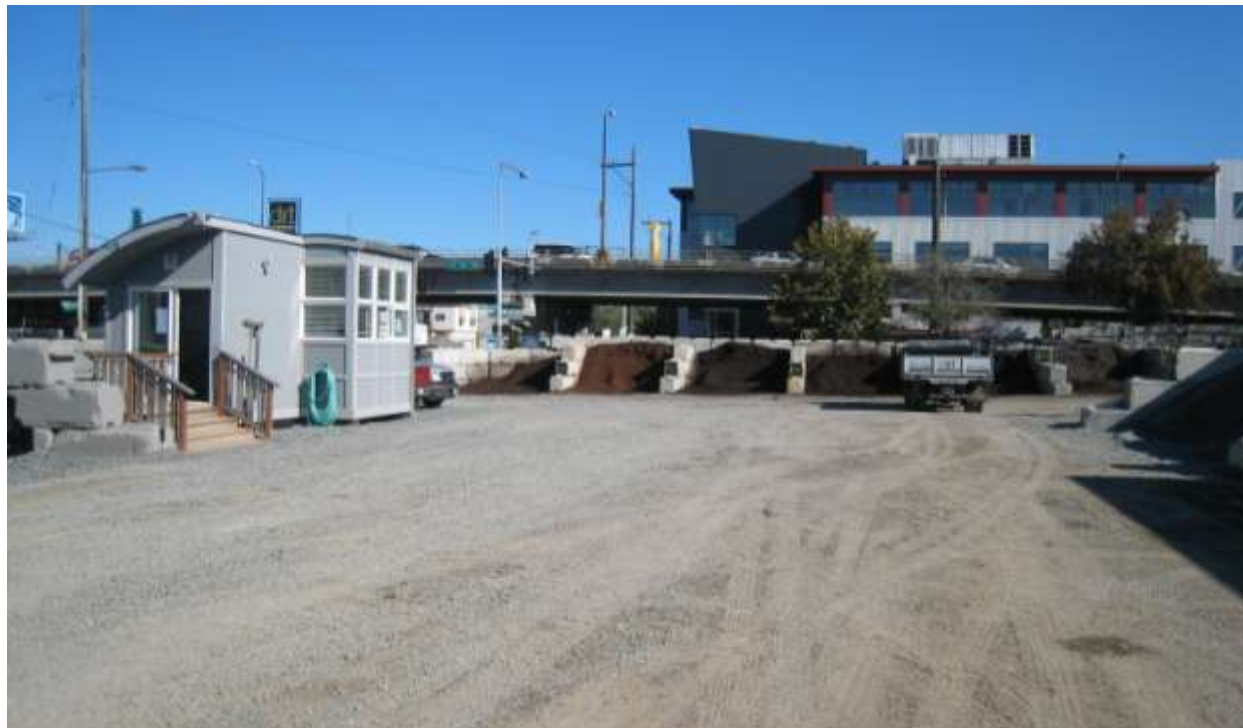
Based upon the Site visit conducted on October 13, 2010, the soil cover at the Site likely continues to eliminate exposure to contaminated soils by ingestion and contact, but this needs to be re-evaluated in light of the Site use discrepancy. The soil cover appears in satisfactory condition and no repair, maintenance, or contingency actions are recommended at this time. However, the Site is now operating as a location for the sale of dirt, compost, and other similar materials, and this is not consistent with the requirement in the covenant for continued industrial use; there is open access to the public. A photo log is available as Appendix 6.5.

Photo 1: Front area with attendant's booth on the left - from the west

Based on this periodic review, the Department of Ecology has determined that the requirements of the Restrictive Covenant are not met. No additional cleanup actions are required by the property owner at this time, but additional review in Ecology's VCP is needed to re-evaluate the remedy and amend the covenant and perhaps qualify for a property specific NFA letter. It is the property owner's responsibility to continue to inspect the Site to assure that the integrity of the soil cover is maintained.

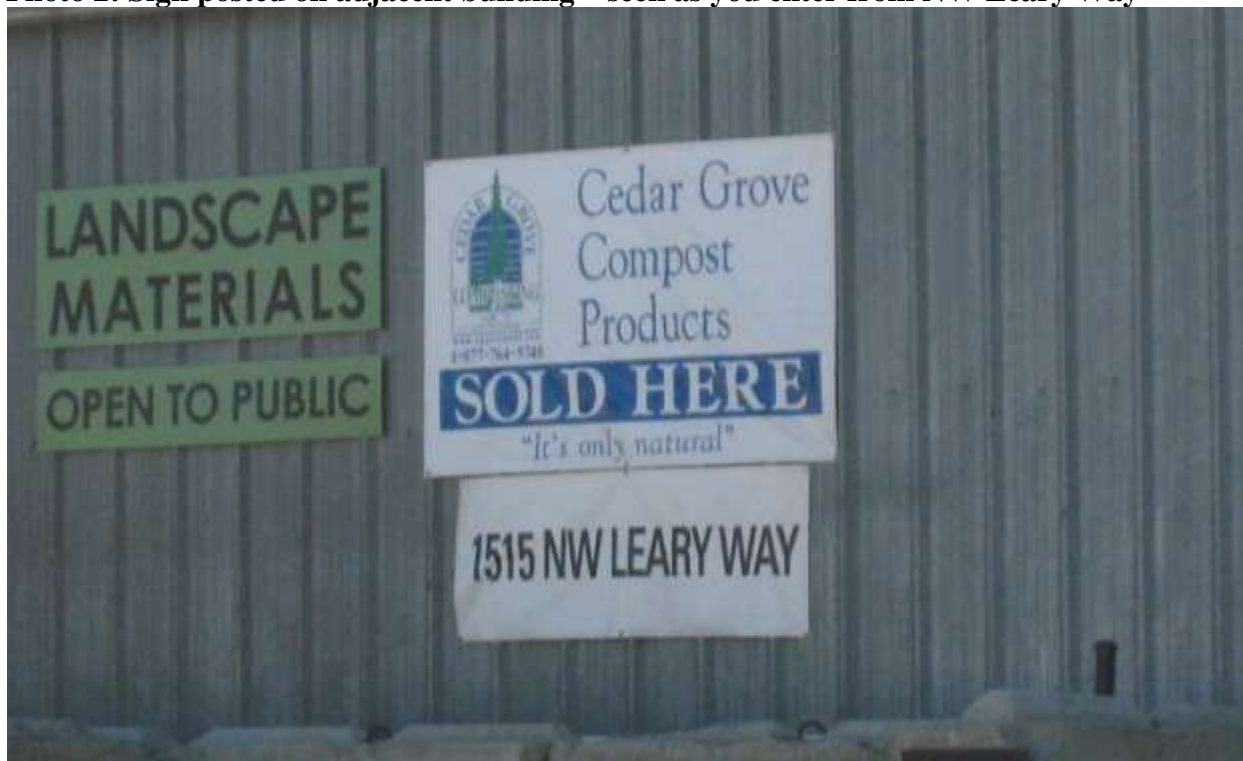
Photo 2: Sign posted on adjacent building – seen as you enter from NW Leary Way

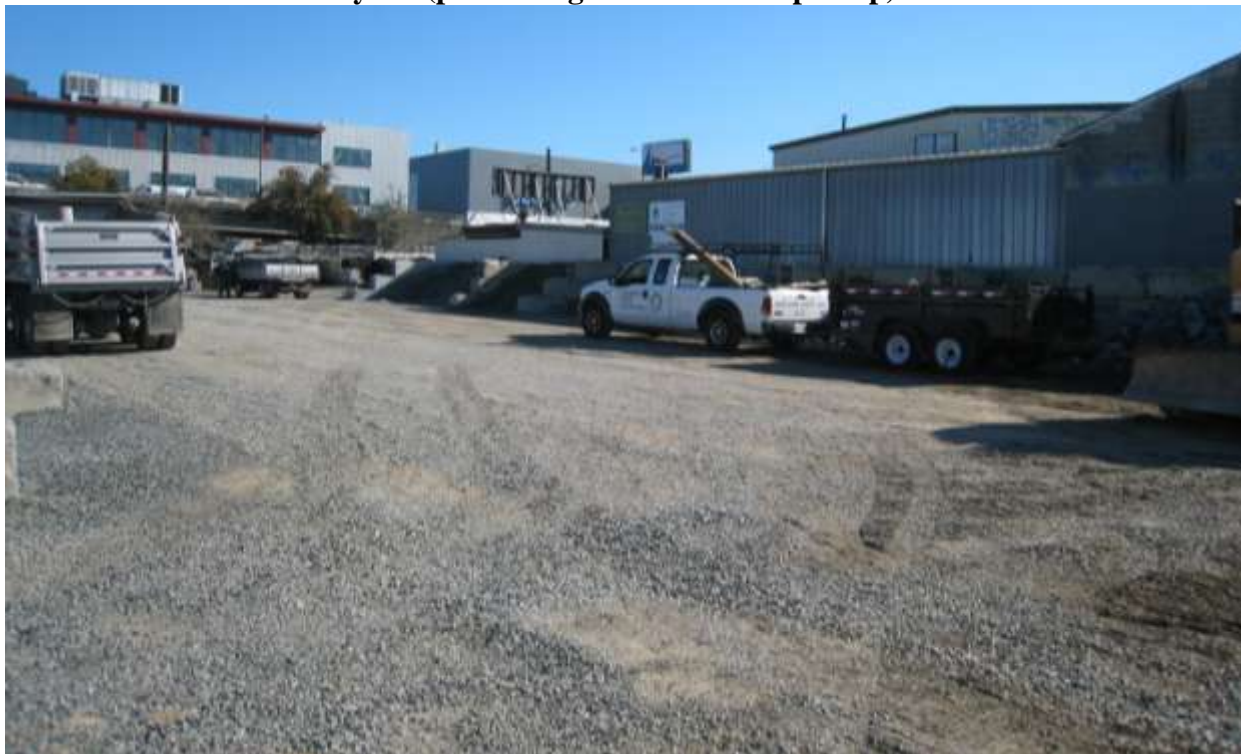
Photo 3: Another view of yard (photo 2 sign visible above pickup) - from the northwest

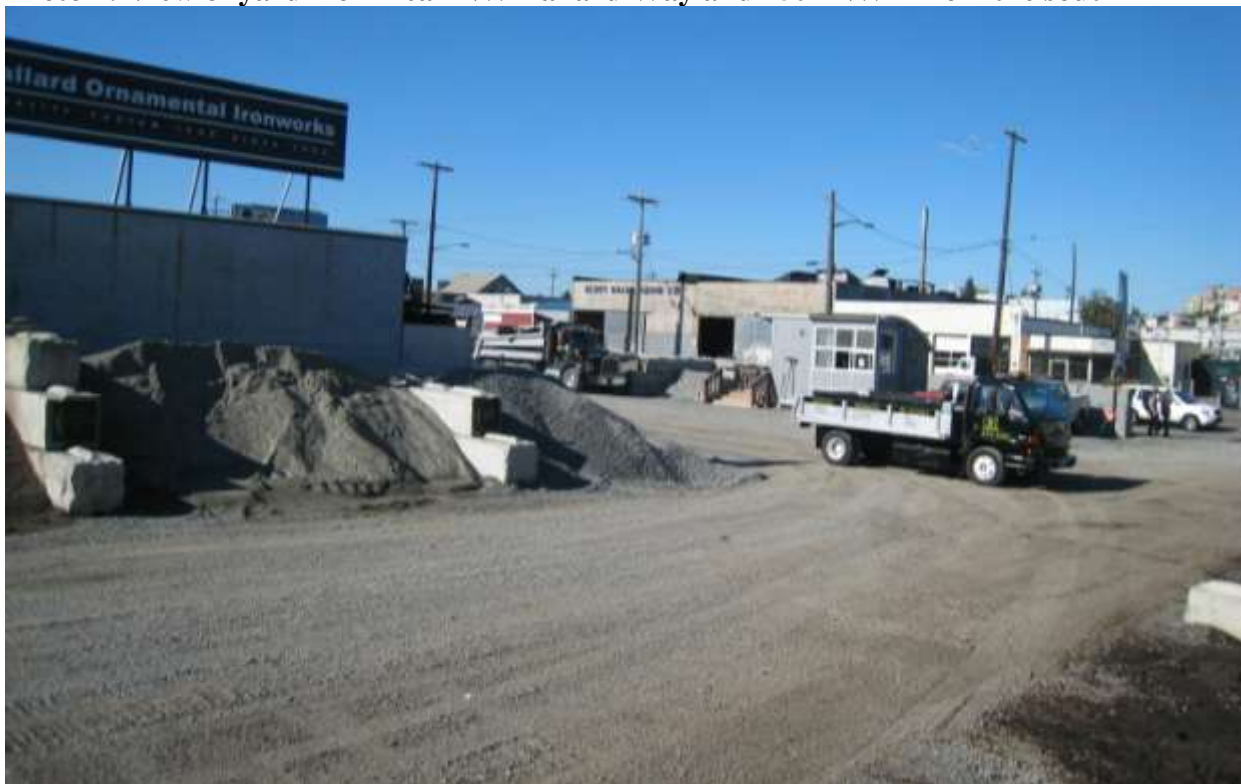
Photo 4: View of yard from near NW Ballard Way and 15th NW – from the south
