EVALUATION OF POTENTIAL
SOIL AND GROUND WATER CONTAMINATION
AT THE ISAACSON CORPORATION PROPERTY
SEATTLE, WASHINGTON

December 21, 1983

Isaacson Corporation
8620 East Marginal Way South
Seattle, WA 98108

Patrick H. Wicks, P.E.
Consultant in Hazardous Waste Management
2535 - 152nd N.E., Suite A
Redmond, WA 98052

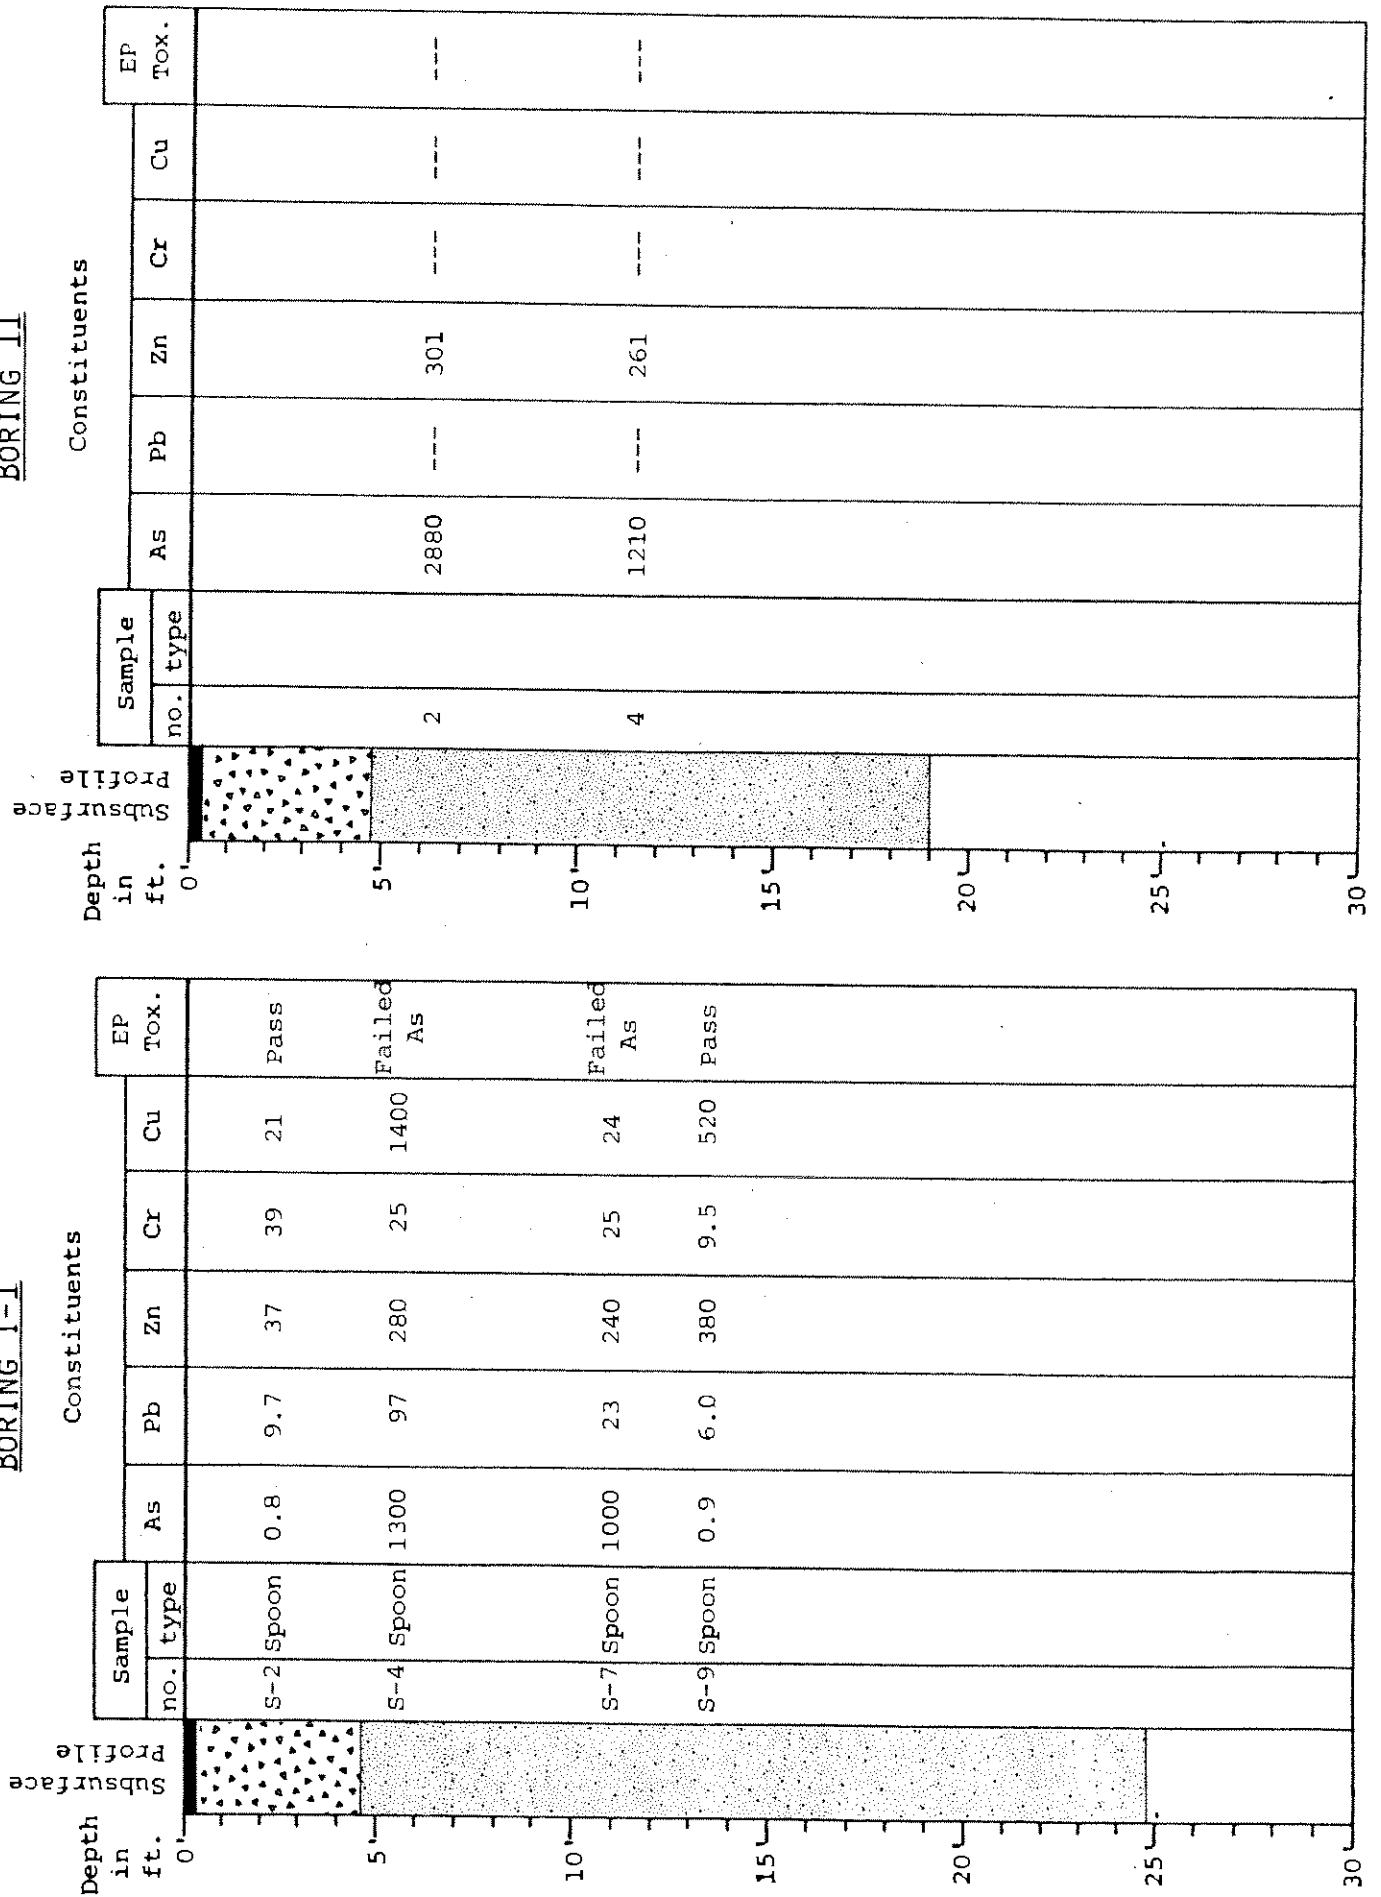
Figure 6. Fill and Soil Chemical Analysis Profiles - Sheet 1
BORING I-1

EP toxicity tests were conducted on five soil samples from Borings I-1 and I-2. Two of the samples tested from Boring I-1 failed EP toxicity because of high arsenic, and the third Boring I-1 sample passed. The two soil samples from Boring I-2 passed the EP toxicity test.

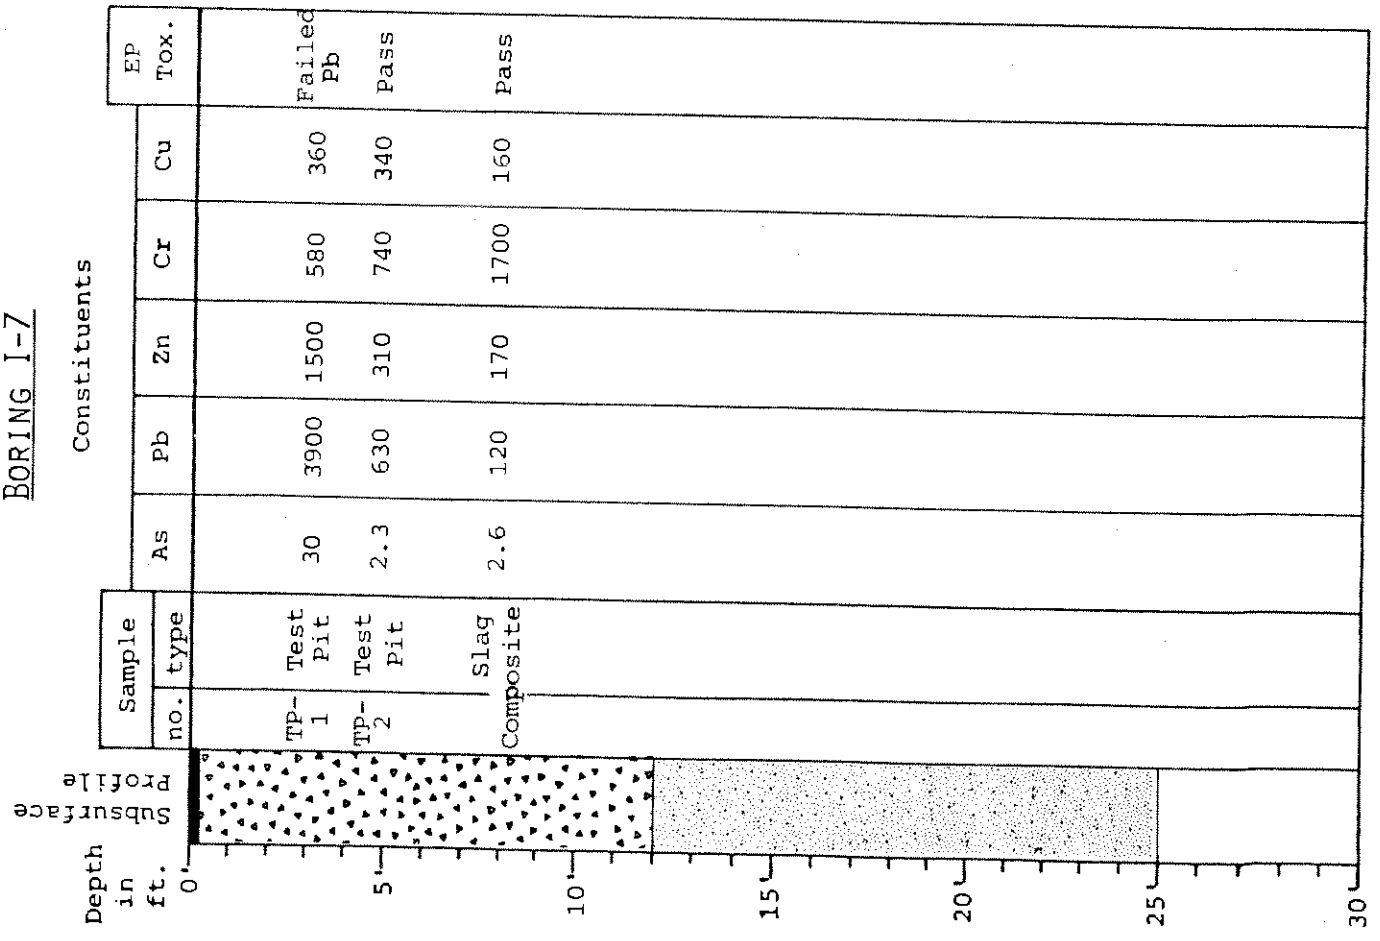
BORING I-7

EP toxicity tests of fill soil samples from Borings I-1 and I-7 were conducted. Of the three soil samples tested, sample TP-1 in Boring I-7 failed the EP toxicity test because of high lead concentration, and the other two samples passed.

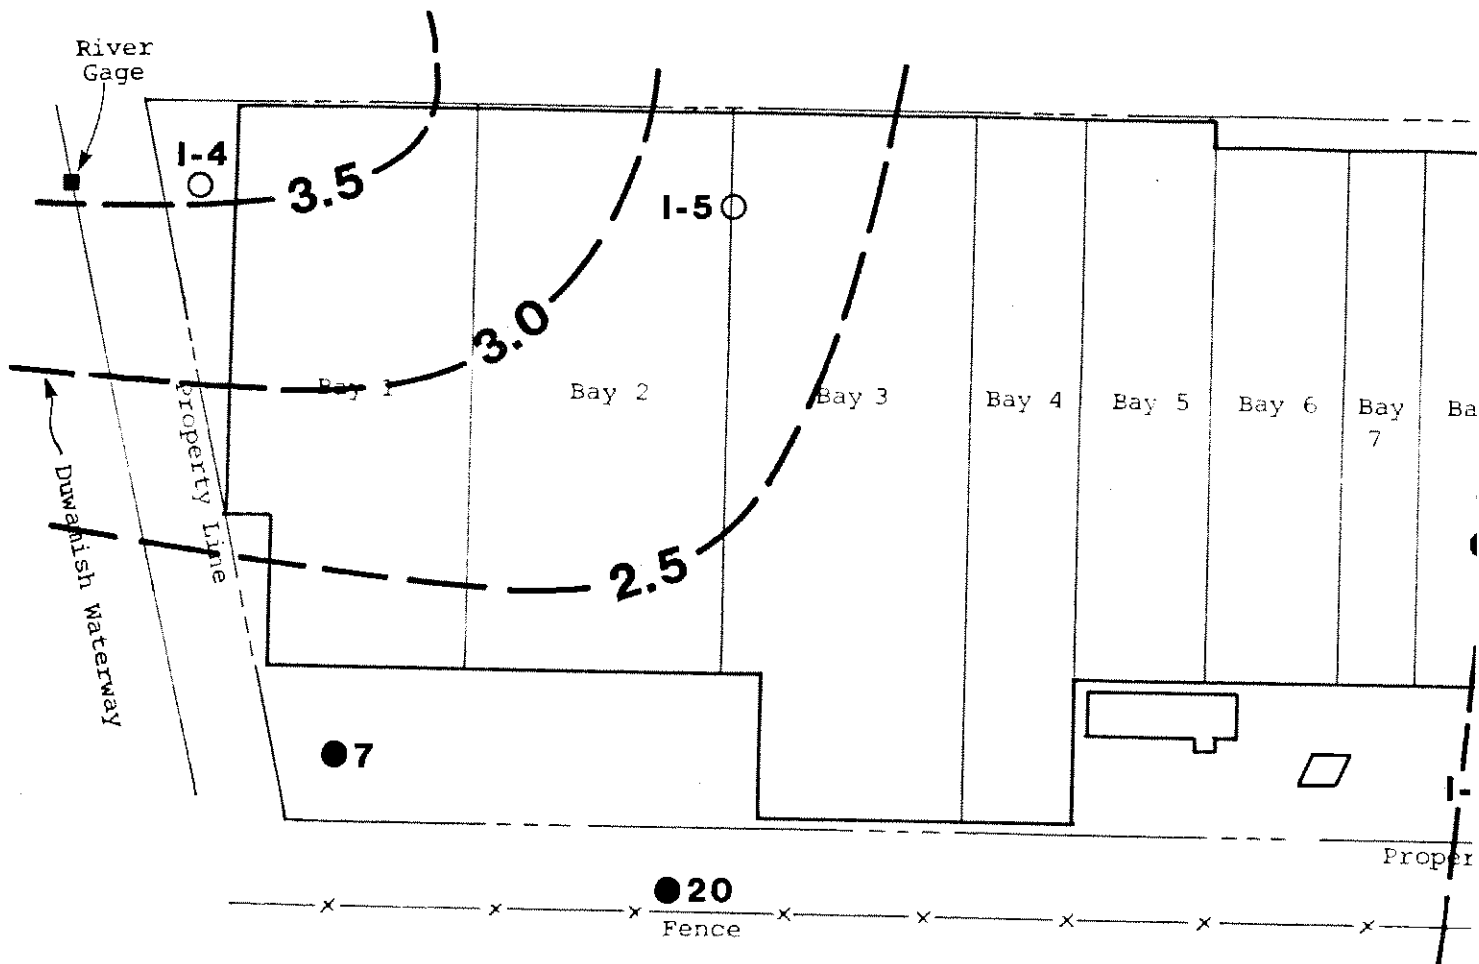
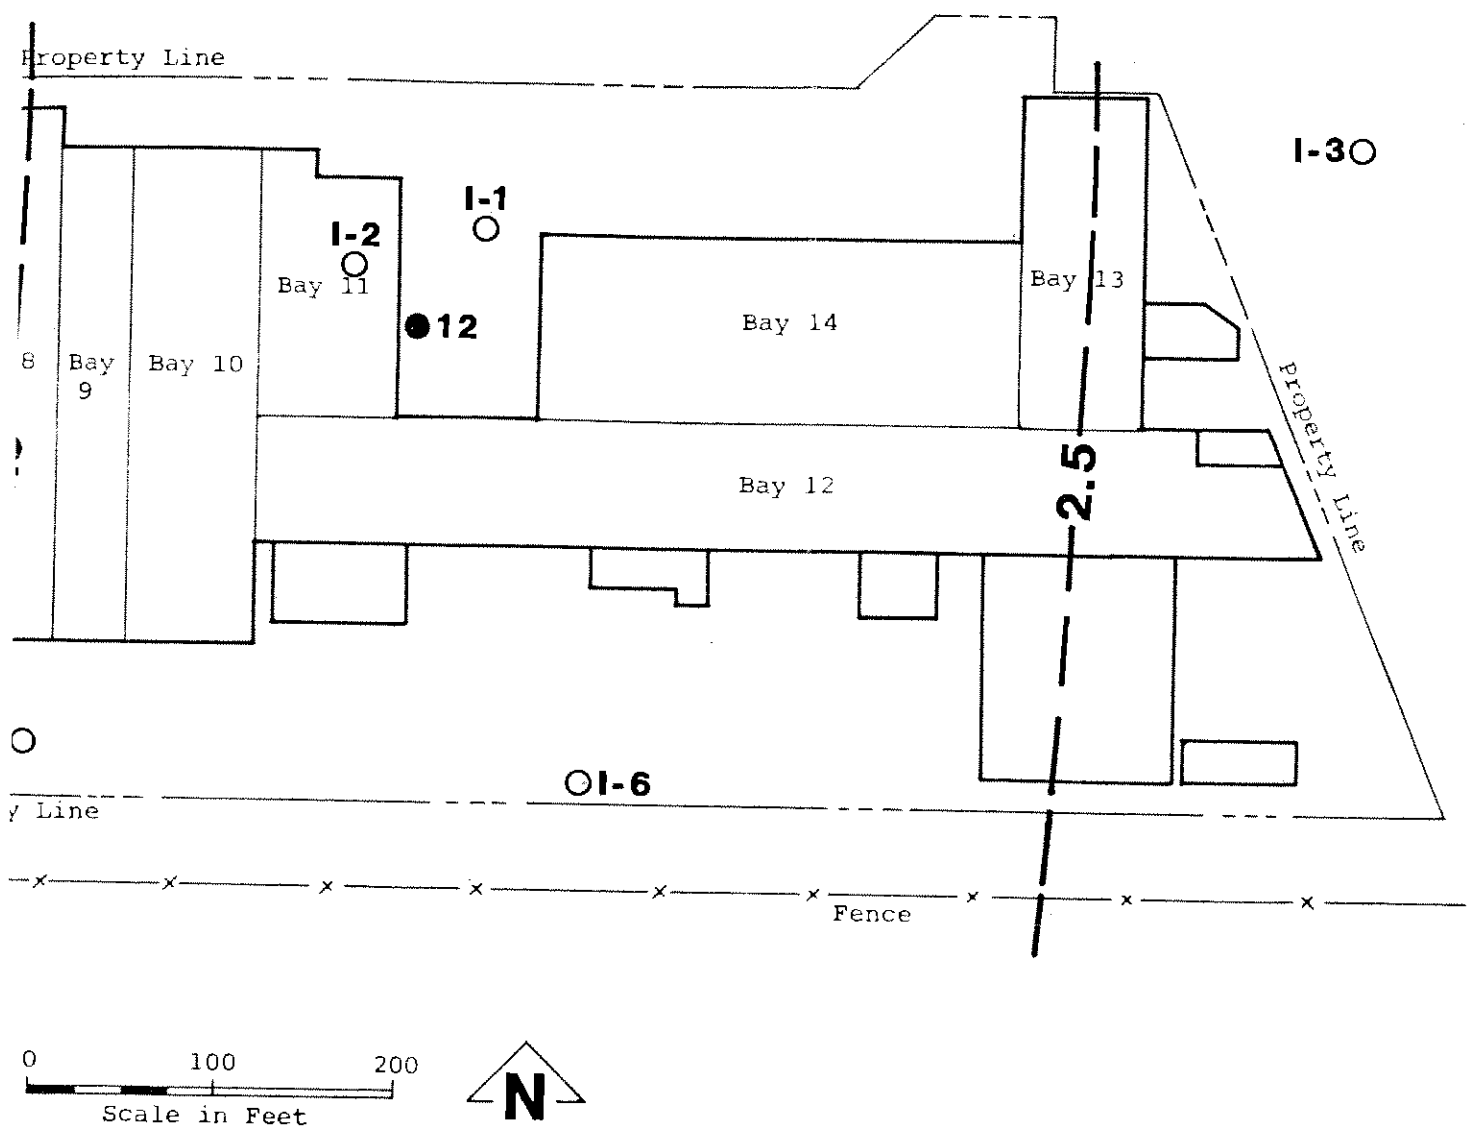
Figure 7

Figures 7 and 8 show that the water table surface in the eastern portion of the site is fairly constant, and slopes from east to west at a rate of approximately 0.0009 feet per foot. This relatively flat gradient is typical of large alluvial valleys similar to the Duwamish.

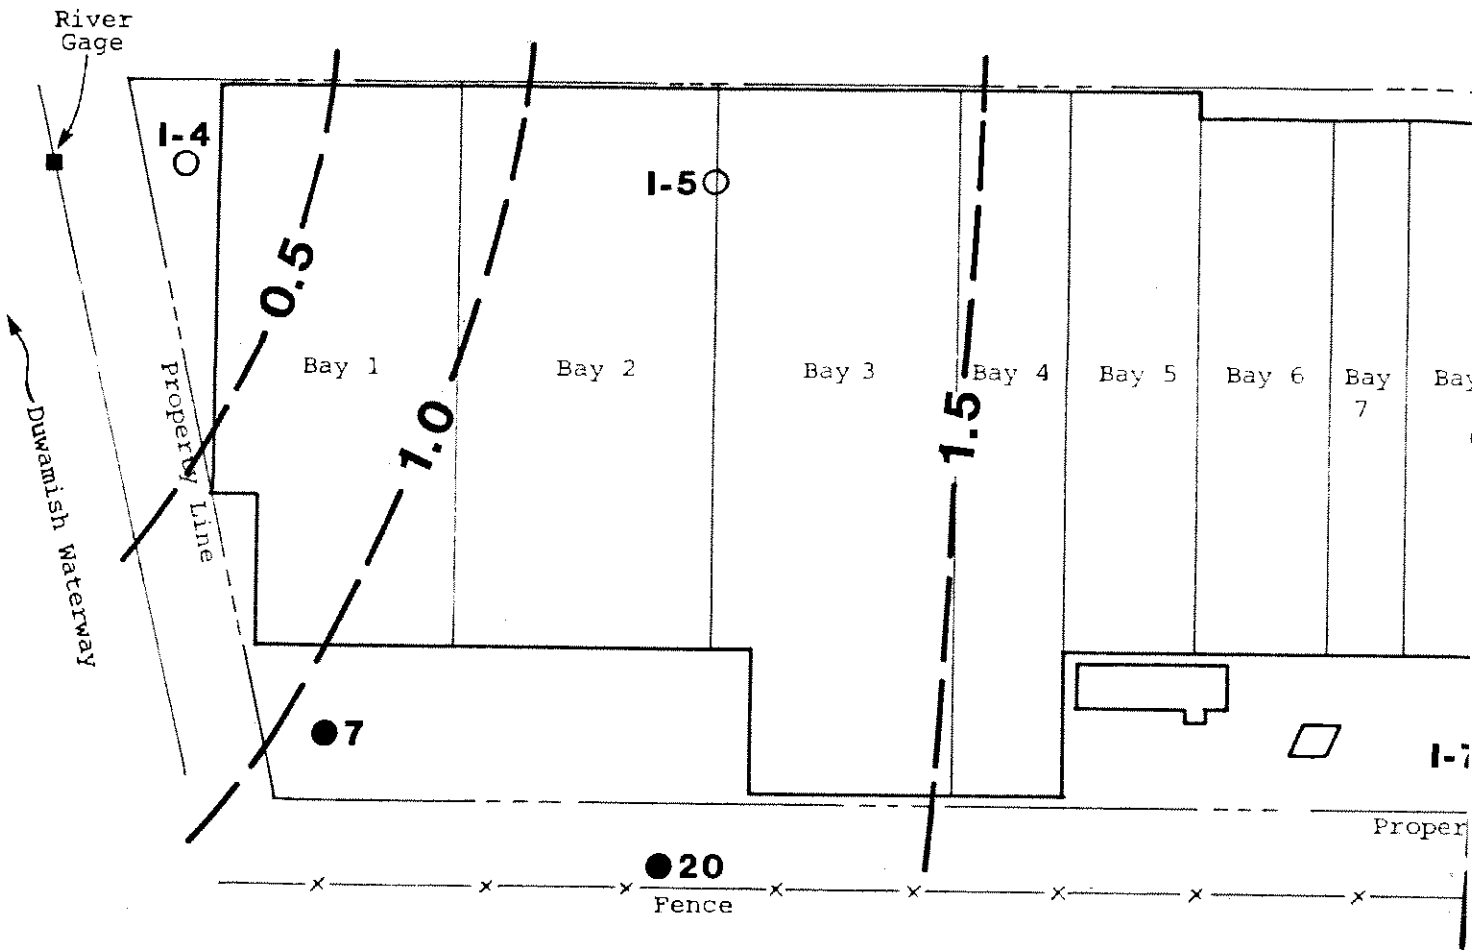
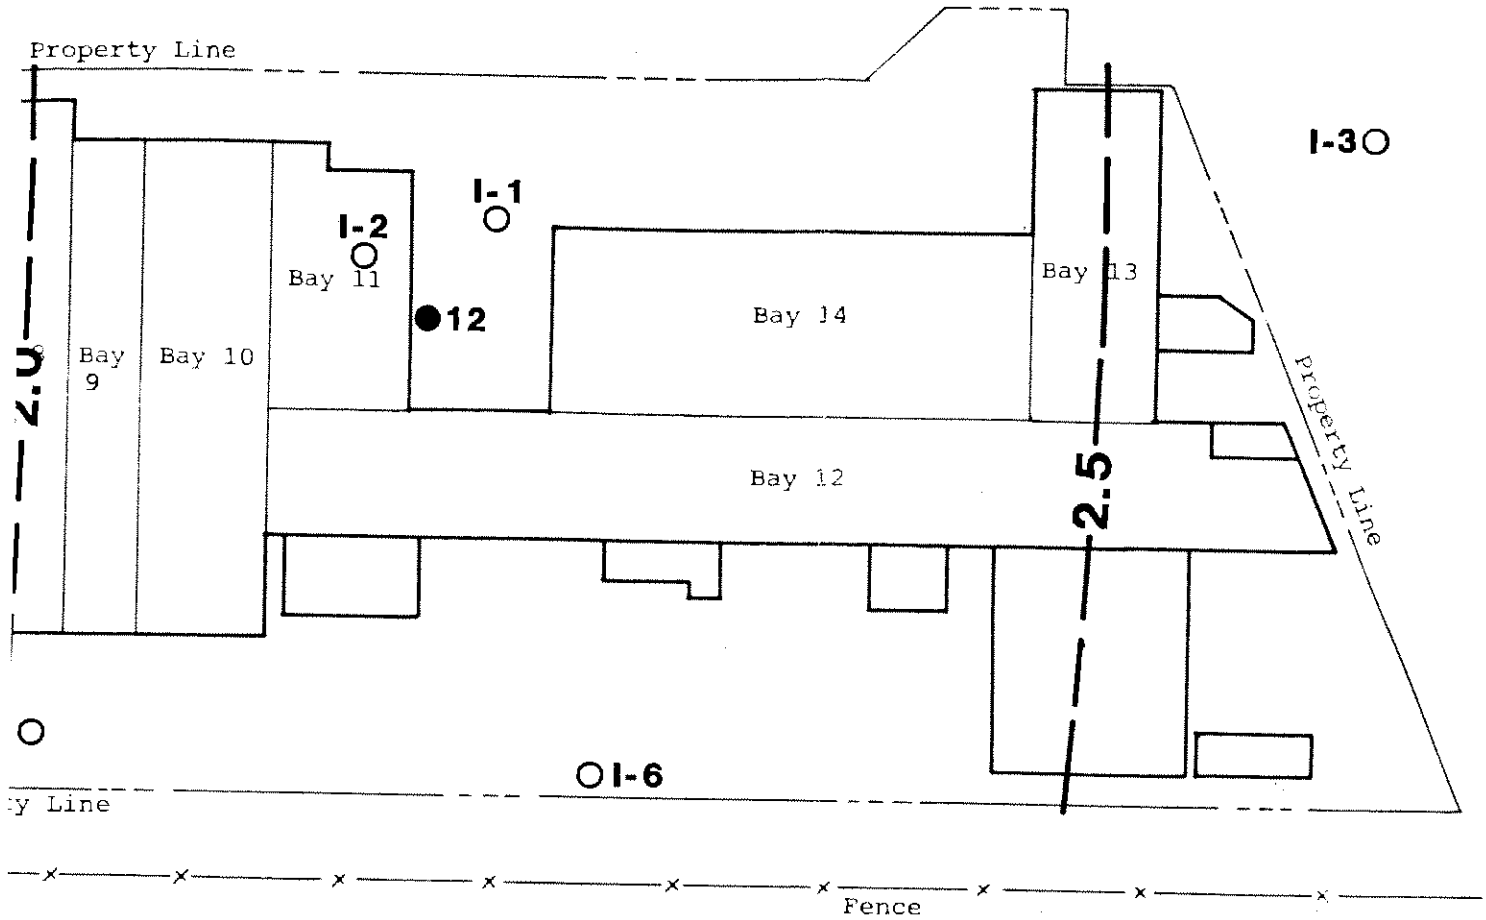
Figure 8

The water table gradients on the western portion of the site are strongly influenced by tidal fluctuations in the Duwamish River, and ranged from approximately .001 to .004 feet per foot, more than four times higher than those found on the eastern portion of the site. Note this gradient reverses with the tidal extremes.
