Data Report

**BUILDING 14-09
THOMPSON-ISAACSON
SITE INVESTIGATION**

Prepared for
The Boeing Company

May 4, 1988

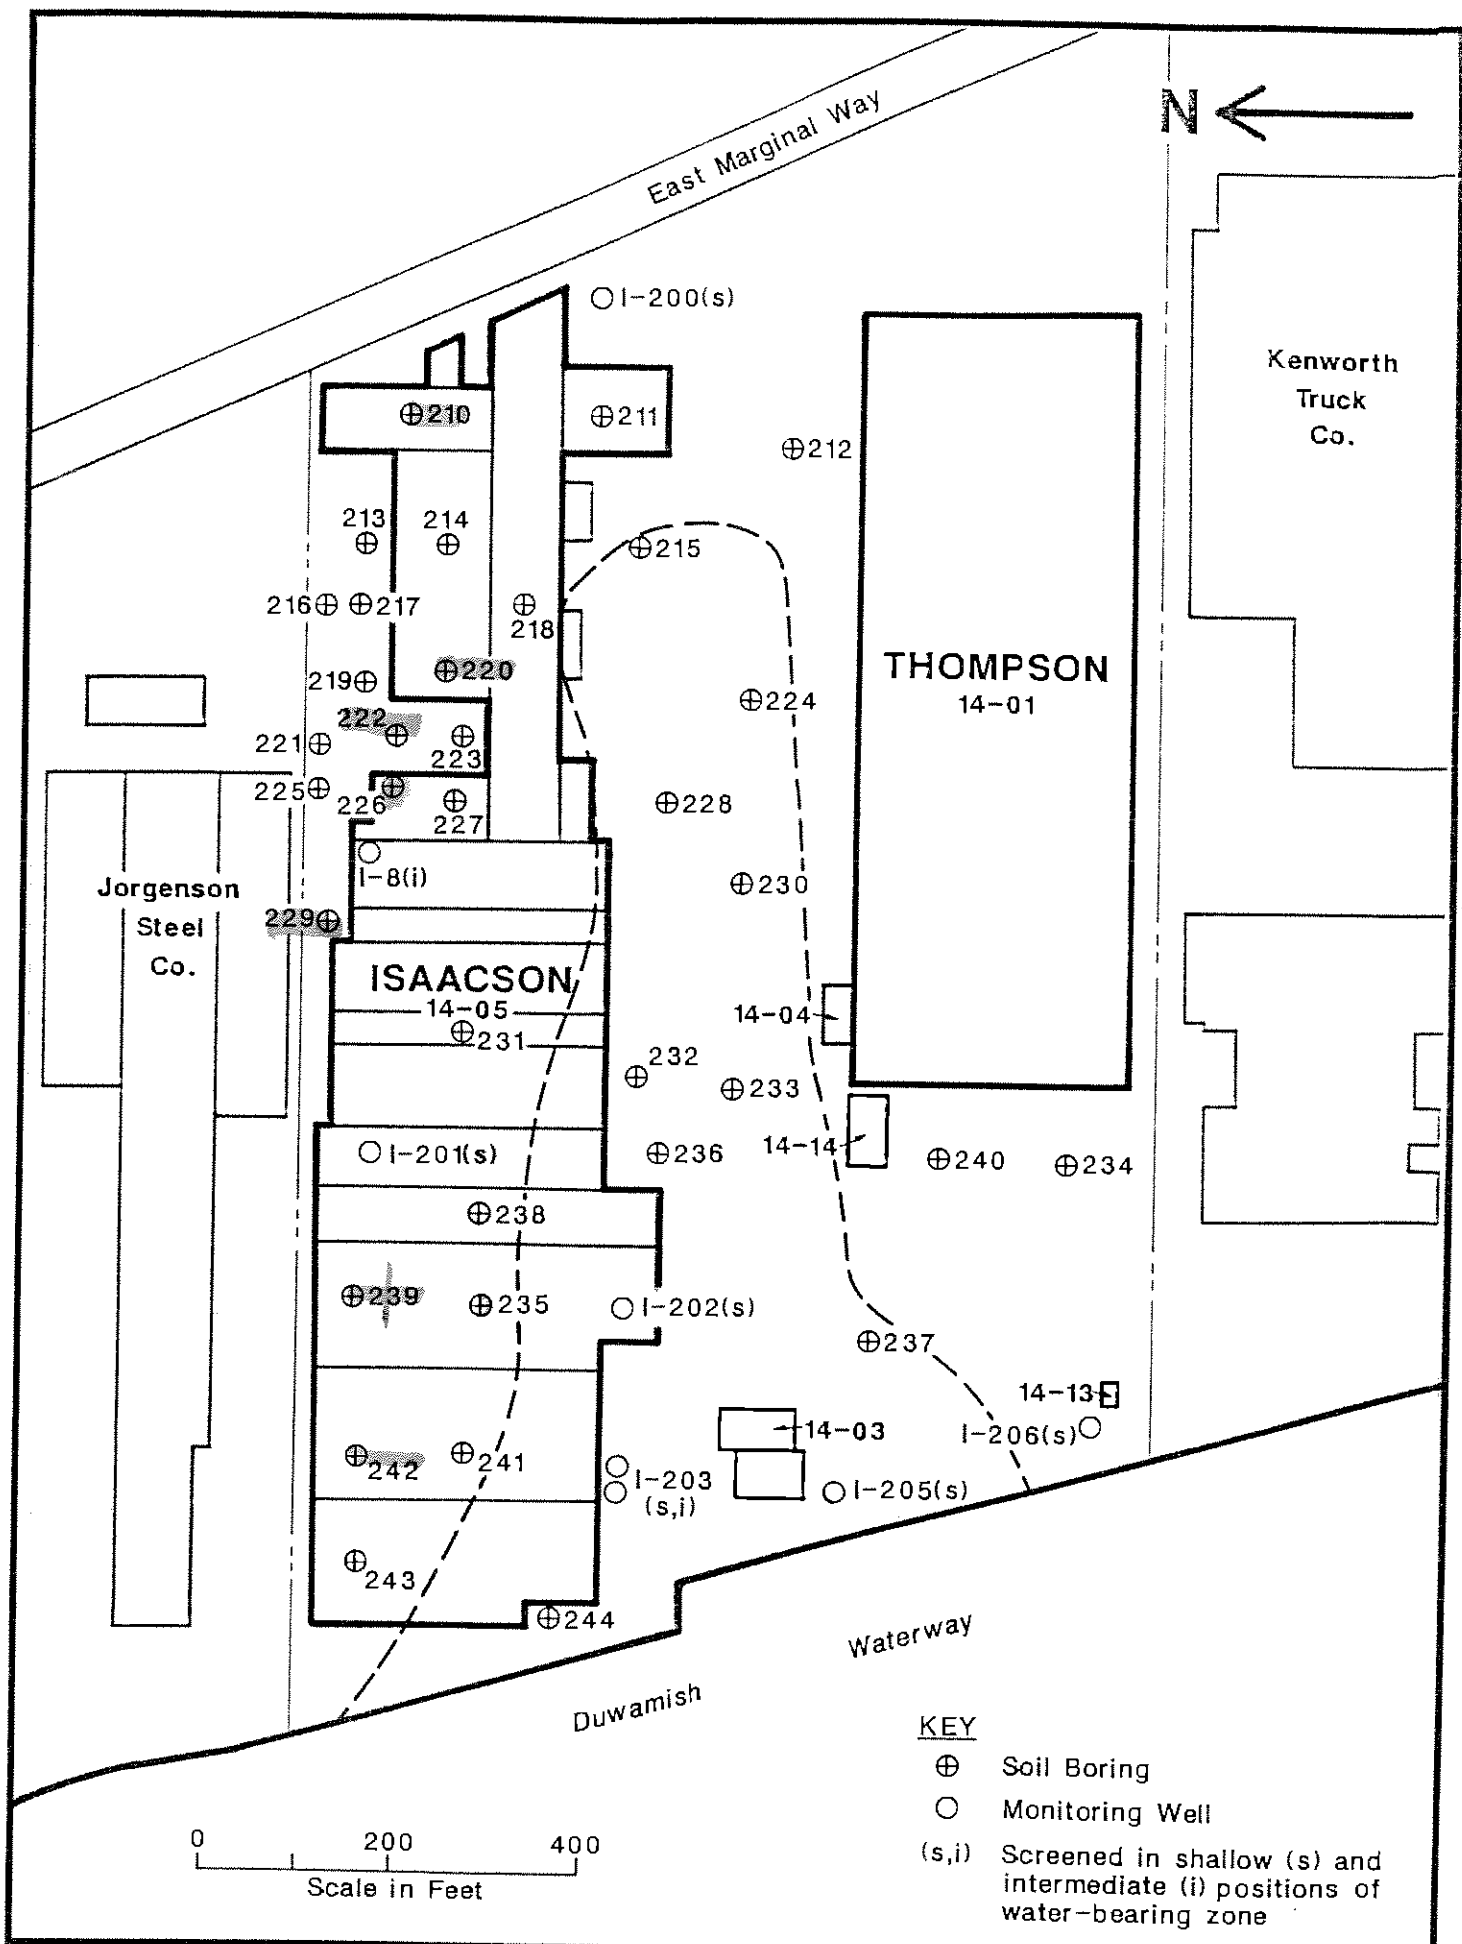
Thompson - Isaacson: Location of Current Study Soil Borings and Monitoring Wells

Soil samples were collected at 44 explorations on the Thompson-Isaacson site. Eight (8) of these explorations were completed as monitoring wells. The locations of the 44 borings and monitoring wells are shown on Figure 5-1. The soil and monitoring well explorations are categorized as either "slip area" borings or wells (those located within the boundaries of former Slip No. 5) or "non-slip" borings or wells (those located outside the Slip No. 5 boundaries).

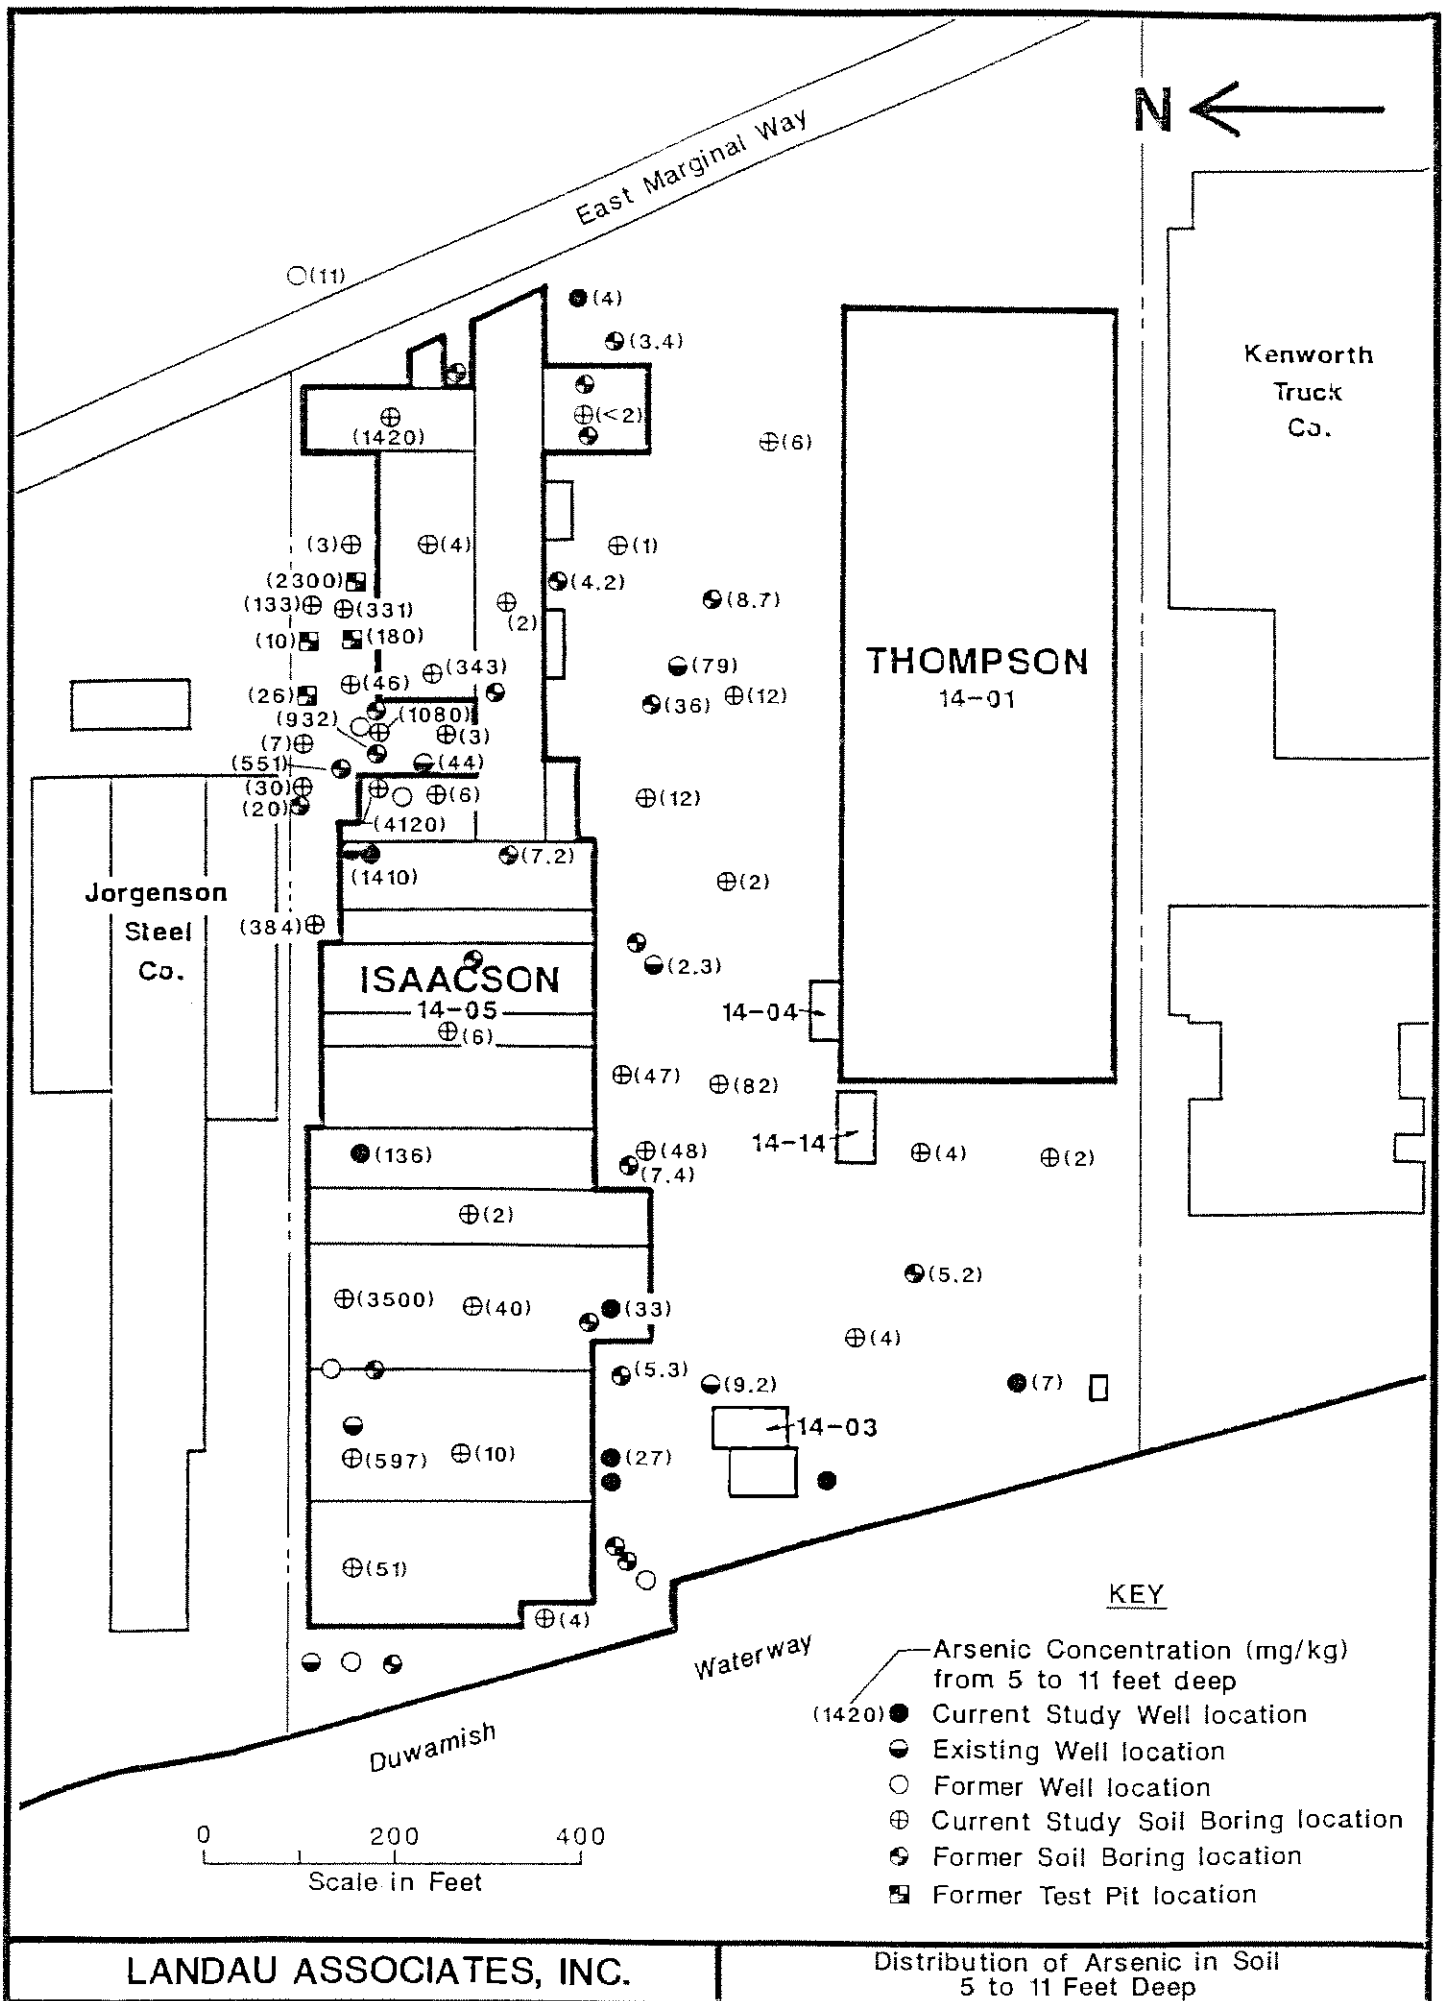
Distribution of Arsenic in Soil
5 to 11 Feet Deep

The cross-sections were developed using all past and current arsenic analyses (excluding material excavated during previous investigations). The three plan view maps display arsenic concentrations in soil located between 0 and 5 feet (Figure 5-8); 5 and 11 feet (Figure 5-9); and 11 and 15 feet (Figure 5-10) below the ground surface. All soil below approximately 11 feet depth is below the high ground water level.
