# **PERIODIC REVIEW**

# Eastside Jeep and Eagle (former) Facility Site ID#: 2497

400 116<sup>th</sup> Avenue N.E., Bellevue, Washington

October 2014

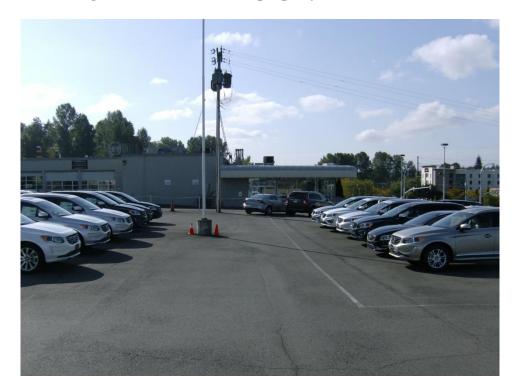
Photo 1: View of the property looking north - from the south property line

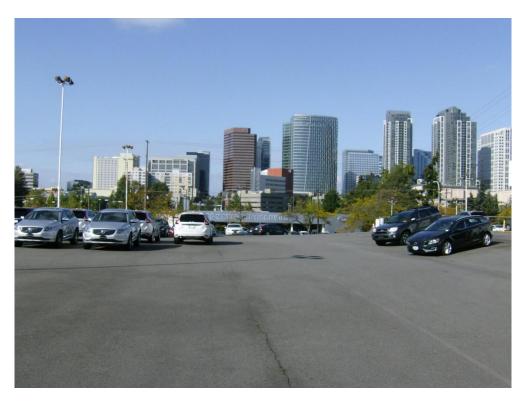
Photo 3: Monitoring well at south boundary

Photo 4: View from east looking west
