Scoping of Lateral Loading Study Lower Duwamish Waterway, WA

Site Reconnaissance Report

FINAL

June 2009

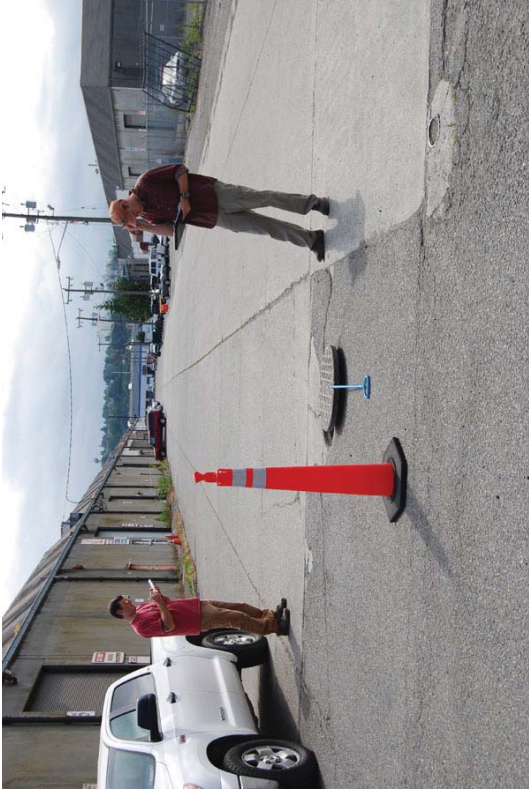
Outfall SPU #105 was not identified in the field, possibly due to its being located either behind riprap or below the water level. The most appropriate manhole access to this outfall's drain line is found at the western end of S Nevada Street (see Figure 2 and Appendix A, p. A-1). Although the outfall was not identified, water flowing westward in the drain line suggests that the outfall is actively emptying into the LDW.

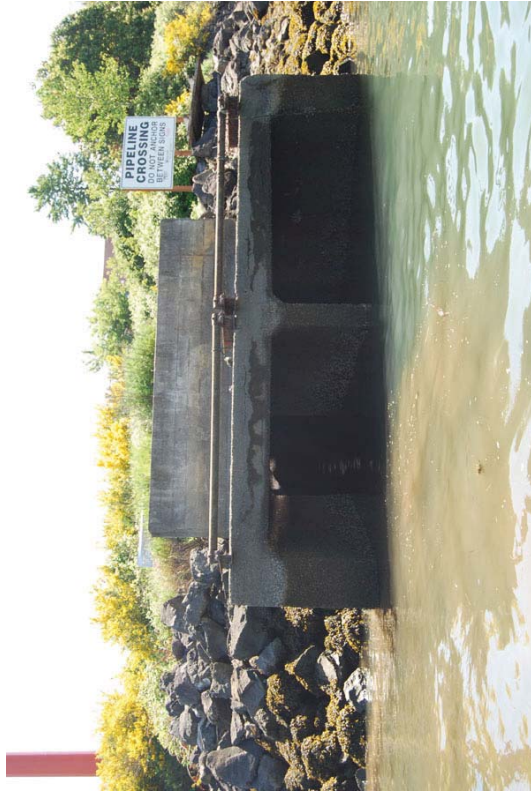
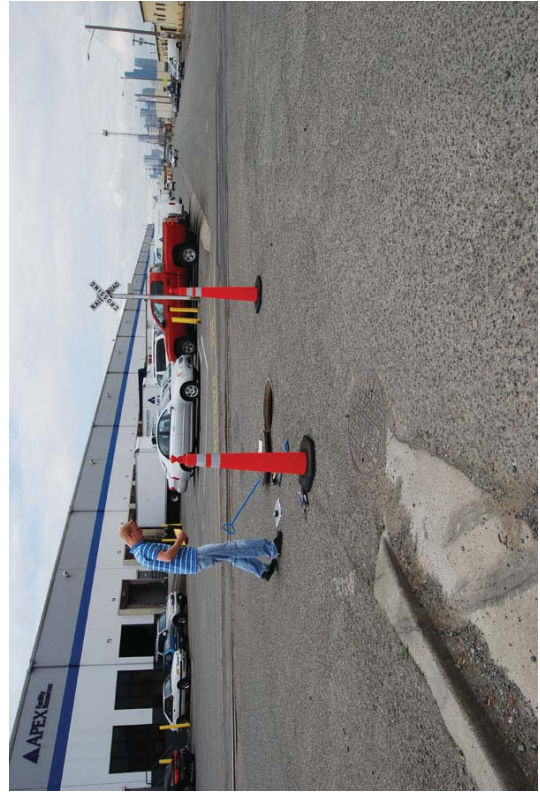
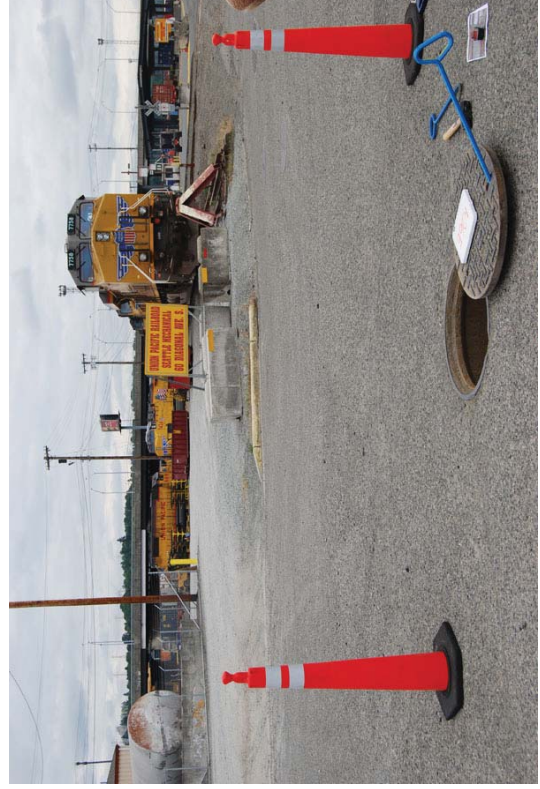
Outfall RI #2155 is a 144-inch diameter, open-ended pipe located within a concrete housing platform. Atop the platform are two manholes that allow access to the mouth of the outfall (see Figure 3 and Appendix A, p. A-2). Hinges at the entrance to the outfall may have once held a tide gate. The most suitable site for accessing the drain line is a manhole found northeast of the intersection of S Oregon Street and Colorado Ave S. This access location is found in the corner of a parking lot, just south of railroad tracks.

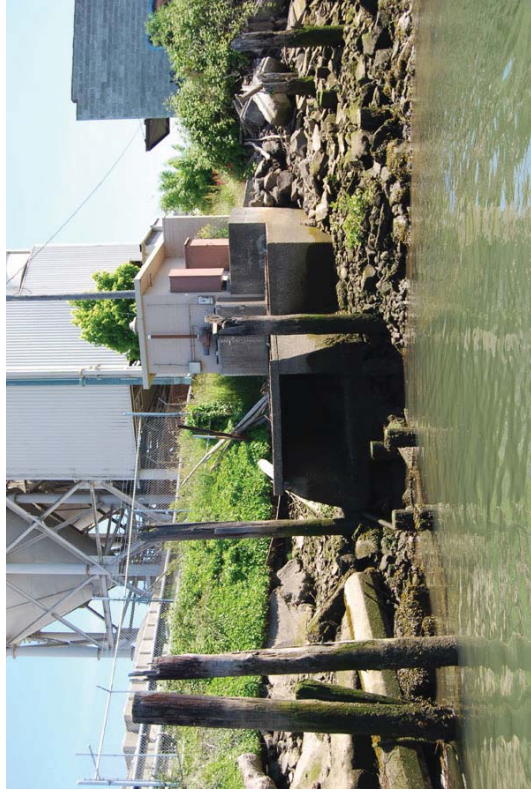
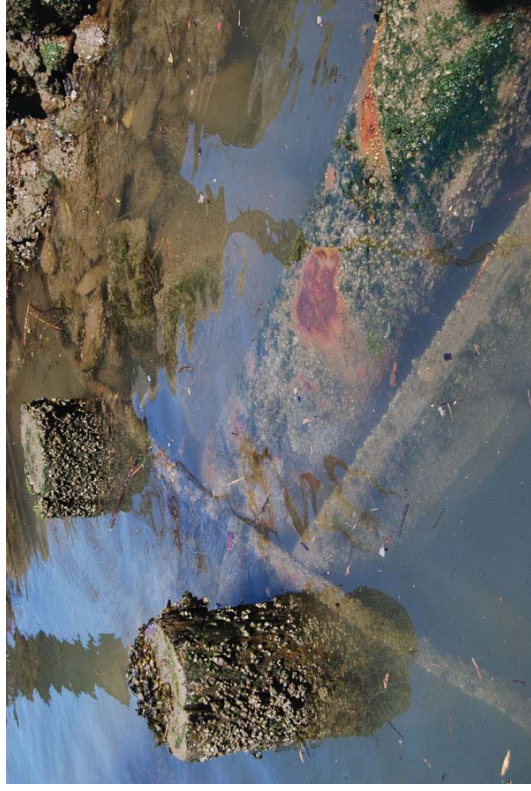
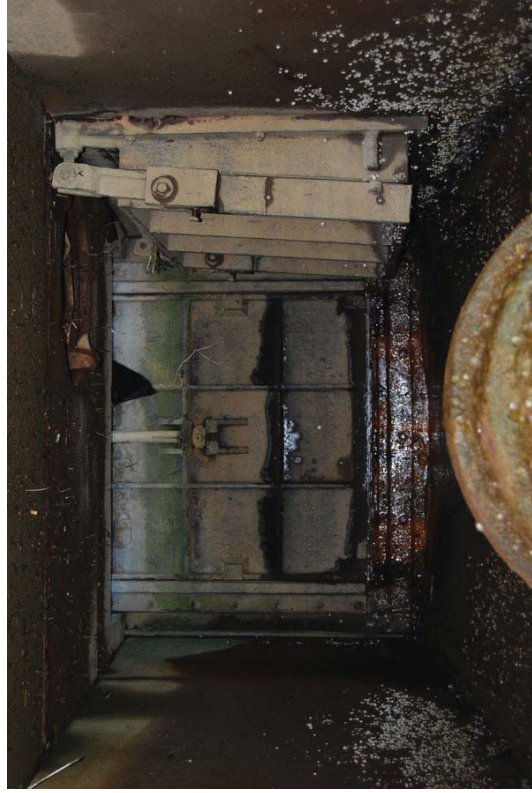
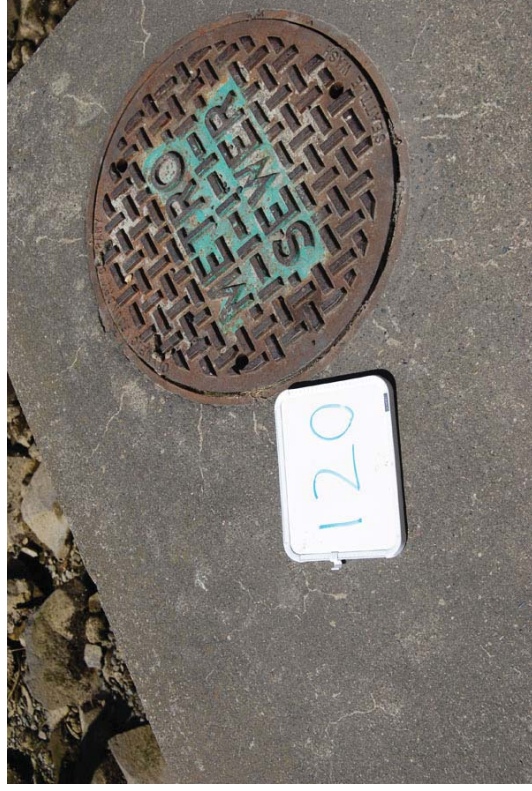
Outfall RI #2223 consists of a large concrete structure on the riverbank. Stormwater that passes through this outfall first collects in a cistern located underneath a small building atop a concrete platform (see Appendix A, p. A-3). Water overflowing the cistern collects in an overflow chamber on the south side of the building. Water can escape the overflow chamber through a tide gate, where it is then funneled into a pipe that discharges to the LDW at a subtidal elevation. A hydraulic floodgate on the west side of the building may be opened during storm events to allow direct discharge from the cistern. No suitable manhole access to the drain line upgrade of the CSO was found.

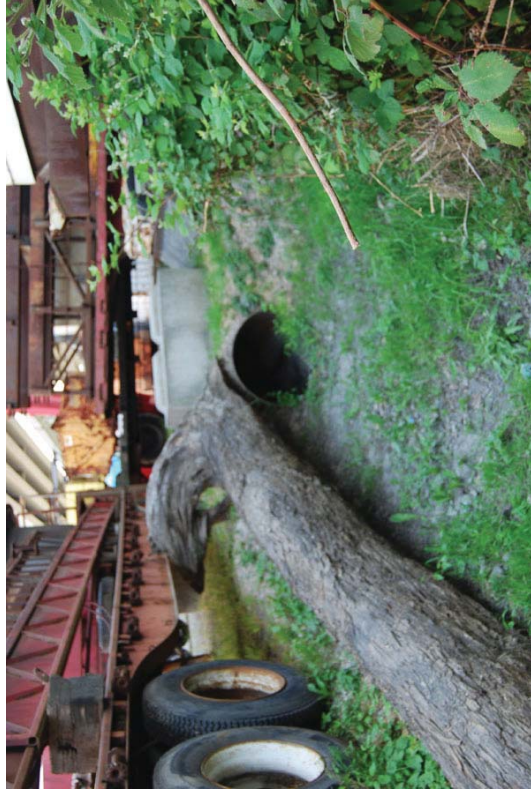
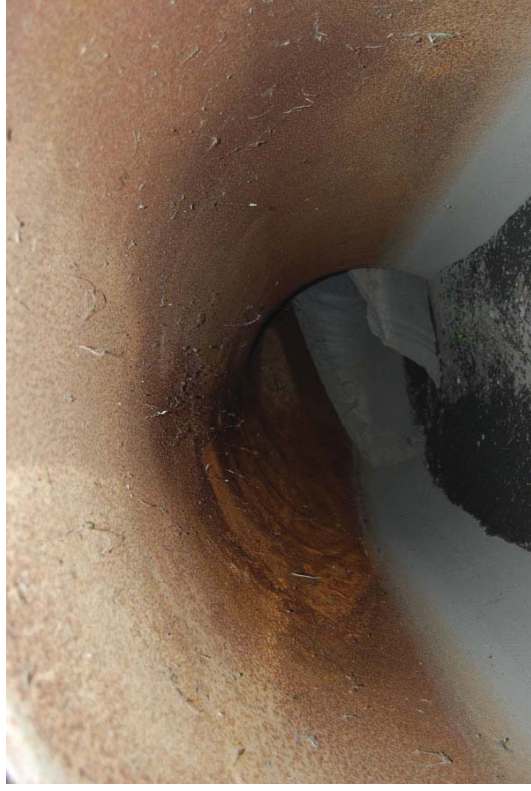
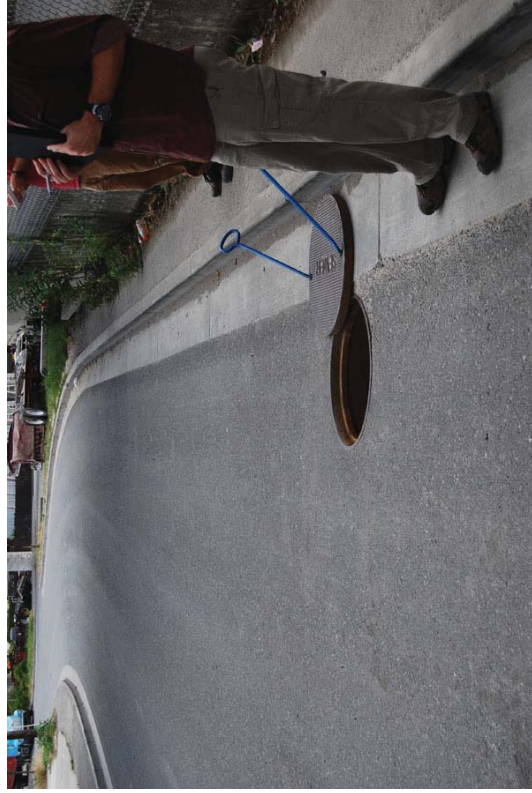
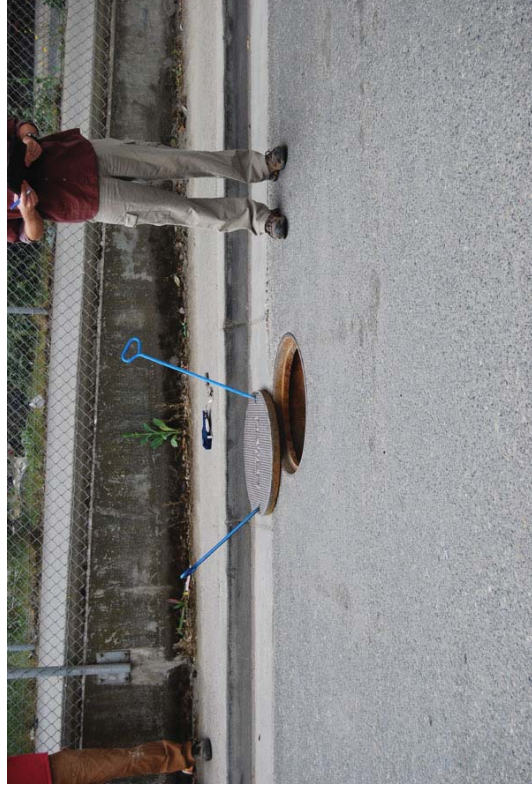
Outfall RI #2503 consists of a 36-inch diameter, open-ended drain pipe that discharges into a ditch underneath the southbound 1st Avenue S Bridge onramp (see Figure 4 and Appendix A, p. A-4). The outfall is located above the Duwamish high water line. Although currently dry, the outfall pipe is partially in-filled with gravel and sand. Manhole access to the drain line is found on S Michigan Street underneath the 1st Avenue S Bridge. An alternative sampling location closer to the outfall is found in a gravel lot near the train tracks that pass under the 1st Avenue S Bridge. Unlike the S Michigan Street access site, the alternative location receives stormwater draining from the bridge's roadway. However, the drain line located at the alternative access is very shallow (4 feet), likely requiring sampling equipment to be placed on the ground surface rather than underneath the manhole.

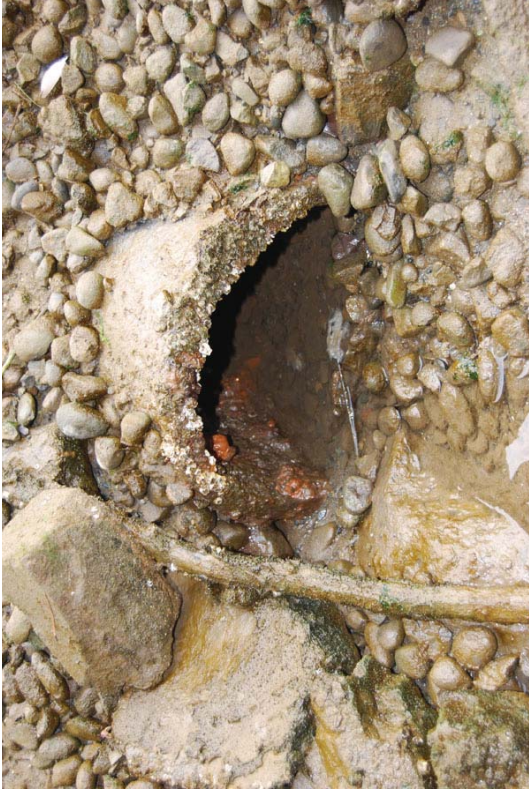
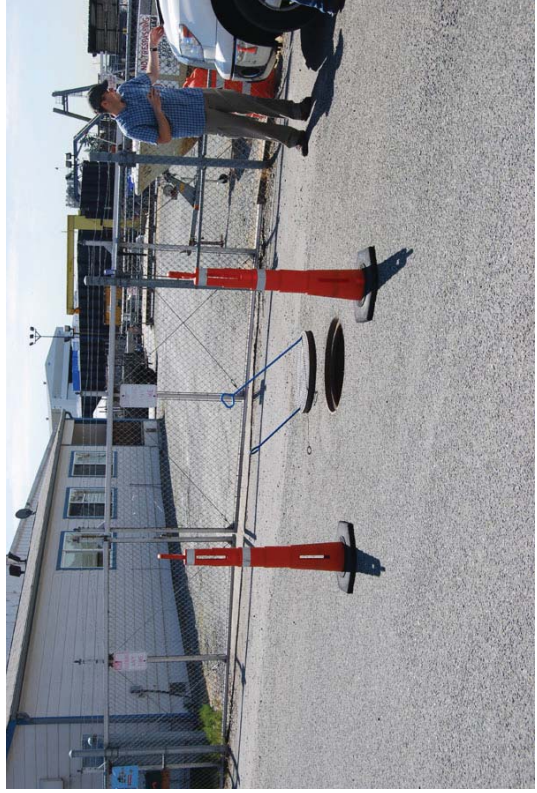
Outfall SPU #142 consists of a 14-inch diameter, open-ended, iron pipe that discharges to the LDW amongst riprap underneath the 1st Avenue S Bridge, adjacent to a public boat launch (see Figure 4 and Appendix A, p. A-5). Flow through the outfall was approximately 5 gallons per minute (gpm) at the time of observation. Manhole access to the drain line is found along S River Street near the boat launch, in front of a chain-link gate on Muckleshoot property.

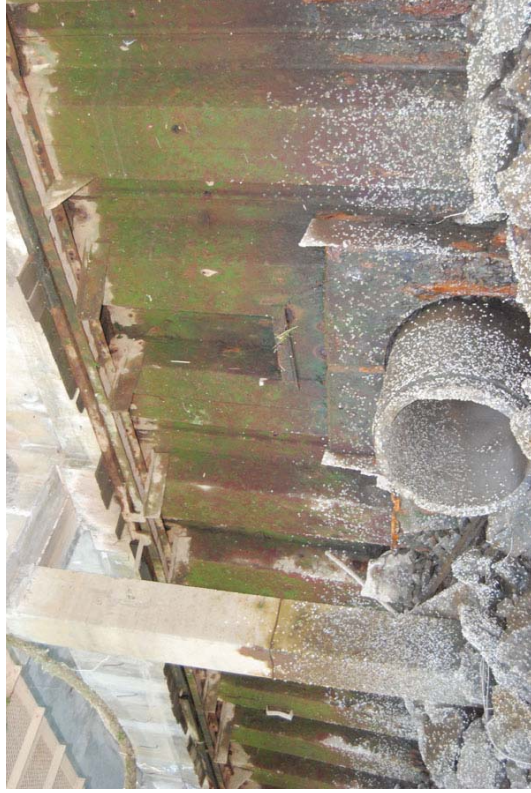
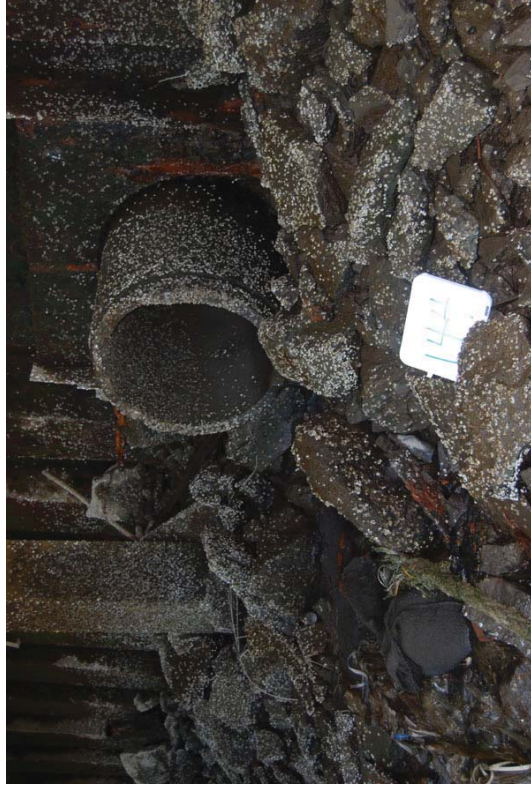
Outfall SPU #144 consists of a 30-inch diameter, open-ended concrete pipe that emerges from a bulkhead underneath a pier (see Figure 5 and Appendix A, p. A-6). Flow through the outfall was approximately 10 gpm at the time of observation. The most appropriate sampling access manhole is located just west of the intersection of S Brighton Street and Fox Avenue S, outside of the Delta Marine North gate.

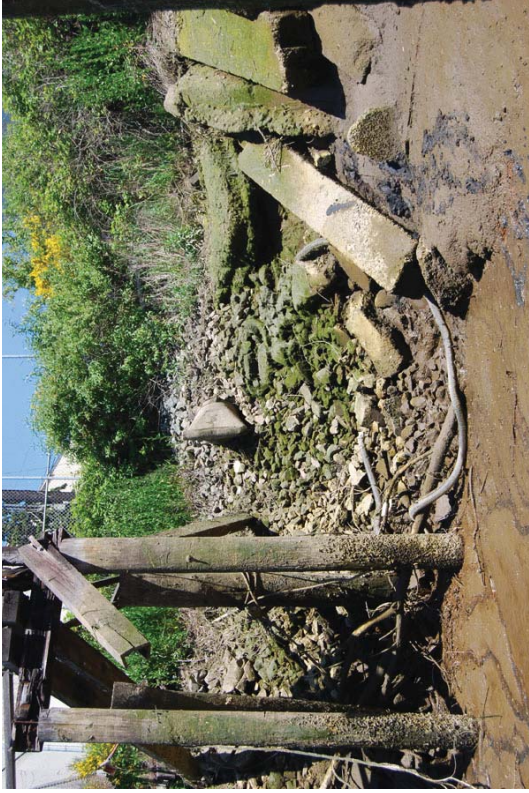
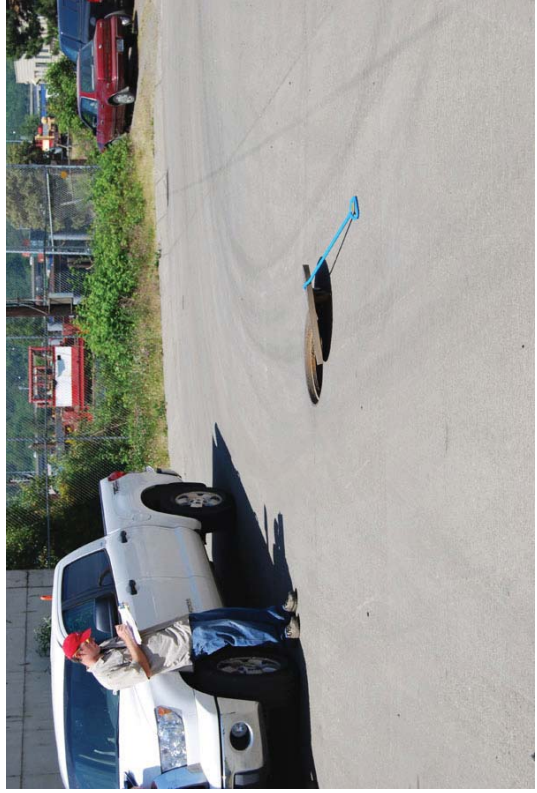
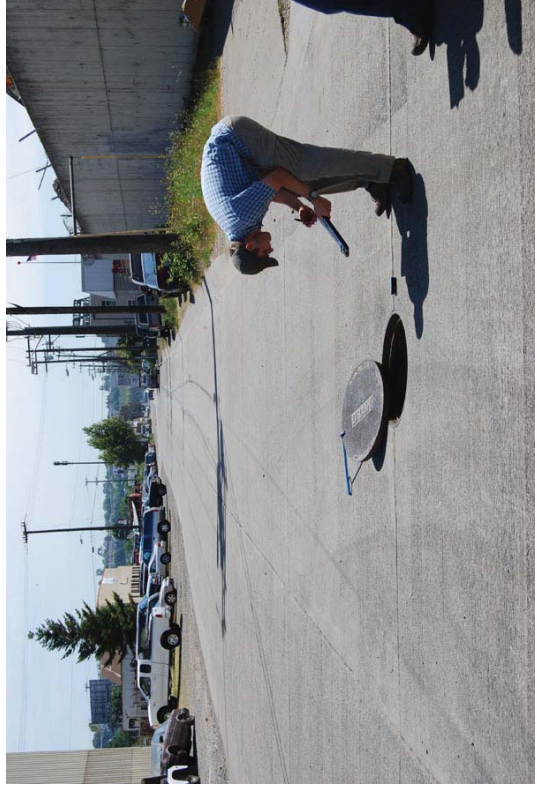
Outfall RI #2026 consists of a 30-inch diameter concrete pipe capped with a pinch valve (see Figure 6 and Appendix A, p. A-7). The pipe emerges from riprap in a small cove at the end of S Myrtle Street. Suitable access to the drain line is found at a manhole located in the turnaround at the west end of S Myrtle Street.

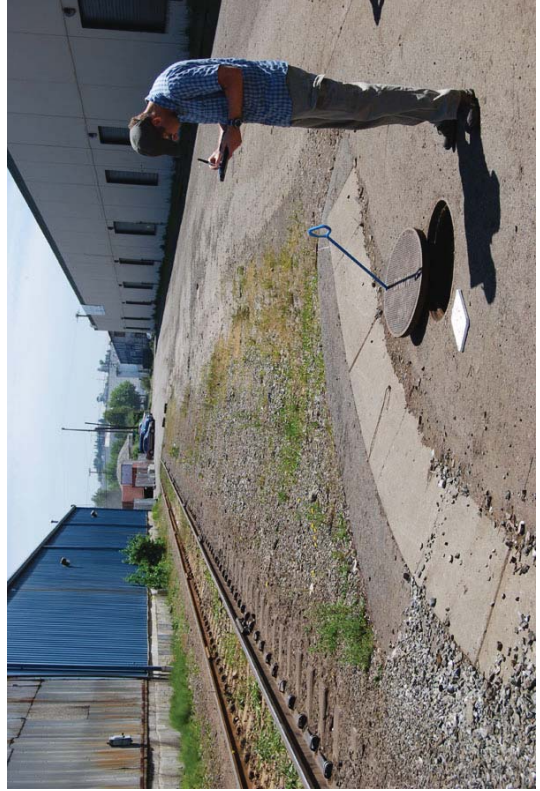
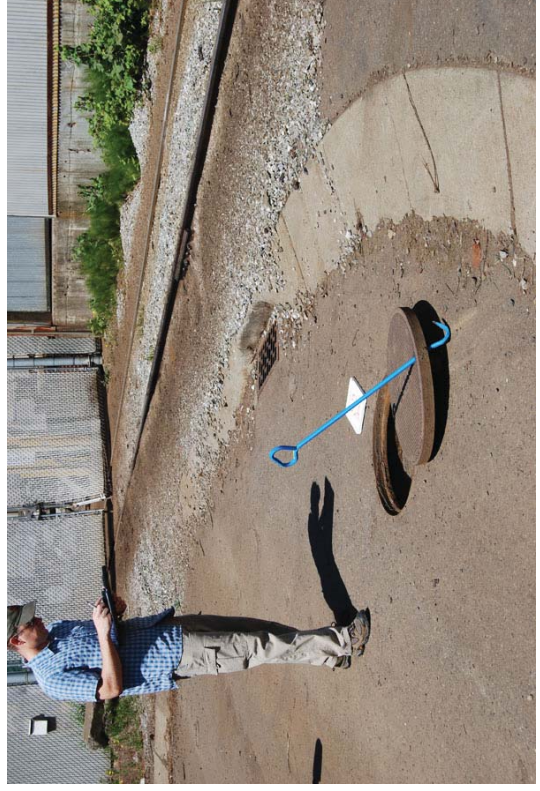
Similar to Outfall RI#2026, Outfall RI #2035 consists of a 30-inch diameter concrete pipe capped with a pinch valve (see Figure 6 and Appendix A, p. A-8). The pipe emerges from riprap adjacent to a pier. Access to this drain line is available at a manhole found in the turnaround at the west end of S Garden Street.

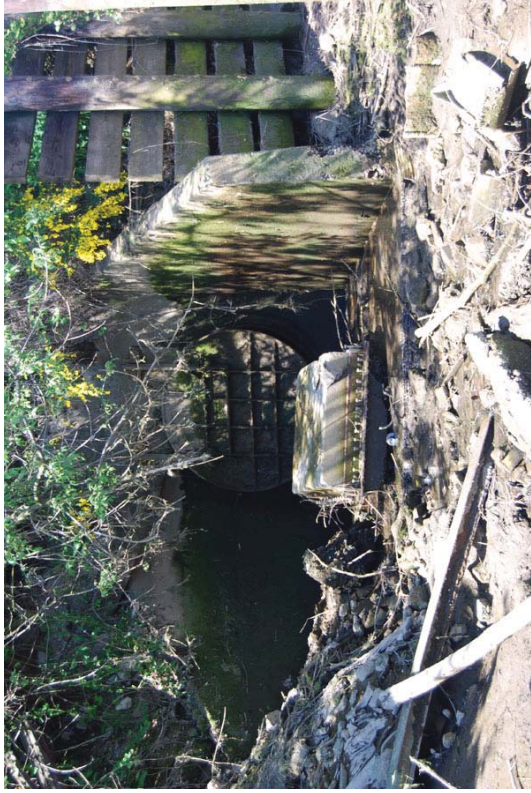
Outfall RI #2046 drains a portion of the I-5 Freeway. The outfall is located in Slip 4 and consists of a 72-inch diameter pipe that emerges from the bank riprap at a concrete wall with wing walls (see Appendix A, p. A-9). The pipe opening is covered by a tide gate attached to the wall. Suitable manhole access to this drain line was not found.

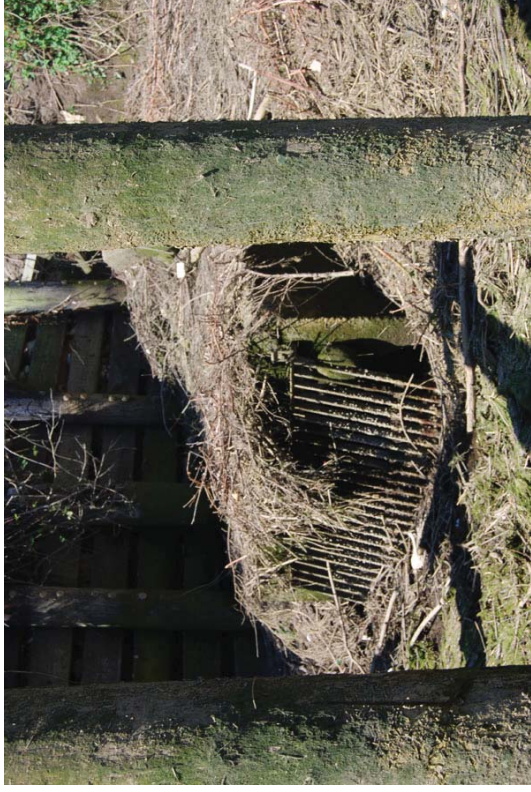
Outfall RI #2047 is located just east of Outfall RI #2046 in Slip 4. The 72-inch diameter pipe opening is partially in-filled with miscellaneous debris and is covered by a grate (see Appendix A, p. A-10). This outfall drains a flume on the northeast side of E Marginal Way. Suitable manhole access to this drain line was not found.

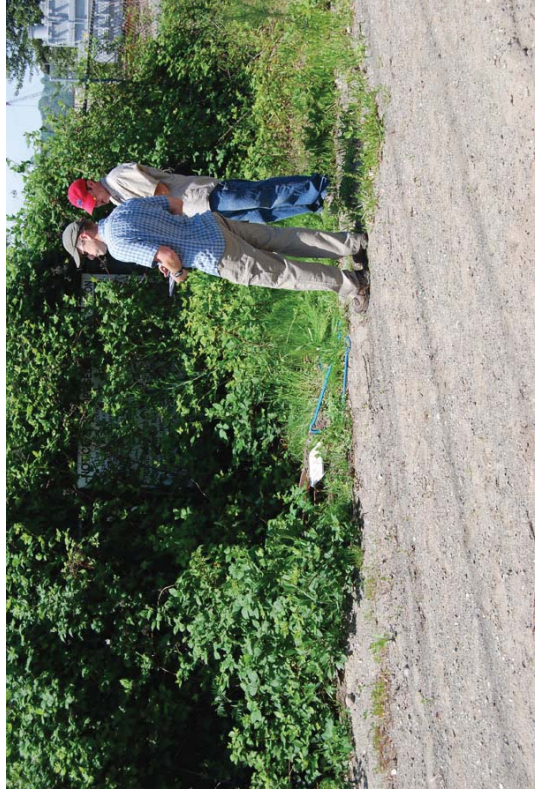
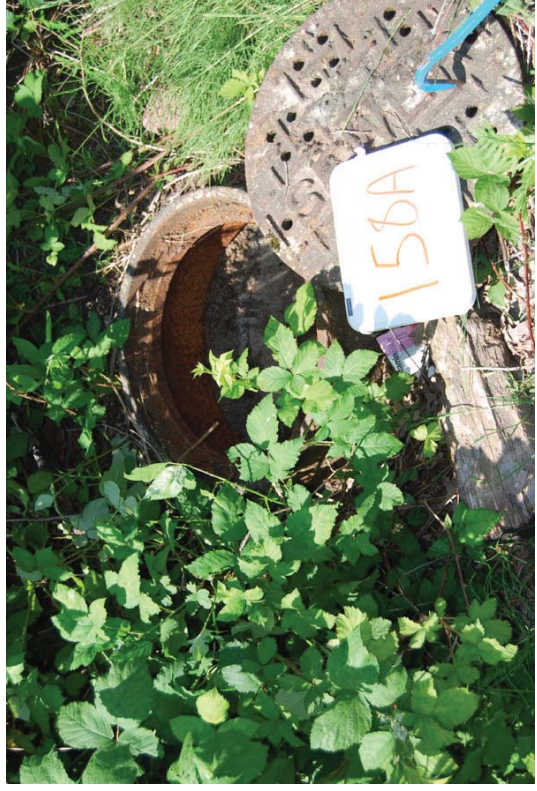
Outfall RI #2048 consists of a 24-inch diameter, open-ended concrete pipe that emerges from bank riprap (see Appendix A, p. A-11). No flow was occurring at the time of observation. Manhole access to this drain line is found northeast of the outfall, amongst brush adjacent to railroad tracks. This drain line has recently been plugged on Boeing property and is therefore not suitable for sampling.

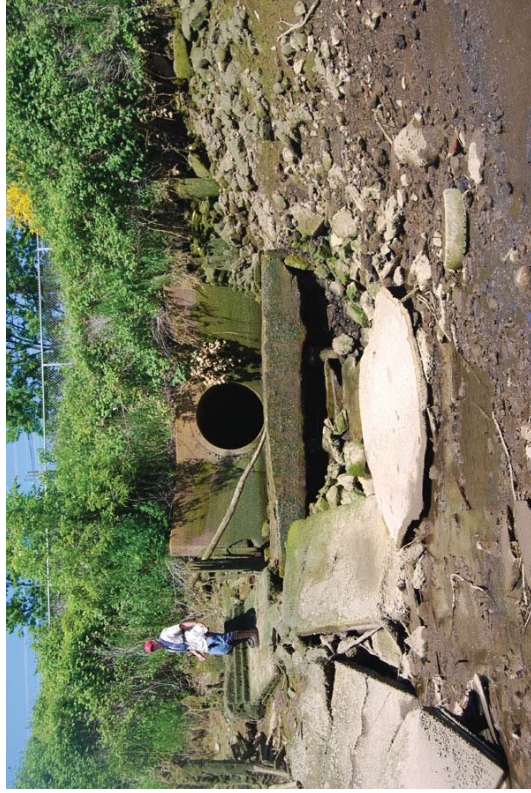
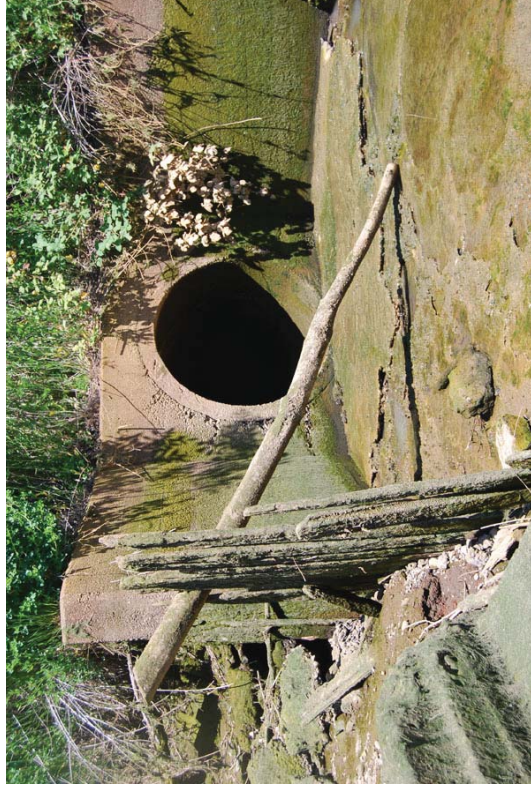
Outfall RI #2049 is a 60-inch diameter, open-ended pipe that empties into Slip 4 at a concrete wall with wing walls (see Appendix A, p. A-12). Flow through the outfall was approximately 5 gpm at the time of observation. Suitable manhole access to this drain line was not found.

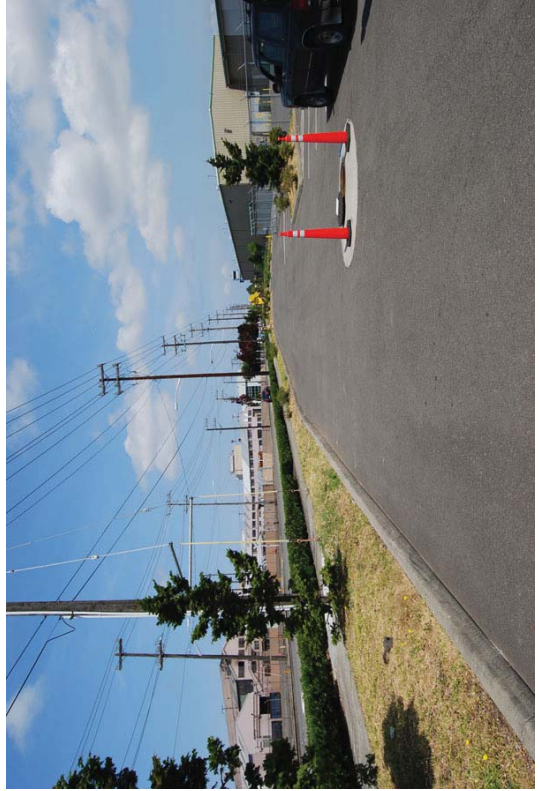
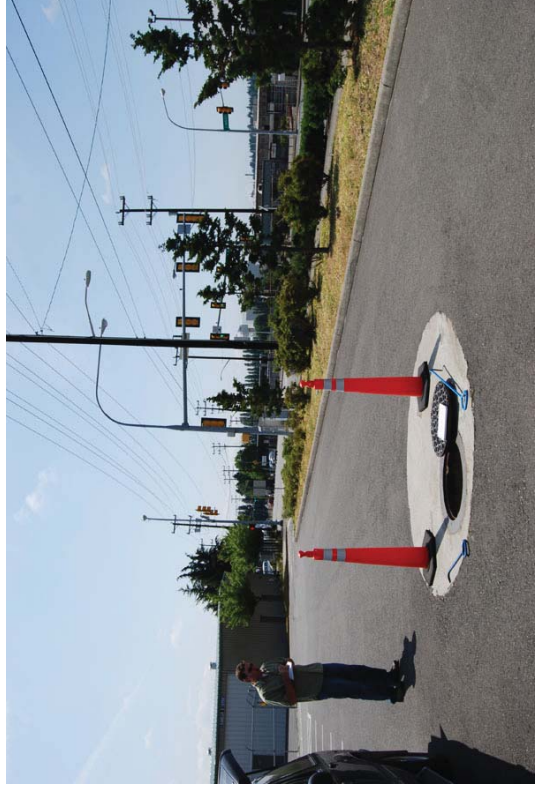
Outfall RI #2062 consists of a 48-inch diameter, open-ended steel pipe that protrudes from a bulkhead (see Figure 8 and Appendix A, p. A-14). Water flow was approximately 20 gpm at the time of observation. This outfall drains the northern portion of the King County Airport. The most suitable manhole access to this outfall's drain line is located in the roadway of S 87th Place, a King County Airport access road parallel to East Marginal Way S.

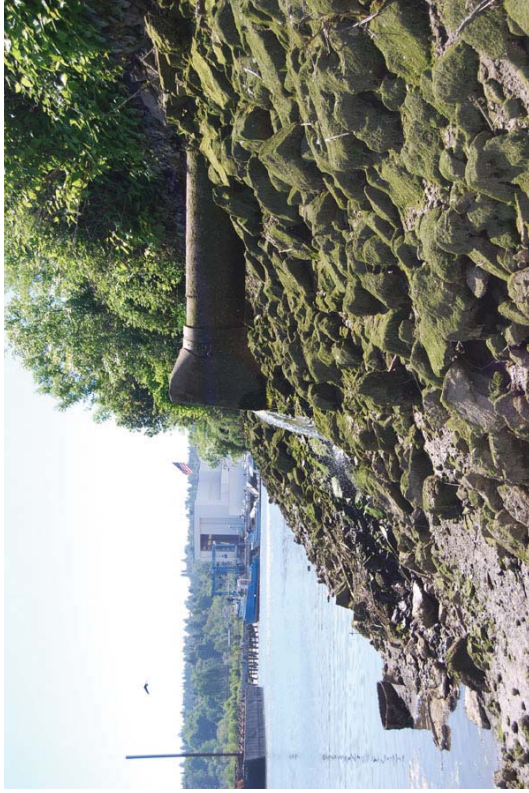
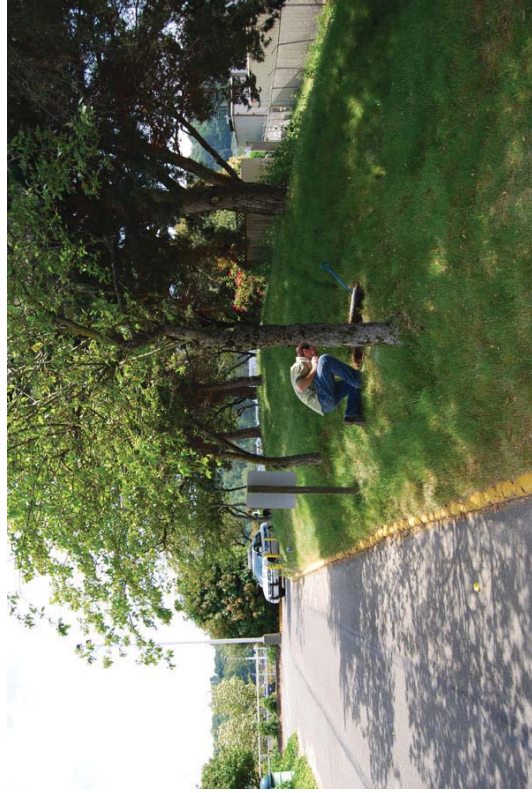
Outfall RI #2080 is a 24-inch diameter, riveted, steel pipe with a pinch valve closure at its end (see Figure 9 and Appendix A, p. A-15). The pipe extends out from bank riprap near the high water mark. Water flow was approximately 30 gpm at the time of observation. The most appropriate manhole access to the drain line is found in a grassy median east of East Marginal Way S.

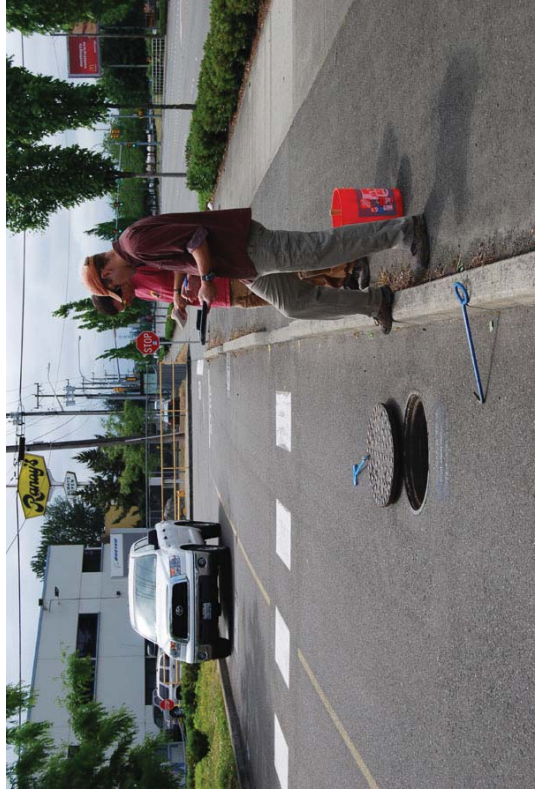
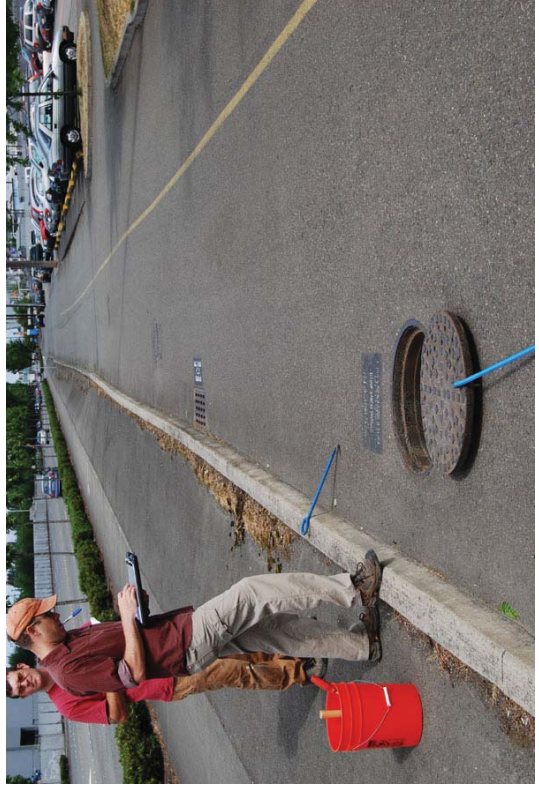
Outfall RI #2095 consists of an 84-inch diameter pipe that empties into the LDW at a concrete wall with wing walls (see Figure 10 and Appendix A, p. A-16). The opening is covered by a tide gate that hangs from the concrete wall. Drain water pours over a concrete platform before reaching the LDW. The most suitable manhole access to the drain line upstream of the CSO is found along a Boeing access road parallel to E Marginal Way. A bottle-type sediment trap was observed within the drain line attached to the wall of the pipe.

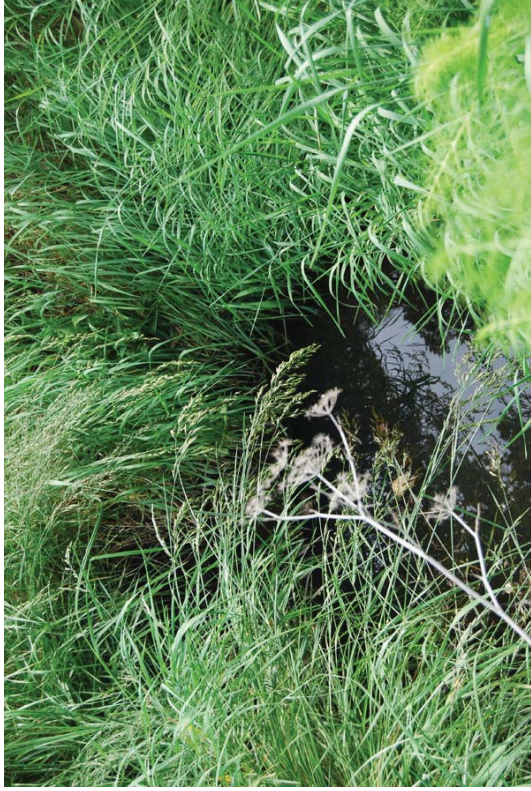
Outfall RI #2149 consists of a 24-inch diameter pipe emptying into a swale at a roadside park (see Appendix A, p. A-17). Locations of drain lines and access sites for the outfall are unknown.

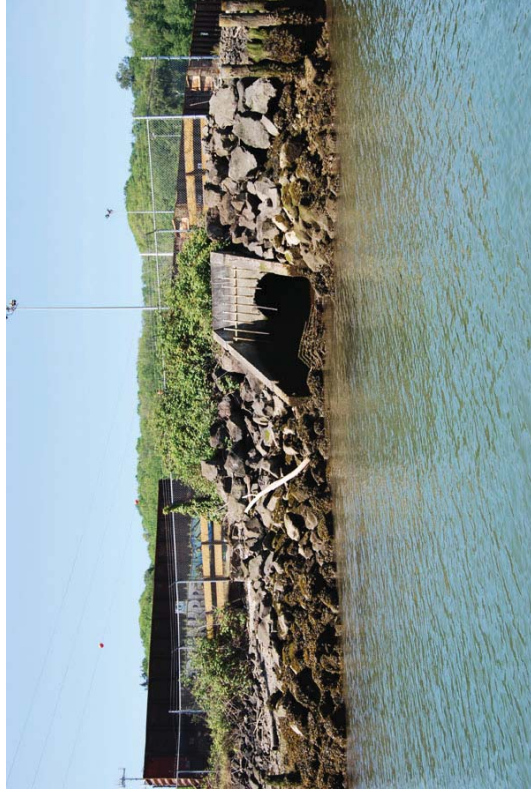
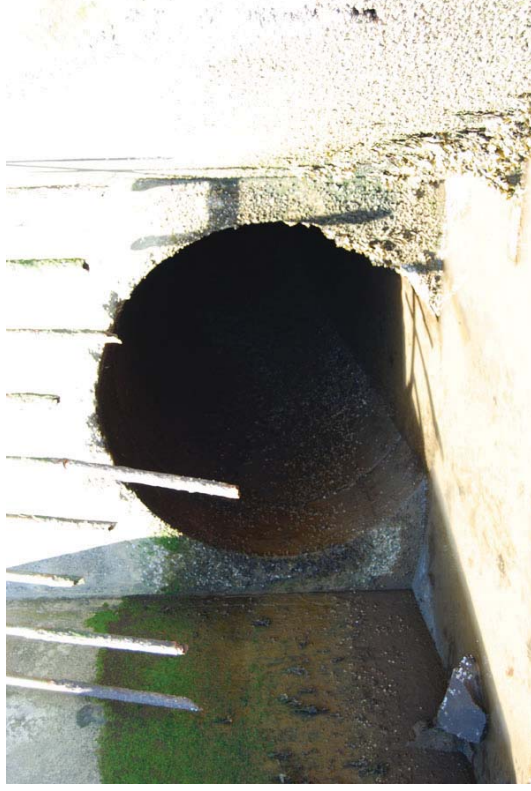
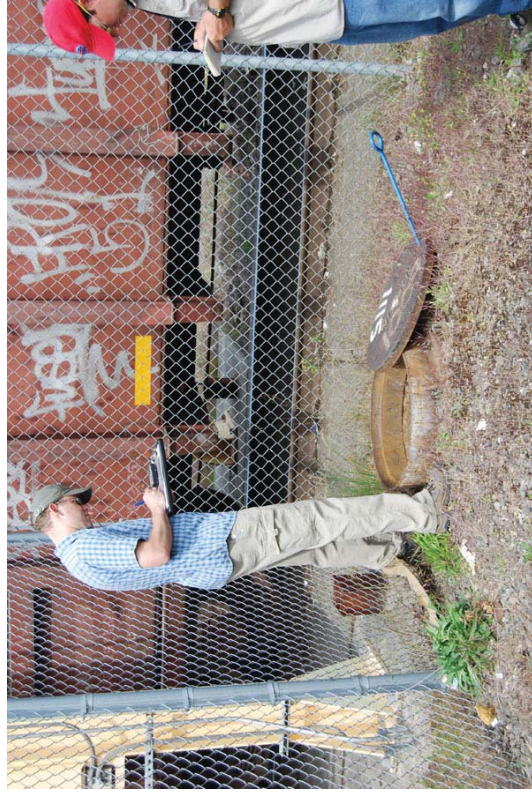
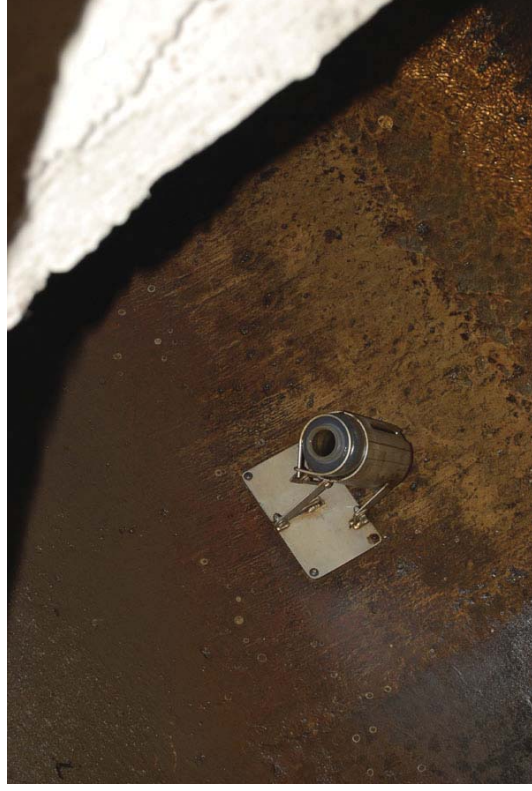
Outfall RI #2147 consists of a 72-inch diameter pipe that empties into the LDW at a concrete wall (with wing walls) surrounded by bank riprap (see Figure 11 and Appendix A, p. A-18). The opening of the pipe is partially blocked by the remnants of a metal gate. The most appropriate access to the drain line is found at a manhole located outside the T-105 gate along SW Idaho

Street. This manhole is found between railroad tracks and along the T-105 fence line. A bottle-type sediment trap was observed within the drain line attached to the wall of the pipe.

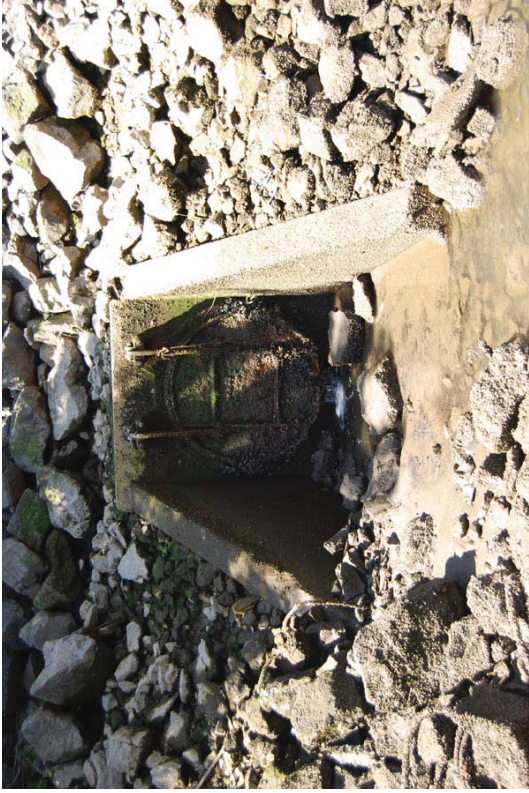
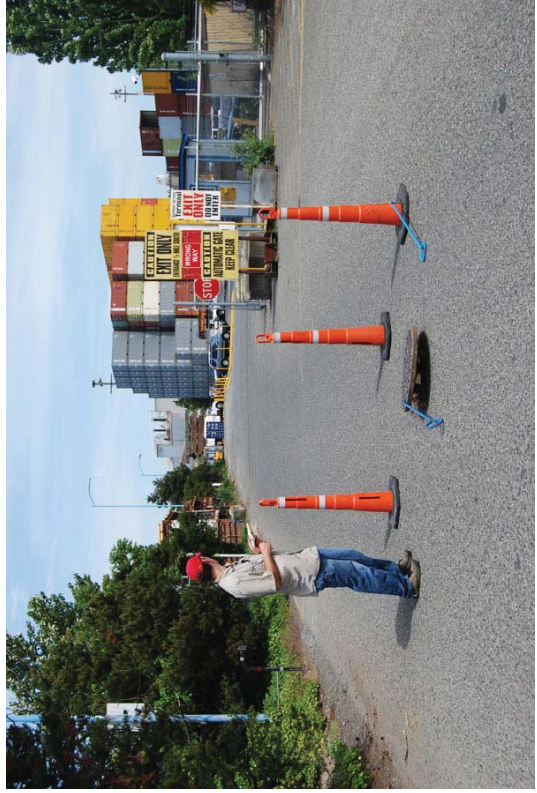
Outfall RI #2127 consists of a 48-inch diameter pipe that empties into the LDW at a concrete wall (with wing walls) surrounded by bank riprap (see Figure 12 and Appendix A, p. A-19). The opening of the pipe is covered with a tide gate attached to the wall. At the time of observation, flow out of the pipe was approximately 50 gpm. The most appropriate manhole access to the drain line is located outside the exit gate of the Port of Seattle. This manhole is located in a roadway used by truck traffic exiting the Port.

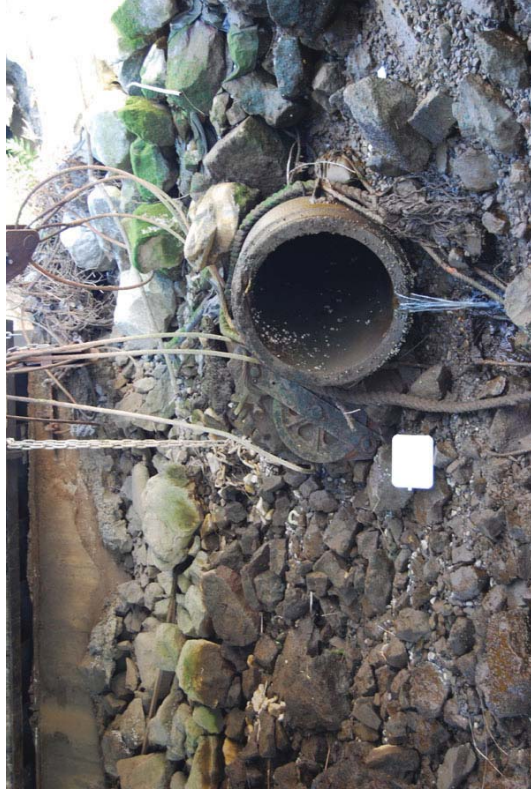
Outfall RI #2220 consists of a 24-inch diameter, concrete pipe that emerges from riprap underneath a pier (see Appendix A, p. A-20). Water flow from the outfall was approximately 10 gpm at the time of observation. No manhole access locations were identified for this outfall.

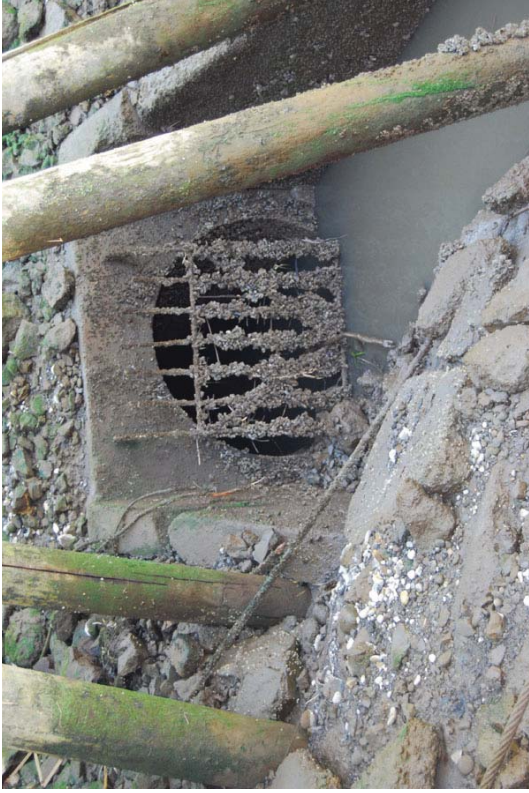
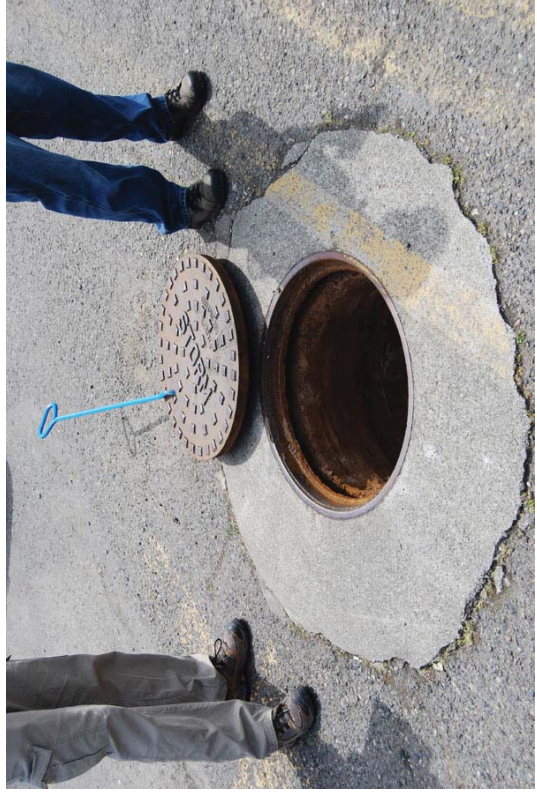
Outfall RI #2125 consists of a 72-inch diameter pipe that emerges from riprap at a concrete wall (see Figure 13 and Appendix A, p. A-21). The pipe opening is securely covered by a grate. The most appropriate manhole access to this drain line is located along SW Front Street, behind a guard house inside the entrance to the Port of Seattle.

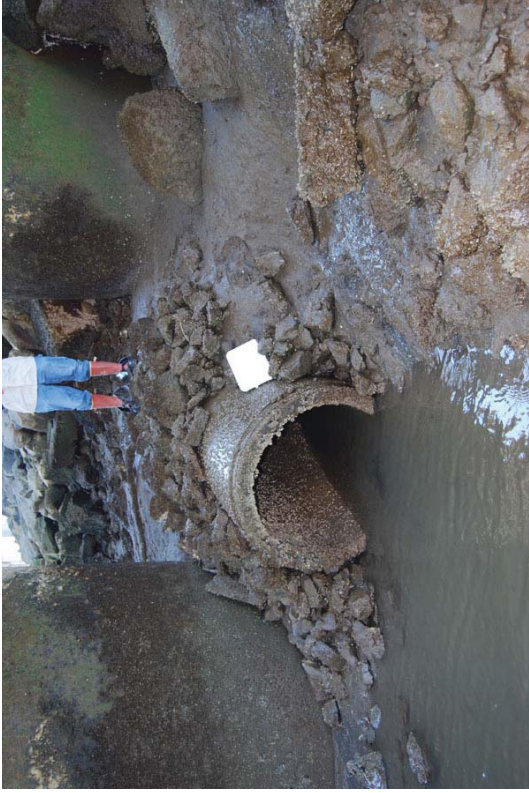
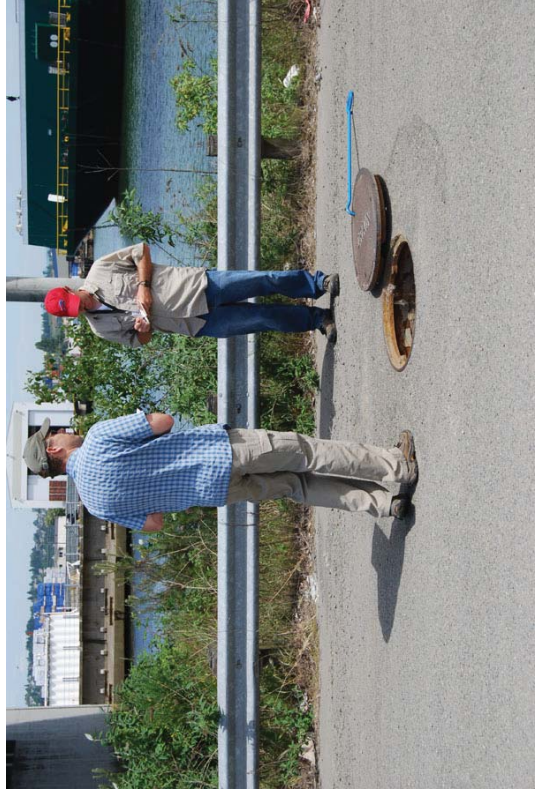
Outfall RI #2506 consists of a 36-inch diameter, open-ended, concrete pipe that emerges from bank riprap underneath the southbound lanes of the 1st Avenue S Bridge (see Appendix A, p. A-23). Manhole access to the drain line is located along the dead end road SW Peninsula Place. This drain line is a CSO and therefore is not suitable for sampling.

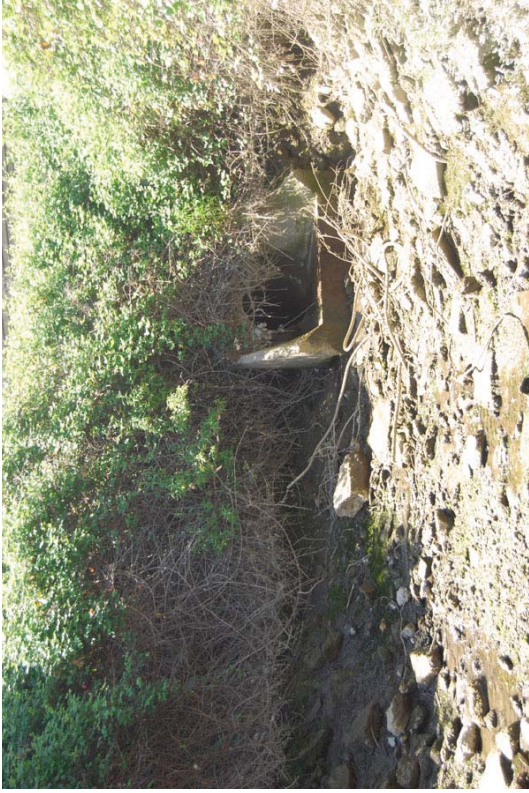
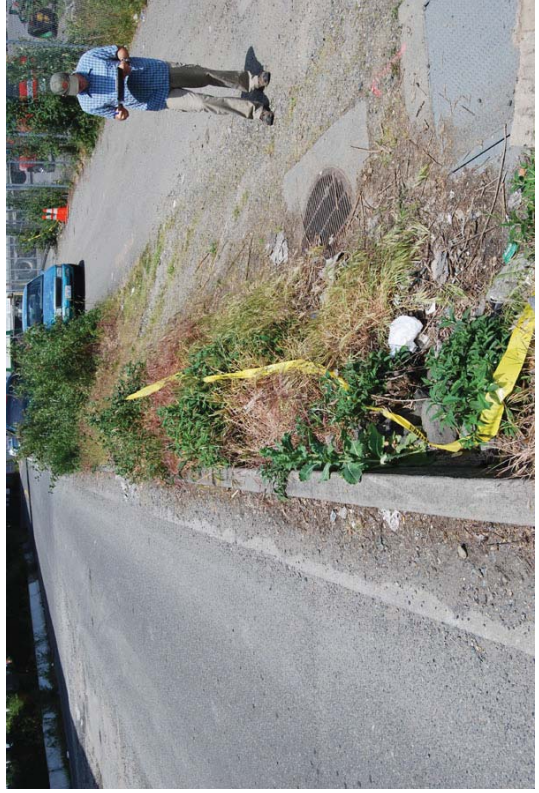
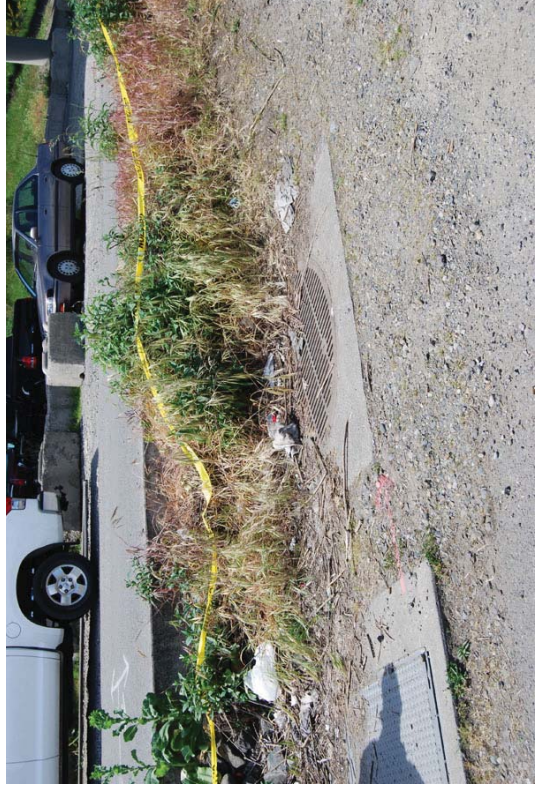
Outfall RI #2120 consists of a 36-inch diameter, open-ended, concrete pipe that empties into the head of an intertidal swale (see Appendix A, p. A-24). Water flow from the pipe was approximately 5 gpm at the time of observation. No definite drain lines for this outfall were

identified from SPU data, but a storm grate west of the outfall may provide access to the drain line.
