Scoping of Lateral Loading Study Lower Duwamish Waterway, WA

Site Reconnaissance Report

FINAL

June 2009

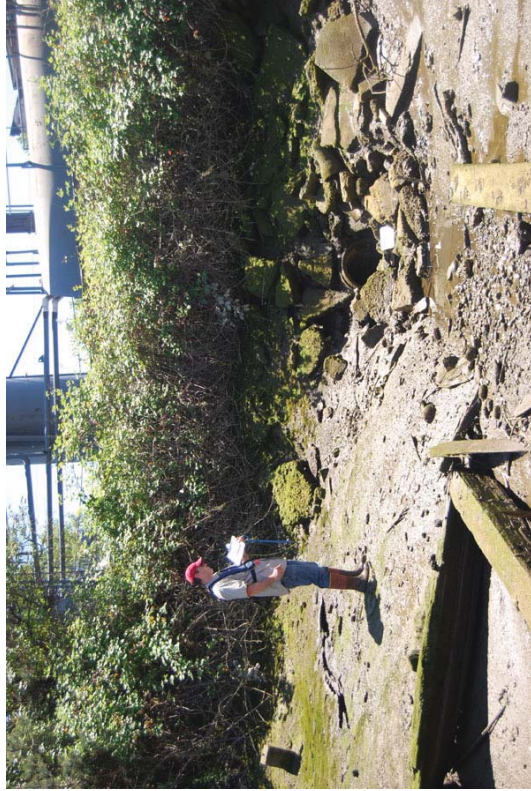
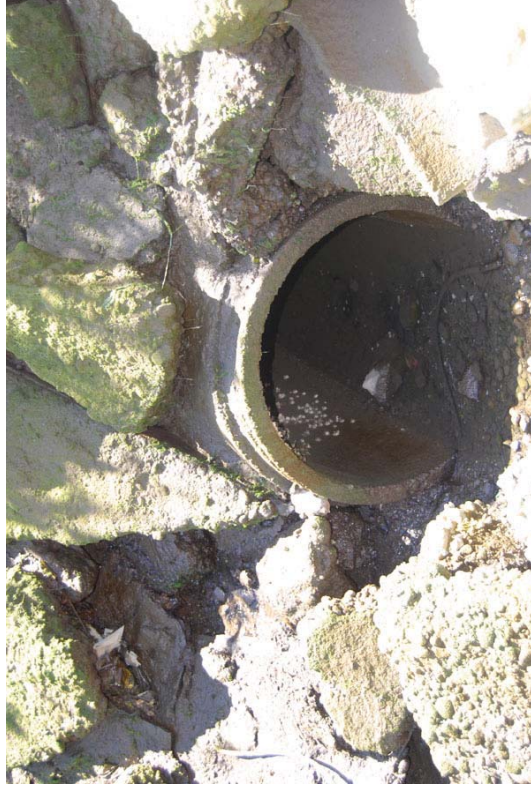
Outfall RI #2118 consists of a 24-inch diameter, open-ended, concrete pipe that empties onto the southern bank of an intertidal swale (see Appendix A, p. A-25). No manhole access sites were identified for this outfall.

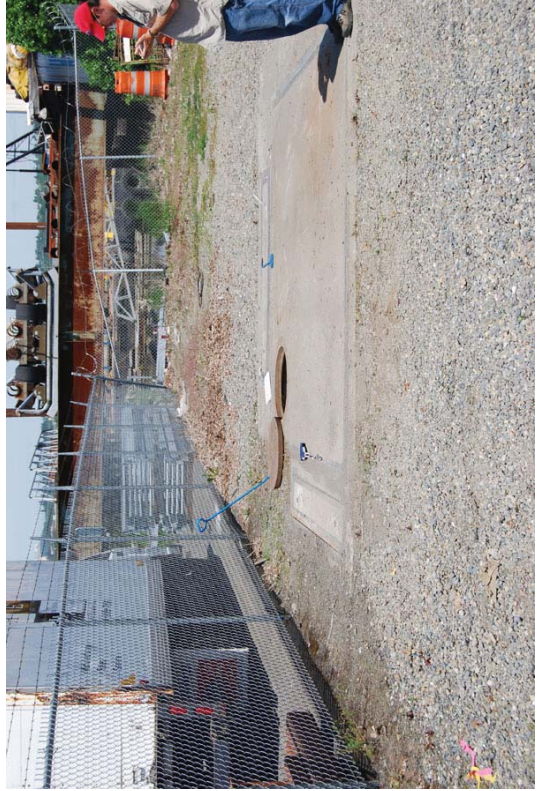
Based upon SPU data, Outfall RI #2112 is believed to empty into the LDW in a small cove (see Figure 14 and Appendix A, p. A-26). River access to the outfall is blocked by piers and barges, while upland access is blocked by a chain-link fence. Manhole access to the drain line is found next to a fence in a gravel lot at the end of 7th Avenue S.

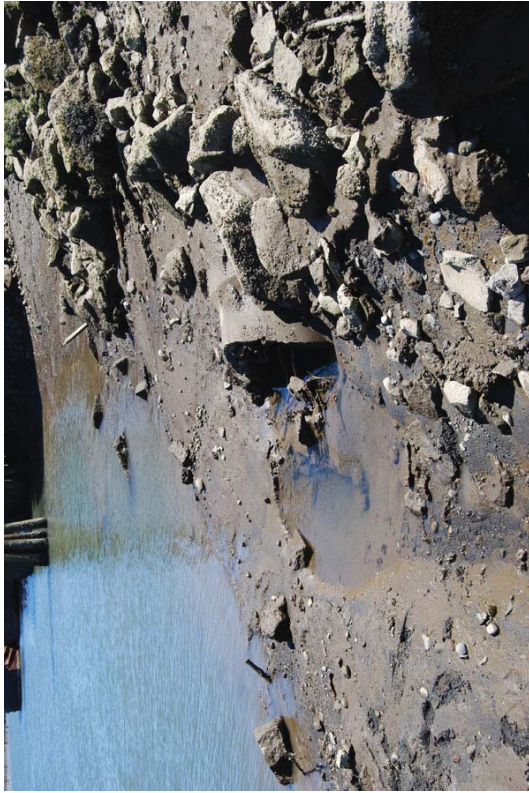
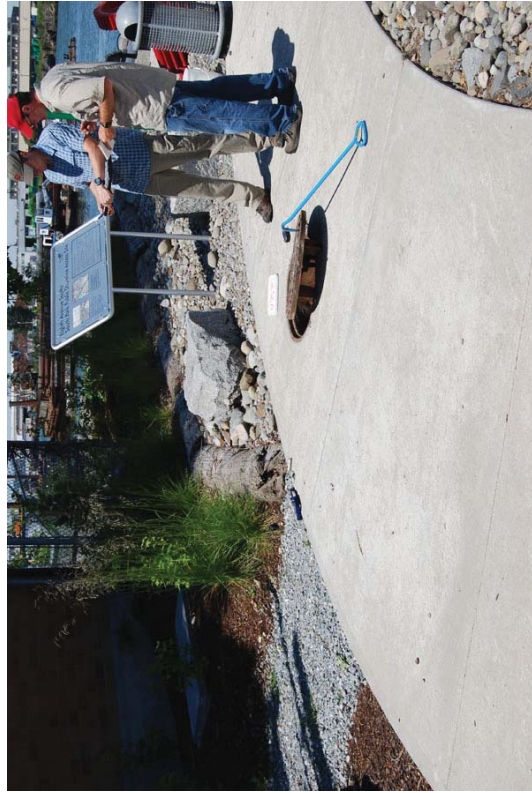
Outfall RI #2107 consists of a 36-inch diameter, open-ended, concrete pipe that emerges from bank riprap (see Appendix A, p. A-27). The outfall is located at a public park at the end of 8th Avenue S. Manhole access is found along a sidewalk within the 8th Avenue S Park. This drain line is a CSO and therefore is not suitable for sampling.

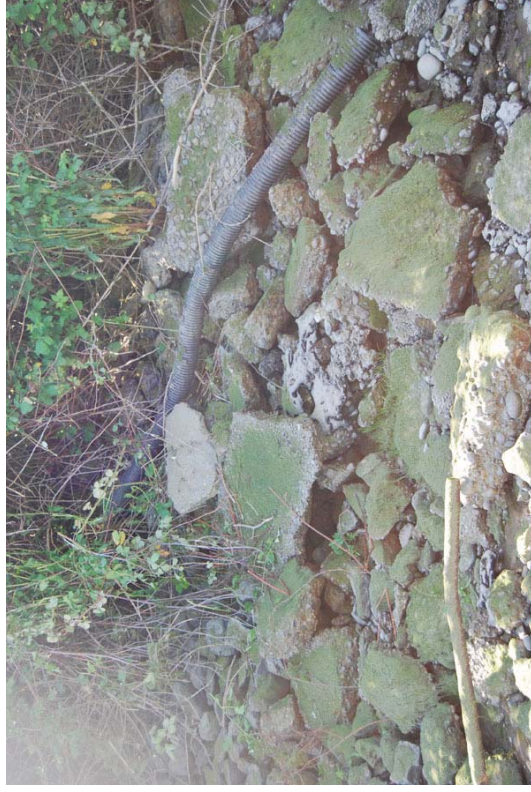
Outfall RI #2210 consists of a 4-inch diameter, open-ended, plastic pipe that emerges from bushes on the bank of Terminal 117 (see Appendix A, p. A-28). No manhole access sites were identified for this outfall.

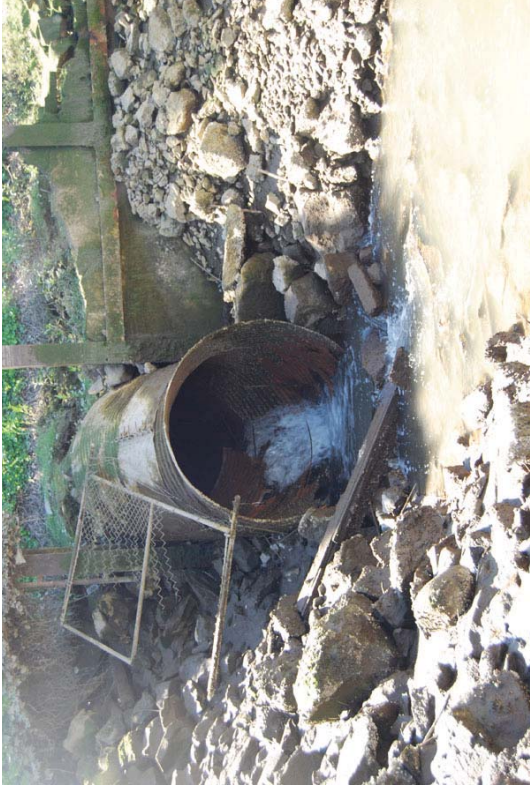
Outfall RI #2100A consists of a 72-inch diameter, open-ended pipe that emerges from bank riprap in the southwest corner of the Duwamish Yacht Club Marina (see Appendix A, p. A-29). Water flow from the outfall was approximately 50 gpm at the time of observation. No manhole access sites were identified for this outfall.

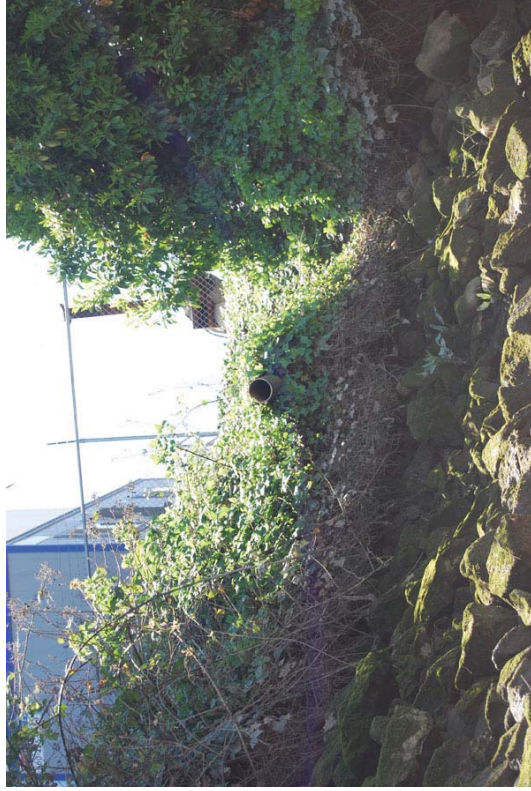
Outfall RI #2100B consists of a 6-inch diameter, open-ended, PVC pipe that emerges from brush in the same corner of the Duwamish Yacht Club Marina as Outfall #374 (see Appendix A, p. A-30). No manhole access sites were identified for this outfall.
