Lower Duwamish Waterway Survey of Potential PCB-Containing Building Material Sources

Summary Report

Washington State Department of Ecology
Toxics Cleanup Program
Northwest Regional Office
Bellevue, WA

June 2011

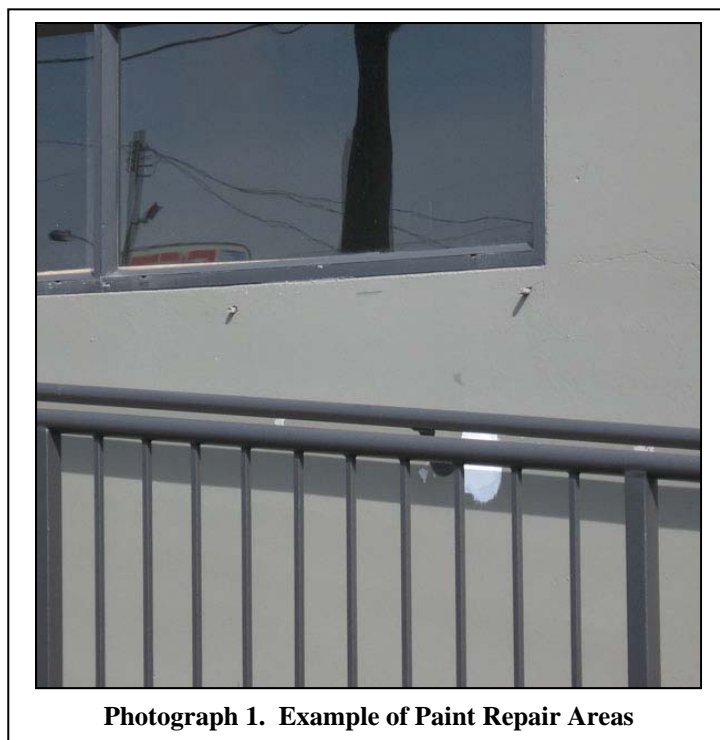
Discrete sample areas and test areas were repaired by an Ecology subcontractor after sampling was completed. An example of a paint sample repair area is shown in Photograph 1 while an example of a caulk sample repair area is shown in Photograph 2. The composite samples were then delivered to ARI in Tukwila, WA, in sturdy coolers under ambient temperatures using proper chain-of-custody procedures.

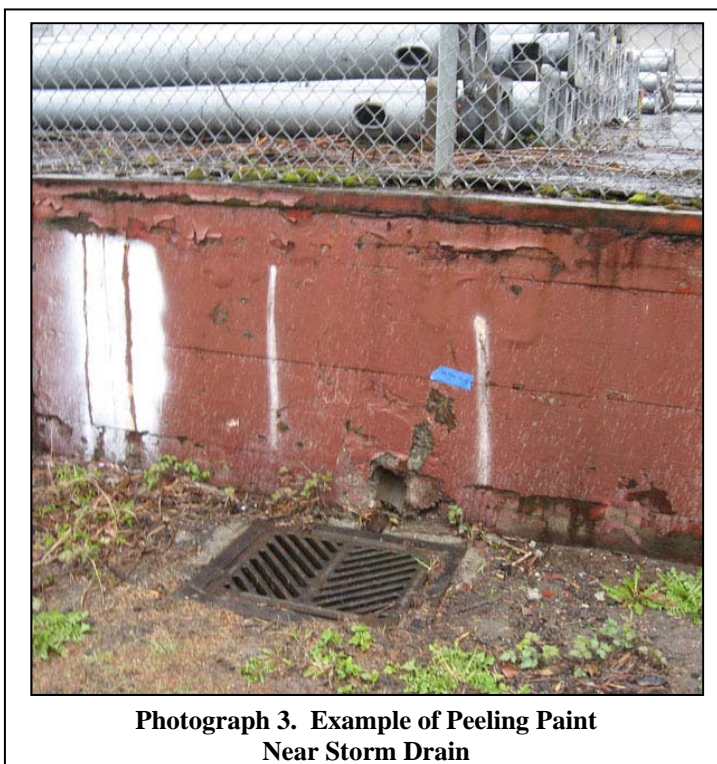
Photograph 3. Example of Peeling Paint Near Storm Drain
